Assessment and Analysis of the Breeding Barn at Shelburne Farms

David C. Fischetti¹, Douglas W. Porter², Ronald W. Anthony³

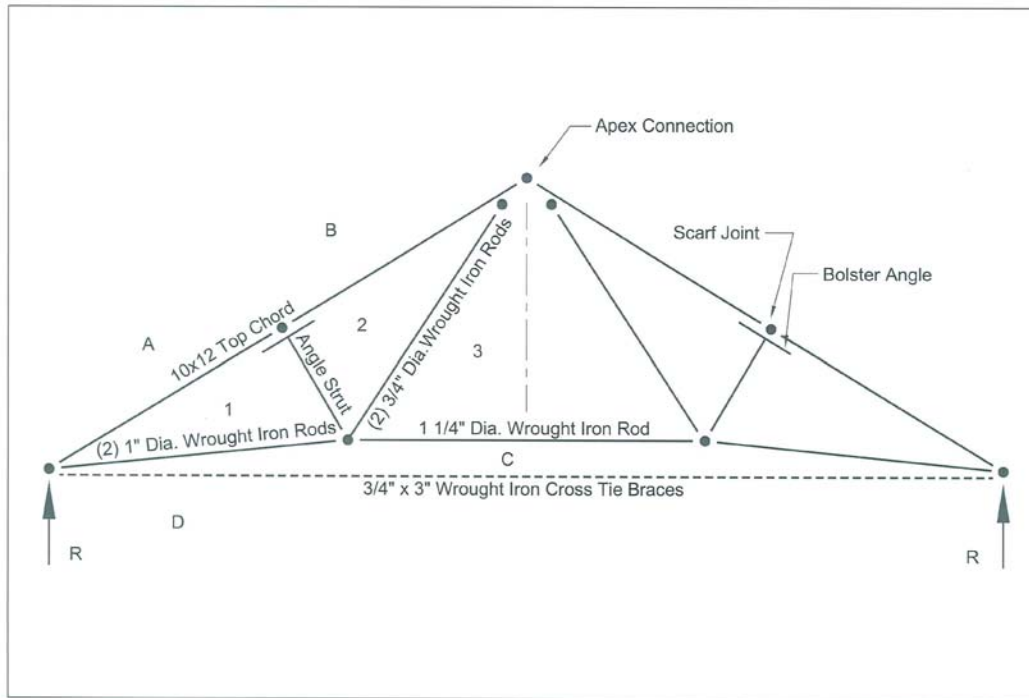
Figure 8. This image shows the location of the bolster angels and the connection arrangement at the apex.

Apparently, the truss in the riding ring evolved from a simple truss analyzed by graphical means, to one with purlins located between joints (Figure 10), to a system combining a truss with a horizontal tie (Figure 11). The wrought iron angles used to bolster the spliced top chord is an interesting detail. These may have been added as an afterthought, sometime during design, to reinforce the top chord acting as a two-span beam supporting purlins at the midpoint of both spans. Although it certainly was possible to obtain southern pine in twelve-meter lengths to produce a two-span continuous top chord, the designers chose to

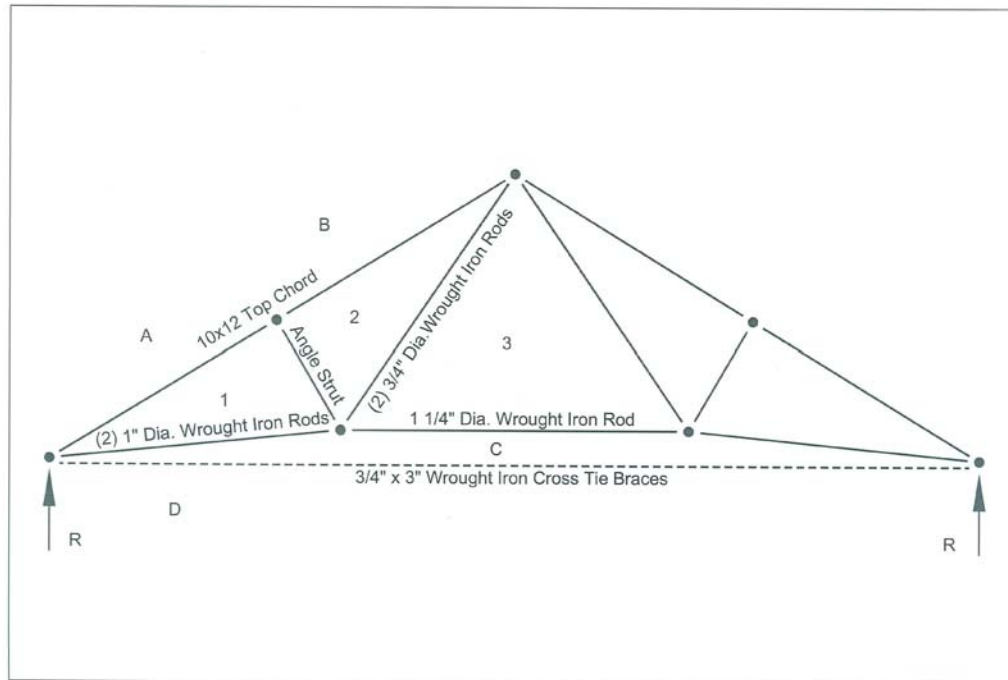
Figure 11. Analysis of the truss with the cross braces included, causes member C3 to revert to compression.

The addition of 1.91cm thick by 7.62cm high cross-brace tie rods to the building, apparently during construction, provides another path for the tensile force to be resisted. By including the tie rods in the analysis of the building cross section, the center tie bar of the truss becomes a zero force member (Figure 11). Analysis of the roof truss by the computer using the appropriate section properties and material stiffness shows that immediate horizontal deflection under dead load only would have been a total of five centimeters. This deflection of the trusses would have manifested itself in bending of the 25.4cm x 25.4cm post from a point at the horizontal chord of the roof trussed above the side aisle to the 20.32cm x 25.4cm girt (sill) at the heel of the truss, a distance of almost two and a half meters. Certainly, a horizontal movement of two and a half centimeters would have been observed in the post for a distance of only two and a half meters in height. If the annex had already been built or partially framed, it would have provided some restraint, pushing most of the deflection towards the posts along the north side of the building which certainly would have been observed by workmen.

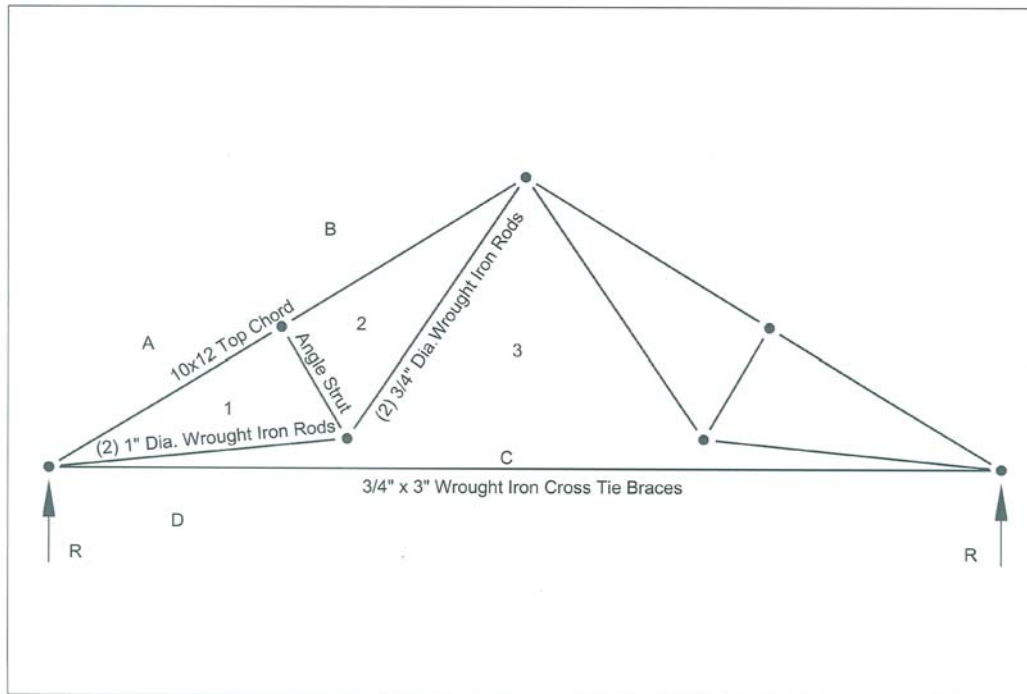
Figure 12. Testing and analysis indicates that the roof system acts as an A-frame with trussed rafters.

The answer was to provide additional ties to limit the movement which is natural to a truss with a raised bottom chord. In providing these ties R. H. Robertson transformed the building cross section into a tied A-frame with trussed rafters (Figure 12).
