Structural Repair of the Breeding Barn at Shelburne Farms

STRUCTURAL REPAIR OF THE BREEDING BARN AT SHELBURNE FARMS

VOLUME II: APPENDICES

THE STRUCTURAL REPAIR OF THE BREEDING BARN AT
SHELBURNE FARMS

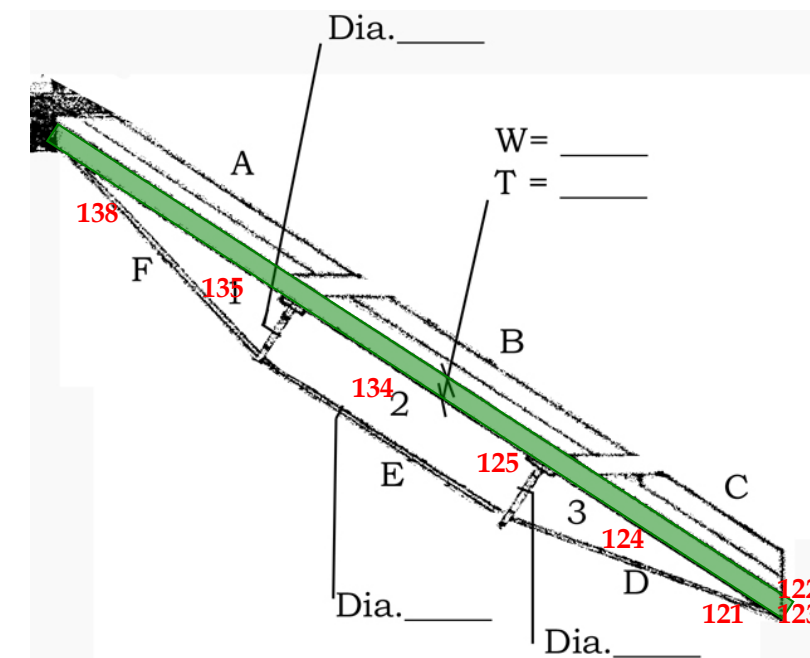
Figure 11. Inspection results from Valley Rafter 1 South.

This rafter is in good condition, as indicated by the green color along its length in Figure 11. The timber, seen from the apex in Figure 12, appears free of splits or slope of grain. The seasoning check shown in Figure 13 is typical for large cross-section timbers that dry in service and does not represent a failure in the timber.

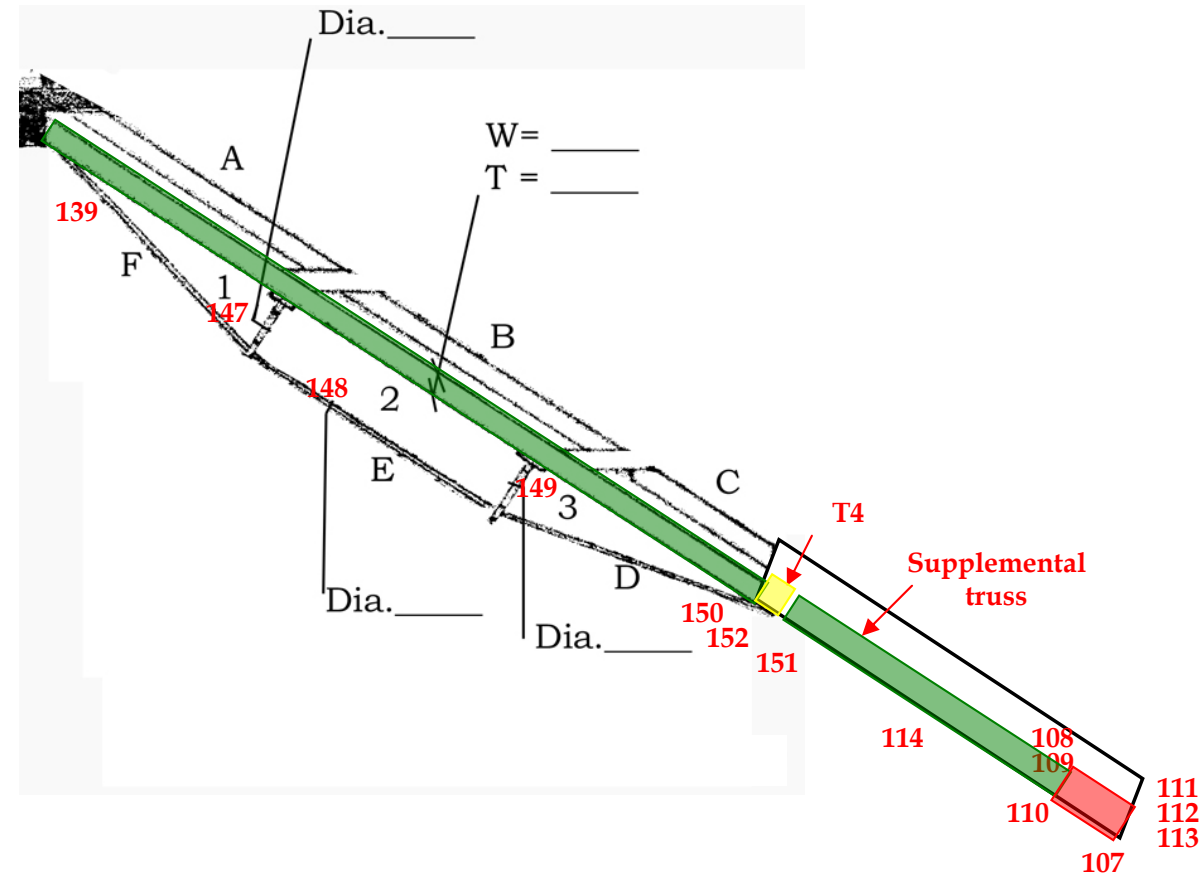
Figure 14. Inspection results from Valley Rafter 4.5 North.

Much of this rafter is in good condition (Figure 14). The timber, seen from the apex in Figure 15, appears free of splits or slope of grain. However, there is possible minor deterioration in the vicinity of Truss 4 (T4 on Figure 14) and some crushing of the timber has occurred. A more serious condition exists at the heel of the rafter, where it bears on the top plate of the north wall (Figure 16). The rafter is severely decayed and is secured to the top plate by four nails that are not in full contact with both the rafter and the top plate (Figure 17).

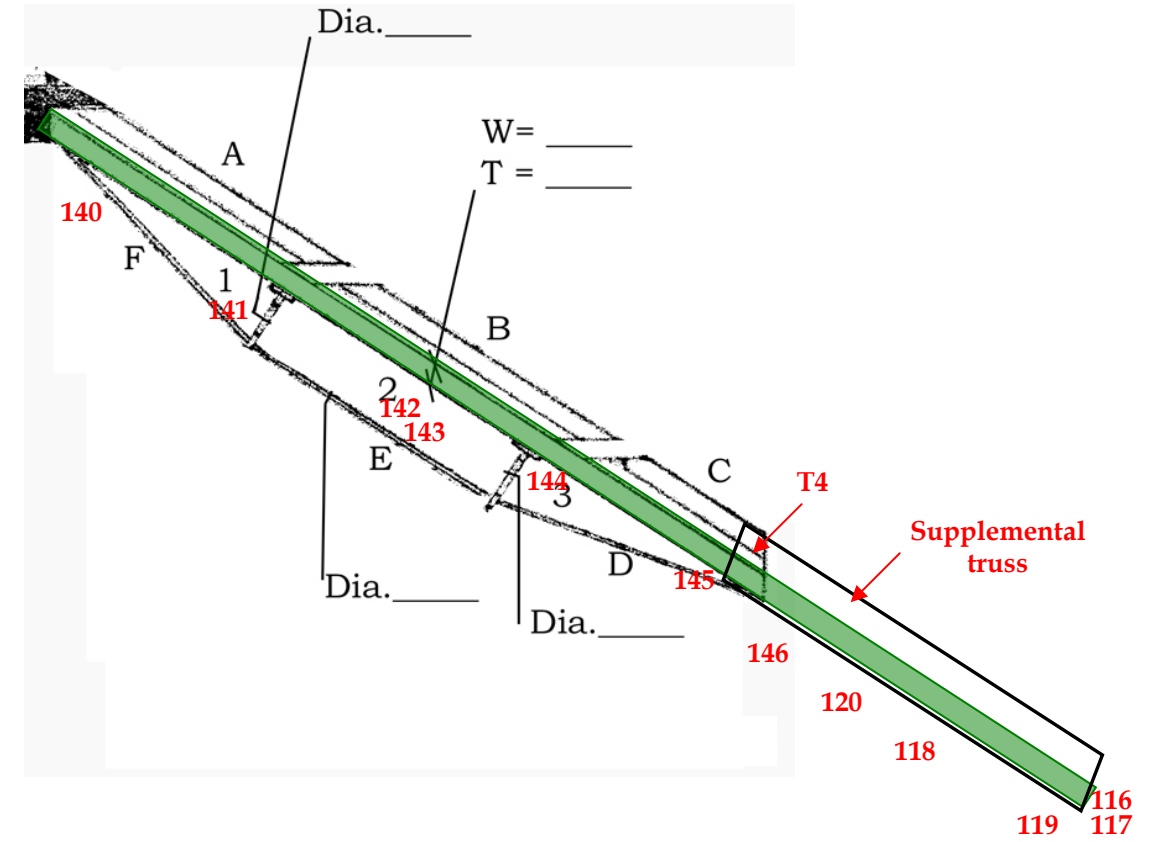
Figure 18. Inspection results from Valley Rafter 4.5 South.

This rafter is in good condition, as indicated by the green color along its length in the schematic shown in Figure 18. Although the general appearance is good (Figure 19), and no deterioration due to decay was found using resistance drilling, this timber has severe slope of grain as indicated by the seasoning check shown in Figure 20. Severe slope of grain will reduce the load-carrying capacity of the timber.

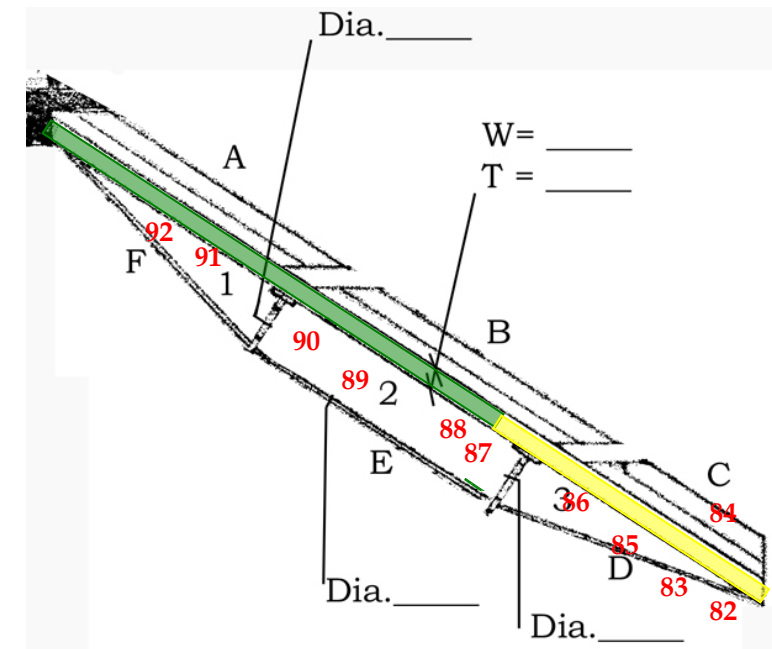
Figure 21. Inspection results from Valley Rafter 8 North

The likely cause of the decay is leaks in the roof that have since been repaired. So long as the moisture content of the timber is below 20 percent, the decay typically cannot be active. Proper maintenance of the roof covering is the key to keeping the timbers in the valley rafters dry. As with any of the deterioration found, the structural engineer should verify that the loss of cross section does not compromise the load-carrying capacity of the timber sufficiently to warrant reinforcement or replacement.

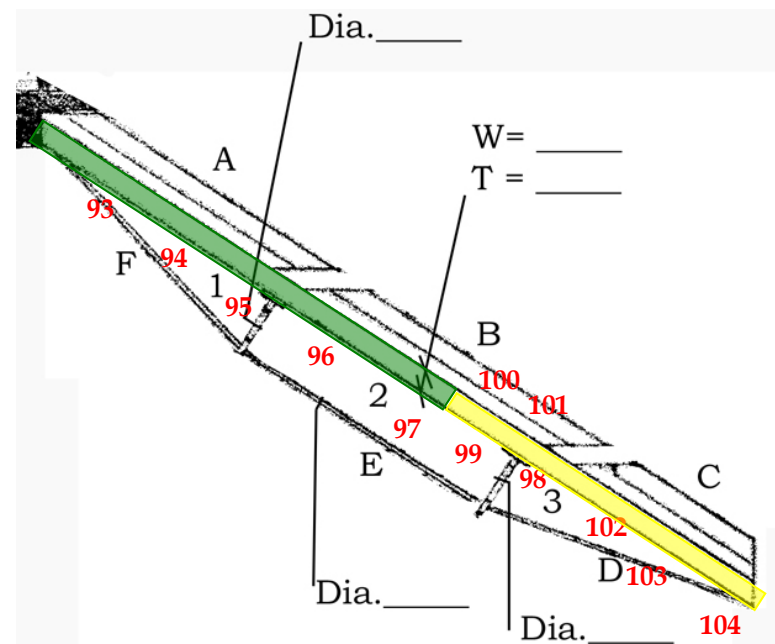
Figure 24. Inspection results from Valley Rafter 8 South.

As shown in Figure 24, this rafter also has minor channelizing along the lower length of the rafter. Viewed from below, no deterioration is visible (Figure 25). Resistance drilling and probing revealed deteriorated wood on the upper surface of the timber from just above the lower queen post to the heel of the rafter.

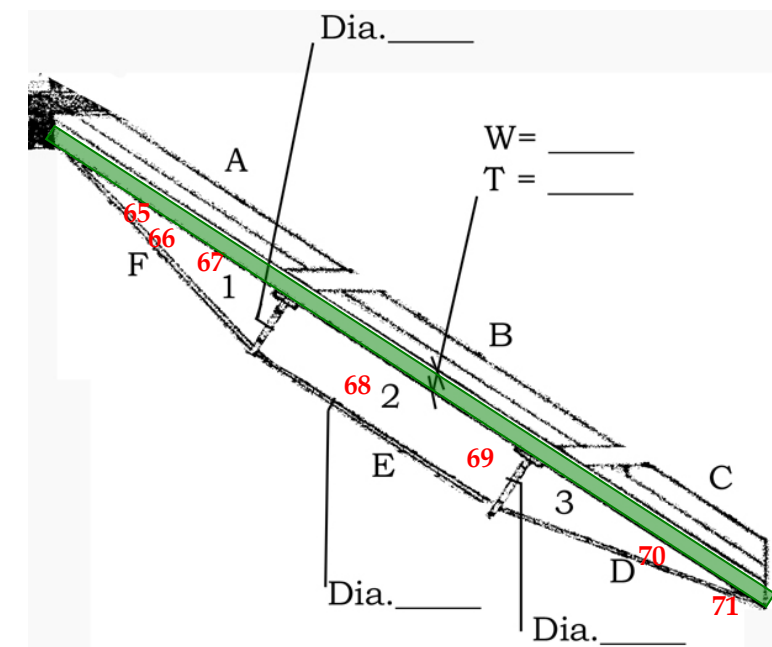
Figure 26. Inspection results from Valley Rafter 11 North.

This rafter is in good condition, as indicated by the green color along its length in Figure 26. The timber, seen in Figure 27, has seasoning checks but minor slope of grain. The seasoning checks visible in Figure 27 are typical for large cross-section timbers that dry in service and do not represent a failure in the timber.

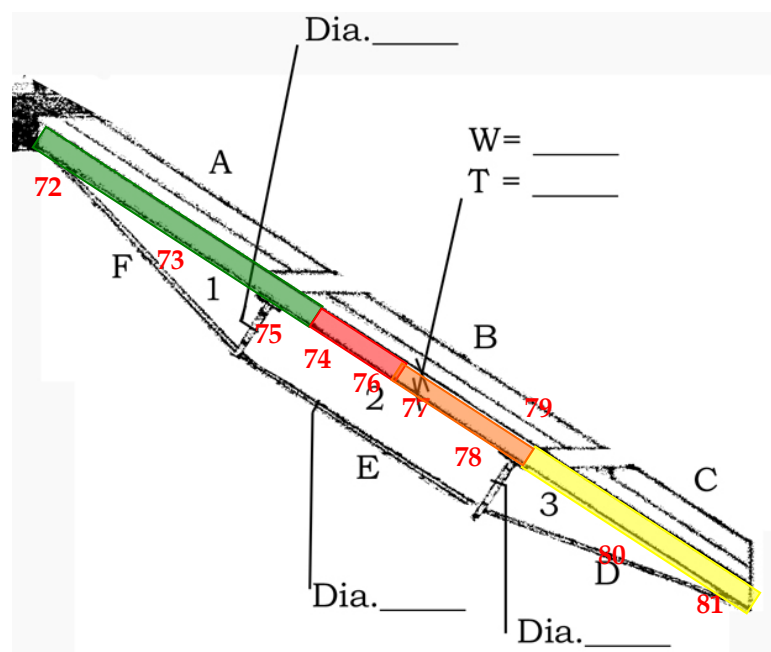
Figure 28. Inspection results from Valley Rafter 11 South.

As shown in Figure 28, this rafter also has minor channelizing along the lower length of the rafter. Resistance drilling and probing revealed deteriorated wood on the upper surface of the timber from just above the lower queen post to the heel of the rafter. The area below the upper queen post has severe decay with significant loss of cross section (Figure 29). Additionally, the upper purlin is severely twisted where it meets the valley rafter (Figure 30).

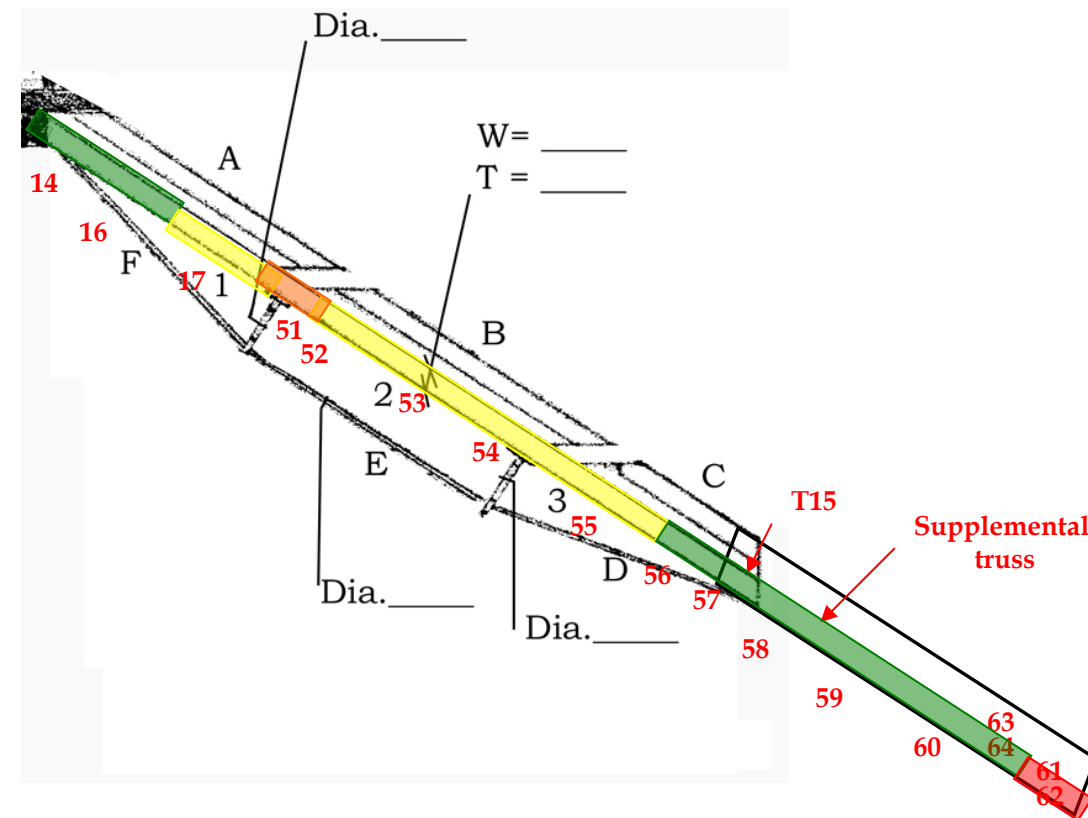
Figure 36. Inspection results from Valley Rafter 14.5 South.

This rafter has minor channelizing along the intermediate length of the rafter (Figure 36). The upper length of the timber above the upper queen post is in good condition (Figure 37). The heel of the rafter, where it bears on the top plate of the south wall, is decayed (Figures 38 and 39).

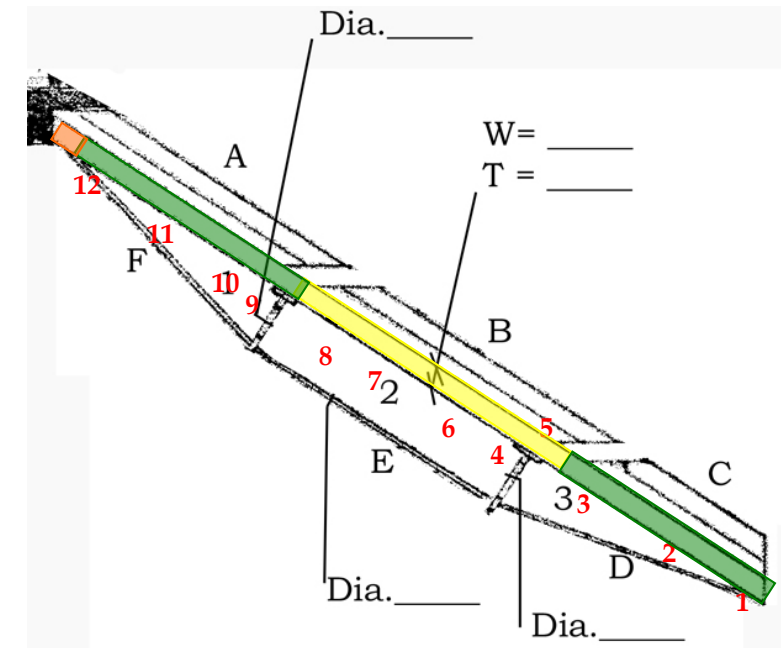
Figure 40. Inspection results from Valley Rafter 17 North.

This rafter has minor channelizing along the intermediate length of the rafter (Figure 40). A seasoning check is visible on the bottom face of the timber (Figures 41 and 42). The wood spacer between the valley rafter and the roof rafter above has deteriorated along much of its length. Between the queen posts the deterioration has extended into the top of the timber in the valley rafter, resulting in channelizing (Figure 43). The timber has an end split at the apex of the valley rafter (Figure 44). The split may have affected the capacity of this connection as a fracture is visible on the bottom of the timber just beyond the steel connector plate (Figure 45).

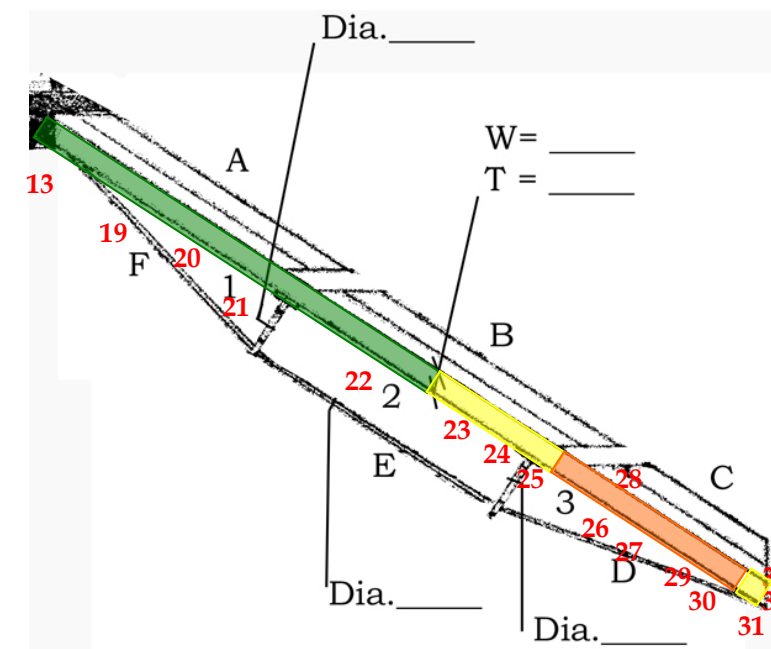
Figure 46. Inspection results from Valley Rafter 17 South.

As shown in Figure 46, this rafter has a range of channelizing along the lower length of the rafter. Resistance drilling and probing revealed minor channelizing between the queen posts that progressively increased to the heel of the rafter. The upper length of the timber is in good condition (Figure 47). The wood spacer between the valley rafter and the roof rafter above has deteriorated along much of its length (Figure 48).

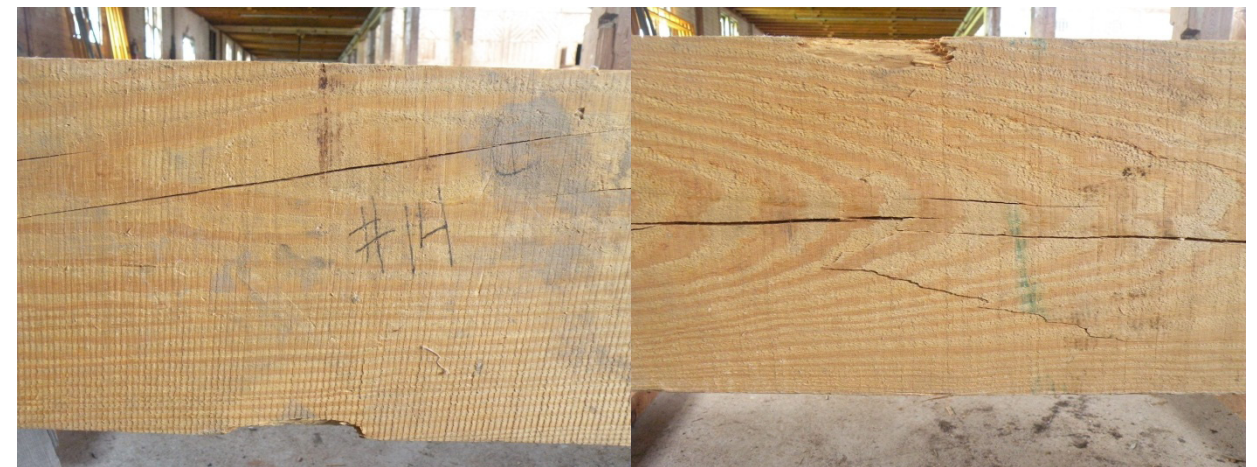
In reviewing the results, it may be helpful to draw attention to a few examples. Figure X2 is one of the solid timber control specimens (#14). The image on the left shows that this specimen had moderate slope of grain, which is known to reduce the strength of timber. The image on the right is a view from the side showing the failure on the tension side of the beam below where the load was applied. For simply supported beams, this failure pattern is typical, although there can be considerable variation due to the presence of local defects in the timber.

Figure 2. Control sample with moderate slope of grain (on the left) and failure on the tension zone (on the right).

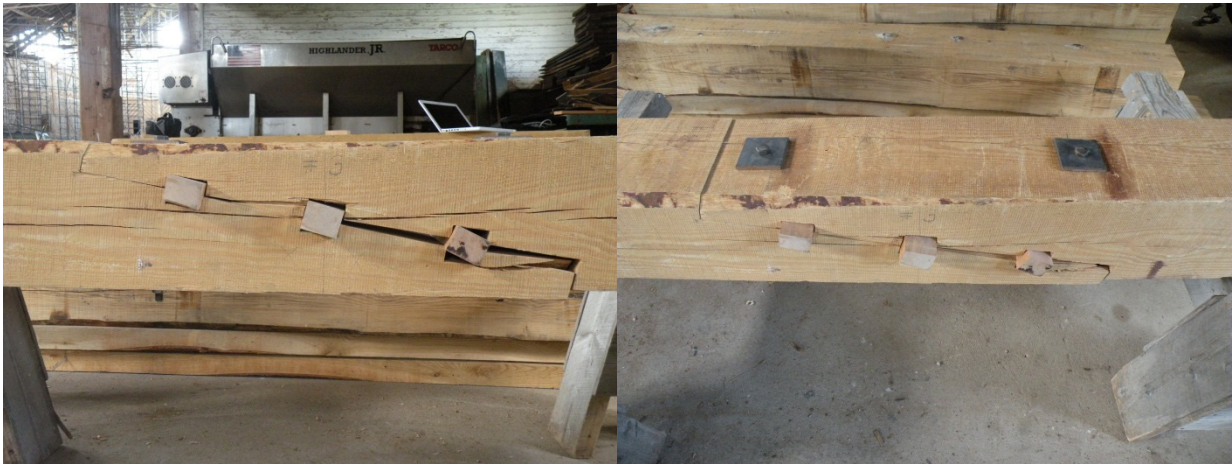
Figure 3 is one of the scarf joint specimens (#3). The image on the left is a side view of the joint after failure. The timber keys tended to rotate as the load increased, allowing the scarf faces to slip relative to one another and open on the tension side of the beam, and ultimately fail at a relatively low load. The image on the right shows the top of the specimen after failure.

Figure 3. Failure of a scarf joint repair specimen.

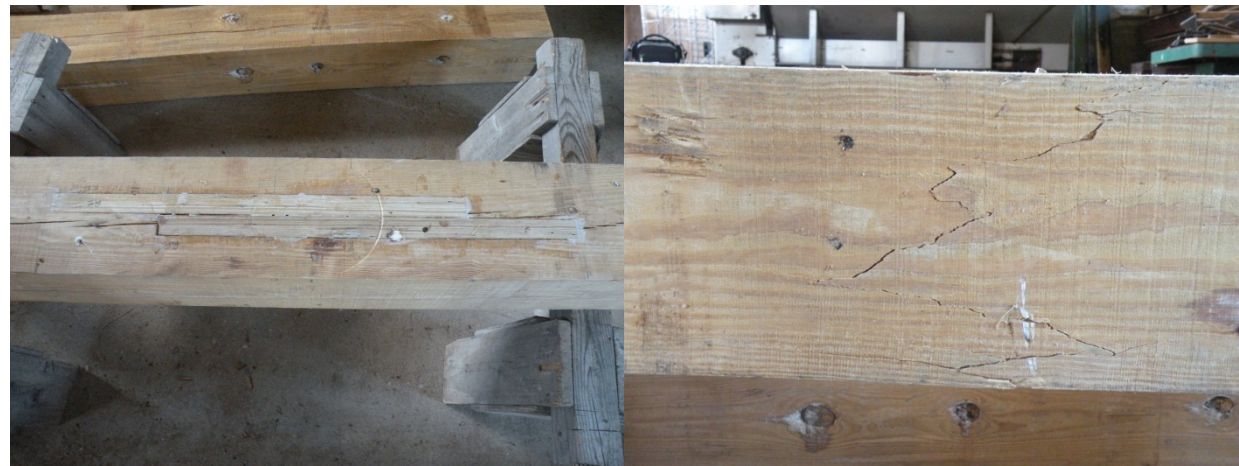
Figure 4 is one of the LVL Dutchman repair specimens (#9). The image on the left is a top view showing the position of two sections of LVL that were glued into the notch cut into the solid timber to simulate the removal of the decayed wood. The importance of the gluing process is discussed below. The image on the right shows a side view of the failure, which is typical for the type of failure that can be observed in solid timber. The significance of this failure mechanism, in addition to the high load at failure, is that the test results indicate the repair could provide a reasonable representation of solid timber behavior. Since the repair is installed from the top of the timber, visual impact is minimized.

Figure 4. High-quality LVL Dutchman repair specimen after failure.

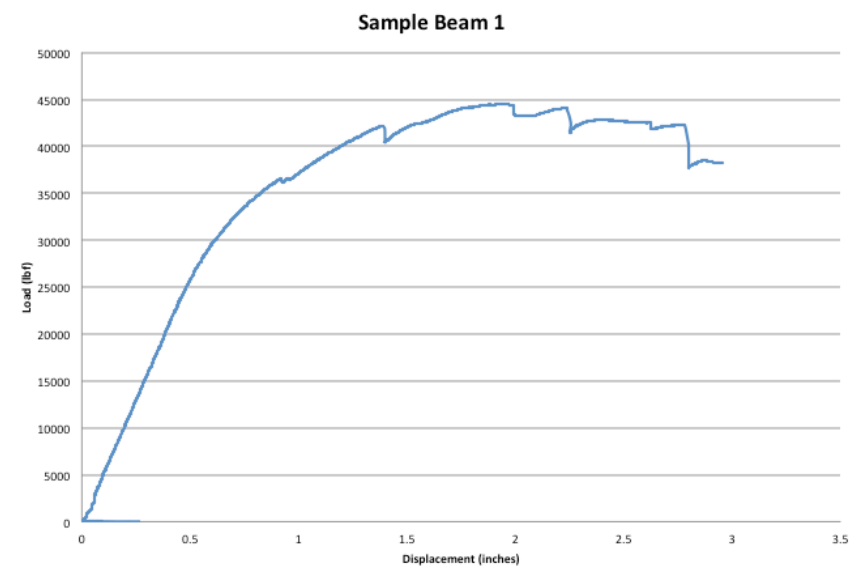
SAMPLE NO: 1 (10 3/16 x 10 1/4)
SAMPLE TYPE: Control
MODE OF FAILURE: Shear failure (sample left) at 44,000 lbf

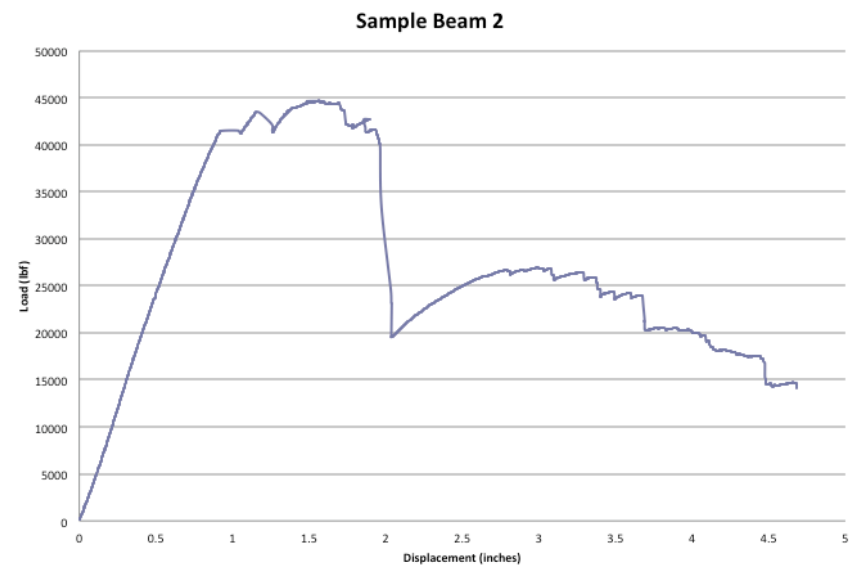
SAMPLE NO: 2 (10 1/4 x 10)
SAMPLE TYPE: LVL dutchman
MODE OF FAILURE: Compression failure at load cell followed by tension failure shortly after at about 44,600 lbf; accompanied by shear failure (sample right). On opening the joint, it was clear that adhesive was never applied to the Dutchman, but only to the mortise. The lvl was easy to remove in pieces once the timber had been cut across the repair

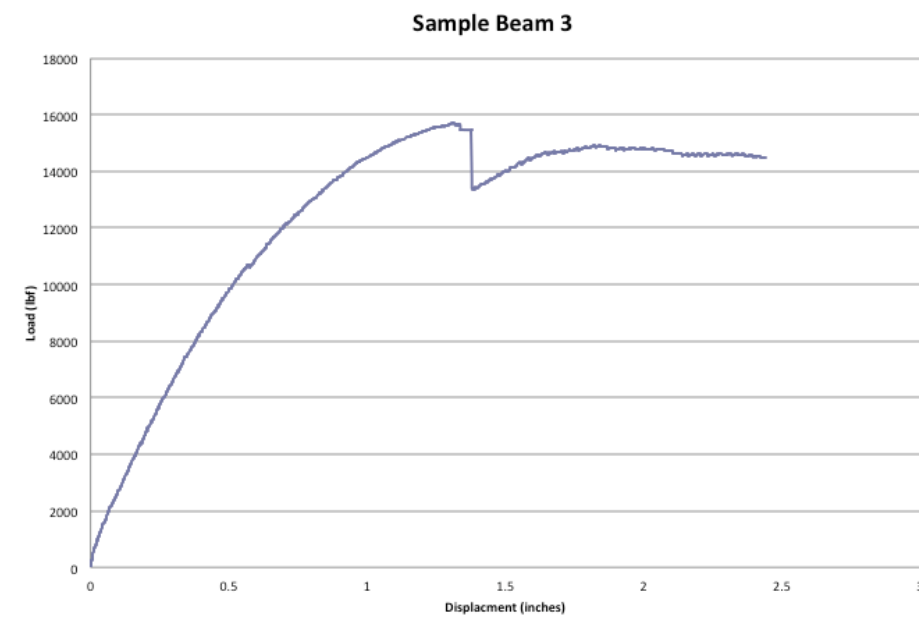
SAMPLE NO: 3 (10 1/8 x 10 3/16)

MODE OF FAILURE: Opening of joint on tension side accompanied by rolling of the key and failure of the upper half of joint at 15,600 lbf

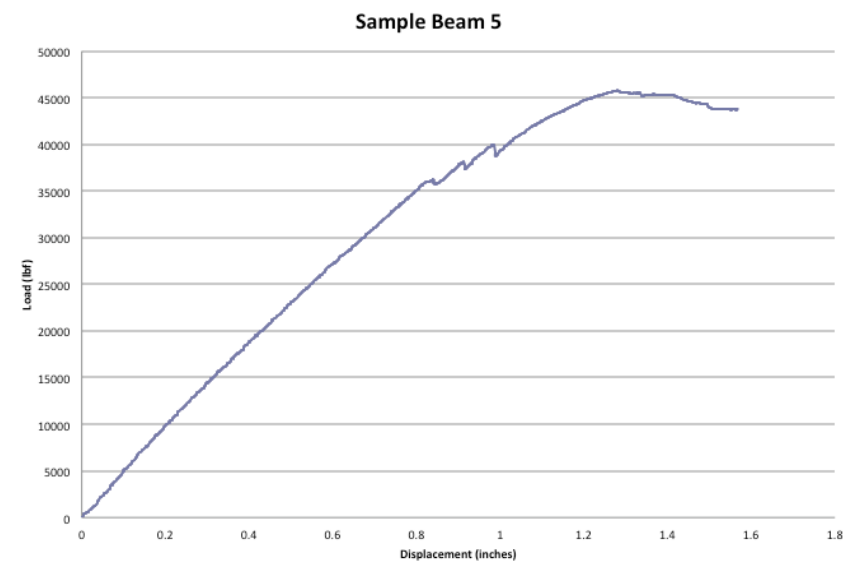
SAMPLE NO: 5 (9 7/8 x 10)

MODE OF FAILURE: Compression failure followed by tension failure at load cell at 45,800 lbf.

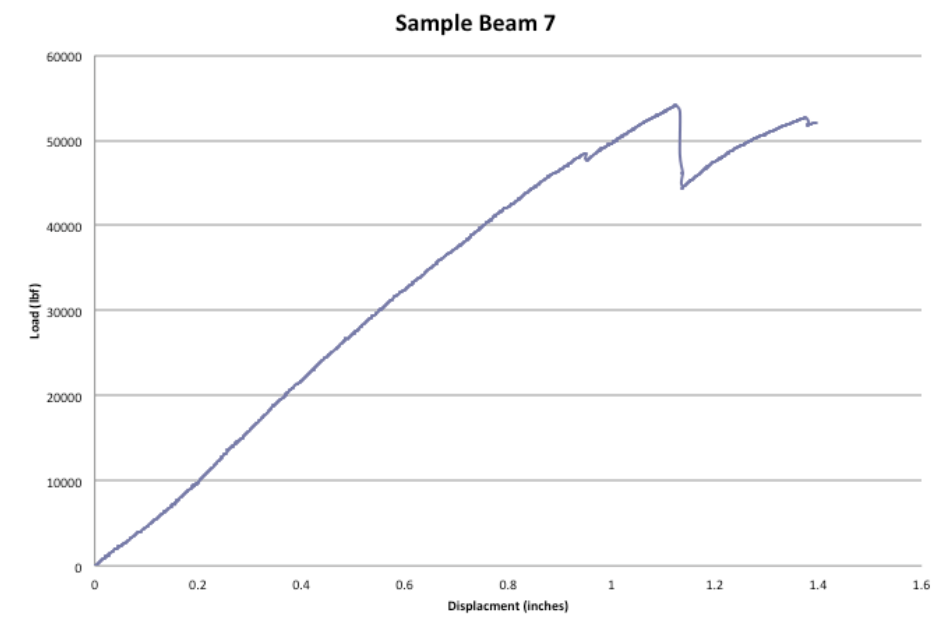
SAMPLE NO: 7 (10 x 10 1/16)

MODE OF FAILURE: Tension failure initiated in lower third of sample depth at about 47,500 lbf. Glue joints at top surface began to open at about 48,000 lbf. A second crack below the neutral axis but originating at about the same level as the bottom of the trench appeared at 53,000 lbf.

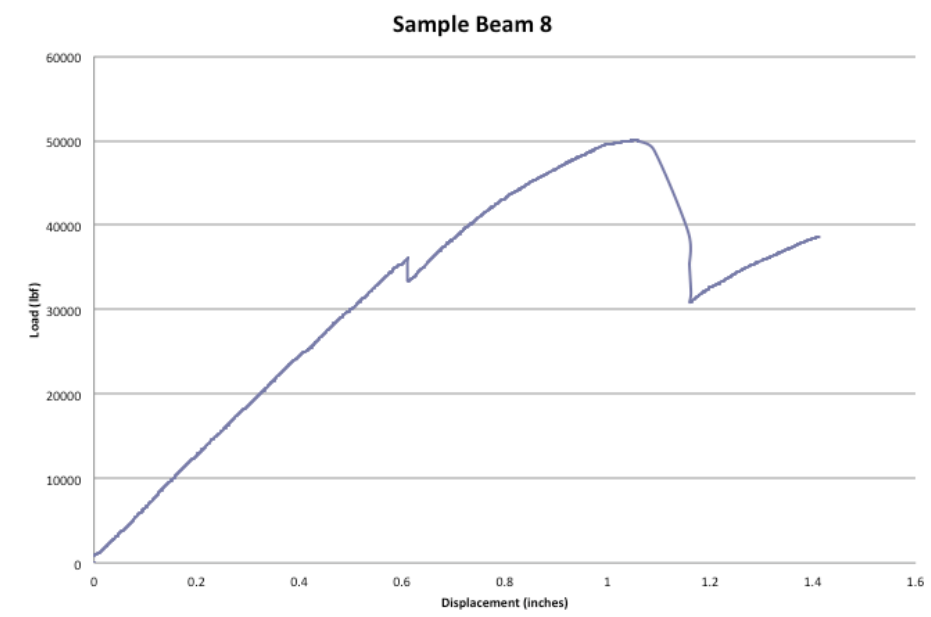
SAMPLE NO: 8 (10 1/16 x 10 1/8)

MODE OF FAILURE: Glue joints at top surface began to open @ 56,000 lbf, with abrupt failure in tension @ 62,000 lbf.

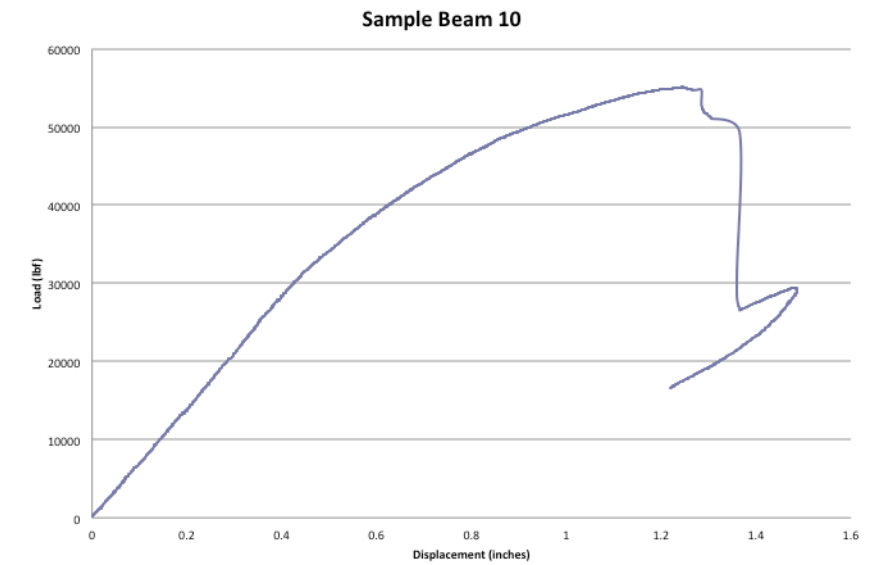
SAMPLE NO: 10 (10 x 10)

MODE OF FAILURE: Shear cracks appeared at ends of sample @ 50,000 lbf, with tension failure initiating @ 51,000 lbf, complete @ 52,500 lbf

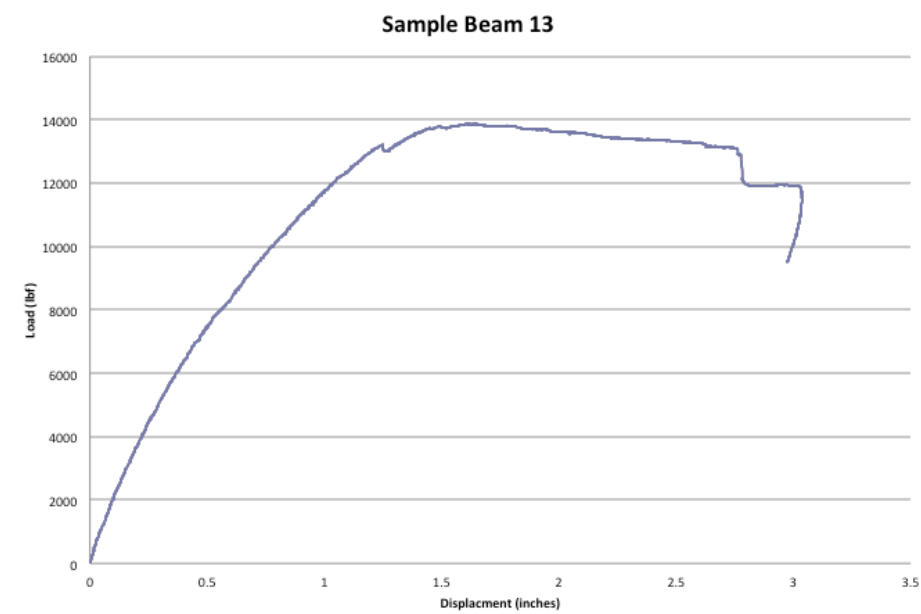
SAMPLE NO: 13 (10 x 10 1/16)

MODE OF FAILURE: Opening on tension side noticeable by about 4,000 lbf. Beginning to see compression around bottom washers at 8,000 lbf. Some compression noticeable around key at 12,000 lbf. Overall deflection of about 2 3/8-inches at 13,000 lbf.

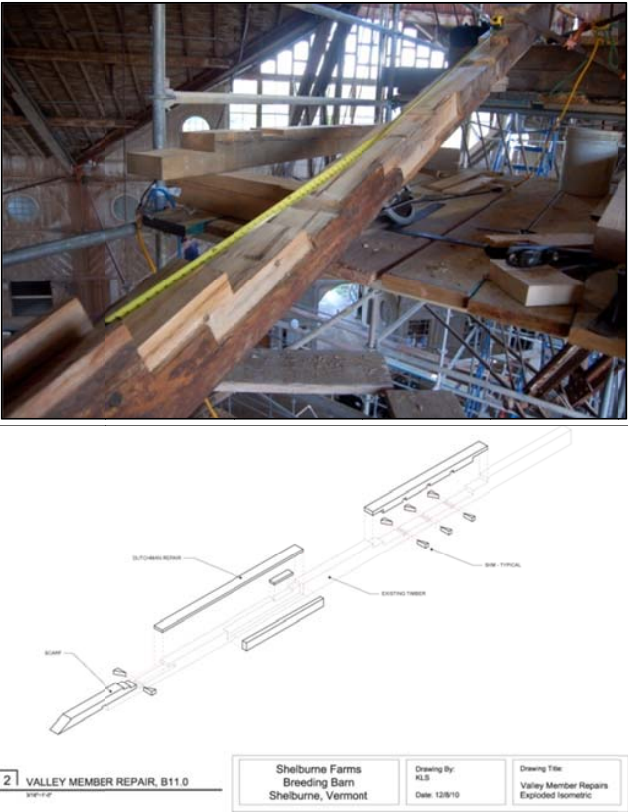
Figure 16 – The valley member at B11.0 with decayed material removed in the upper half of the span (top). Note the shear block mortises cut in the member and in the timber dutchman on the scaffolding behind the valley timber. The extent and location of the damage necessitated a change in the types of repairs employed (bottom).

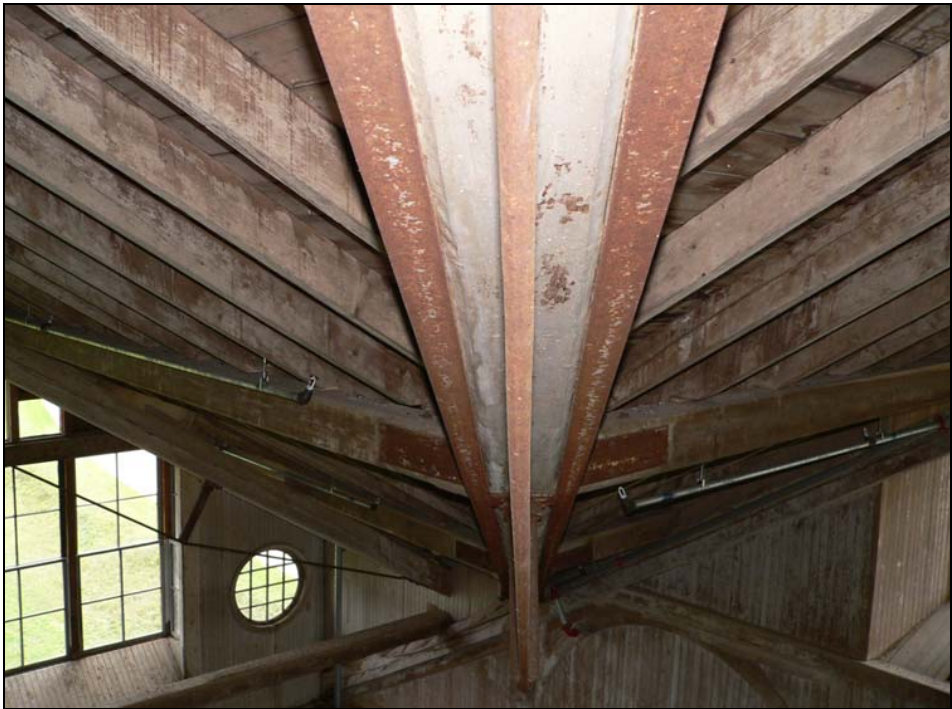
Figure 5. Valley Rafter 17 South viewed from the apex.
