Structural Repair of the Breeding Barn at Shelburne Farms

STRUCTURAL REPAIR OF THE BREEDING BARN AT SHELBURNE FARMS
VOLUME I: REPORT NARRATIVE

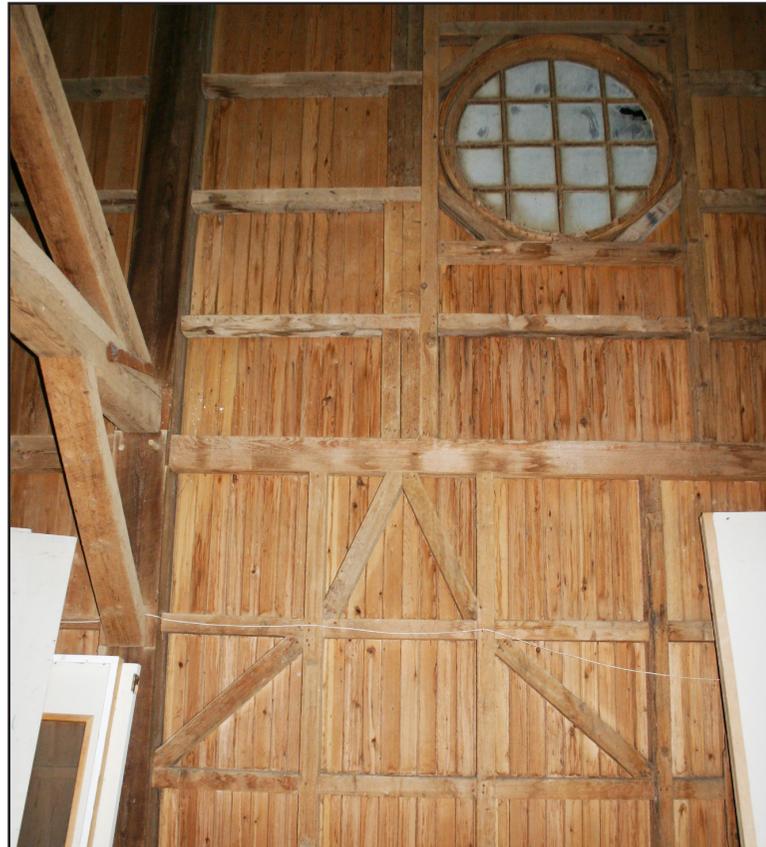
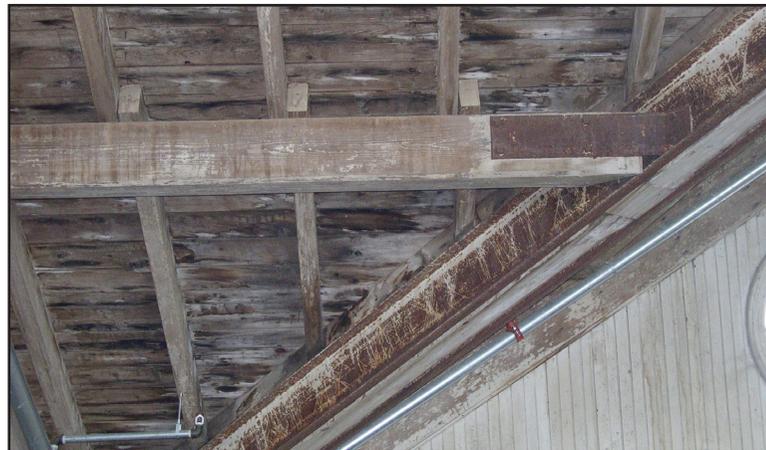
Sometime after initial construction of the barn trusses were added on the inboard sides of east and west dormer pairs (left). Truss construction differs from the original configuration, though the quality is very high. Location of the additional trusses away from columns required additional structure in the riding ring walls (right). Steel channels were added to valley members ca. 1930. Purlin bridles were replaced with bent strap connections (bottom right).

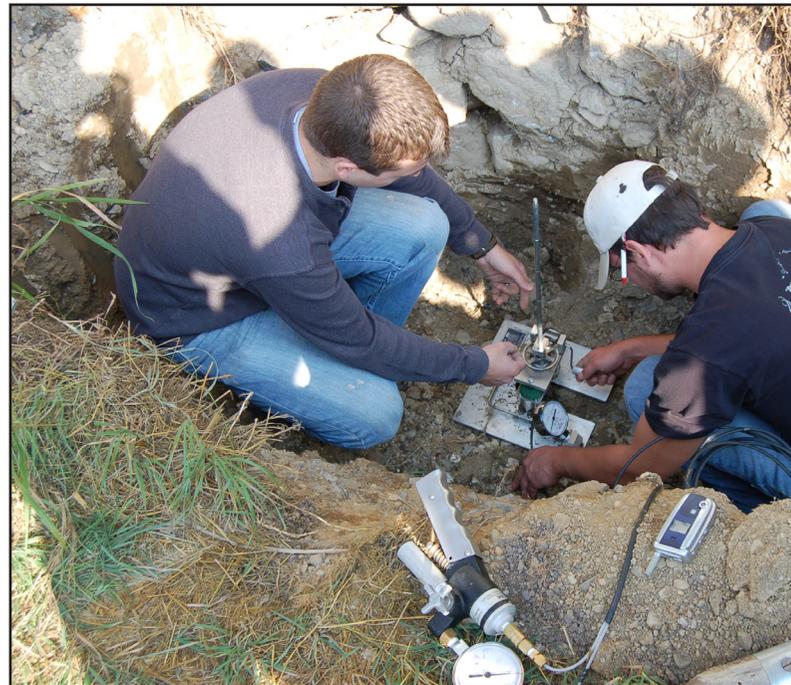
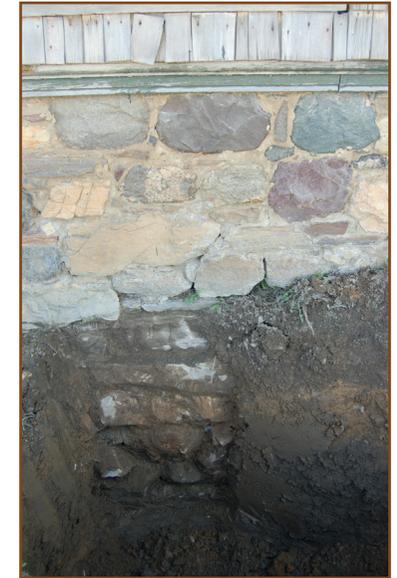
Investigation of the foundation stonework began in 2006 with a condition assessment that revealed the stonework on the annex and on the east, west, and south façades of the main block to be in fair to good condition. Stonework on the northeast had been replaced with reinforced concrete above grade. On the northwest façade, a reinforced concrete counterwall had been added to the original foundation sometime in the 20th century. The counterwall was poorly detailed, and encased the timber sills and the bottoms of columns and studs. Most of the encased timber was decayed as a result, and there were visible displacements in the north wall frame.

Condition assessment of the barn foundation included test pits for subsurface inspection of foundation stonework, and the collection of geotechnical data.

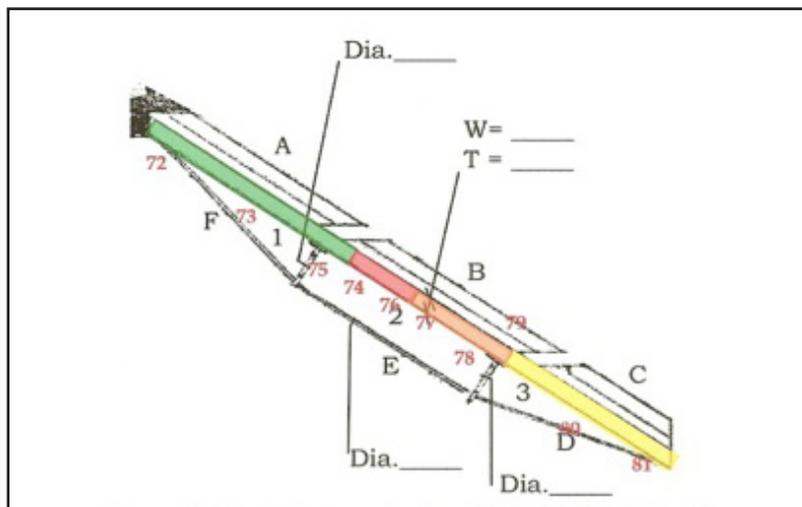
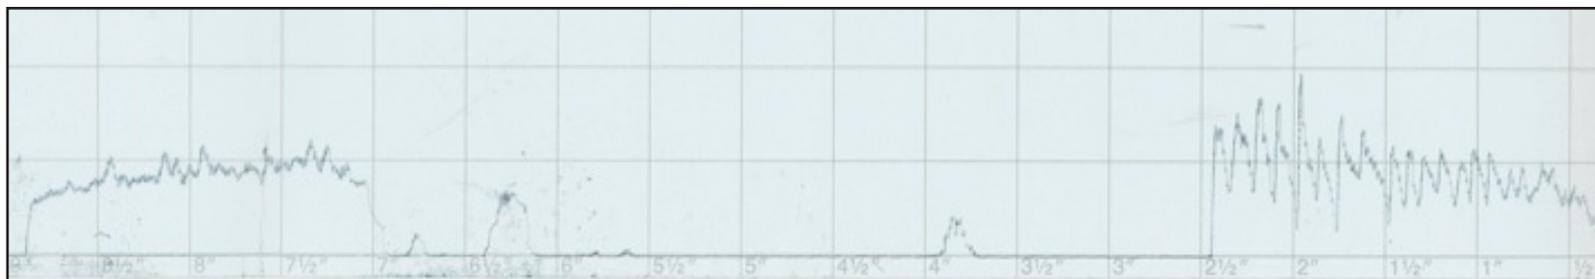
loss. Of the twelve timbers examined, five had substantial section losses due to decay. With three of the valley members, losses appeared as decay channels located in the upper half of the timber section, probably the result of water leaking through the roof and finding its way into drying checks. Two of the members were severely deteriorated at rafter heels, where they bear on timber plates in the walls surrounding the riding ring.

The investigator is using a resistance drill to locate and measure voids in a valley member (top). Note the steel channels that prevent drilling except at the top and bottom of the member. The sample resistograph strip (bottom) indicates a void about 4½-inches in width near the middle of the member. Graphic presentation of resistance drill results for the valley member at 11.0 South (left). The color-coding indicates levels of damage.

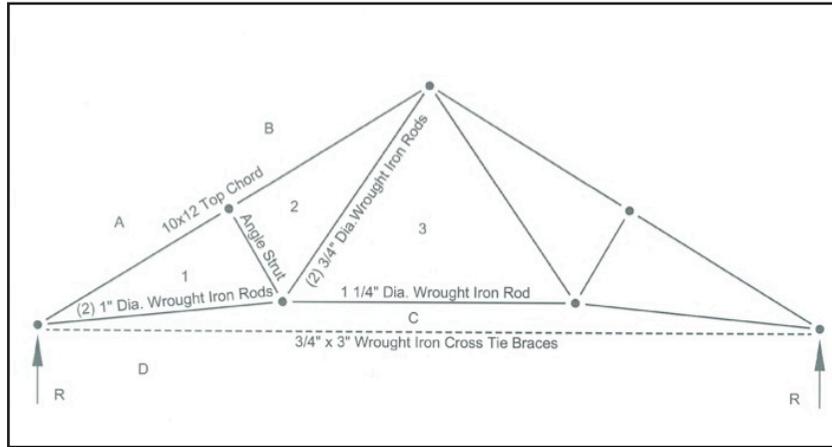
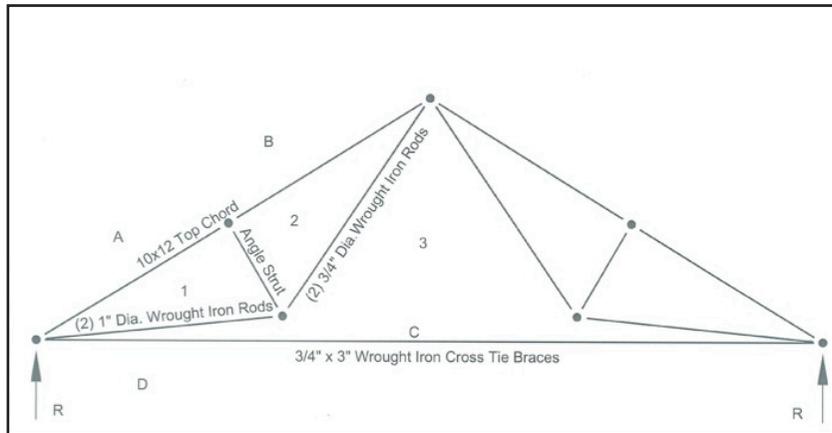
Computer models were constructed of the truss alone (top), and of the truss with the cross-brace tie substituted for the center tie (bottom). Analysis of the primary truss indicated overstresses in bottom chord elements. Adding the cross-brace tie, which Robertson apparently did sometime during construction, reduced stresses in iron and timber elements.

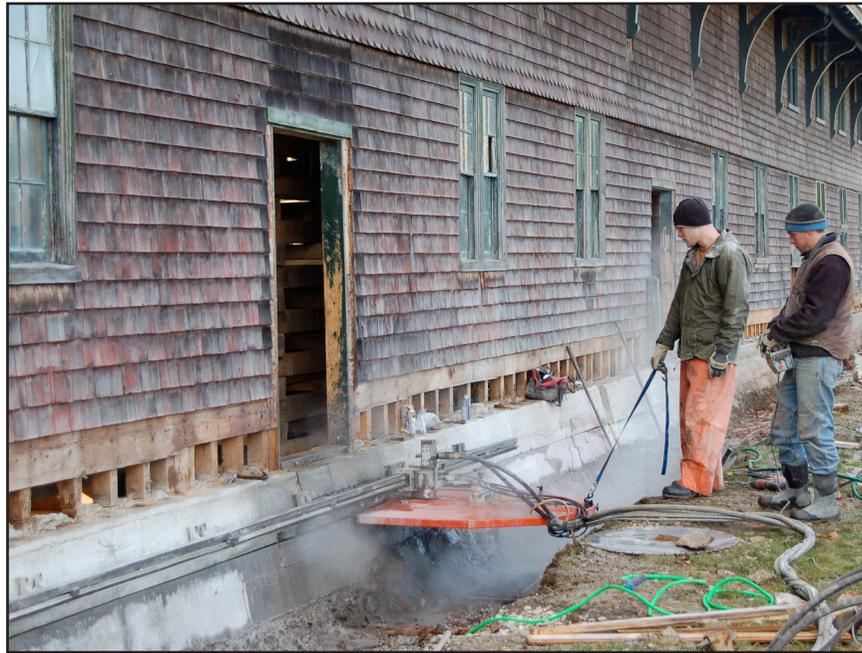
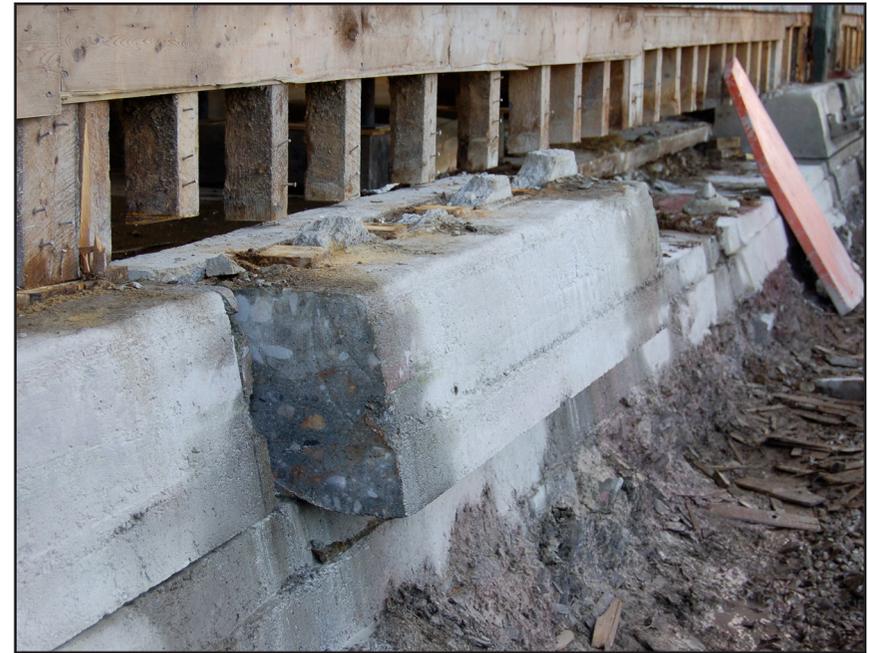
The concrete counterwall on the northwest façade was removed to a depth of approximately six inches below grade, and a new stone stem wall was constructed to support replacement sills.

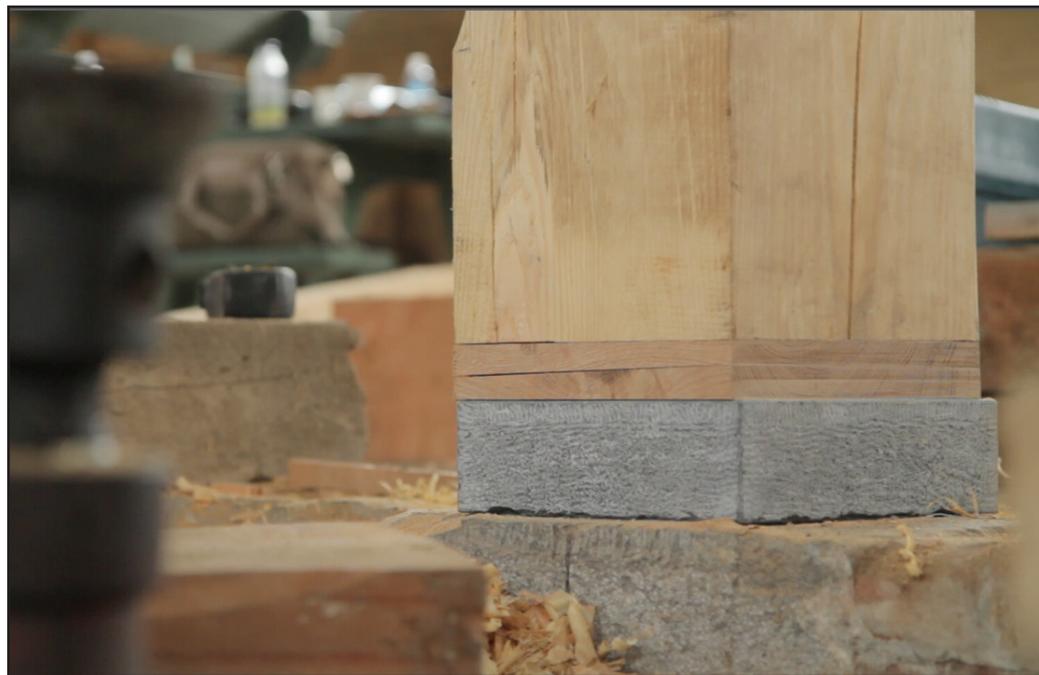
Of the 70 columns surrounding the riding ring, nearly 50 of them were significantly decayed at the bases, partly due to installation of concrete floors in the mid-20th century. In addition, several columns were damaged by animals and agricultural machinery.

Riding ring columns were repaired by scarfing in new timber to replace decayed portions, using a nosed scarf form found elsewhere in the barn. New column bases were placed on limestone plinths and white oak shims, elevating them above a concrete floor installed in the mid-20th century.

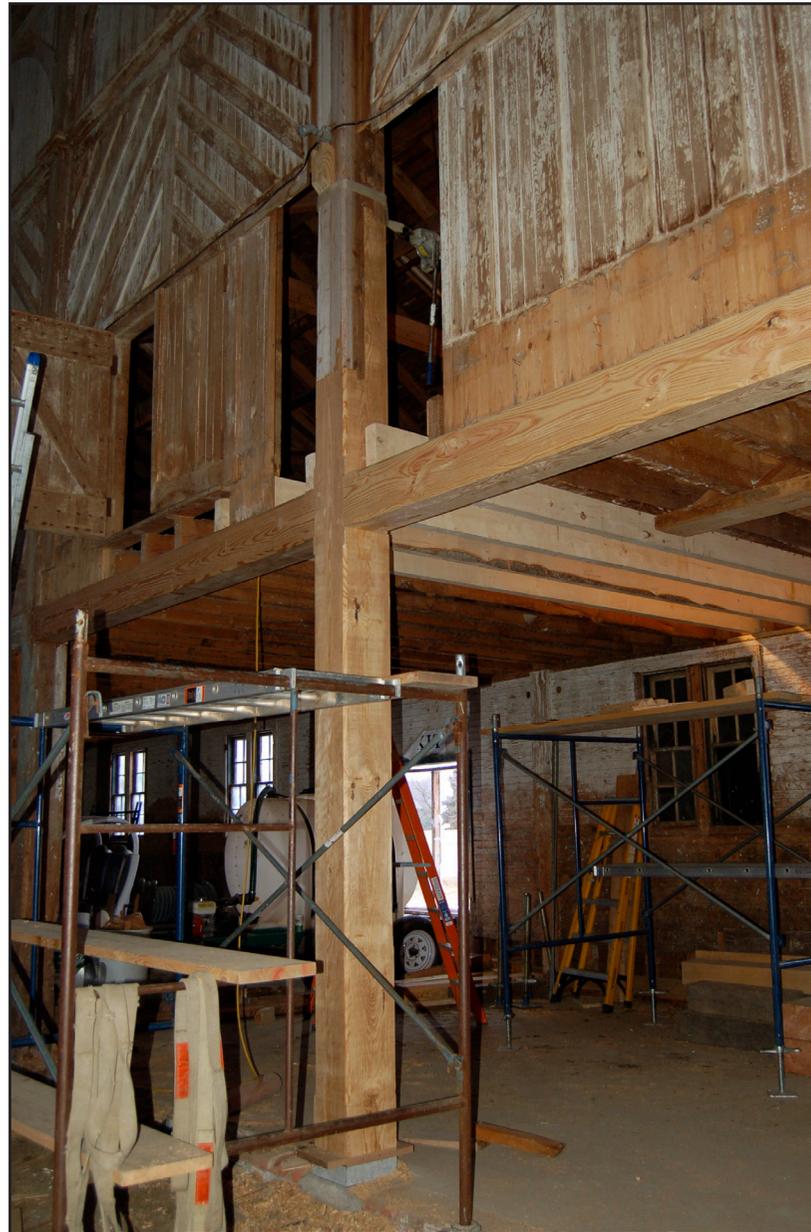
Four of the column repairs (B4.5, B14.5, J4.5, and J12.5), associated with roof leaks at the dormer valleys, extended into the aisle level. In each case, the columns had been repaired at least once before, and misalignment of shoulders in the scarfed splices had resulted in buckling of the columns above the aisle floor. At J4.5, floor girts on either side

Four of the columns located below dormer valleys required repairs extending into the aisle level. Here, a new column base is raised into position (left) and is shown installed with replacement girts (right).

of the repaired column were replaced. New repairs included appropriate dimensioning of scarf joints and installation of free tenons or splines to replace missing joinery that supported aisle floor girts.

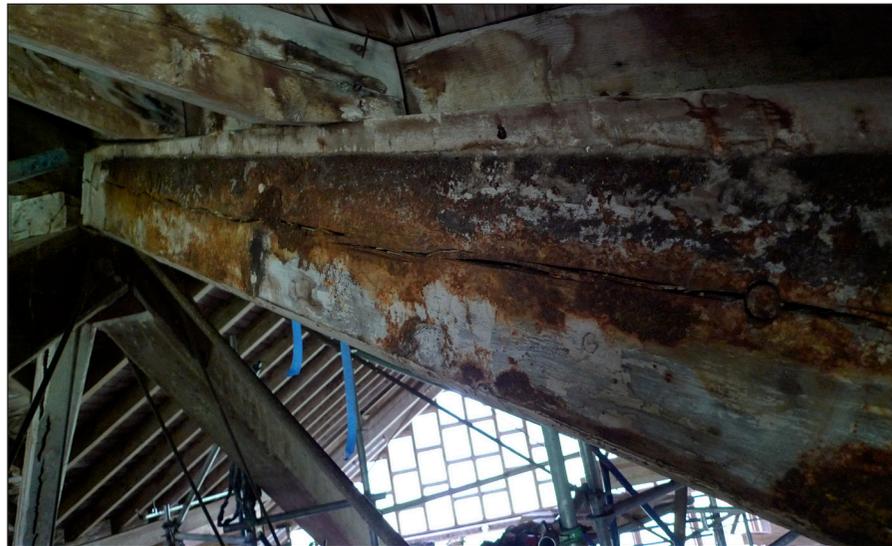
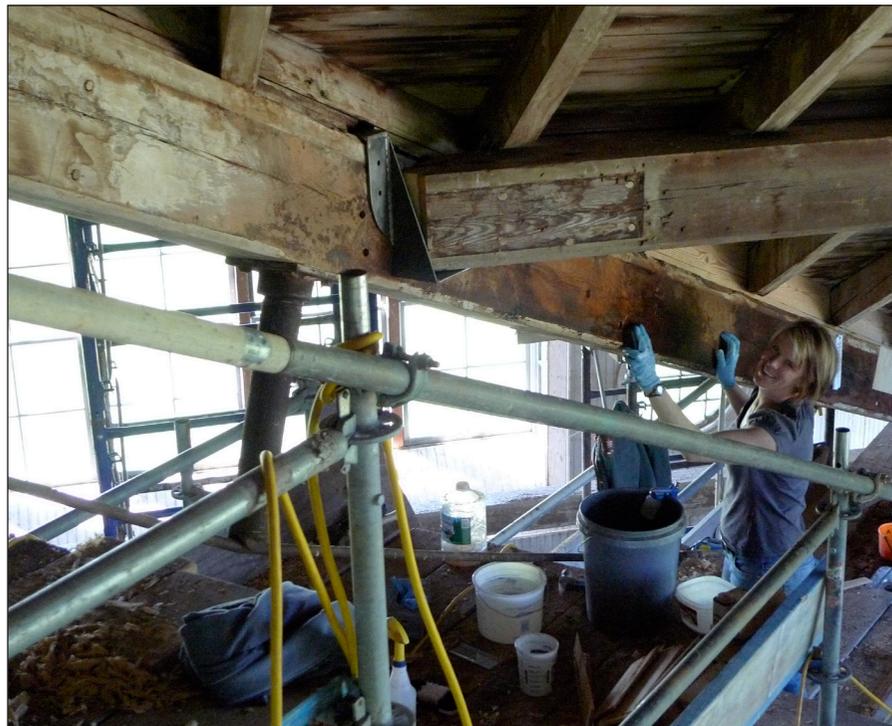
Steel channels left scaly rust deposits and stains on timber surfaces. Cleaning involved use of a nonionic detergent and water
