**Fitzgerald Environmental Associates, LLC.**

## **Alder Brook Watershed Phase I and II Stream Geomorphic Assessment Report**

December 29, 2006

Essex Waterways Association  
Essex, Vermont

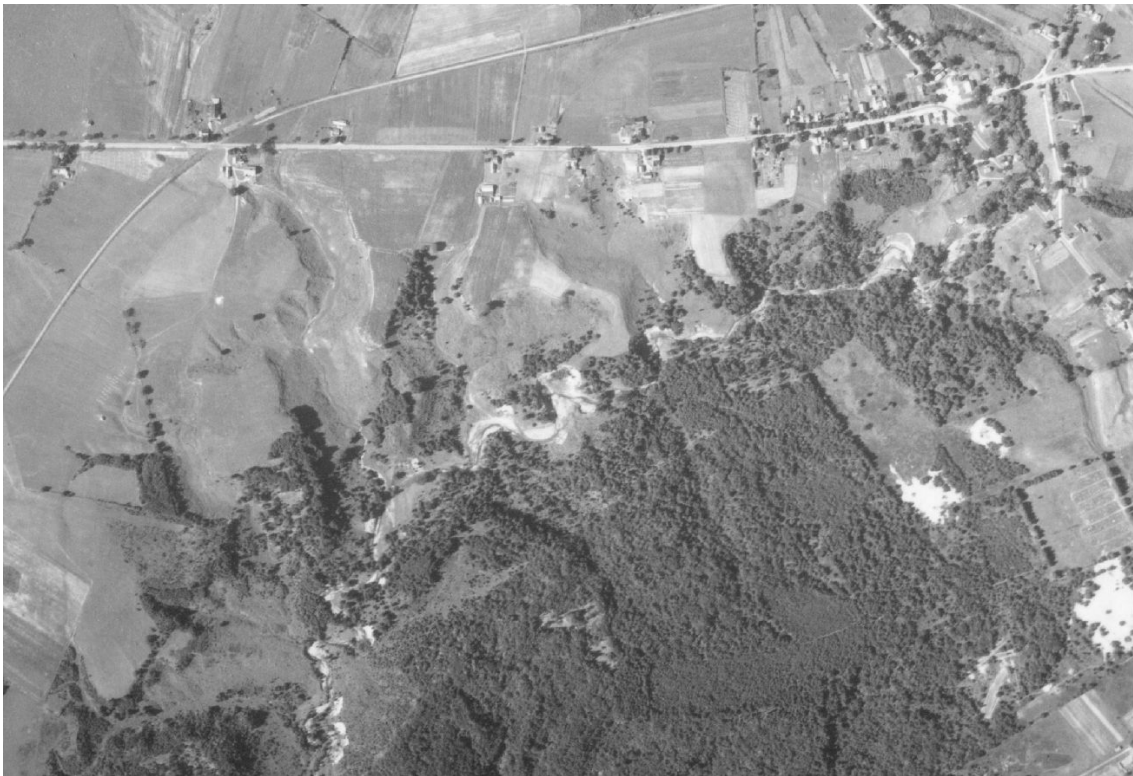
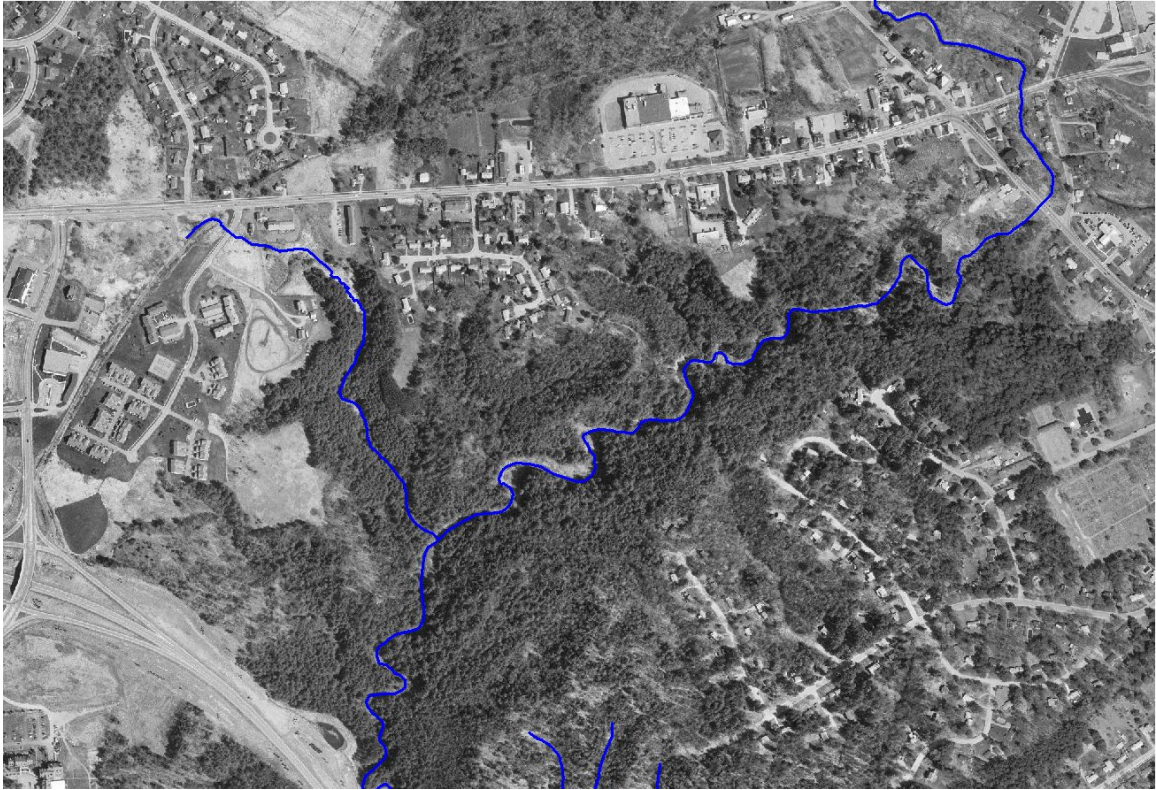
Figures 5 and 6 depict the uppermost reaches of the lower watershed zone (M05 and M06). The land cover surrounding the stream corridor in this area has undergone marked recovery from its denuded state in the 1930's. Much of the current forest cover is still in the initial stages of recover, as noted in the dominance of softwoods (white pine). However, large areas of residential development to the north and south of the stream corridor, and in the vicinity of Essex Center, have converted forest cover to dispersed areas of impervious cover (e.g., roadways and rooftops). This current day conversion is partly driving the watershed-scale impacts to water quality that were observed in the lower watershed zone during the Phase II field assessments. The effect of this impact will be described in great detail in Section 5 of this report.

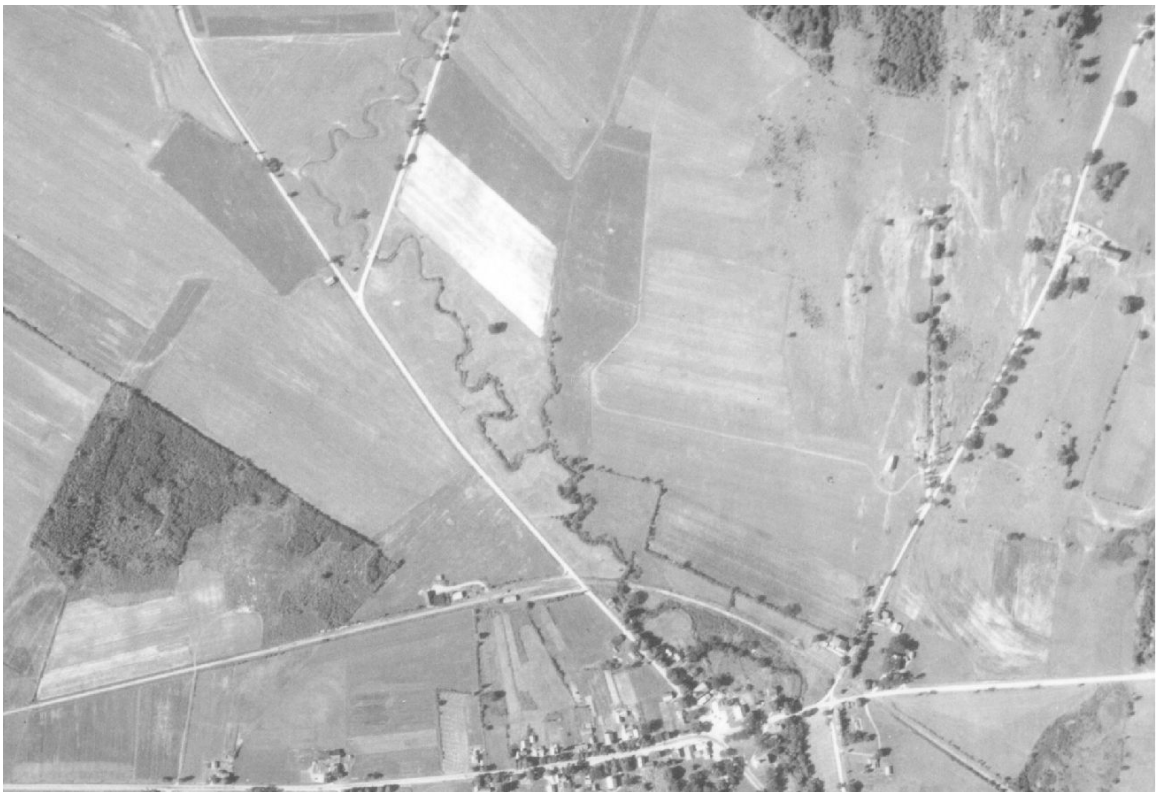
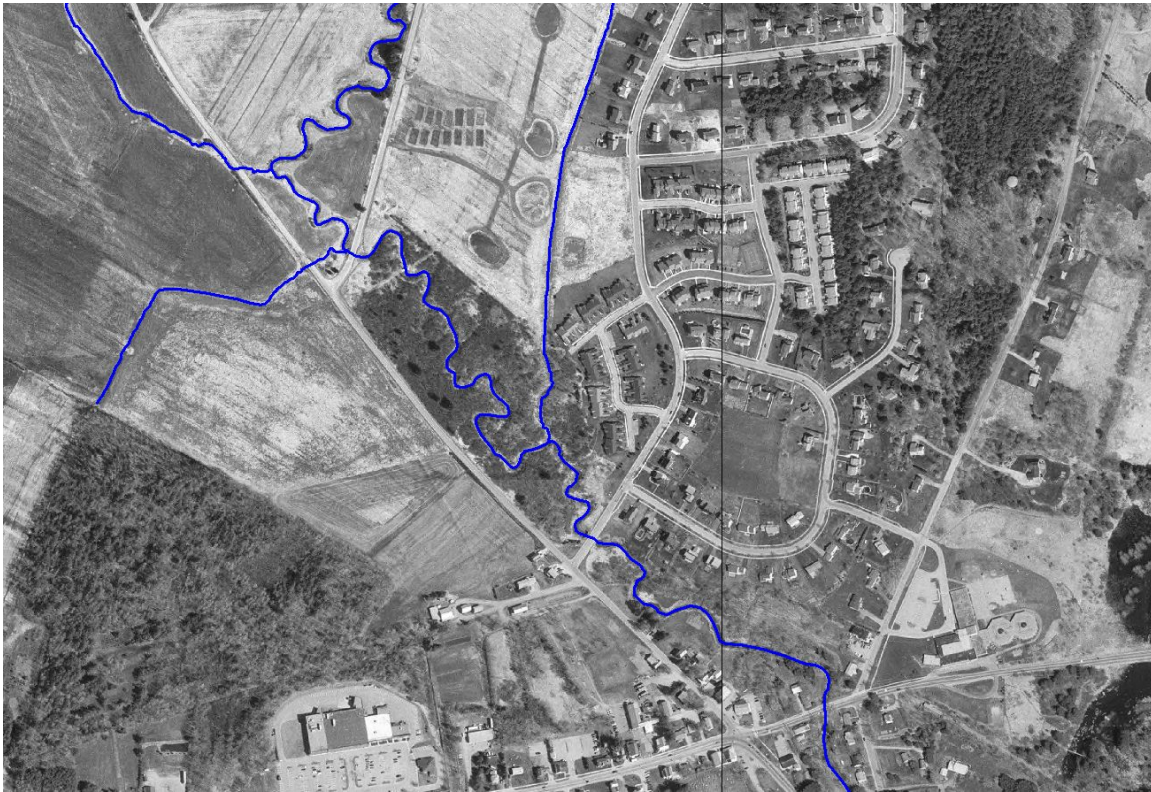
Similarly, Figures 7 and 8 illustrate some areas of forest recovery above Essex Center, however large areas of once pervious farmland to the northwest of the stream corridor have been replaced by residential land use. These areas discharge stormwater runoff to the channel below Clover Road, and appear to be adversely affecting water quality and channel stability in downstream reaches. Also noteworthy in Figures 7 and 8 is the similarity of channel location and sinuosity over the 60 year time period, despite the historic clearing along the stream corridor. This similarity suggests that the recovery of the landscape

from agricultural impacts did not drastically change the sediment and hydrologic regimes of Alder Brook during this time period.

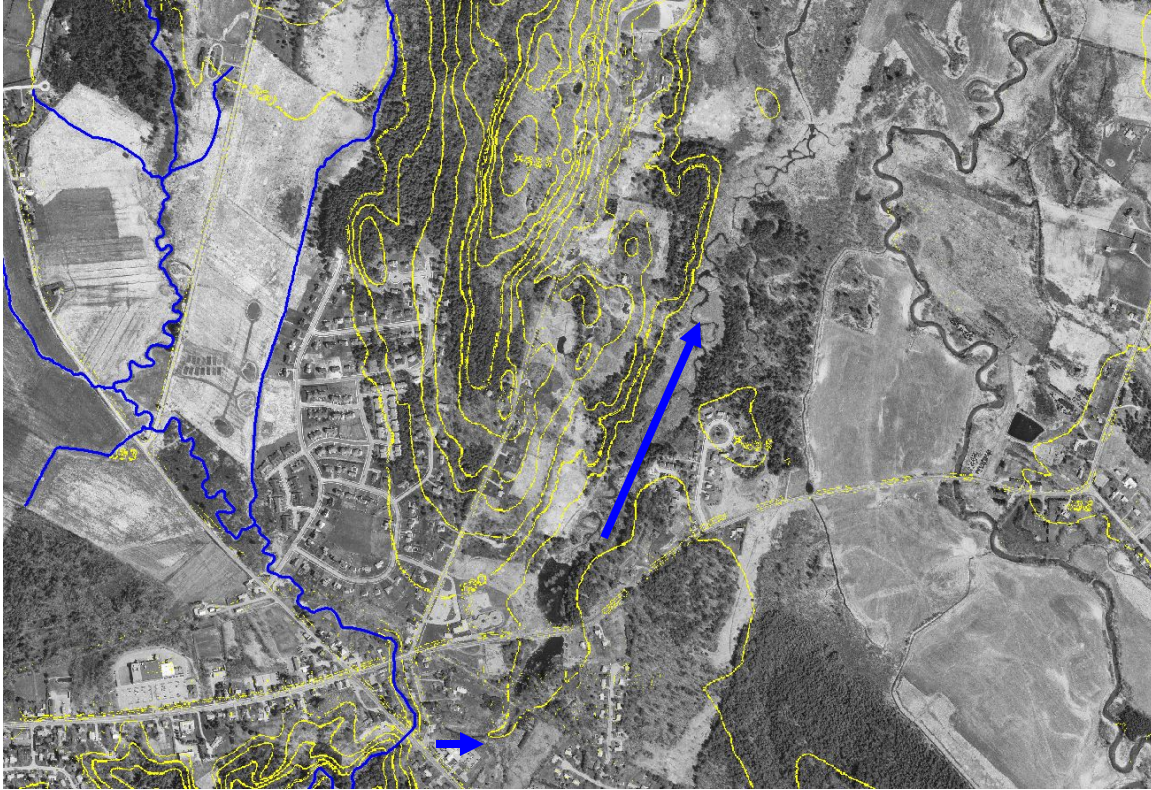
In addition, a review of the 1999 aerial photograph with topographic contours overlain (see Figure 12) reveals the old channel location to the Browns River. This channel can be clearly seen to the north where it nears the Browns River, and the topography indicates where the channel once turned from the east to the north outside of Essex Center. This old channel, although overgrown by vegetation, can be observed in the field today. The channel continues to maintain mostly stagnant surface waters (likely fed by groundwater inputs) and has been colonized by beavers over the years. Further discussion of the diversion and flood are found below in Section 3.5.

**Figure 12. 1999 Aerial Photograph Depicting Abandoned Channel to Browns River**

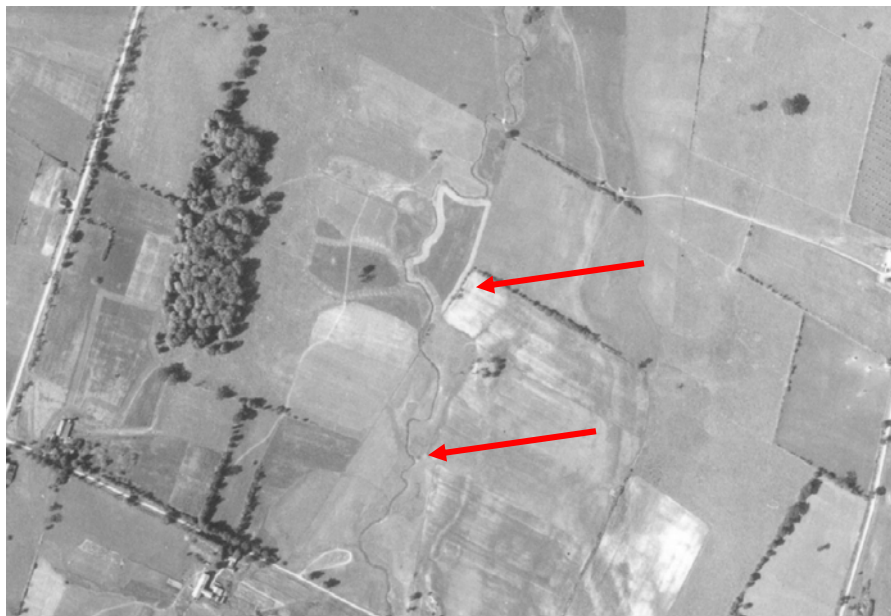
Historic photography from 1937 of the middle and upper part of the watershed above Route 15 also indicates that significant channel straightening occurred in areas that were heavily cleared for agriculture. Portions of the channel in reaches M09 through M14 were straightened, probably in the late 1800's or early 1900's. Figure 13 depicts a section of the channel in Reach M10 upstream of the Col. Page Road crossing. In some of the reaches in this zone of the watershed, the channel has undergone little planform change since the 1930's (M09 and M10), whereas other reaches have migrated considerably. The effect of historic straightening and its consequences for the sediment regimes is discussed in further detail in Section 5 of this report.

**Figure 13. 1937 Aerial Photograph of Channel Straightening in Reach M10**

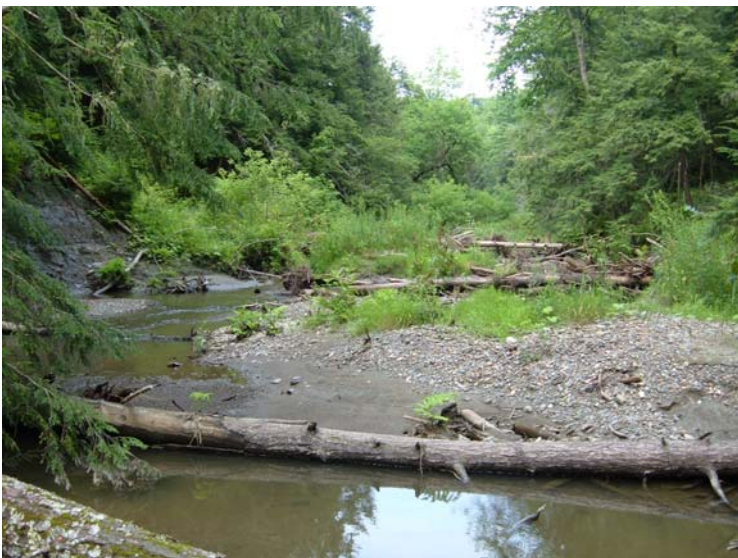
**Figure 15. Severe Aggradation in Reach M02**

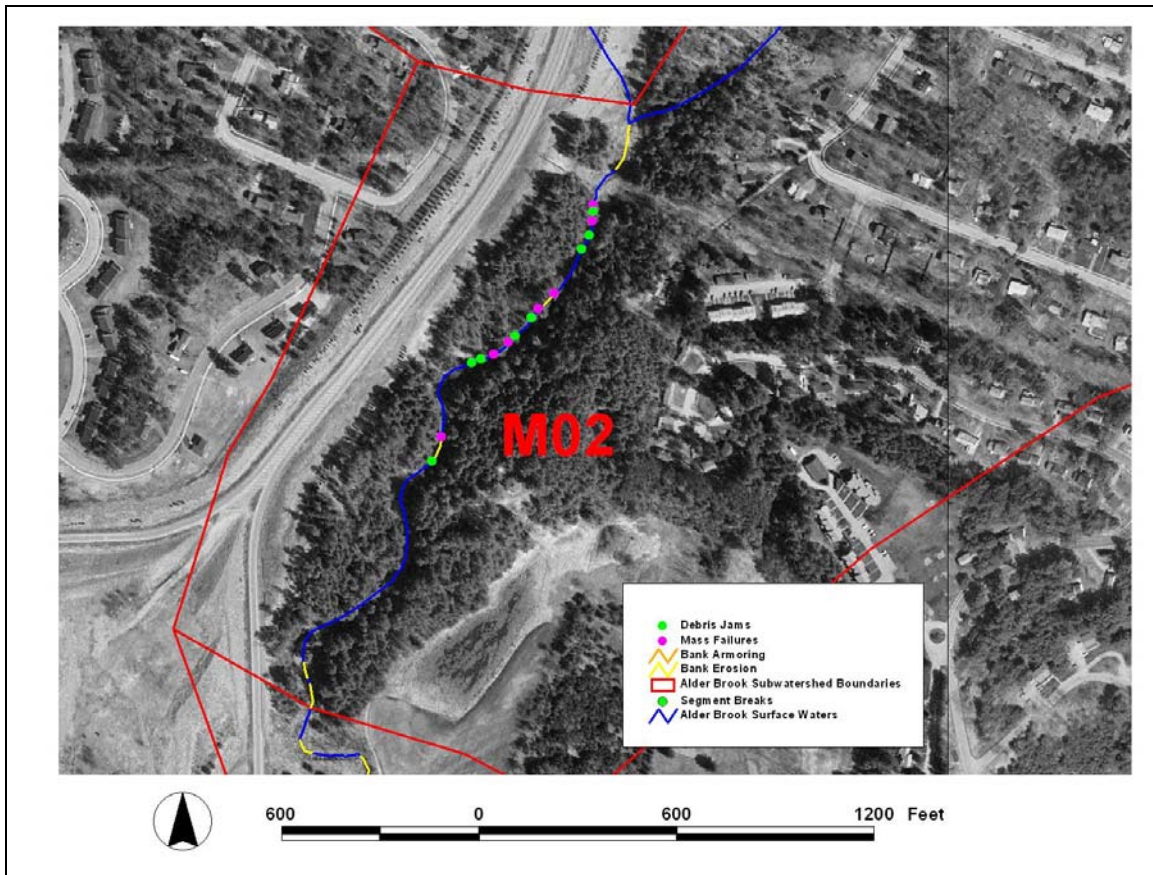
**Figure 16. Spatial Scale of Sedimentation Features in Reach M02**

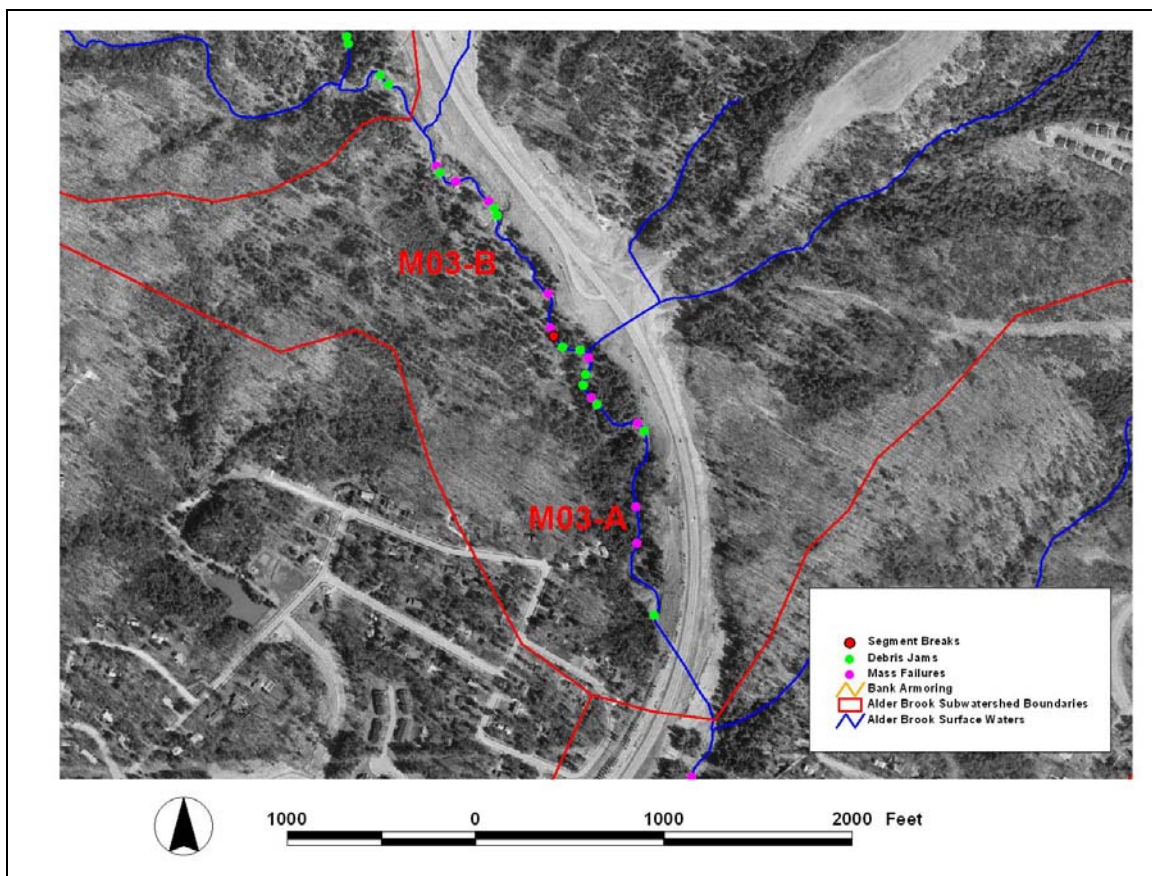
This reach extends from the upstream end of the first Circ Highway culvert up to the M04 reach break where a tributary enters from the northeast. The reach length is 4171 feet and the overall channel slope is 1.0%. M03 has been broken into 2 segments because of a change in channel dimensions and bedform. The lowermost segment, M03-A, has a slightly higher channel slope than Segment B, resulting in a B-type stream dominated by plane bedform. This reach has been assessed as having good geomorphic stability and habitat conditions. Although it likely went through a long period of instability after the diversion of 1830, it has reestablished a new equilibrium condition and has thus been classified in Stage I of channel evolution. The high number of depositional features noted for this segment in Table 7 are largely found in the upper section, where a “slug” of sediment associated with the Circ Highway construction and berming is migrating downstream (see Figure 17).

**Figure 17. Spatial Scale of Channel Features in Reach M03**

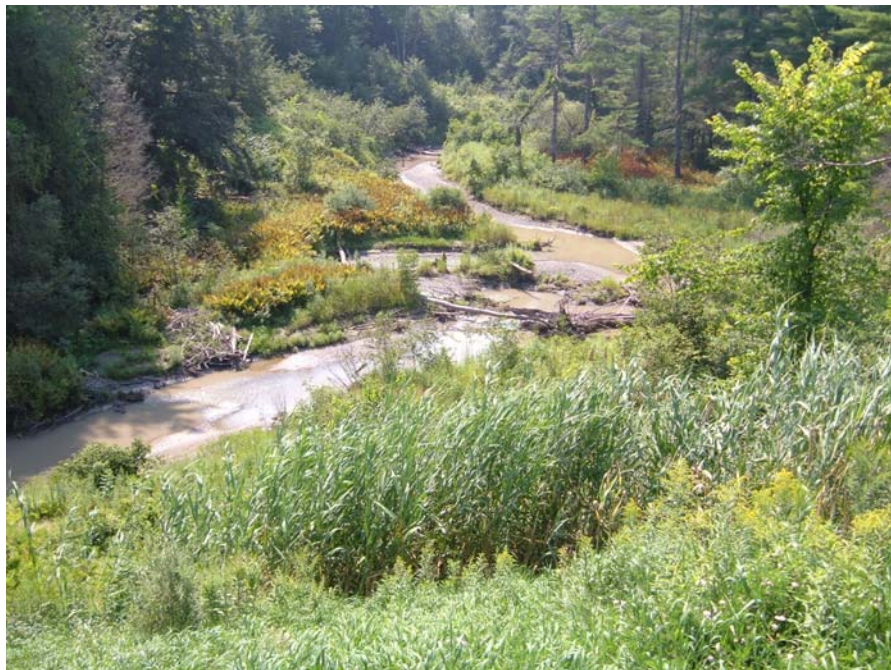
Segment B is found from the berm encroachment for the Circ “jughandle” up to the M04 reach break. This segment has a lesser channel slope, resulting in a C-type channel with riffle-pool bedform. This segment has been significantly impacted by direct sedimentation from road construction and berm encroachment. There are 2 sections of channel that have been straightened, representing approximately 10% of the entire reach length. The area with the greatest amount of aggradation and lateral adjustment in M03-B is the upper section closest to the reach break. Here the impacts to channel bed stability and planform can be easily observed in the field (can be seen from the Circ above; see Figure 18). Due to the degree of aggradation and widening observed in this segment, channel evolution has been assessed at Stage IIb, and fair geomorphic stability and habitat conditions have been noted.

**Figure 18. Reach M03 as observed from the Circ Highway**

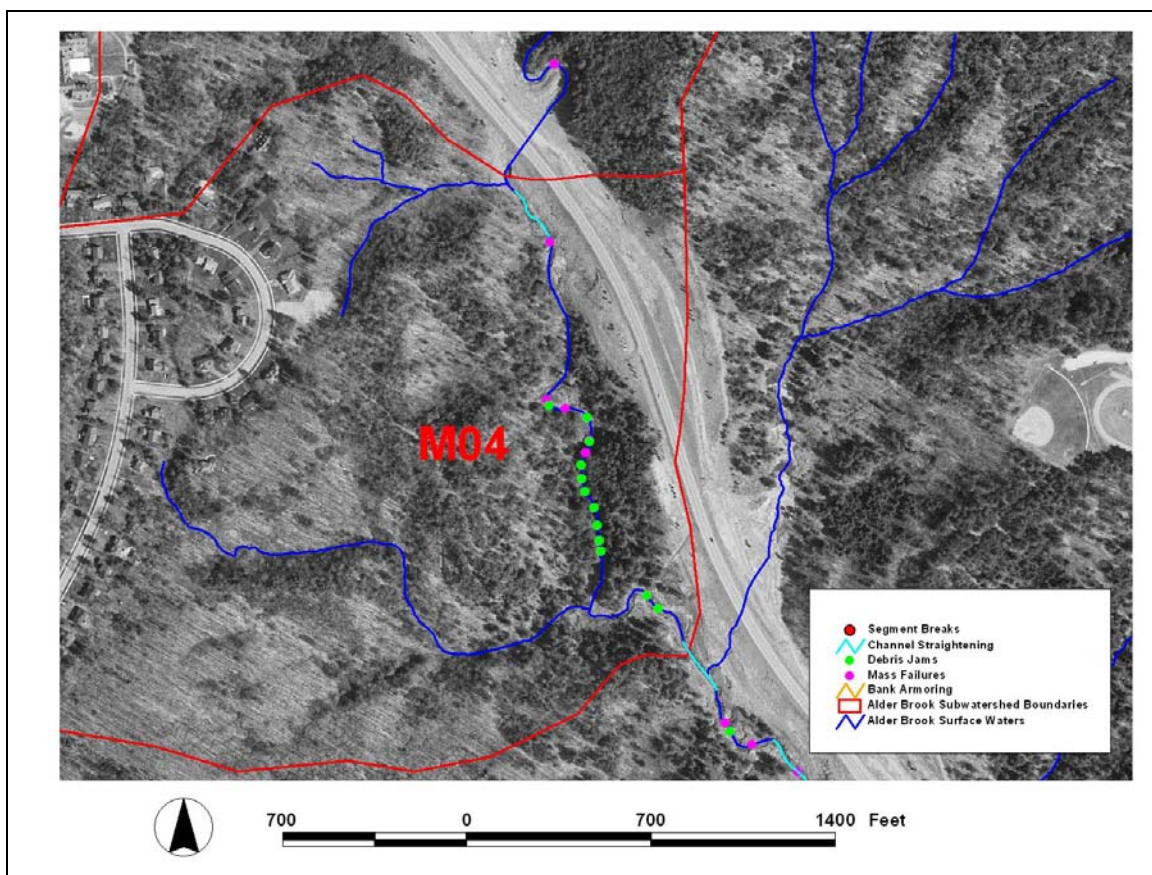
**Figure 19. Spatial Scale of Channel Features in Reach M04**

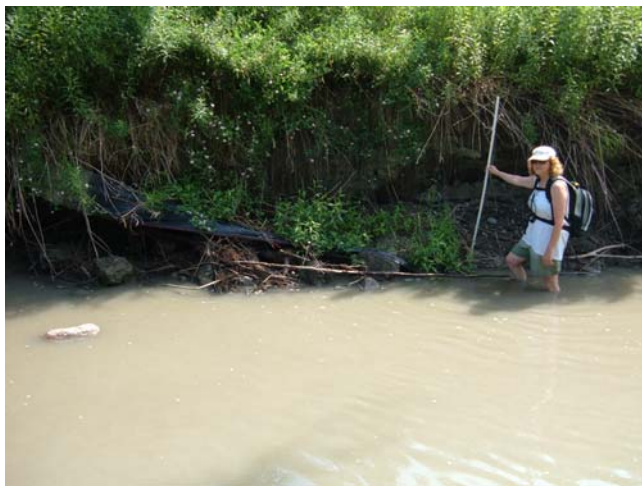
The aggradation and widening in the middle and lower portion of the reach, caused by the Circ Highway construction and channel straightening, will likely continue to affect the lower section of the reach, and eventually Reach M03, for years to come. However, due to the narrow confinement of the valley, few if any floodplain restoration opportunities exist in the vicinity of the berming and road encroachment in the upper reach. There are some failing slopes along the berming that should be monitored over time (see Figure 20), as these slopes are continuing to contribute large amounts of sediment to the channel and causing widening downstream. If the bank failures continue, an active approach to stabilizing them may be necessary in the future.

**Figure 20. Bank Failure Along Circ Berm in Reach M04**

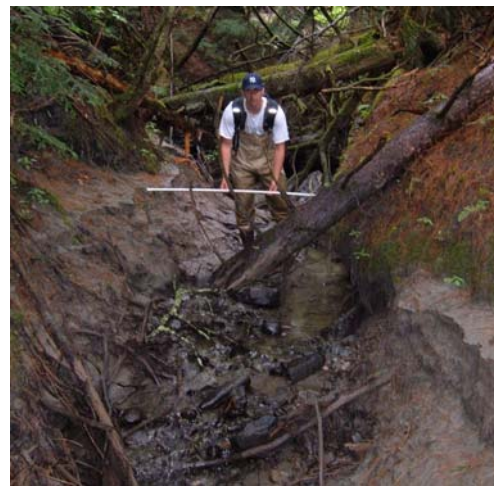
**Figure 21. Gully in Reach M06**

were observed in both reaches that are deeply incised and are delivering significant amounts of sediment to the main channel, causing severe lateral adjustment below *and* immediately above the gully confluence. Although the incision in the lower portions of these gullies may be relics of rejuvenated tributaries from the historic incision associated with the diversion of 1830, many are being heavily impacted and aggravated by urban runoff today. The Fern Hollow Road gully is one such example, and the effect of the sediment delivered to the main channel (quantified in Table 5) can be observed in the mainstem as the sediment slug continues to migrate downstream, as seen in Figure 22.

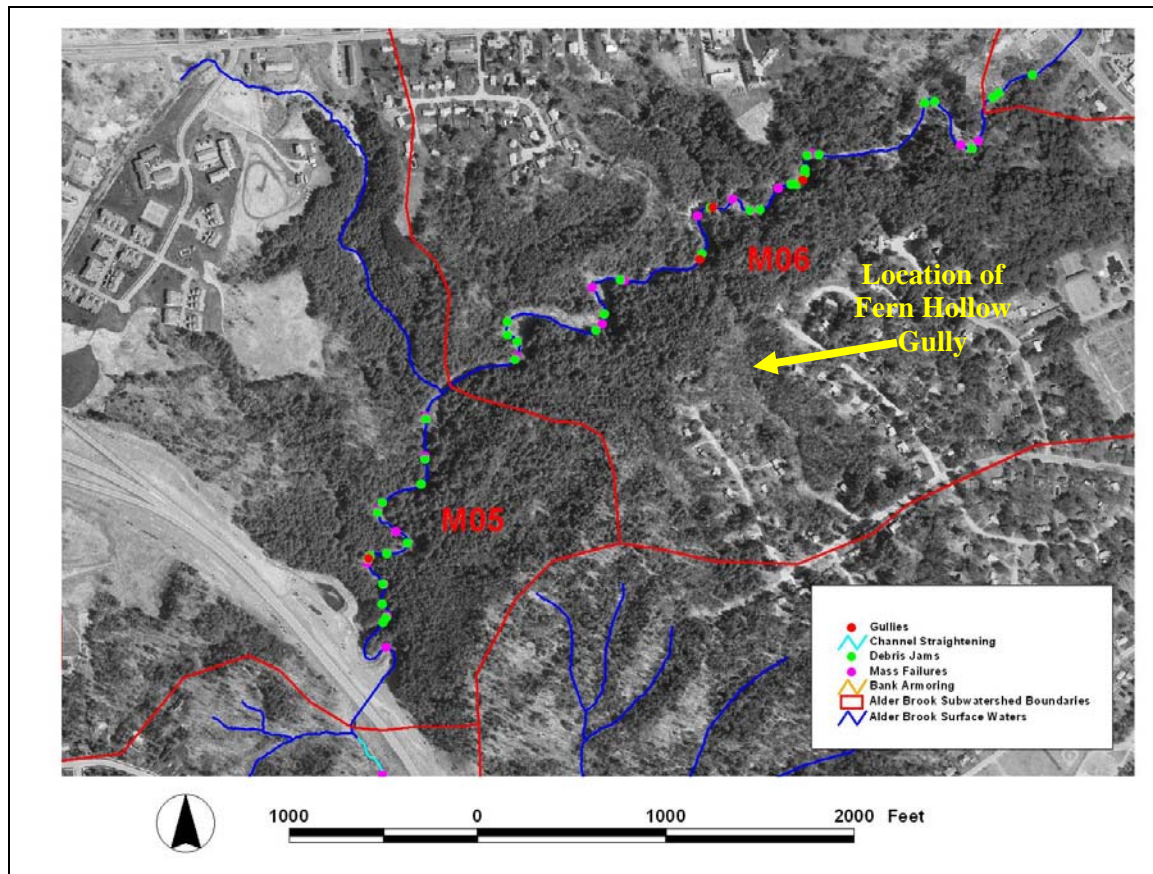
**Figure 22. Spatial Scale of Sedimentation Features in Reaches M05 and M06**

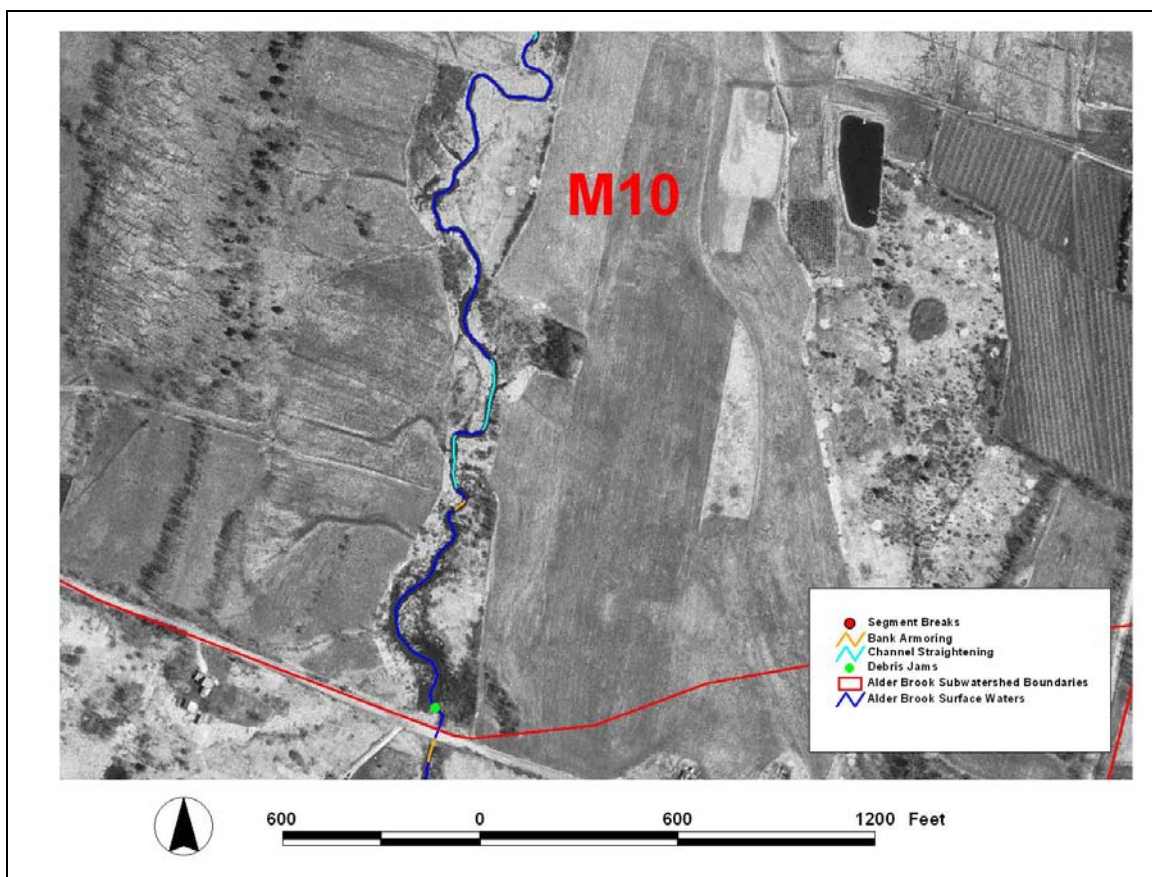
reference sand conditions to cobble and gravel bottom with plane bedform. These areas of bedform change are found largely in the lower portion of the reach where armoring was present (see Figure 26). With the exception of this change from reference conditions, good physical stability and habitat conditions were noted for these reaches (reference RHA score for M11). A review of historic aerial photography, as well as the presence of abandoned terraces suggests there has been a process of channel change and restabilization over time. Channel Evolution Stage V has been noted for both reaches. Since there is good floodplain connectivity and buffer integrity in both reaches, it is not likely that restoration efforts would improve sediment attenuation or habitat conditions. Therefore, no project areas have been identified.

**Figure 25. Direct Channel Impact Mapping in Lower Reach M10**

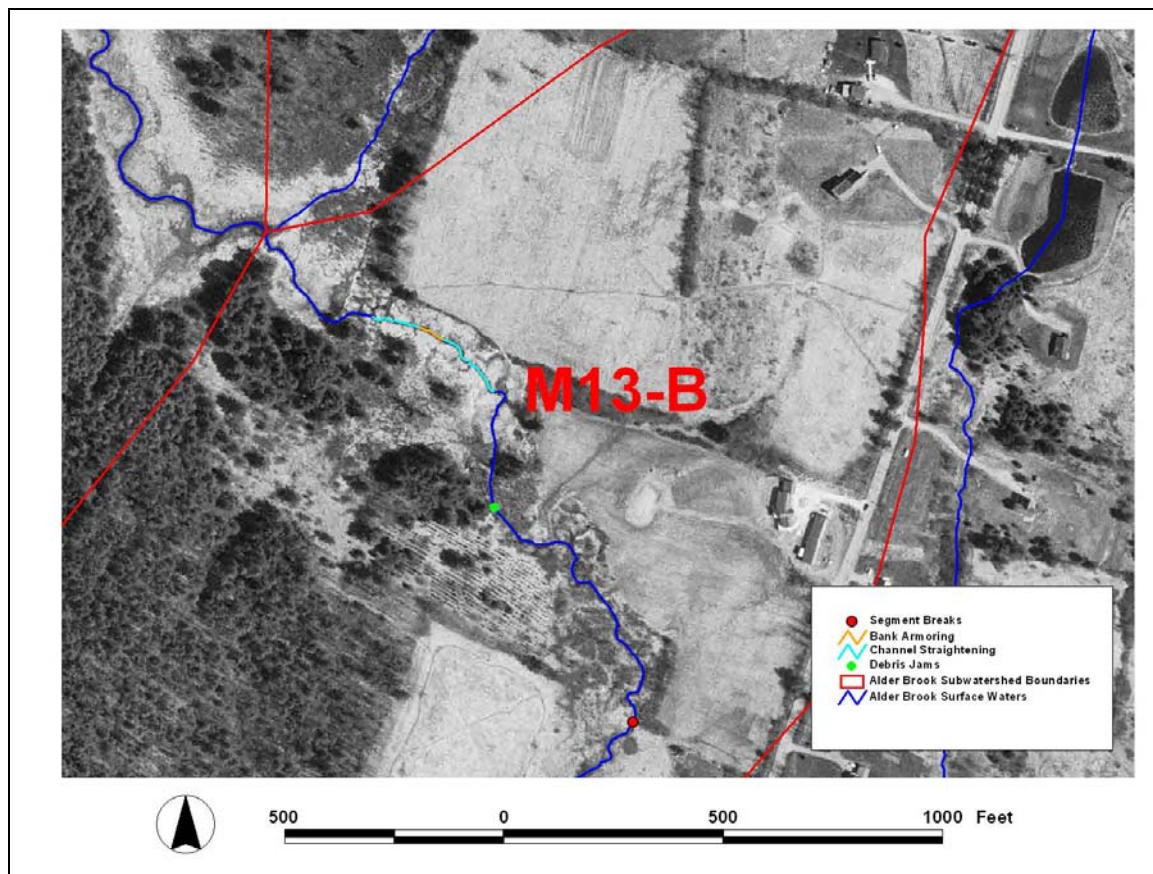
assessed due to limited property access. Observations from Segment B suggest that the historic straightening (see Figure 26) has resulted in a bedform and substrate departure from reference conditions, whereby the increase in energy gradient has caused a coarsening of the bed and a loss of channel undulation normally observed in sinuous channels in this setting. Nevertheless, the channel has recovered significantly from the historic impacts and is currently in Stage IV of channel evolution with good physical stability and habitat conditions. Due to the floodplain connectivity and buffer integrity found in this reach, it is not likely that restoration efforts would improve sediment attenuation or habitat conditions. Therefore, no project areas have been identified.

**Figure 26. Direct Channel Impact Mapping in Segment M13-B**

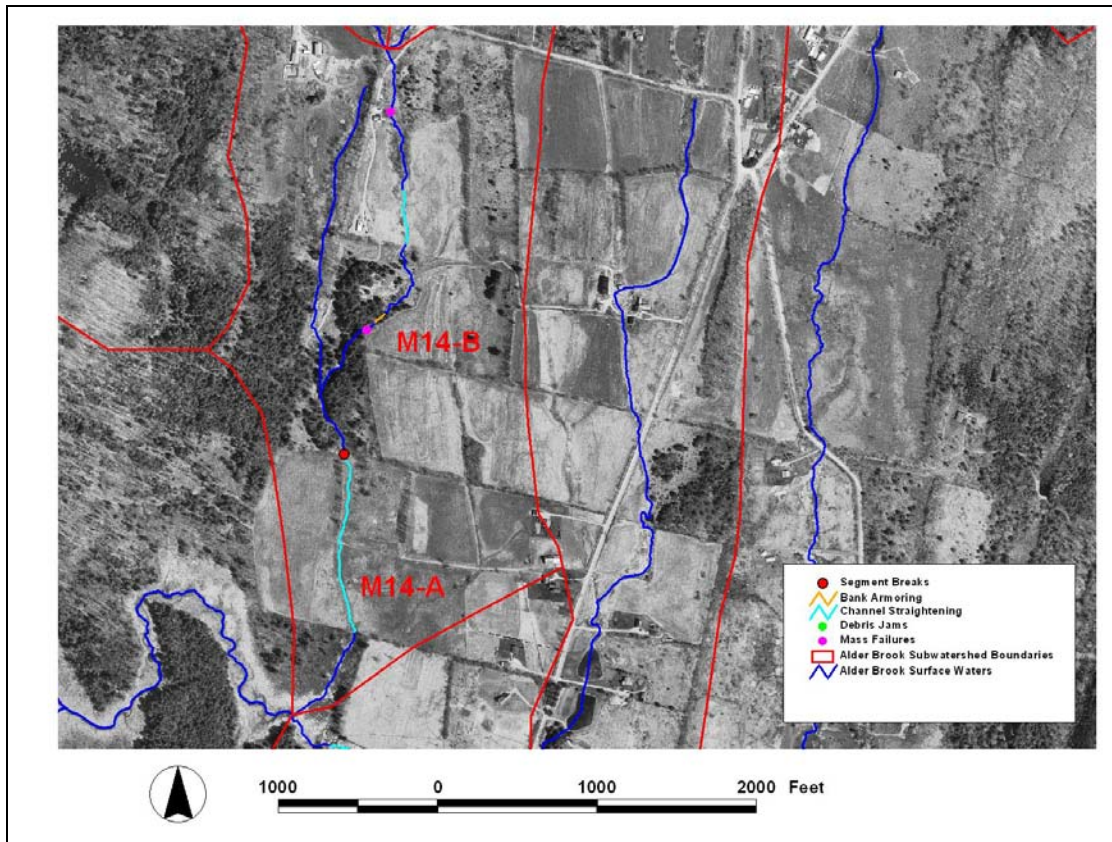
channel straightening was evident in both segments (observed from afar in segment A) and is depicted in Figure 27. This historic straightening has caused some incision in areas of the segment that was not noted in the channel cross-section measurements. The channel stability and habitat conditions of Segment B have been assessed as fair. In addition, active pastureland in Segment A and lower Segment B is causing significant instability in the channel.

**Figure 27. Direct Channel Impact Mapping in Reach M14**
