# **A century of urban landslides: the legacy and consequences of altering riverbank landscapes**

**\*Isabella B. Bennett<sup>1,2</sup> and P. R. Bierman<sup>1,2</sup>**

## **ABSTRACT**

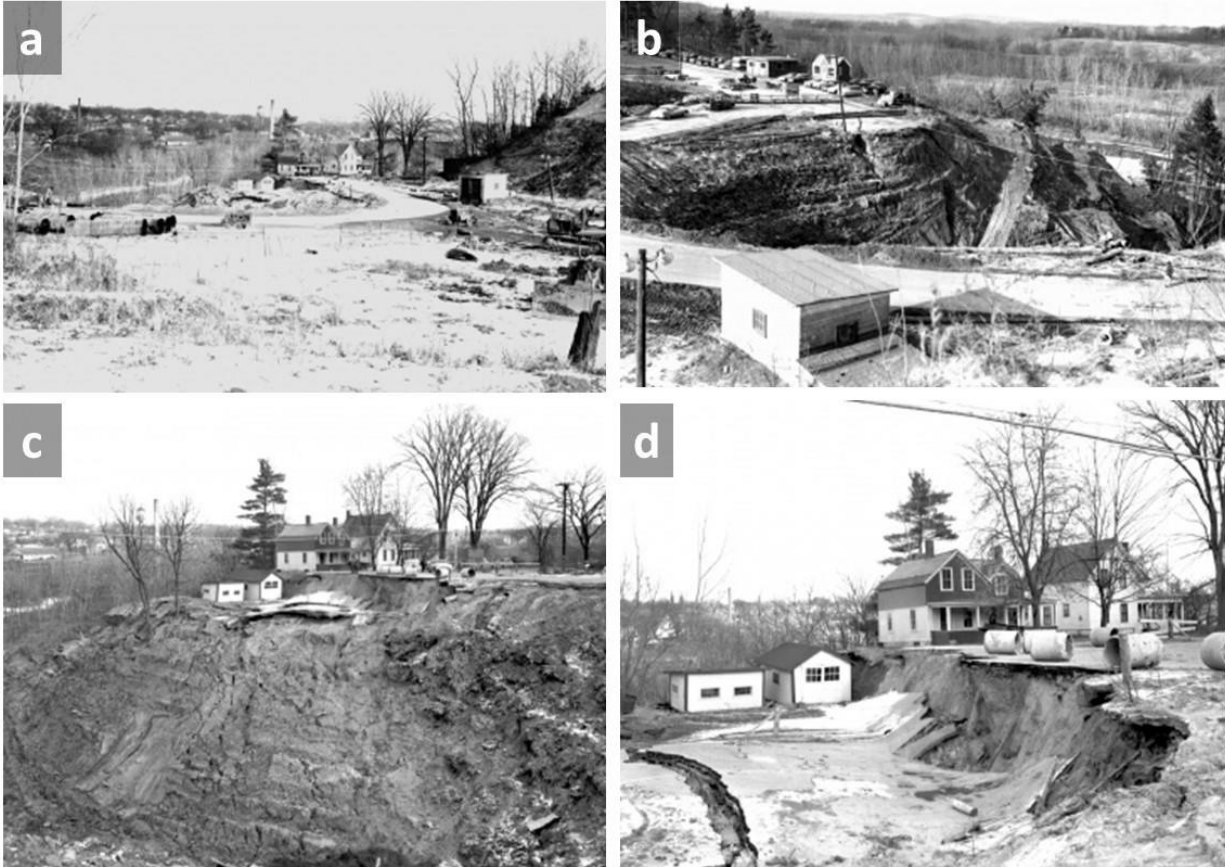
**Fig. 7.**

The largest landslide to date on Riverside Avenue occurred in 1955. This slide was preceded by several smaller slides (Figures 4 and 7; Table 1). The 1955 slide destroyed more than 90 meters of roadway and displaced at least two structures four meters below their initial position (Figure 7C, D). Newspaper records indicate that the first slide at this location occurred in August 1955, causing road damage that was subsequently patched. A week later, the slope failed again, this time undermining the road and creating a six by five-meter hole in the road (“Burlington Youths” 1955). In late September, a bypass road was constructed (“Emergency Road” 1955) and the repair work was contracted by early November for \$37,500 (over \$400,000 in 2023 dollars) (“St. Johnsbury Men” 1955). Weeks later, on November 18<sup>th</sup>, the largest slide

occurred, displacing thousands of tons of material (“Washout Rips Riverside” 1955). After this slide, the city closed Riverside Avenue and constructed a new asphalt road to bypass the area while the landslide damage was repaired (Knight Consulting Engineers Inc. 1984) (Figure 7A, B).

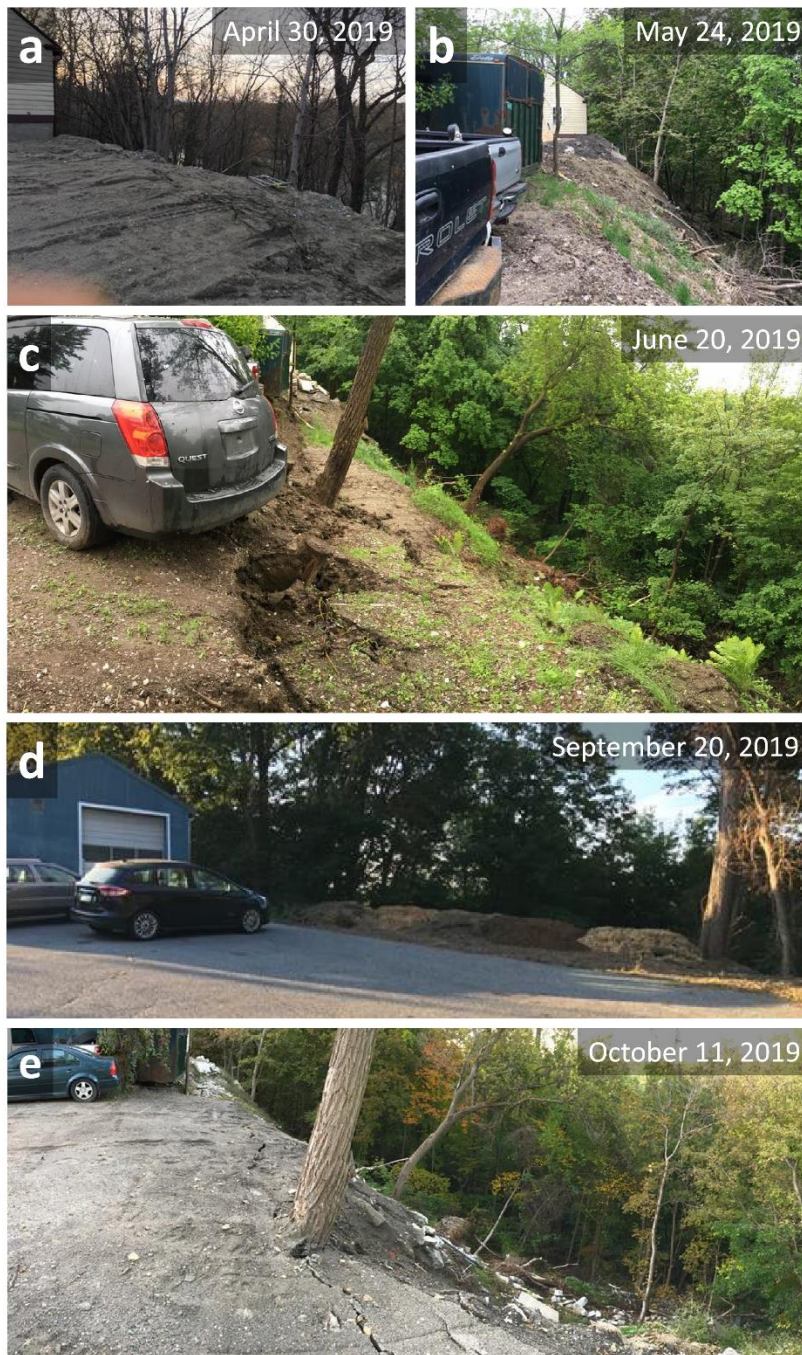
**Fig. 8.**

The most recent fill was placed in 2018 and 2019 without permitting or engineering controls (Figure 8D). Property owners added truckloads of sand, gravel, wood chips, and demolition waste directly to the top of the terrace at multiple proximal locations. These materials settled at the angle of repose over the cut face of the riverbank (Figure 8B). Within a year of emplacement, this material failed in three locations in shallow translational landslides, one of which ran out nearly to the river’s edge (Figure 9; Table 1 #18, 19, 20). Several months before

the 2019 landslides, *en echelon* ground cracks, several cm wide and meters long, opened parallel to the face of the slope (Figure 8A). The cracks grew wider over time and some slide blocks near the face of the slope were displaced downward 10-20 cm (Figure 8E).

539 *with tensional ground cracks parallel to the free face. The Winooski River is visible between the*  
540 *trees, which are growing on the steep riverbank. (b) Photograph of fill dumped over the bank*  
541 *and at the angle of repose. (c) Photograph of vertically displaced ground cracks to the right of*  
542 *the automobile. (d) An example of modern illegal dumping on this slope at 411 Riverside*  
543 *Avenue. In this photo, dumped material is primarily composed of woodchips and other organic*  
544 *material, and was placed on top of ground cracks at the edge of the slope. (e) Photo taken in the*  
545 *same location as (c) after additional fill was added to the slope surface in August, showing*  
546 *cracks reforming in the fill. Note the same tree in both photographs.*

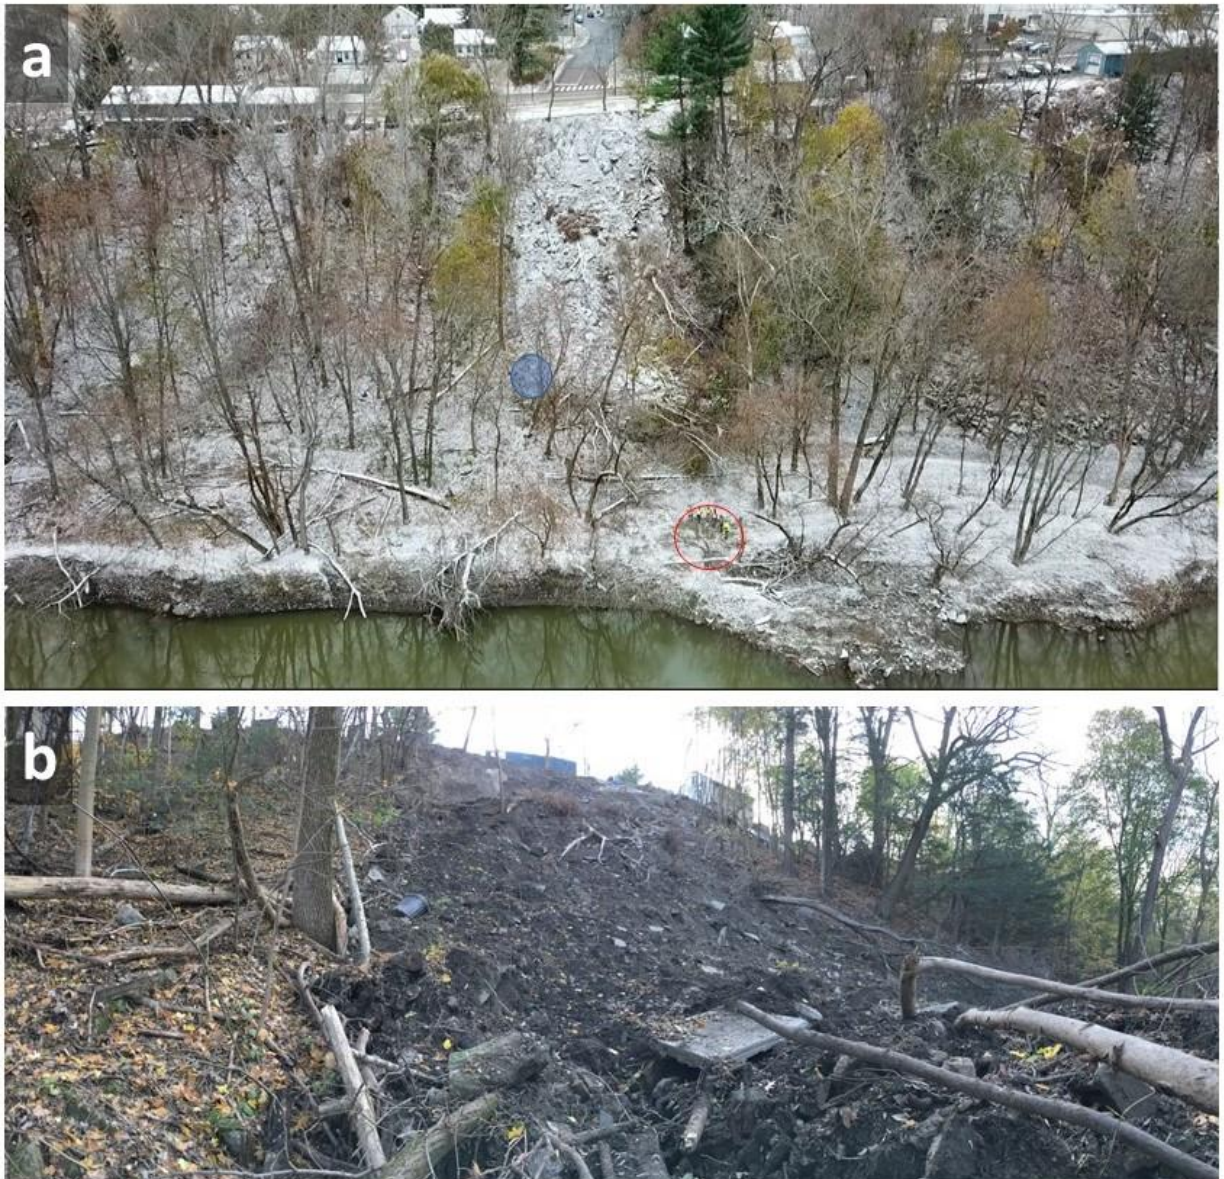
**Fig. 9.**

The 2019 landslide occurred during the night of October 31 and/or the early morning of November 1 (Figure 9). It was coincident with a record-breaking late October storm, which developed in an exceptionally warm and moist late fall air mass. The storm delivered about 8 cm (3.3 inches) of rain to the Burlington, Vermont area within a 10-hour period. Several bands of precipitation delivered rain at rates of 1.25 to 2.5 cm per hour (0.50 to 1.0 inch per hour). The heavy rain triggered urban flash flooding and swift rises in the stage of area rivers. Given the quantity of water delivered in this storm, we infer that a rapid and substantial increase in sediment pore pressure contributed to the slope failure. Using aerial imagery of the slide, we determined that the failed volume was between 3600-5000 m<sup>3</sup>.
