1. Report No.	2. Government Accession No.	3. Recipient's Catalog No.
4. Title and Subtitle Cost-Effective and Rapid Concrete Repair Techniques		5. Report Date February 8, 2016

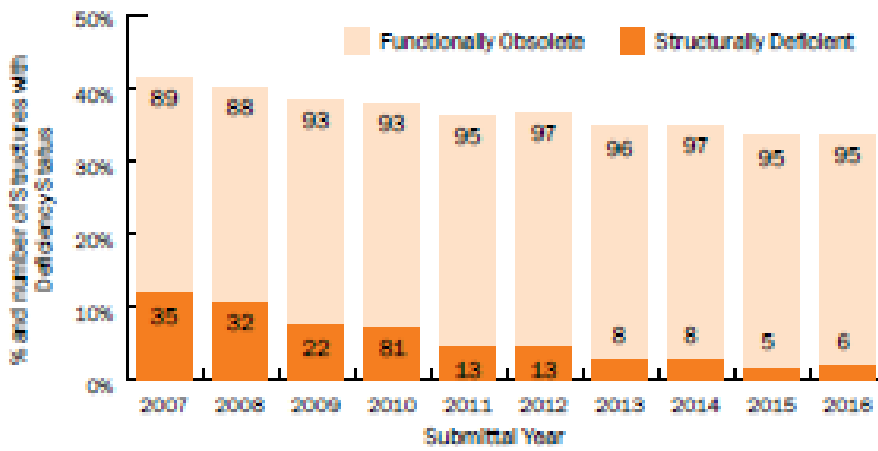
State Highway Structure Trends

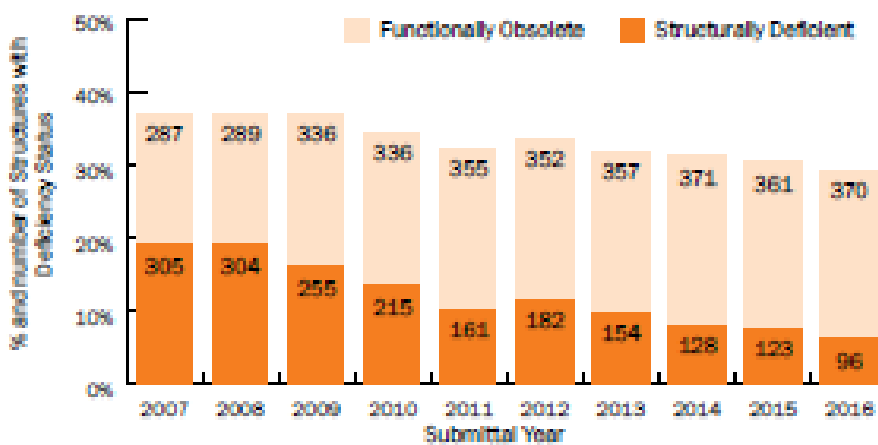
Figure 1.1 Downward trends of percent structurally deficient and functionally obsolete bridges in Vermont (VAOT 2017)

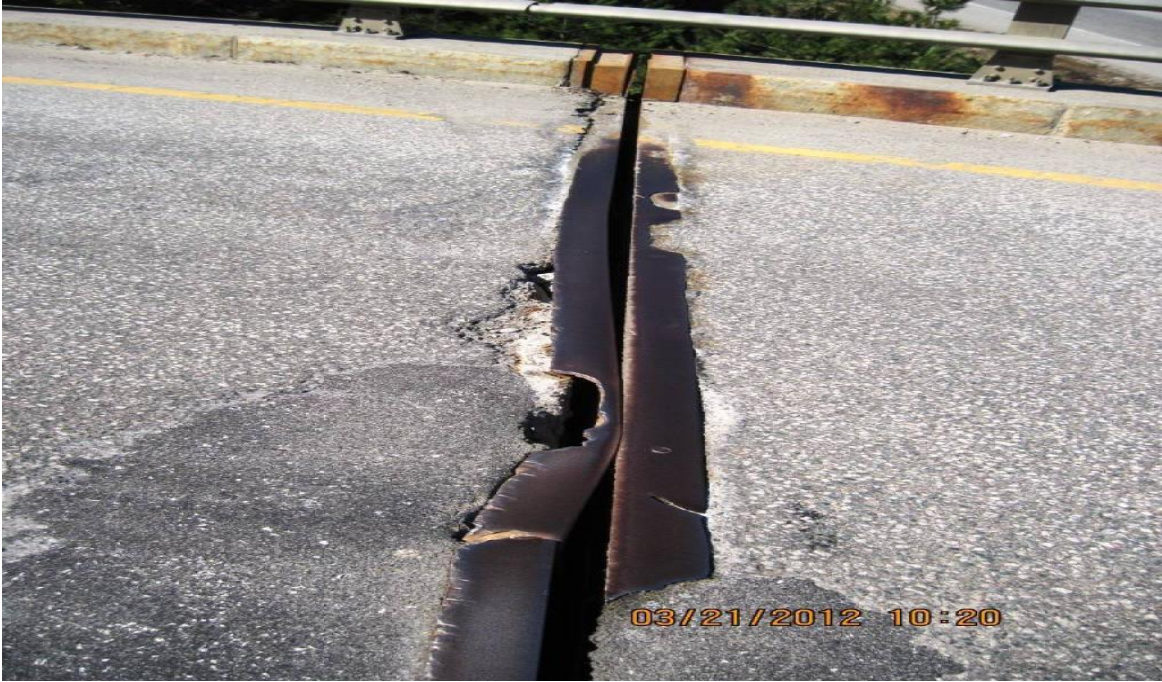
4.3 shows a damaged steel expansion joint and bearing for Vt. Rte. 903 Conn Berlin Br. #1. Figure 4.4 shows a replacement that eliminates the steel joint.

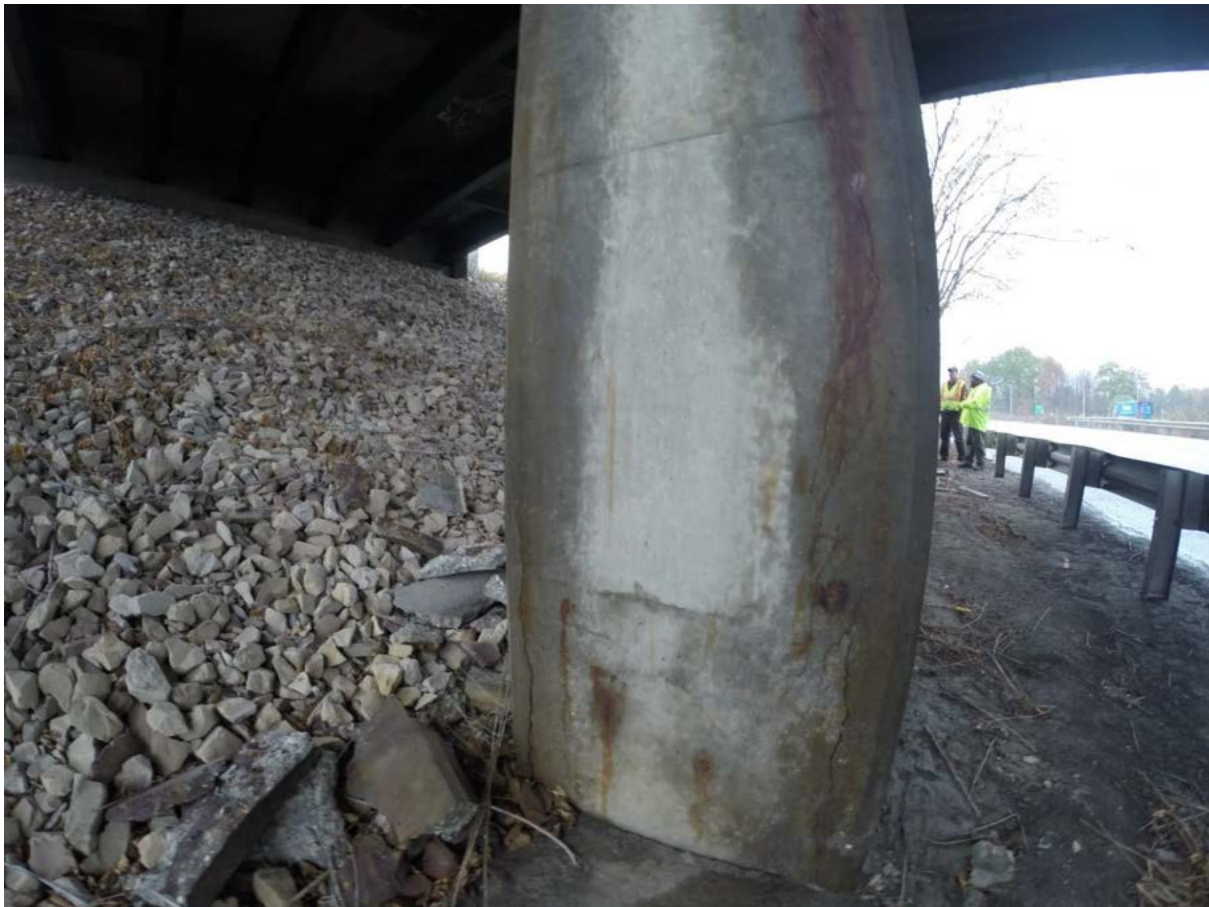
Figure 5.9 Column on Colchester/Milton I-89 Bridge showing cracking, likely due to swelling corroded reinforcing bars

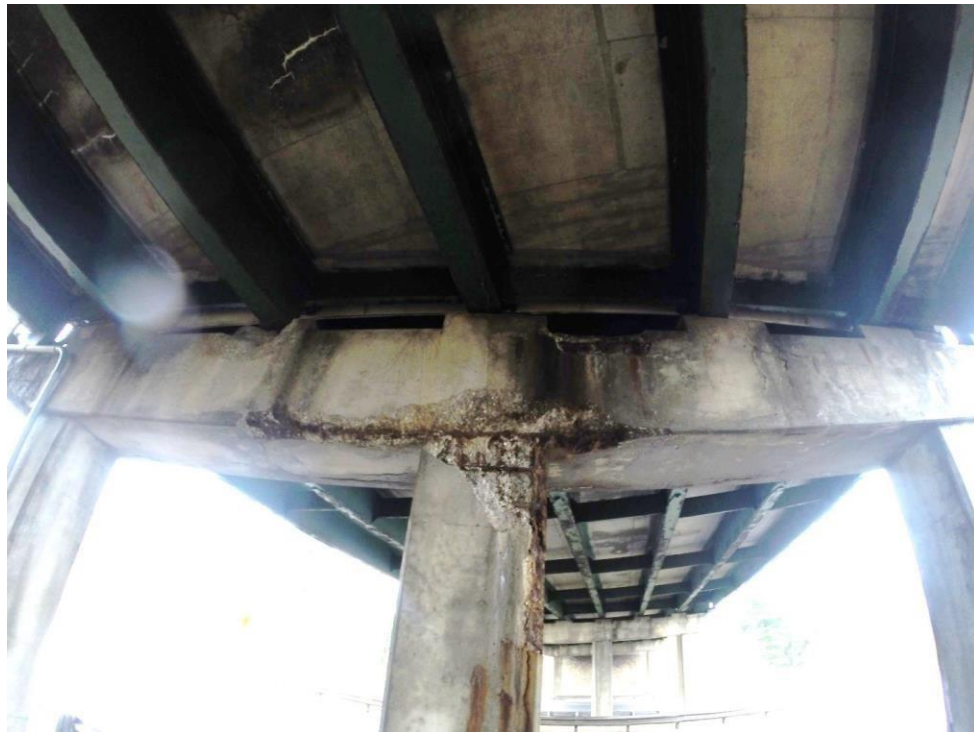
Figure 5.11 Spalling on pier cap of Colchester/Milton I-89 Bridge

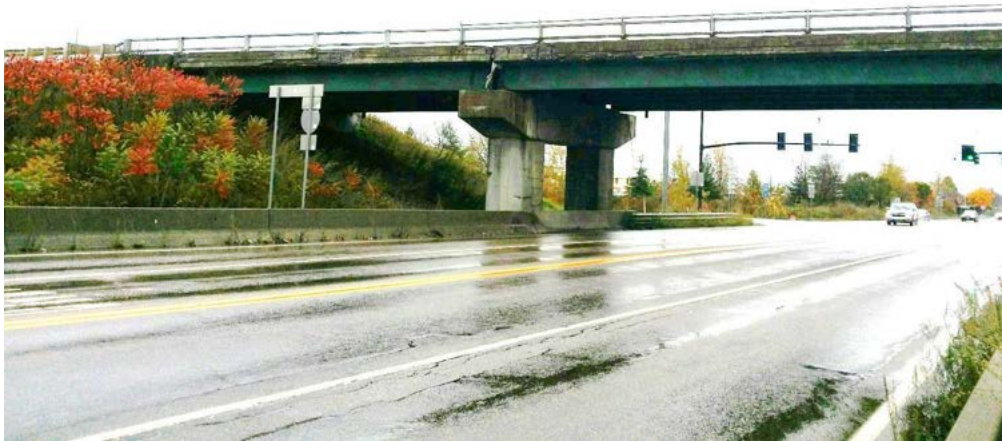
Figure 5.21 Williston I-89 Overpass Tafts Corner with encasement repair of the pier, failed expansion joint gutter and distressed fascia

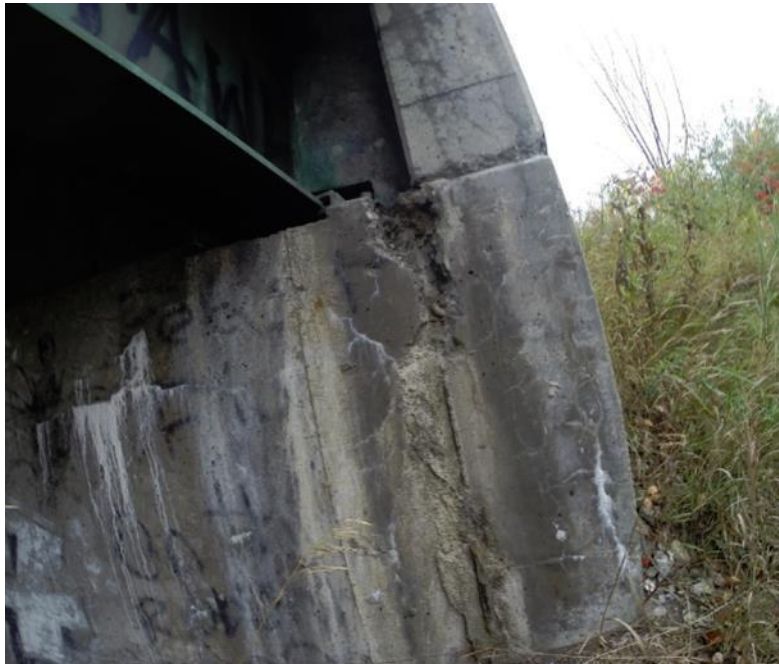
Figure 5.28 Scaling on Abutment and Beam on Williston I-89 Oak Hill Rd Underpass Bridge

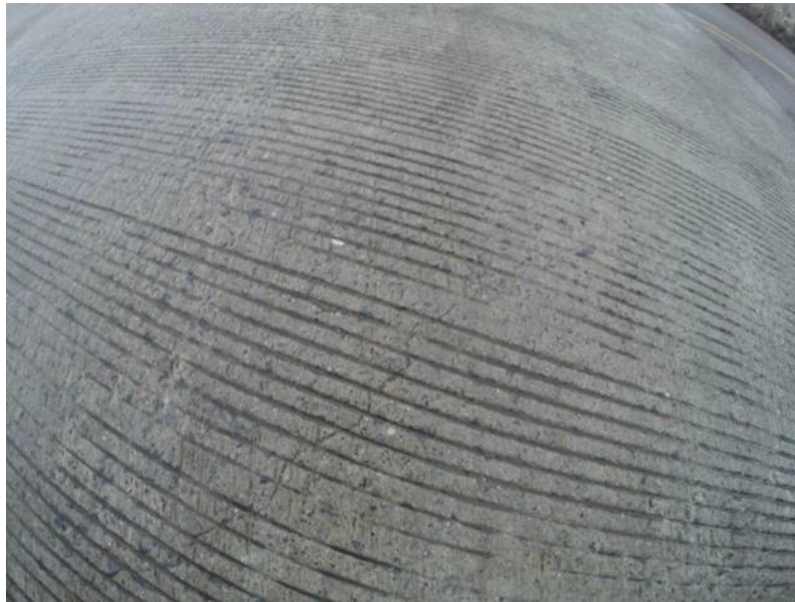
Figure 5.42 Deck patterned with cross-span cracks, approximately every 200 mm on Stowe Rte 100 Gold Brook Crossing Bridge

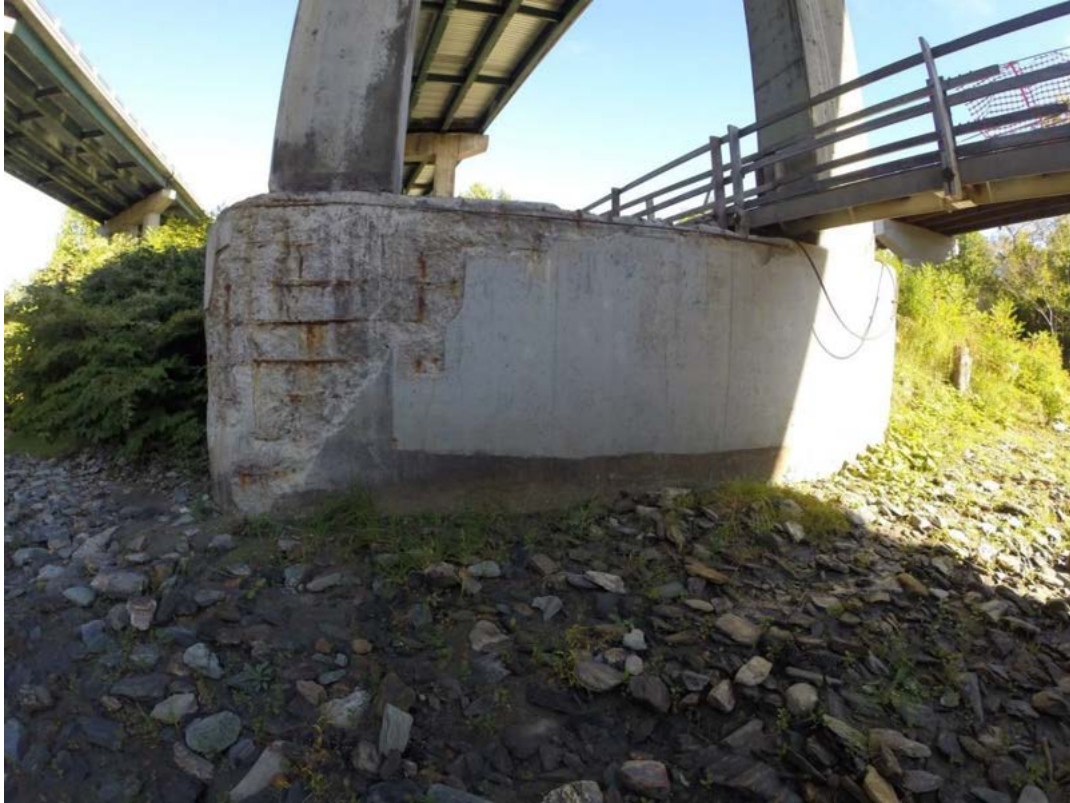
Figure 5.46 End view of pier base with damaged concrete removed on I-89 Waterbury Overpass Bridge

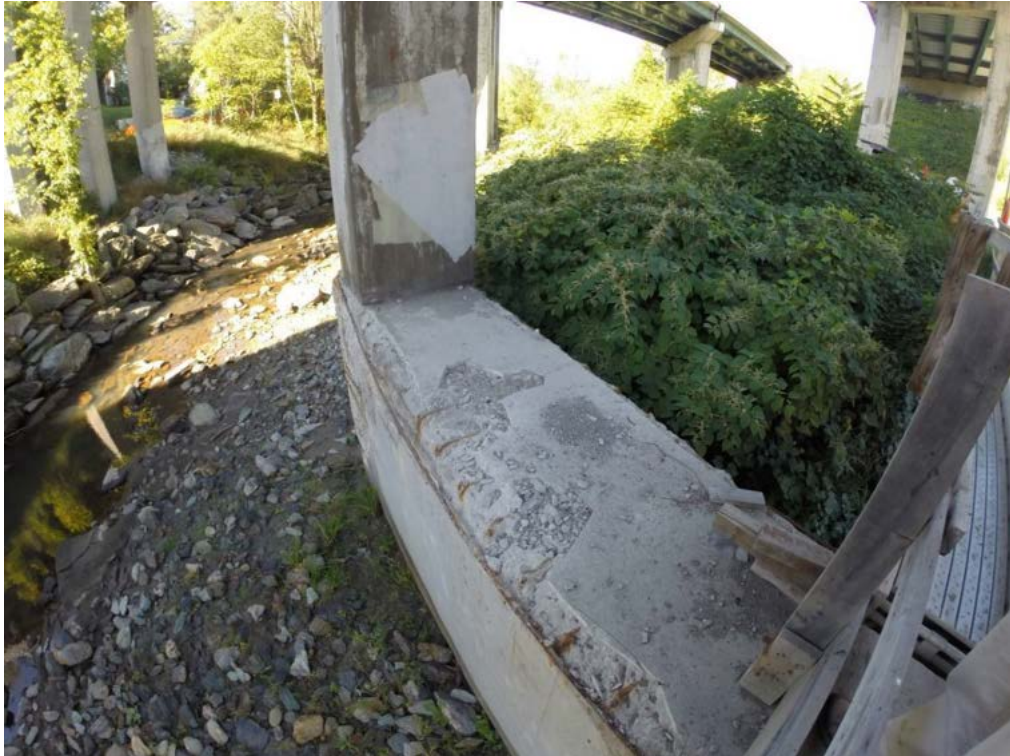
Figure 5.47 Top view of pier base with damaged concrete removed on I-89 Waterbury Overpass Bridge

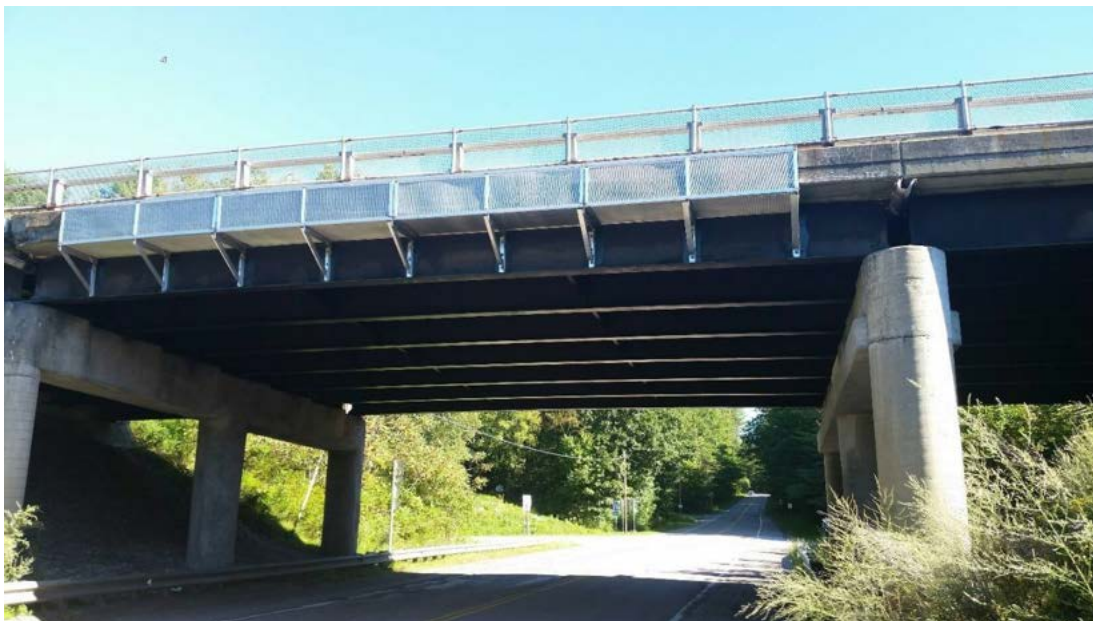
Figure 5.53 I 89 Middlesex Overpass Bridge with supplemental rack to protect vehicles passing under by catching pieces of concrete that spall and fall from the fascia

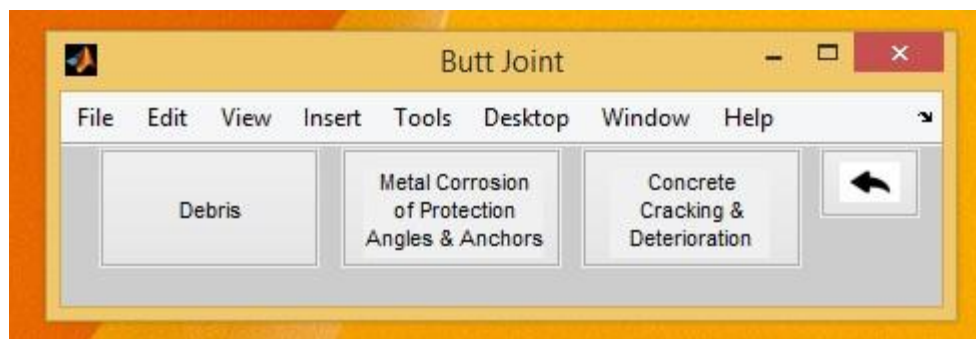
Figure 6.14 Screen shot of particular bridge deck element GUI (going through flowchart), enables picking type of damage to element to select proper repair procedure

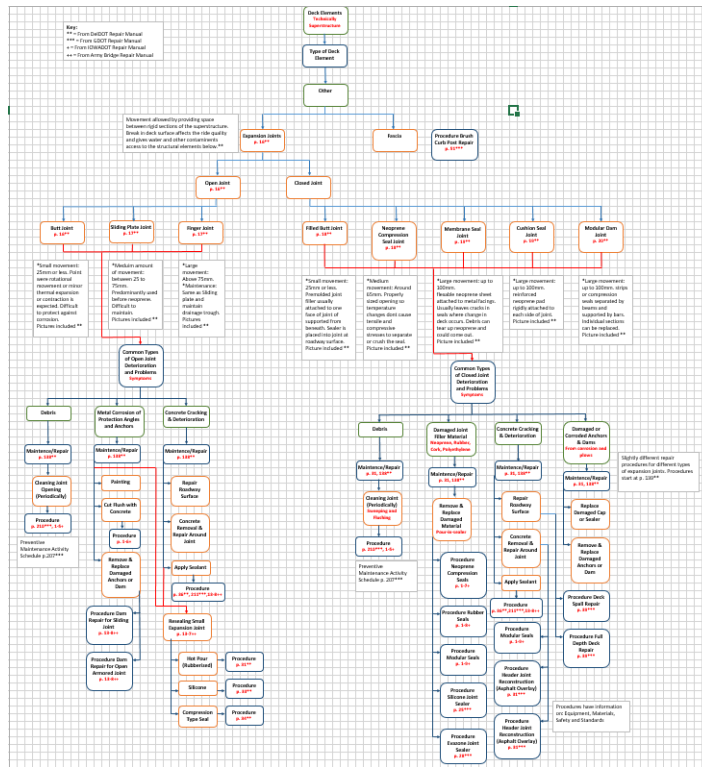
Figure 3: The Full Decision Tree can be accessed as the Excel File: (Expansion Joint and Fascia Deterioration Repair Decision Tree)

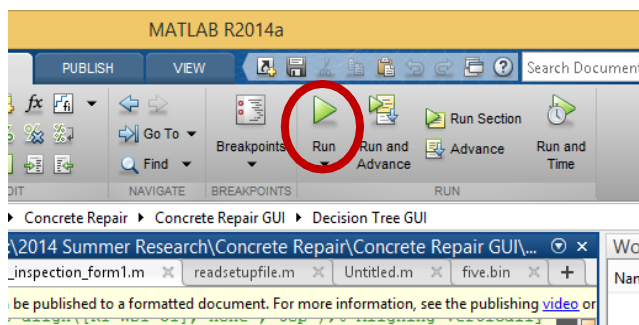
3. The **Bridge Inspection Form** window should pop-up, depicted in Figure (Figure 5). The window gives the user the option of clicking between two buttons:
 - a. The **Field Inspection Form** button, which directs the user to the electronic form
 - b. The **Field Inspection Coding Guide** button, which directs the user to a PDF version of the guide.

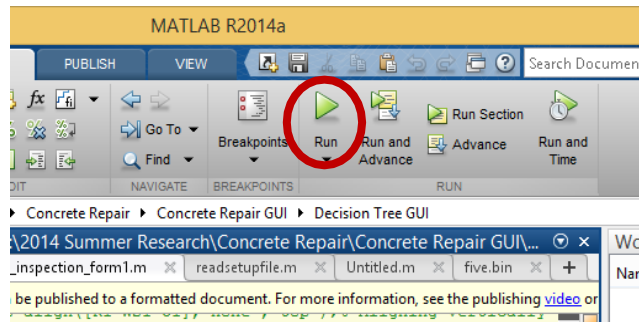
3. The **Concrete Repair Flow Chart** window should pop-up, depicted in Figure (Figure 15). The window gives the user the option of clicking between multiple buttons:
 - a. Choose from six deck elements: **Structural Deck, Sidewalk, Curb, Railing, Wearing Surface** or **Other** (shown by red oval) *Only **Other** is currently active*
 - b. The **Definitions** button (to the right of the red arrow), which directs the user to a Definitions pop-up window that defines the bridge terminology of the previous window. *For Further Information on the **Definitions** window, reference **Step 11** in **1.2. Decision Tree GUI**.*

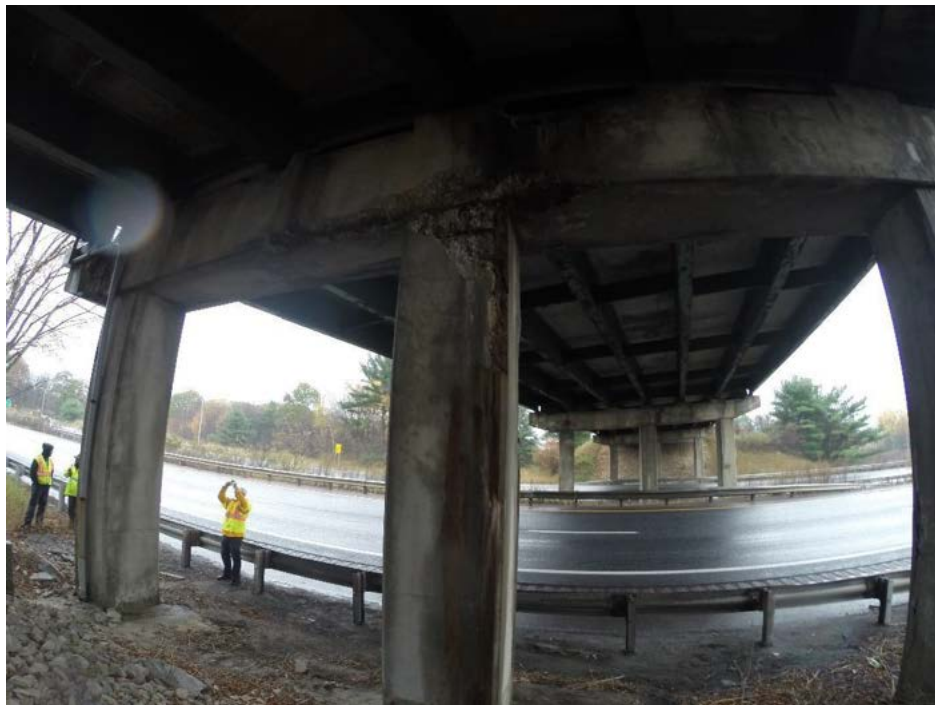
Figure 19: Column and cap Spalling and steel corrosion

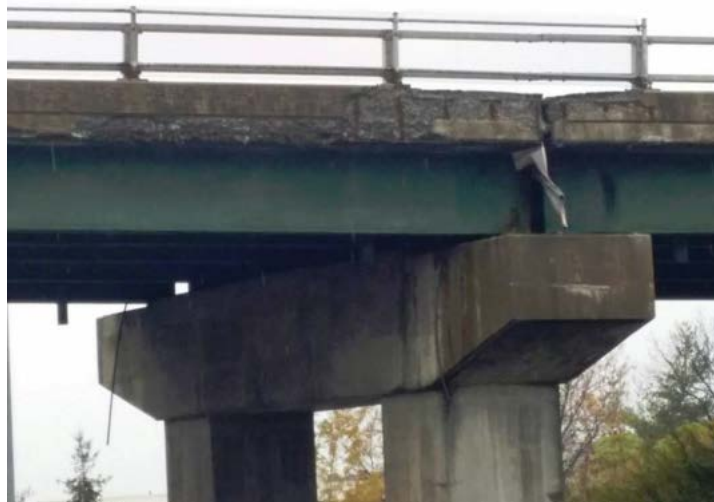
Figure 27: Spalling and steel corrosion on concrete fascia.

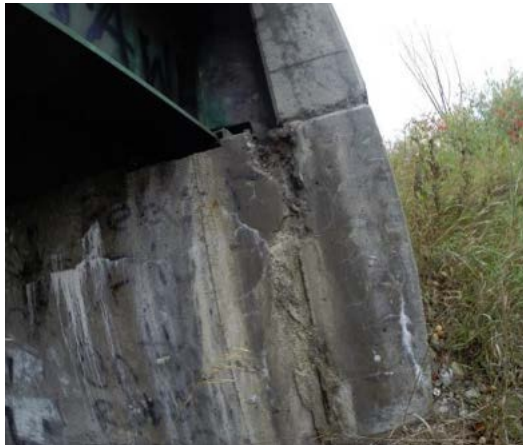
Figure 29: Scaling on abutment around bearing and beam

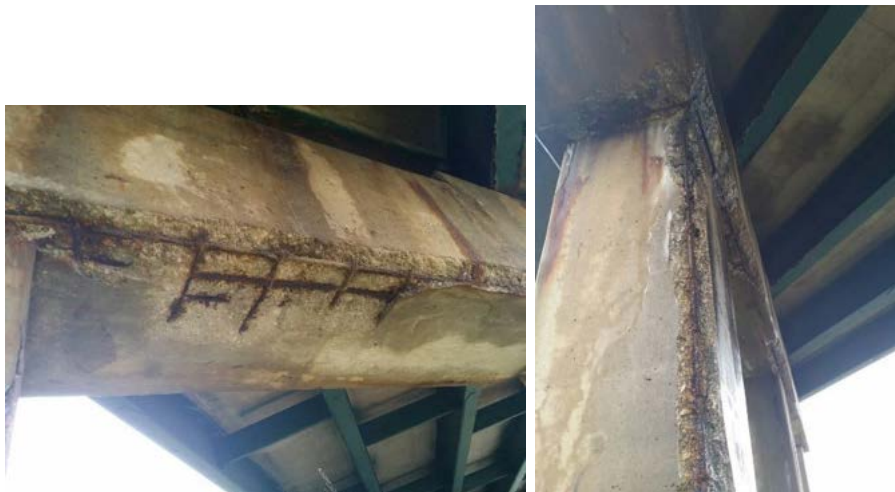
Figure 32: Spalling and steel corrosion on columns and caps
