## Channel Change on the Upper White River Vermont: The role of climatic variability and landuse change on sediment mobility

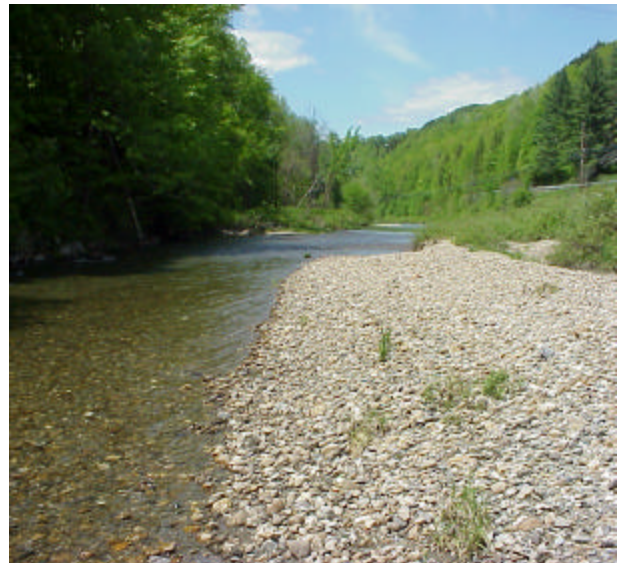
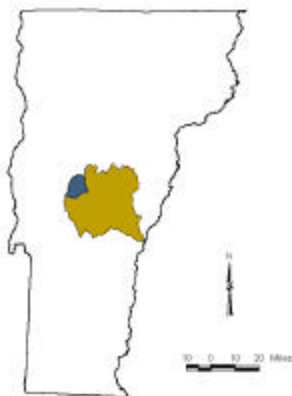
Upper White River basin (shown in blue) within the White River watershed (shown in brown), Vermont.

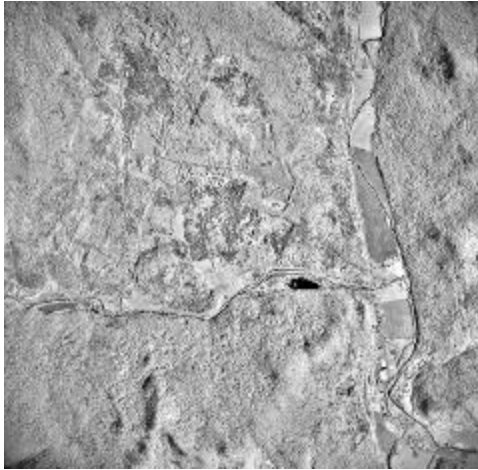
Historical aerial photographs depicting a reach of the Upper White River and adjacent land use, 1975 and 1990.

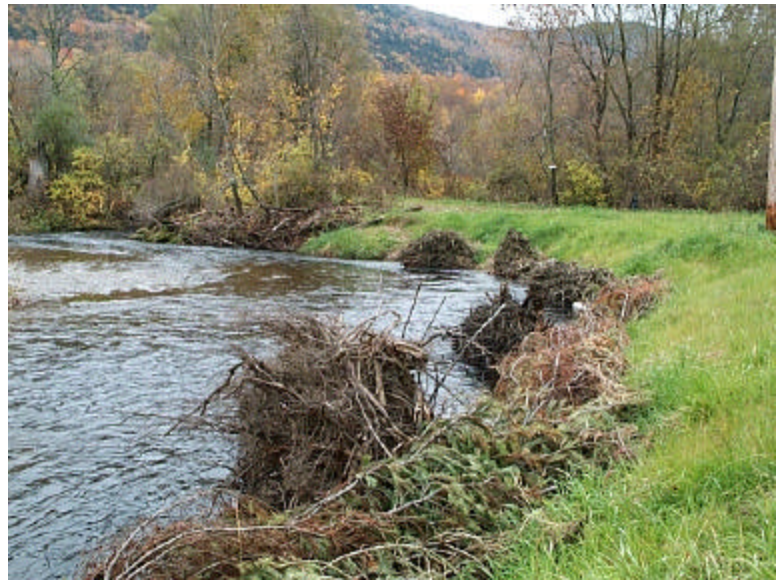
Channel restoration project on the Upper White River, VT
