Compacted Greenspace and Stormwater Hydrology in Burlington, Vermont:
An analysis of 3 remediation treatments for compacted soils and a comparison
of stormwater from two small urban catchments.

A Thesis Presented
By
Nathan Arun Toké
To
The Honors Committee of
The University of Vermont

As partial fulfillment of a Bachelor of Science in Geology
Through the Department of Geology of
The University of Vermont

May, 2003

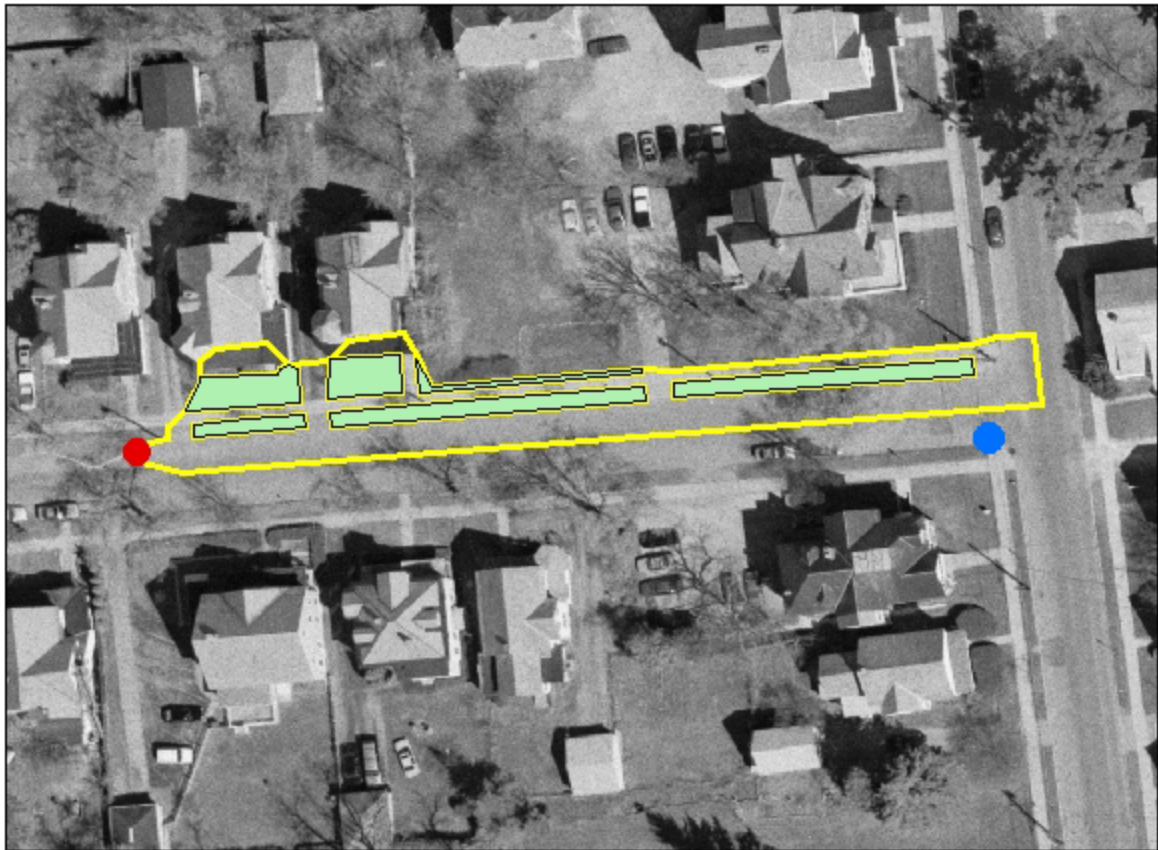
Figure 1.2: Brookes Avenue land cover and drainage basin delineation

Brookes Avenue Drainage Basin is 920 square meters. It is composed primarily of impermeable surfaces including the Brookes Avenue roadway, sidewalk, driveways, and portions of some buildings. There are 6 areas of greenspace covering 25% of the basin (Table 1.1).

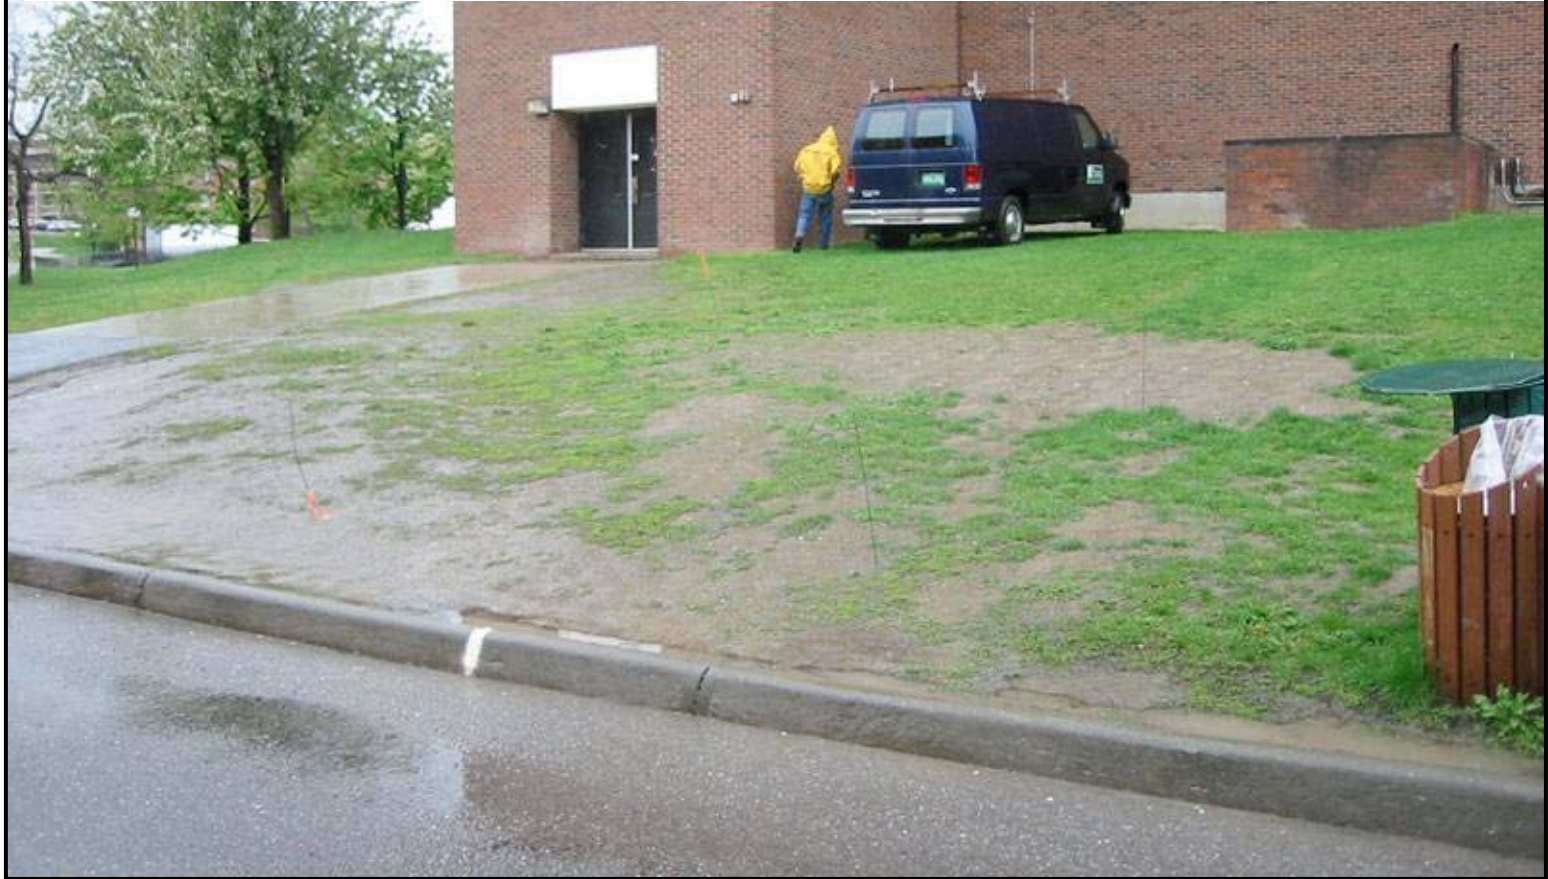
Figure 1.4

Cook, pre-remediation: The soil is clearly compacted and there is little to no vegetative cover. Note that you can see ponding on the compacted soil and there is a van parked on the lawn.

I observed that the southwest lawns of Old Mill, Fleming Museum, and Torrey Hall were compacted in a similar manner and for similar reasons as the Cook site. At all three sites, compacted cut paths between walkways had resulted from a high volume of foot traffic. Furthermore, all three sites are located next to campus roadways. On several

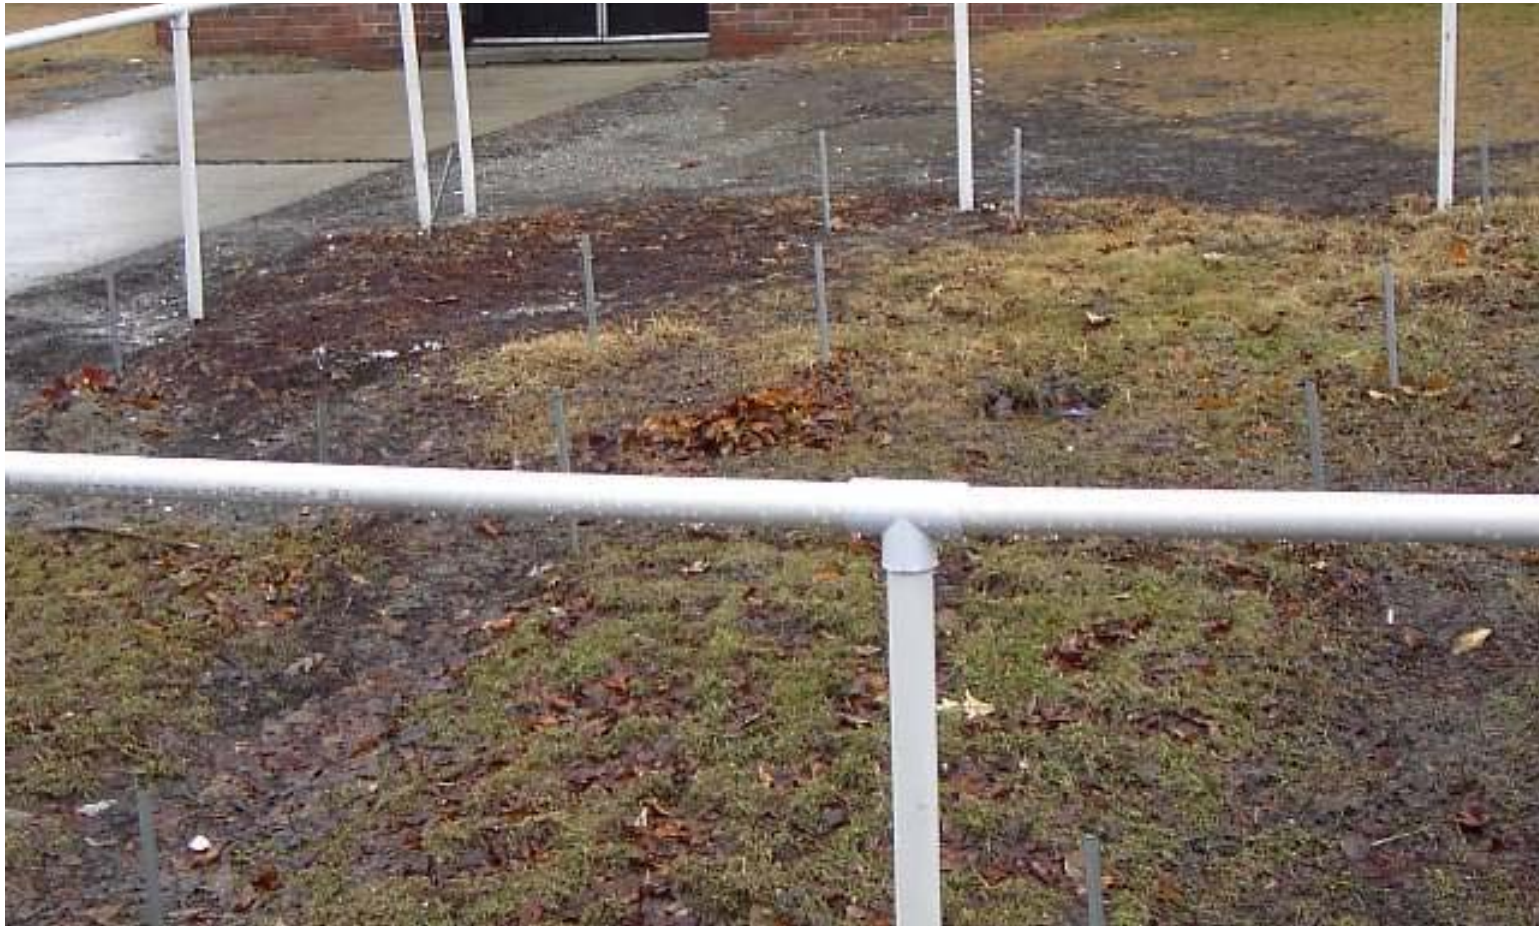
Figure 2.1

The north lawn of the Cook Physical Sciences Building after remediation. Shown here are the Cook control (top left) and Cook 7 (bottom right) sites, the boundaries of which are marked by four metal pins for each plot. Notice the difference in vegetative cover between the two sites. Also shown is Cook 2 (top right) and Cook 8 (bottom left).

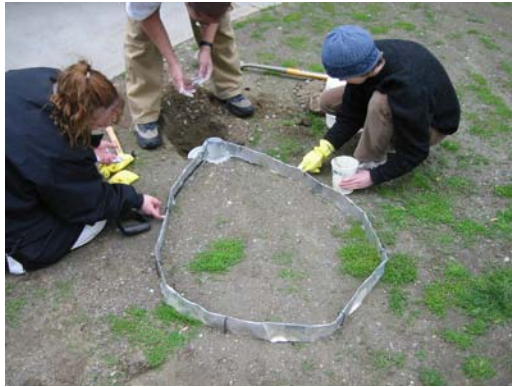
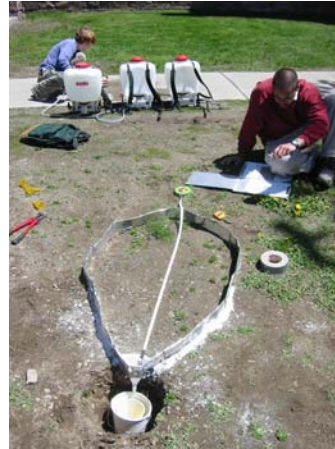
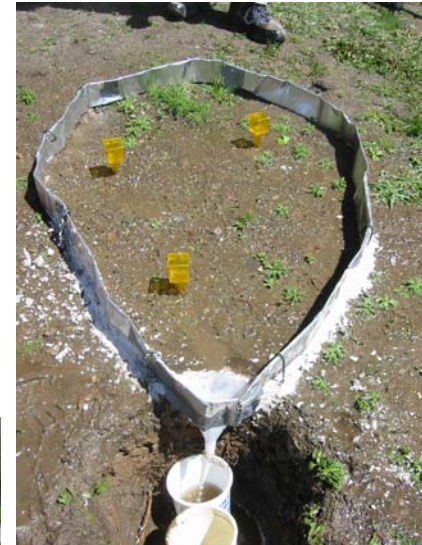
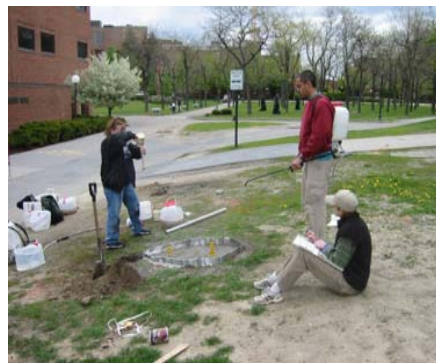
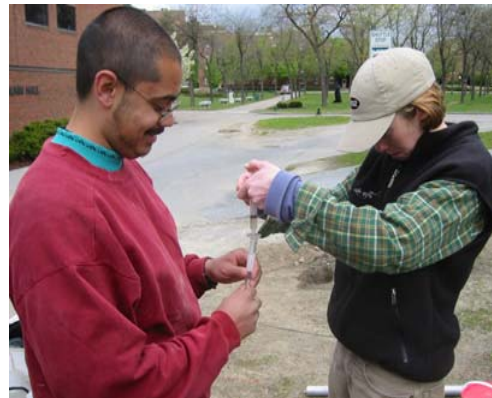
Figure 2.3: Simulated rainfall test: infiltration rate analysis, runoff collection, dissolved load chemical sampling, and measurement of suspended sediment.

Construction of the tear drop Rainfall simulation apparatus.

Area measurement

Rain gauges and Runoff collection

Runoff measurement

Before any remediation was conducted, each of the four compacted sites was tested for pre-remediation parameters during the third week in May 2002. Megan McGee, (2003), studied the parameters of soil density and infiltration capacity. To obtain a steady-state infiltration rate, we used the rainfall simulation method previously employed by Mellilo et al. (2002) and Persico et al. (2002). The infiltration tests involved constructing a tear-drop-shaped test area, such that the narrow part pointed down slope (Figure 2.3). Aluminum sidewalls were pushed into the ground and sealed on the outside of the structure with plaster. Three rain gauges were placed within the measured test plot area. At the test plot outflow, an aluminum collection plate was emplaced, leading to a funnel which allowed the water to flow into a collection bucket located in a previously dug hole. Rainfall was simulated using one to two backpack sprayers. Rainfall amounts were recorded in centimeters, runoff was collected and measured, and corresponding time intervals were recorded. The infiltration tests were conducted until it appeared that a steady state infiltration rate had been obtained (the same amount of runoff was produced over the same time interval).

I constructed several temporary wooden weirs following the installation guidelines given on the v- notch (triangular) weir calculator webpage (<http://www.lmnoeng.com/Weirs/vweir.htm>). The guidelines were followed as closely as possible, but with several replacement weirs necessary because of destruction by angry or inconsiderate drivers; some variations in weir geometry undoubtedly occurred. Weirs were emplaced using existing curbing as the primary support along with cinder blocks, large rocks, and plaster to create a seal along the base and sides of the weir (Figure 2.3).

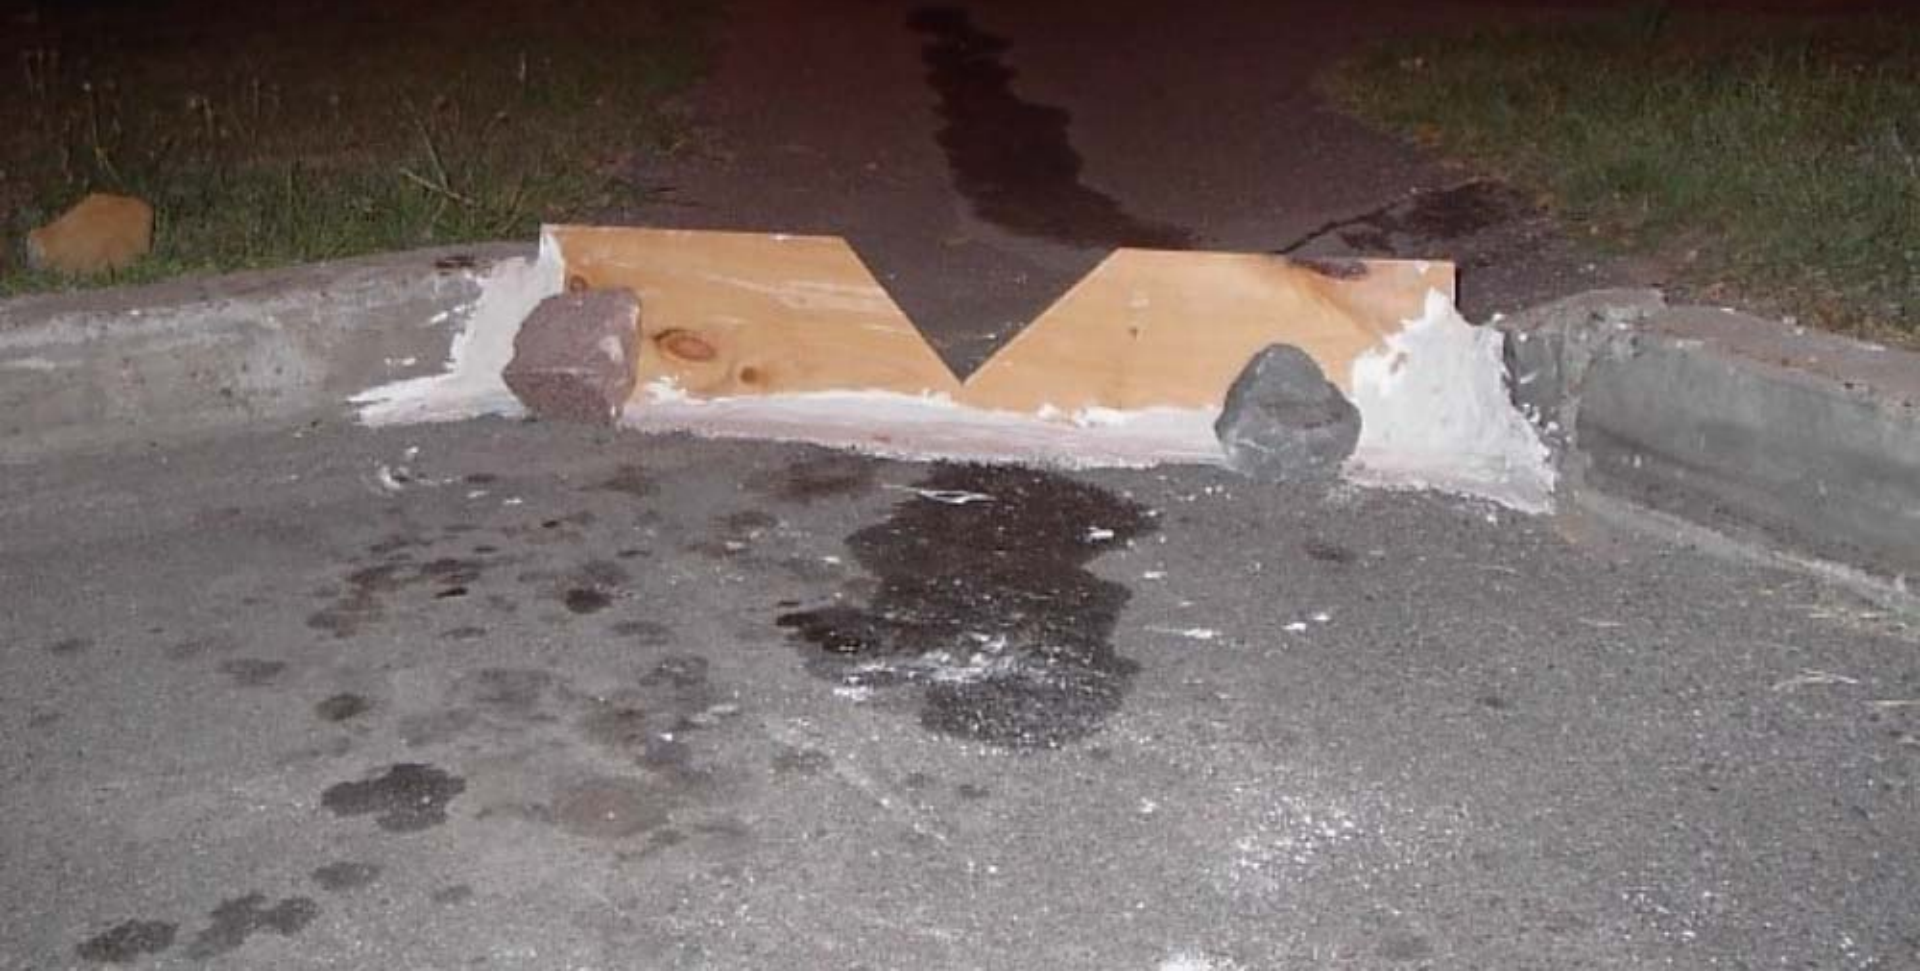
Figure 2.4

The Perkins Parking Lot Weir Constructed on Sept 10th, 2002. The V-notch is 90 degrees and is tapered to a shear edge. The weir is held in place with the existing curb, a plaster seal, and rocks. Note that there are clear automotive fluid stains on the pavement

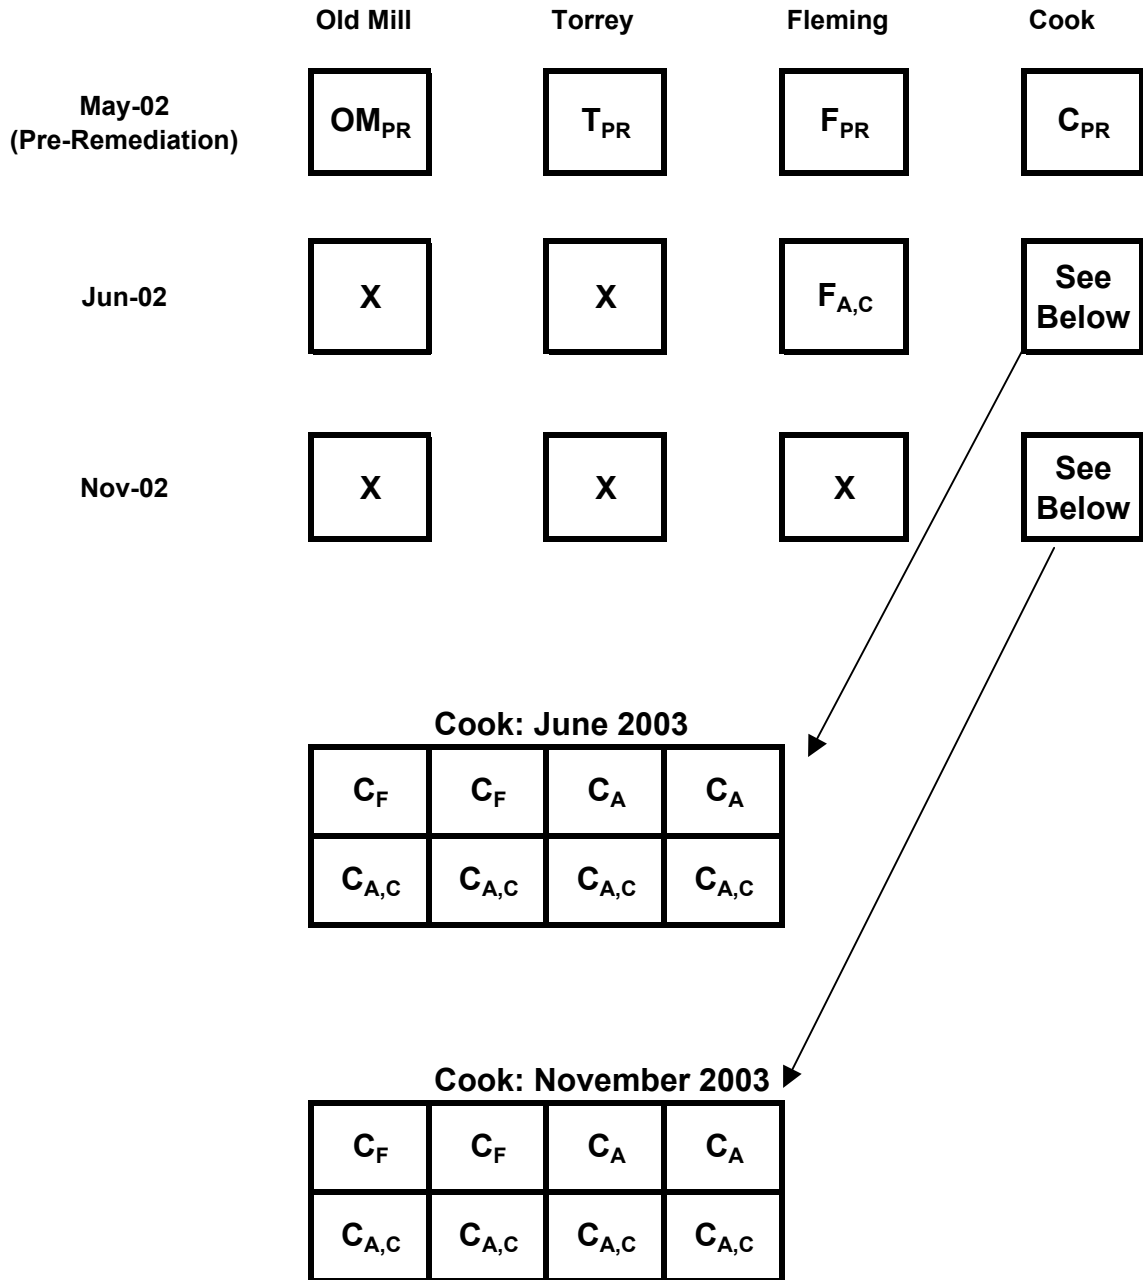
Figure 2.5
Remediation plot diagram displaying remediation sites, treatments and testing dates

Plot data was entered into Minitab enabling a two sample t-test statistical comparison between remediation treatments and plot response for infiltration rates (McGee, 2003), normalized suspended sediment production, and chemical data. However, in order to make a statistical comparison I had to reorganize how I classified the remediation treatments between testing rounds (Figure 2.5). This reorganization resulted in n=4 pre-remediation tests. In June there were n=2 sites (Cook control and Cook 2) which received fencing as the only significant treatment, there were n=2 sites (Cook 3 and Cook 4) which only received aeration, and n=5 sites (Cook 4-8 and Fleming) which were aerated and composted. November testing had the same treatments less Fleming, which was not tested, due to snow (Figure 2.5).

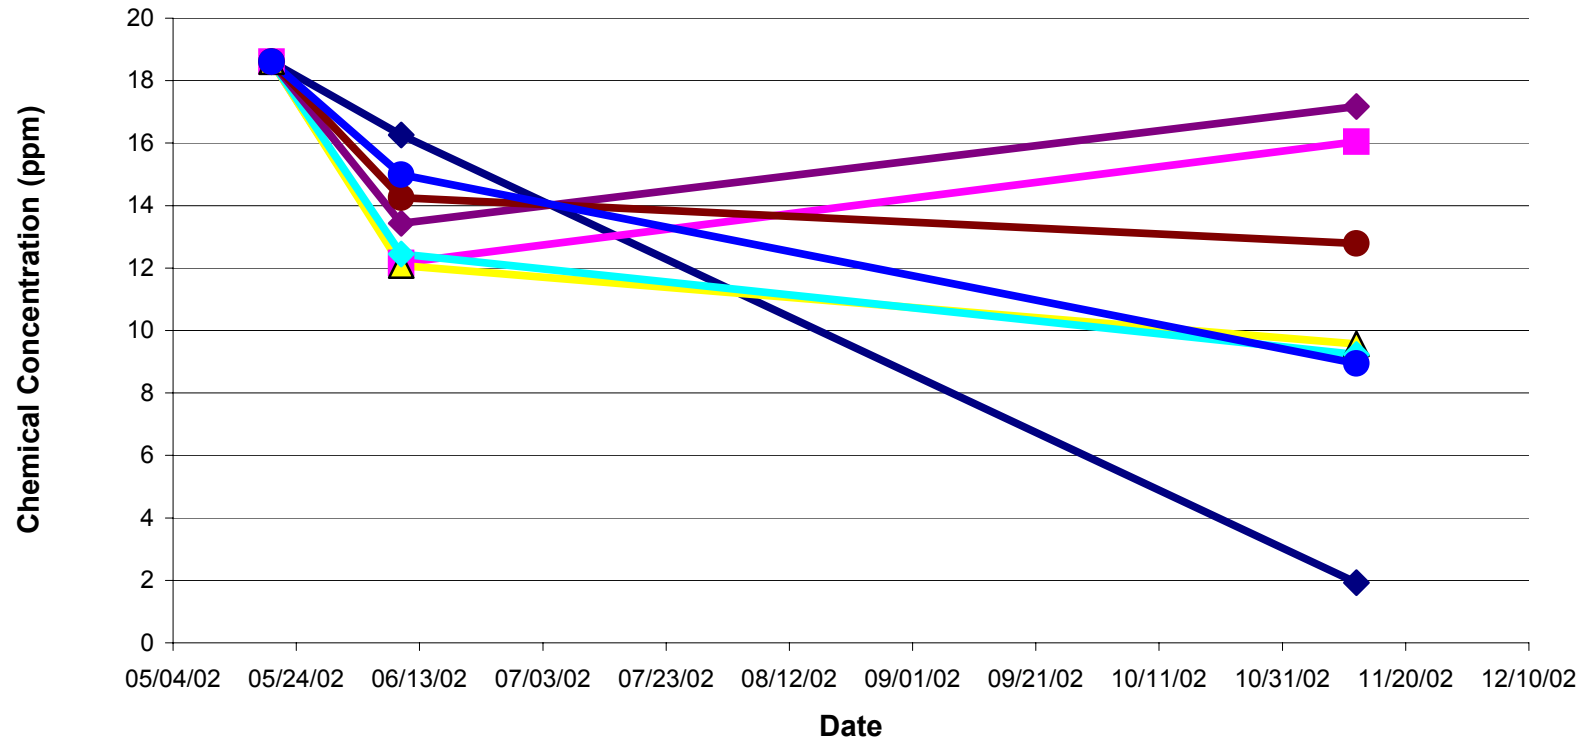
Figure 3.2
Change in sodium concentration in runoff from the Cook remediation test plots

relationships were seen in the changes in chemical concentrations between remediation treatments. A consistent fall in the concentration of sodium through the three rounds of testing was the only significant trend seen in the plot chemistry data. This trend transcended remediation treatments (Figure 3.2). Graphs showing changes in dissolved load concentrations for the other elements can be found in Appendix C and the dissolved load data can be found in Appendix B.

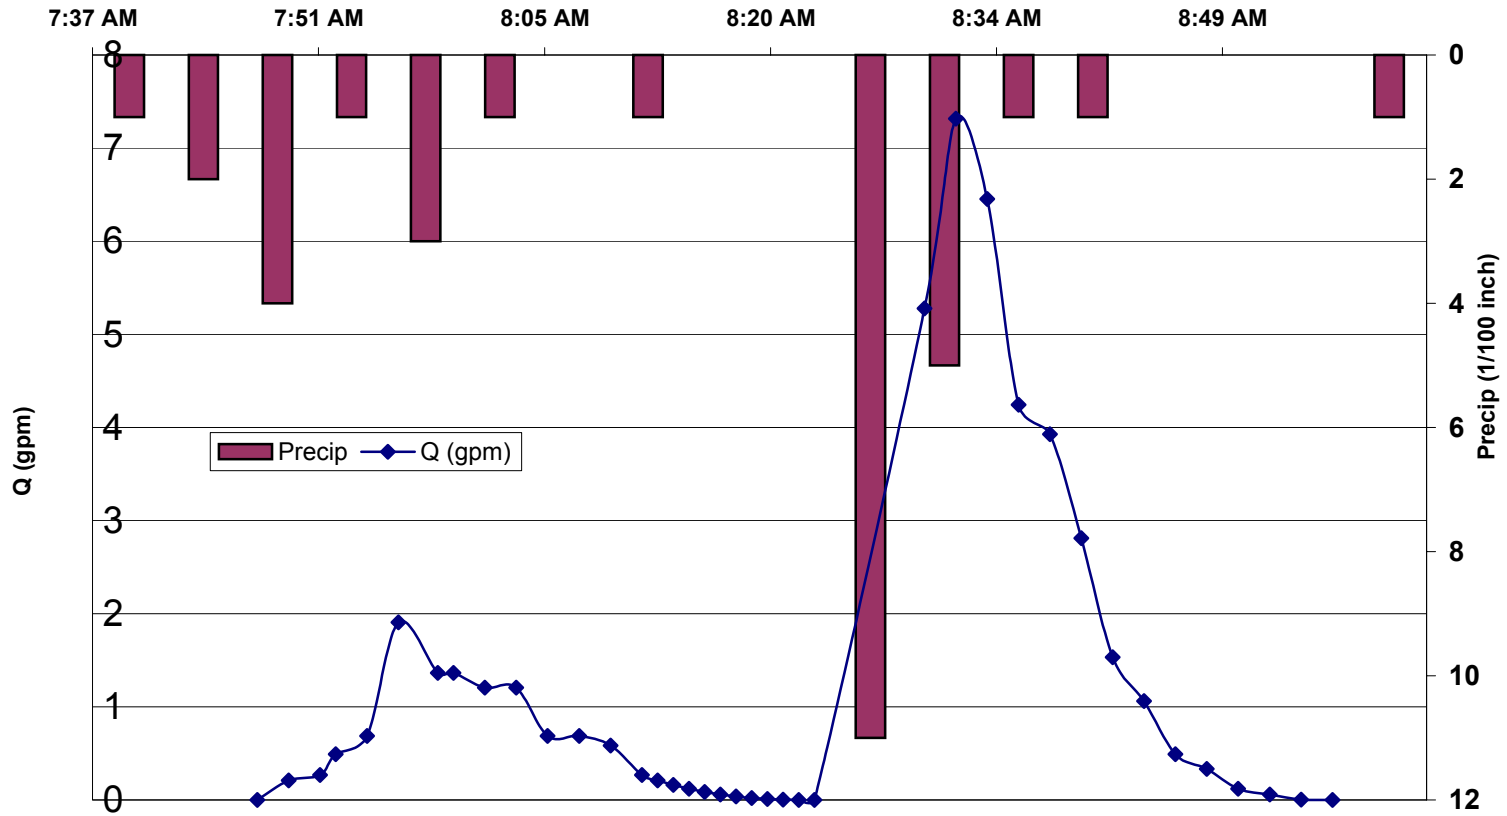
Figure 3.3

Discharge and Precipitation, Brookes Avenue 9/11/02. As a precipitation pulse occurs, it is immediately followed by a surge in stormwater discharge. Note that there are two rain pulses and two rising and falling limbs of this hydrograph.

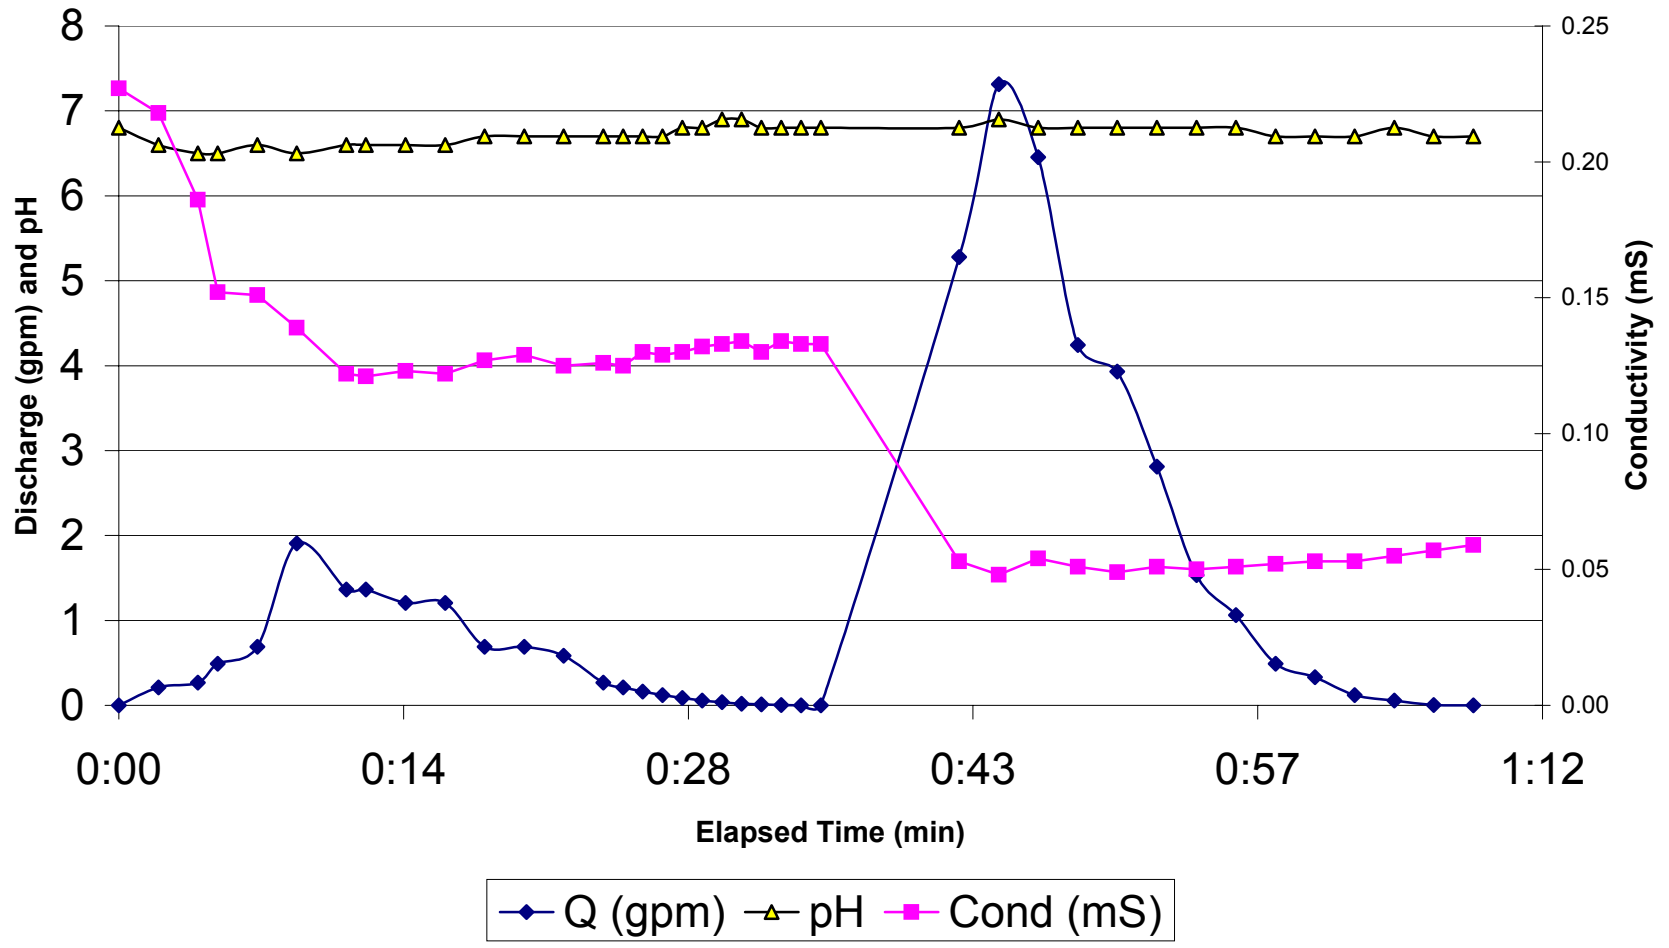
Figure 3.5
Discharge, pH, and Conductivity throughout the 9/11/02 Storm, Brookes Avenue

Measurements of pH from the collected stormwater samples had similar patterns throughout the both storm events and sites. The pH measurements ranged from 6.5 to 7.6 and pH varied by no more than 0.7 through any runoff event. Early storm falls and then general rises in pH were observed over the storm events at both sites. Drops in pH during the storms were associated with increases in rainfall intensity (Appendix A and Figure 3.5). During the shorter 9/11/02 storm only one rain sample was collected, it had a pH of 4.9. During the 12-hour 9/27/02 storm, 16 rain samples were collected with pH values ranging from 5.9 to 7.3.

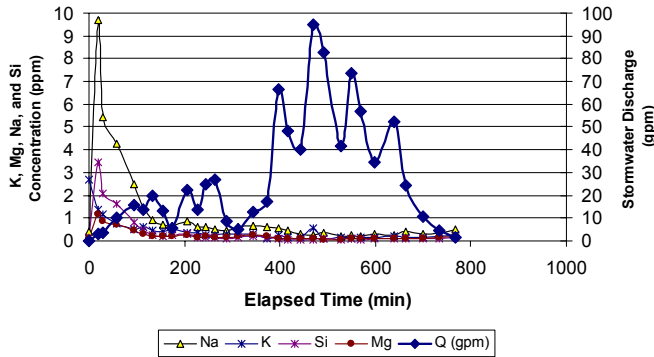
Figure 47: K, Mg, Na, and Si Concentrations (ppm) and Stormwater Discharge (gpm), Perkins Weir, 9/27/02

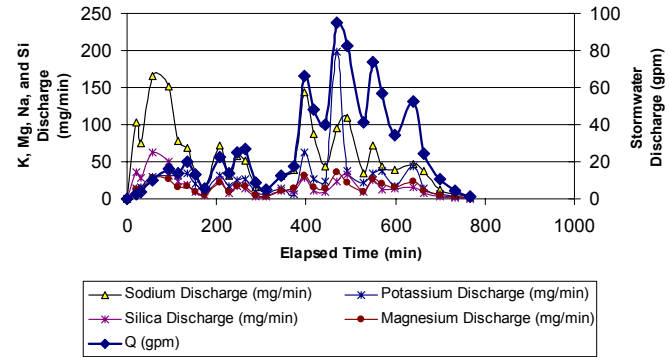
Figure 46: K, Mg, Na, and Si Discharge (mg/min) and Stormwater Discharge (gpm), Perkins Weir, 9/27/02

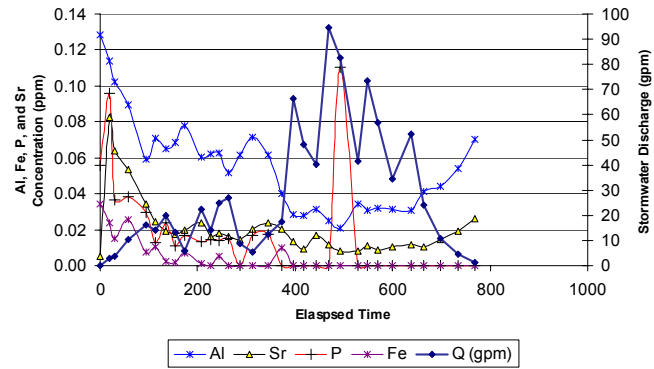
Figure 50: Al, Fe, P, and Sr Concentration and Stormwater Discharge, Perkins Weir, 9/27/02

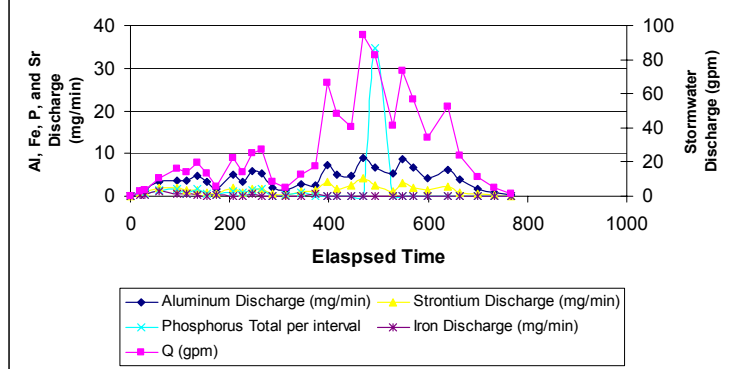
Figure 49: Al, Fe, P, and Sr Discharge and Stormwater Discharge, Perkins Weir, 9/27/02

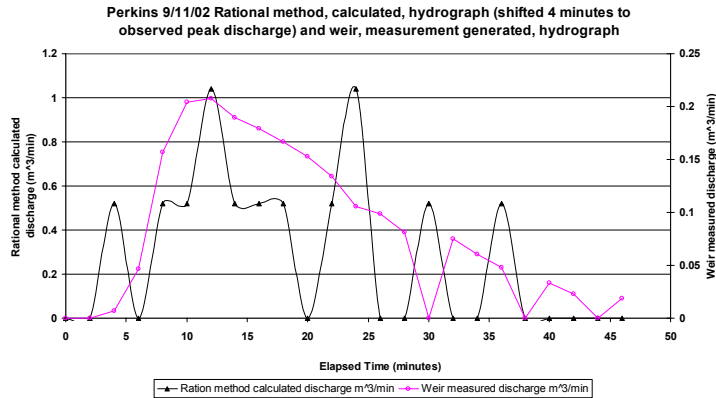
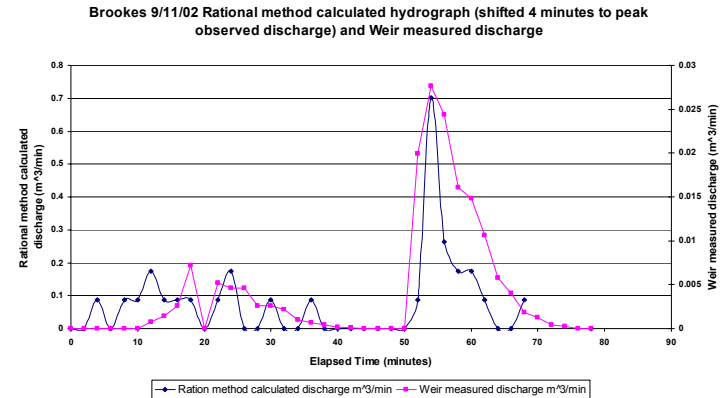
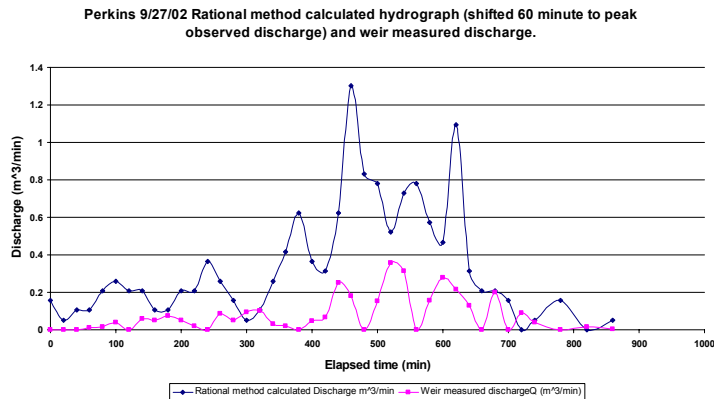
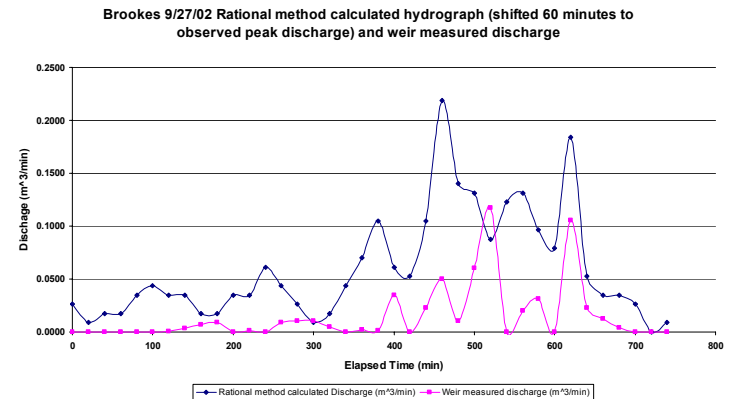
Rational Method Calculated Hydrographs Compared to Weir Measured Hydrographs

was a minimum because my weirs were inadequate to measure the volume of stormwater runoff produced over the Brookes and Perkins drainage basins. To compare loadings between basins I made a calculated estimation of flow for each site and storm based upon the rational runoff method. I used runoff coefficients equal to my estimations for drainage basin impermeability in order to calculate an estimated hydrograph and then integrated the chemical data in the same way as previously described to produce chemical loading data. These data were normalized by precipitation and area to compare chemical loading between sites and storms.
