## Riparian reforestation and channel change: A case study of two small tributaries to Sleepers River, northeastern Vermont, USA

Maeve McBride<sup>a,\*</sup>, W. Cully Hession<sup>b</sup>, Donna M. Rizzo<sup>a</sup>

<sup>a</sup> Civil & Environmental Engineering, University of Vermont, 213 Votey Building, Burlington, Vermont, 05405, USA

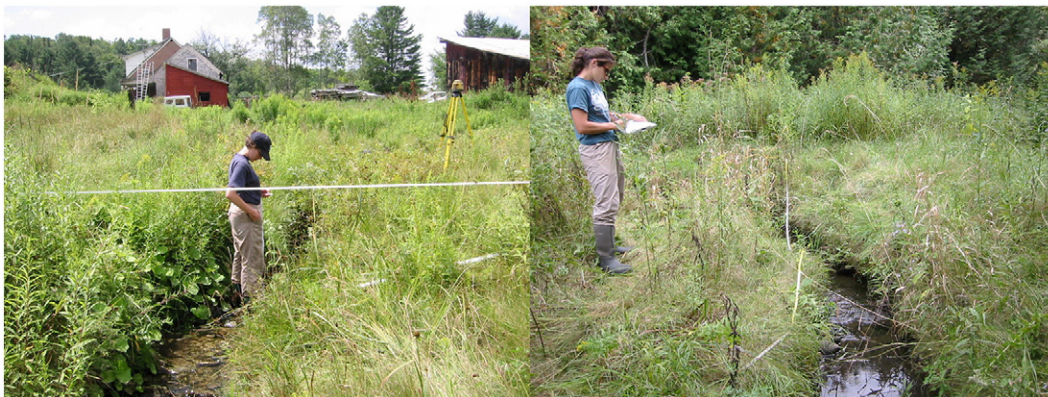
Fig. 3. Photographs of nonforested reaches NF1 (left) and NF2 (right) of W12.

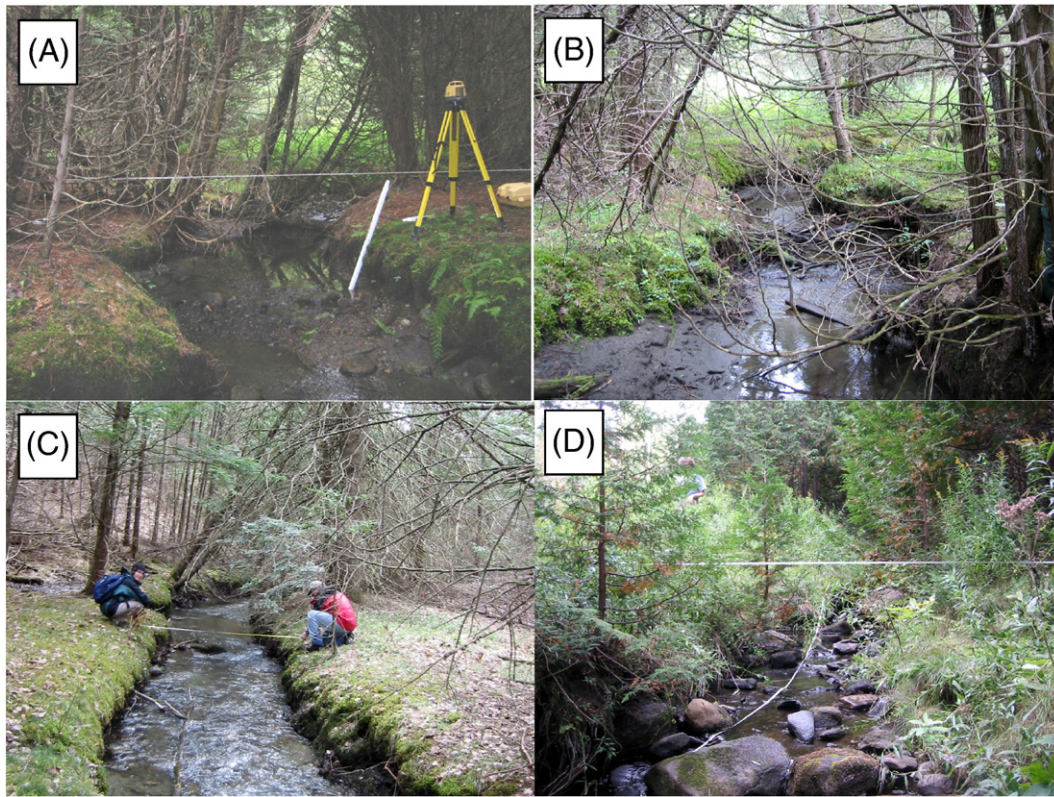
Fig. 4. Photographs of reforested reaches R1 (A), R2 (B), R3 (C), and R4 (D) of W12.

Visual observations and riparian plot measurements highlight differences between the forest vegetation at reach locations. All reforested reaches appeared to have immature forested vegetation both from our visual observations (Fig. 4) and the plot measurements. Forest vegetation in reforested reaches appeared more homogeneous than forested reaches, and this observation was confirmed by the lower standard deviations of the DBH measurements (Table 1). Commonly, we observed “wolf” trees in the reforested reaches, providing evidence for the previously nonforested riparian zones. A “wolf” tree differentiates itself from other trees by its large size and horizontal branches, because it once grew in an open area without competition from other trees (Spirn, 1998). The characteristics of the reforested reaches were variable and unique to each reach: reach R1's floodplain was densely populated with moderate-sized trees with very little woody debris on the floodplain; reaches R2 and R3 had the smallest trees and woody debris of all reaches; and reach R4 had few

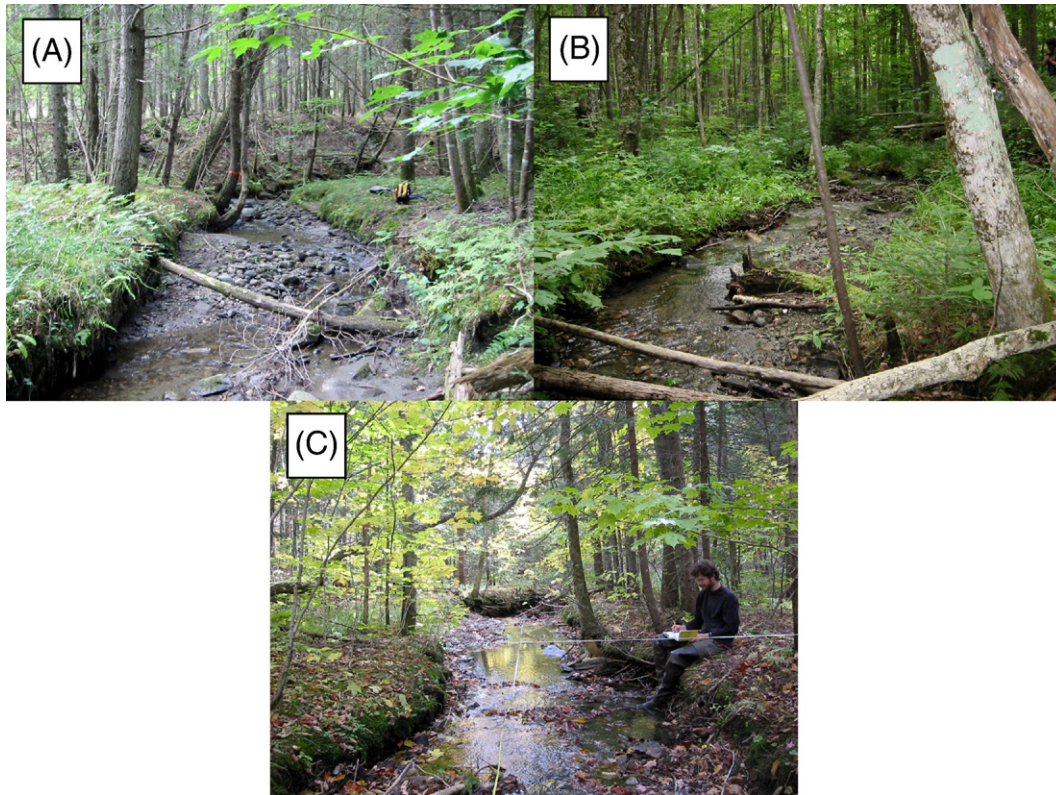
Fig. 5. Photographs of forested reaches F1 (A) of W12, and F2 (B) and F3 (C) of upper Pope Brook.
