# What do the Birds See?

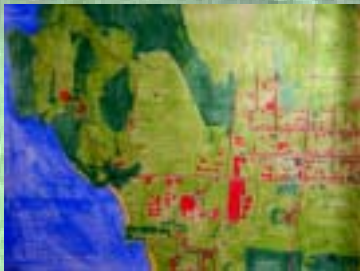
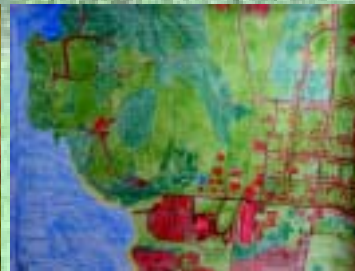
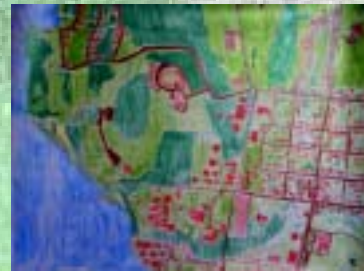
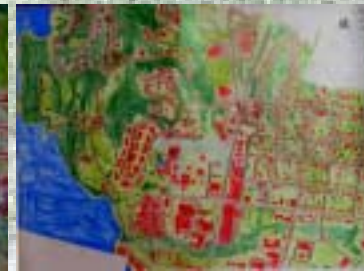
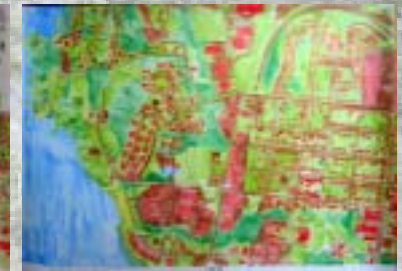
**38% loss of greenspace (1937 to 1999)**

**330% increase in pavement and buildings**

These maps show that pavement and buildings have replaced grass and forests in the Oakledge area drainage basin. Water is absorbed by soil and vegetation, but runs off roads and buildings. This means greater chances of flooding during rainstorms. Also, runoff from thick grass was clean, while runoff from the parking area was contaminated. On the maps, dark green represents trees, light green is fields, brown is roads, red is buildings, blue is water, and yellow is beach
