# **Comparison of Aerial Photographs: 1927 to Today**

Elizabeth Stanley Mann  
Paper for independent study at the University of Vermont, Geology Department  
June 2004

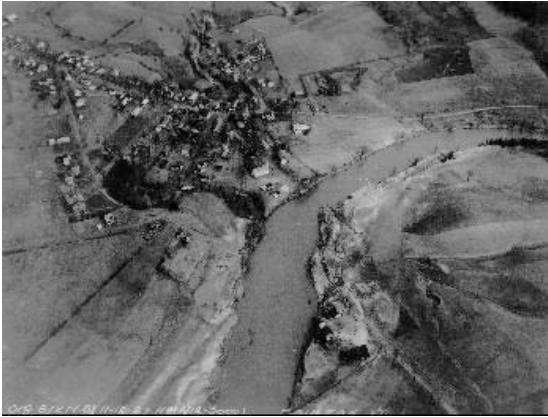
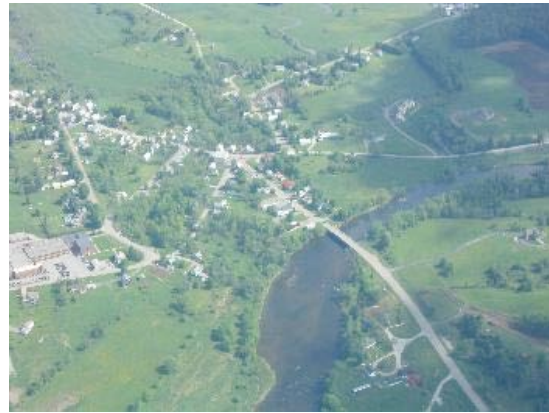
**Fairfax – Lamoille River:**

Little has changed in Fairfax except for the slight expansion of the village, and more development. The road that crosses the river (Route 128) has been made bigger, and the bridge repaired after the flood. There is about the same amount of tree cover, though the fields are now bordered with trees, and there are more trees along the river. The river channel is narrower above the bridge, and similar width below the bridge.

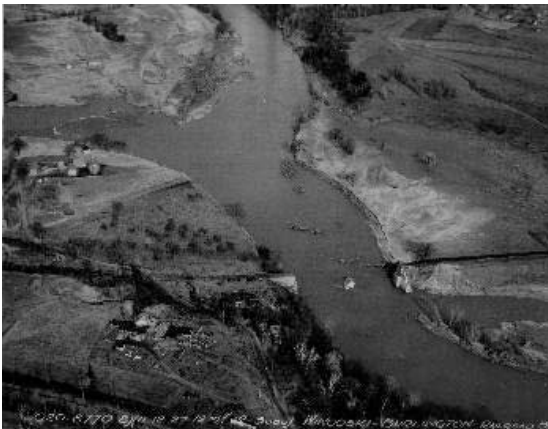
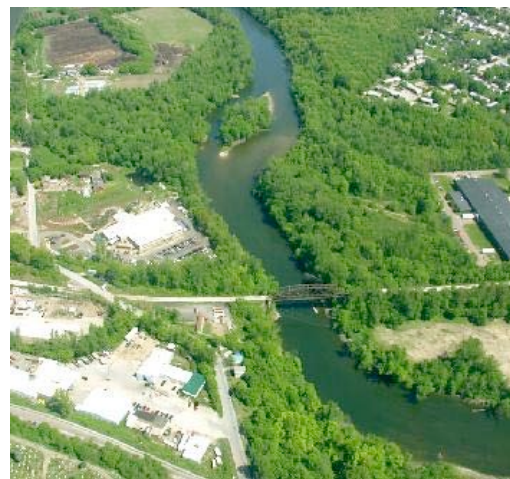
**Burlington – Winooski River:**

Much has changed in this pair. This is also an example of a photo pair in which the elevation and angle are slightly different, we know this because in the historic photo the bridge is slightly larger than in the current photo. It is hard to know whether the flood caused the fork in the river or whether it was there before and has since been abandoned. Most dramatically seen in this picture is the reforestation. The area is almost completely deforested in the historic photo, and almost totally forested in the current image. There is also an island in the in the river now, where there was none in 1927. The land shown in this image has been developed in some areas, although the farm in the 1927 photo is still there today.

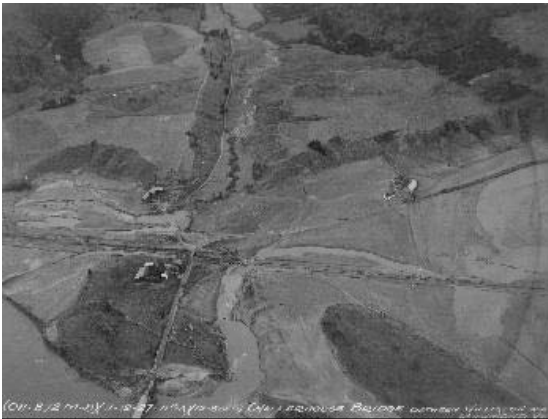
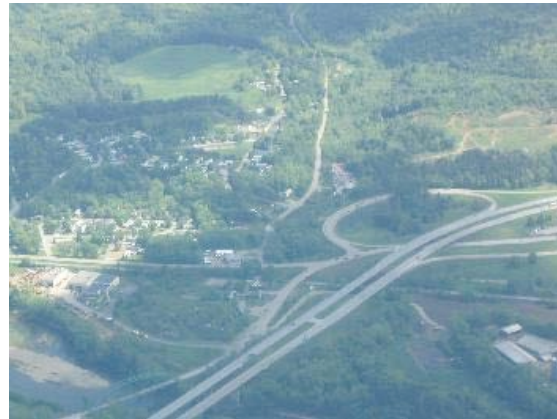
**Williston – Winooski River:**

The two most striking changes in this pair of images is ARE the reforestation and the development. The area has been completely taken over by interstate 89. In 1927 the area in this photo was occupied by three farms, a railroad and Route 2. There are now many more houses, a large industrial business, and several roads. While this area has been taken over by people, it has also been taken over by trees. In the 1927 image there are very few trees except for on the slopes in the background. Now the area is almost completely forested except for the large circular piece of land in the upper left of the image. This landmark was the key reference point in pairing these images.

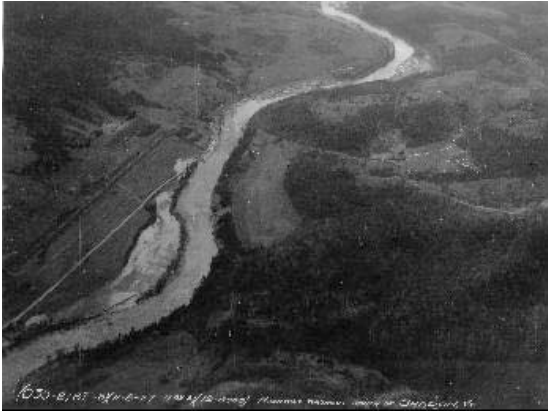
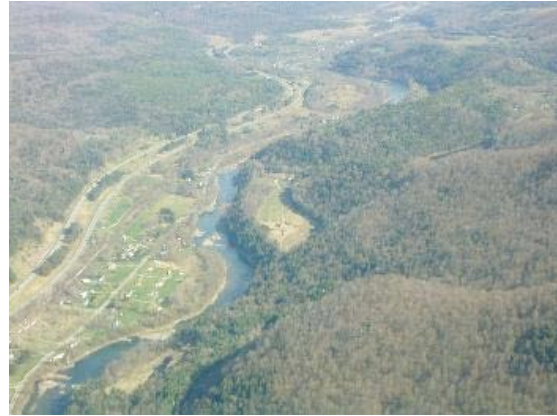
**Sharon – White River:**

Not much change has taken place in Sharon since the 1927 flood. The slopes on either side of the river are more forested than in 1927, and the river is narrower (though the historic photo depicts a flood stage river). A landslide along the river is in the historic photo, and not in the current image. Development has not affected this area at all, the roads are in the same places and there are a few more houses. The most significant changes are more trees and less farming.
