HISTORIC SITE REVIEW

Burlington Wastewater Treatment Plant Project

Department of Public Works

May 4, 1990

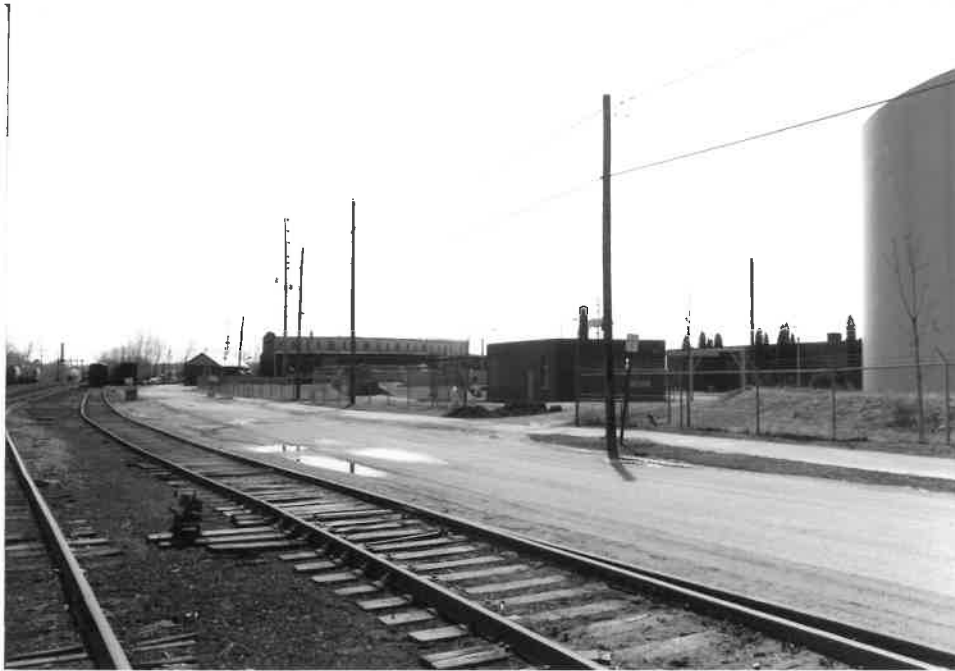
Fig. 1 This photo looking south shows the track of the Vermont Railway running along the eastern boundary of the sewage treatment plant site. The road immediately west of the tracks may follow the original, pre-fill shoreline. (Photo: Thomas Visser, 1990)

The site of the Burlington Waste Water Treatment Plant is located in an industrial area south of Maple Street and west of the Vermont Railway, Inc. railyard west of Battery Street (Map 1). The land occupied by the plant has been filled between 100 and 600 feet west from the original shoreline since the middle of the nineteenth century. The eastern boundary of the site may, in fact, correspond closely to the natural shoreline of the waterfront (Fig. 1).

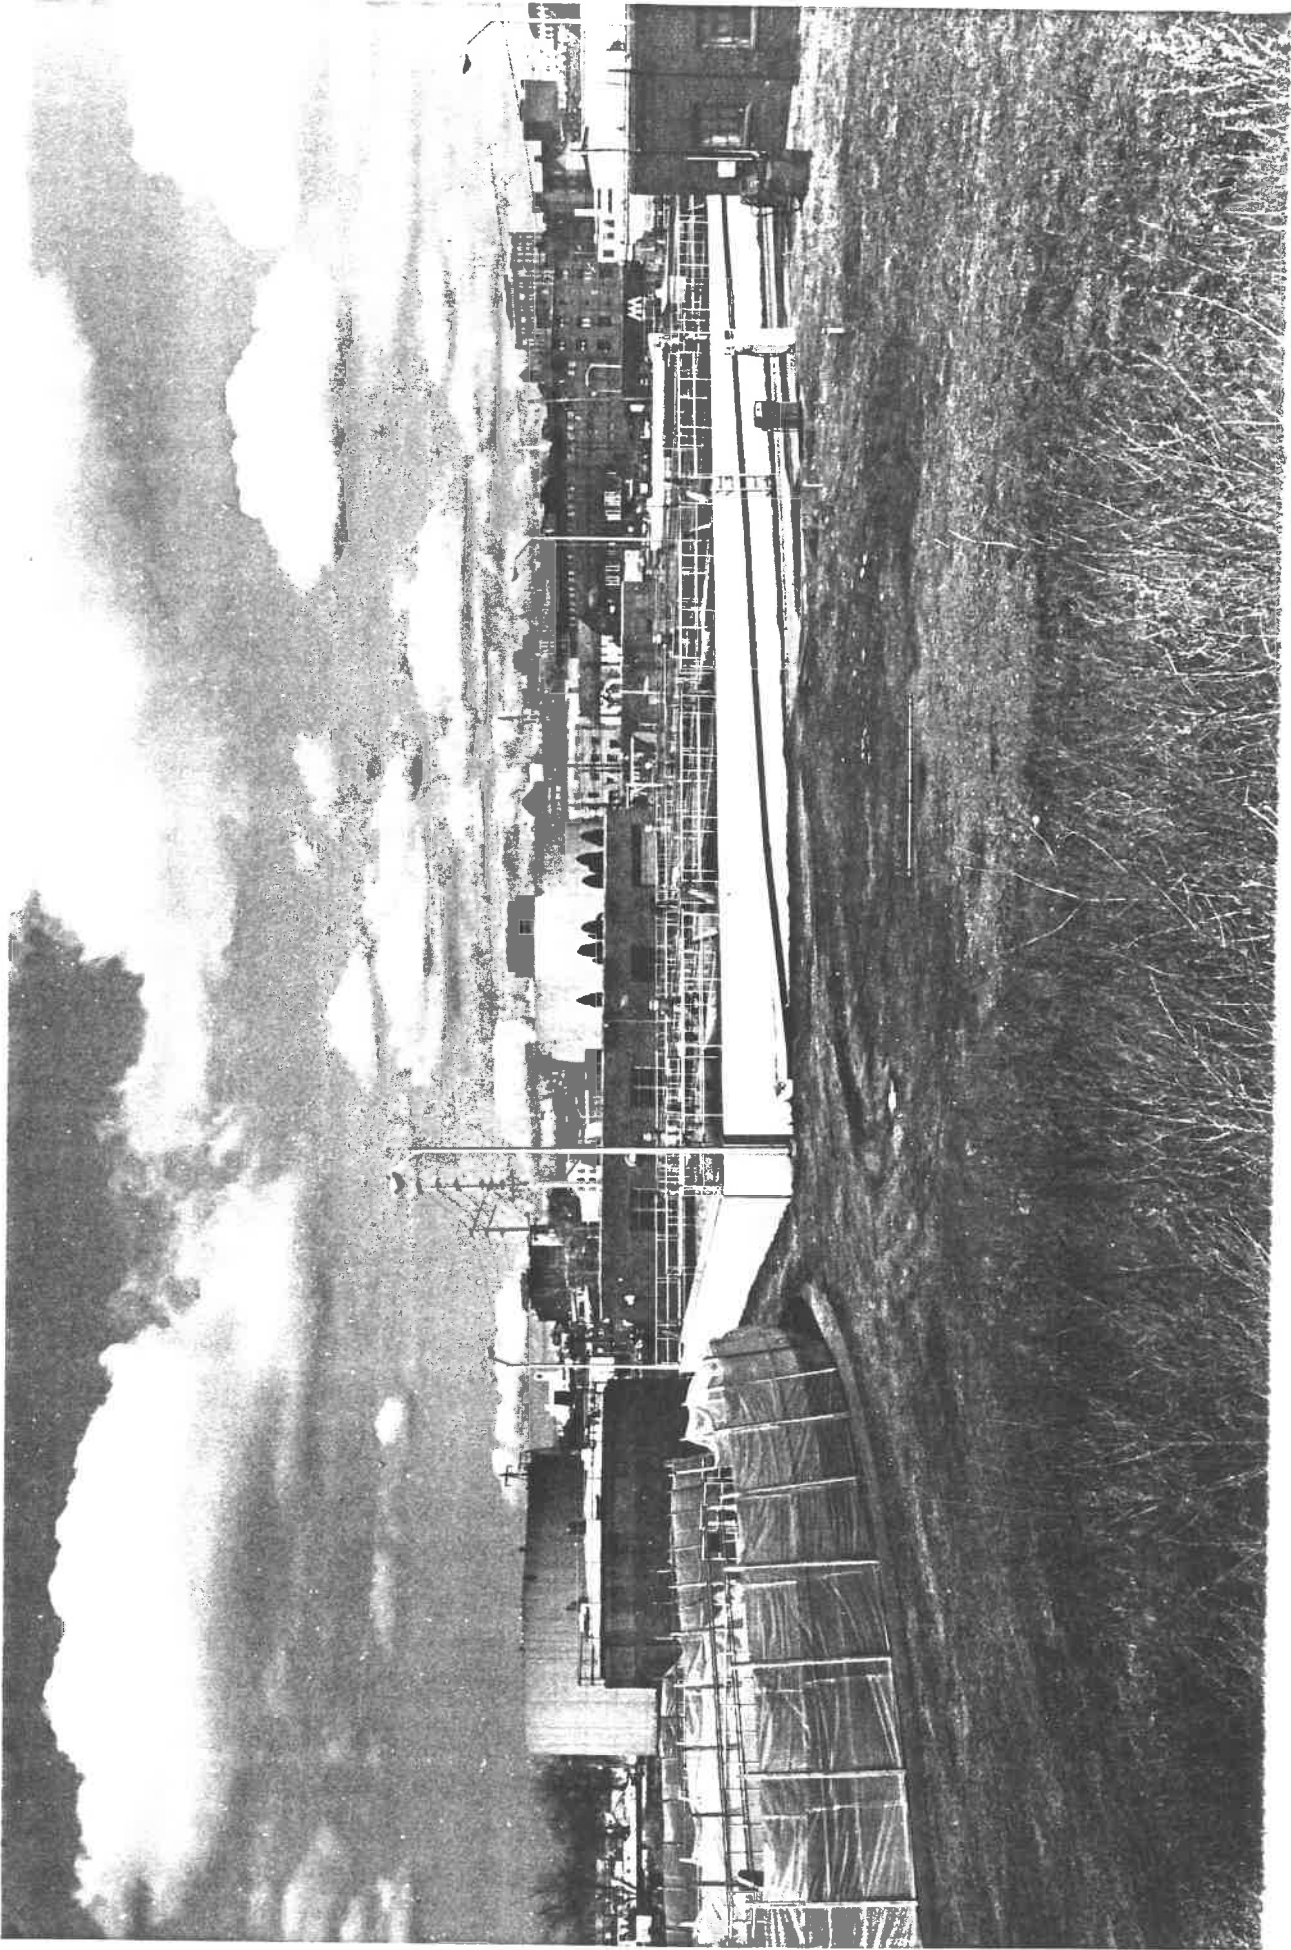
Fig. 2 This photo shows the shoreline of the wastewater treatment plant site looking north from the outfall of the main trunkline sewer. One of the sludge storage tanks that sits over the old boat slip is visible on the left. (Photo: Thomas Visser, April, 1990).

Along the shoreline today, a low rise and an irregular barrier of riprap separate the land from the water (Fig. 2). Rocks line the shoreline from the northern terminus of the property to the sewer outfall at the southern boundary. The 1951 construction plans for the site indicate that a wooden bulkhead, filled with stone, ran the length of this shoreline. While there is no evidence of the bulkhead today, it may have rotted resulting in the collapse of the stone fill (Fig. 3).

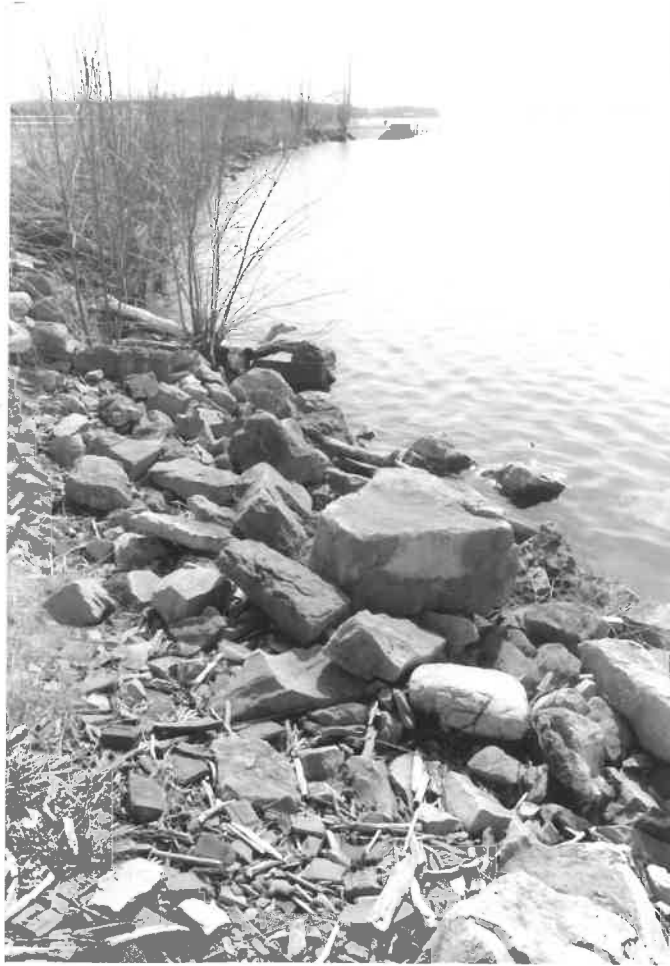
Fig. 3 This photo shows the shoreline of the wastewater treatment plant site looking south from near the northern terminus of the property. In the foreground, driftwood and other debris are visible intermingled with the crushed stone of the lake barrier. (Photo: Thomas Visser, April, 1990)

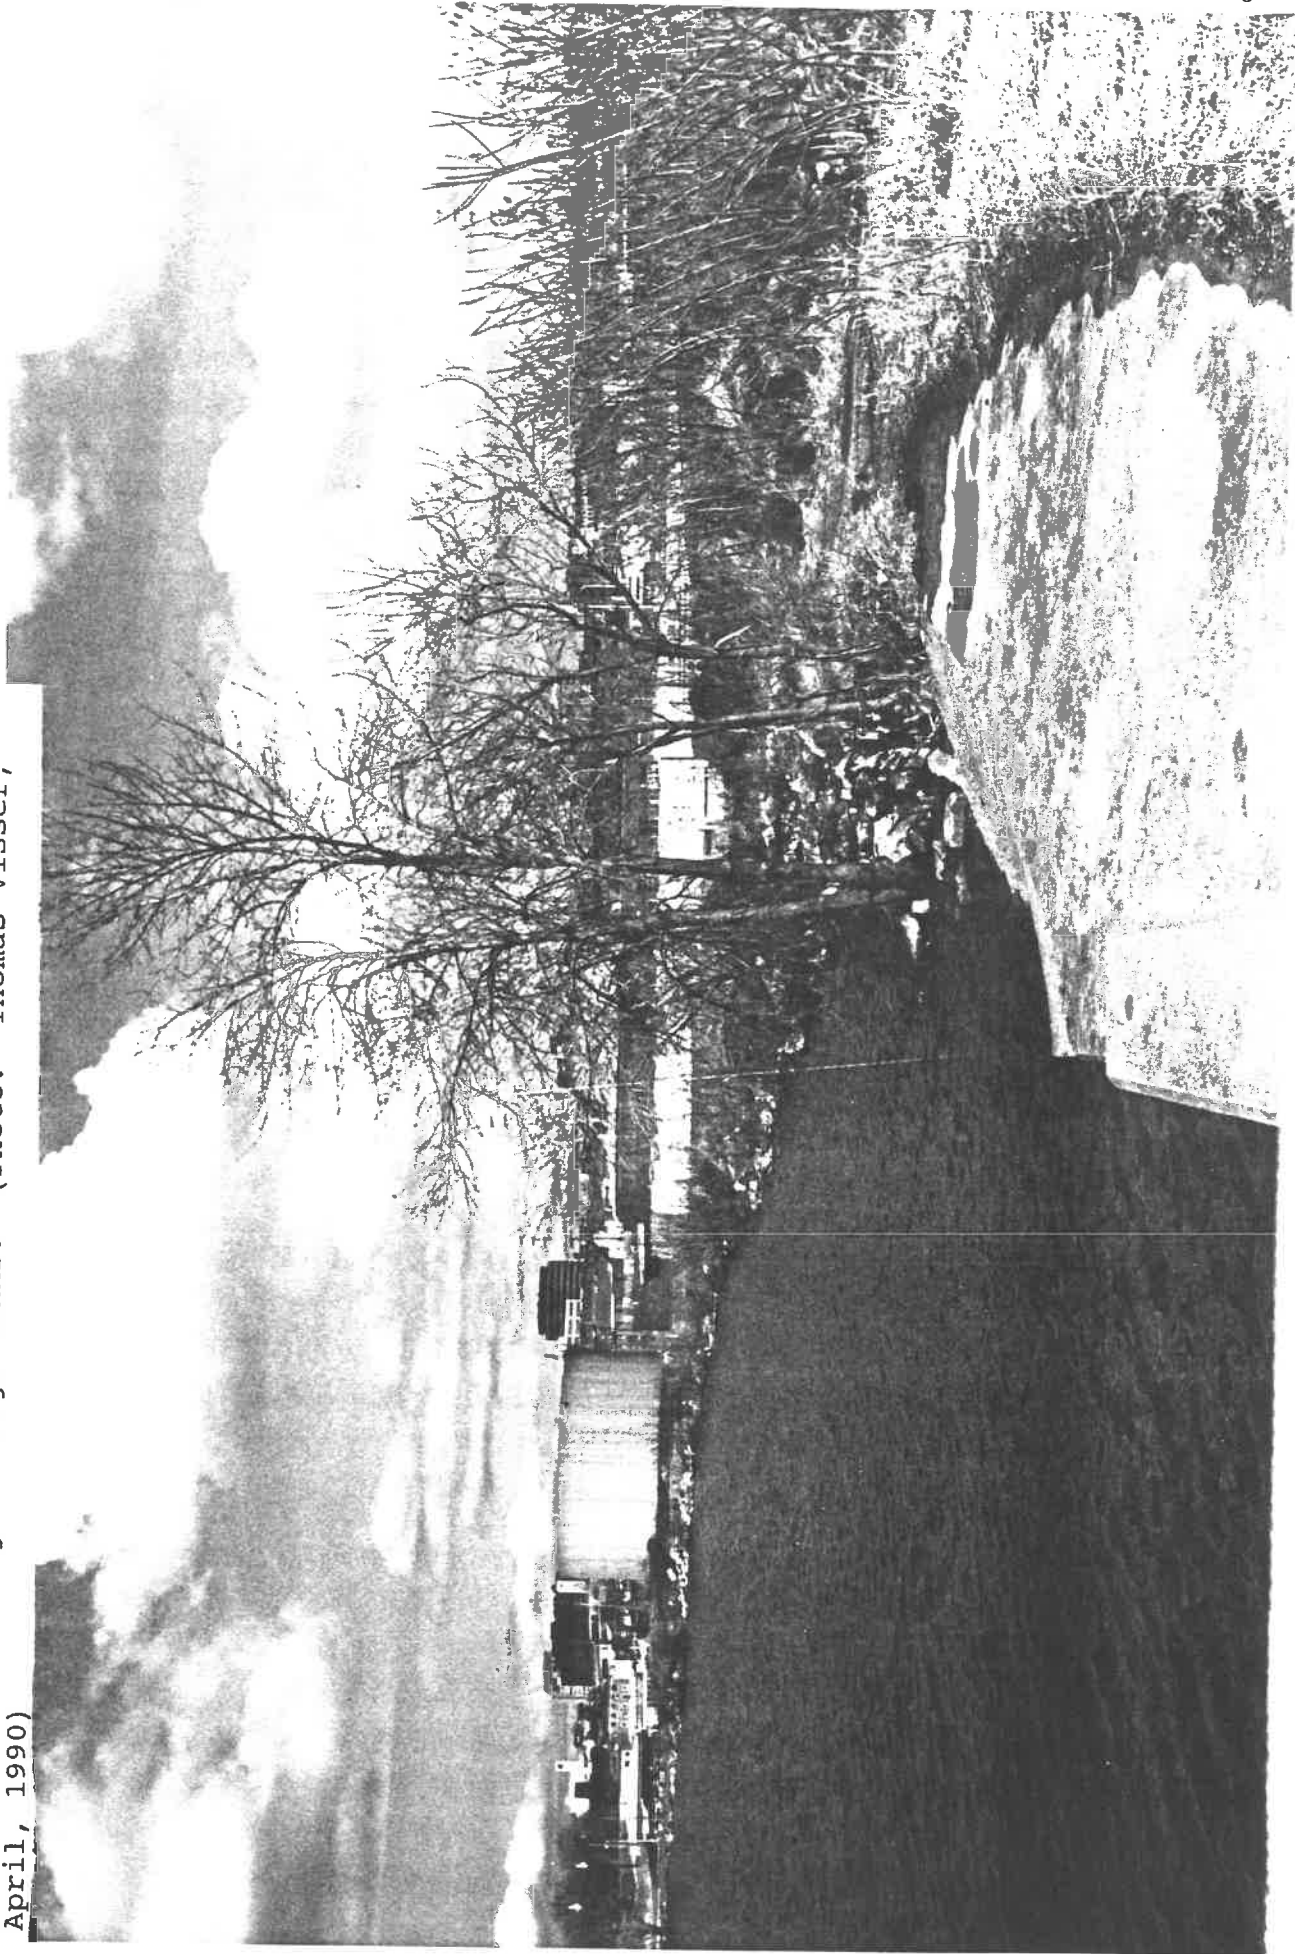
Fig. 4 This photo is a panoramic view of the Burlington Wastewater Treatment Facility looking northeast toward Battery Street. In the foreground the digesters and aeration tanks are visible. Behind them the control building and at the rear of the picture are the sludge storage tanks. (Photo: Thomas Visser, April, 1990)

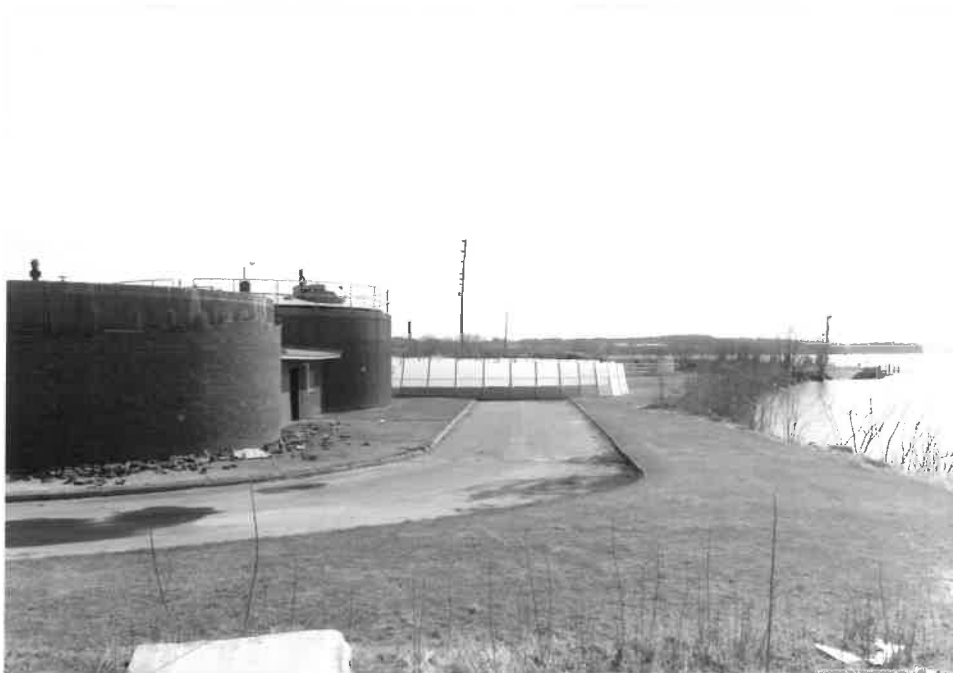
Fig. 5 This photo is looking south from the old boat slip. On the left are the digesters and behind them the aeration tanks. In the distance the sewer outfalls are visible. (Photo: Thomas Visser, April, 1990).

building, located at the center of the site, around the front of the building and across the site to the south (Fig. 5).

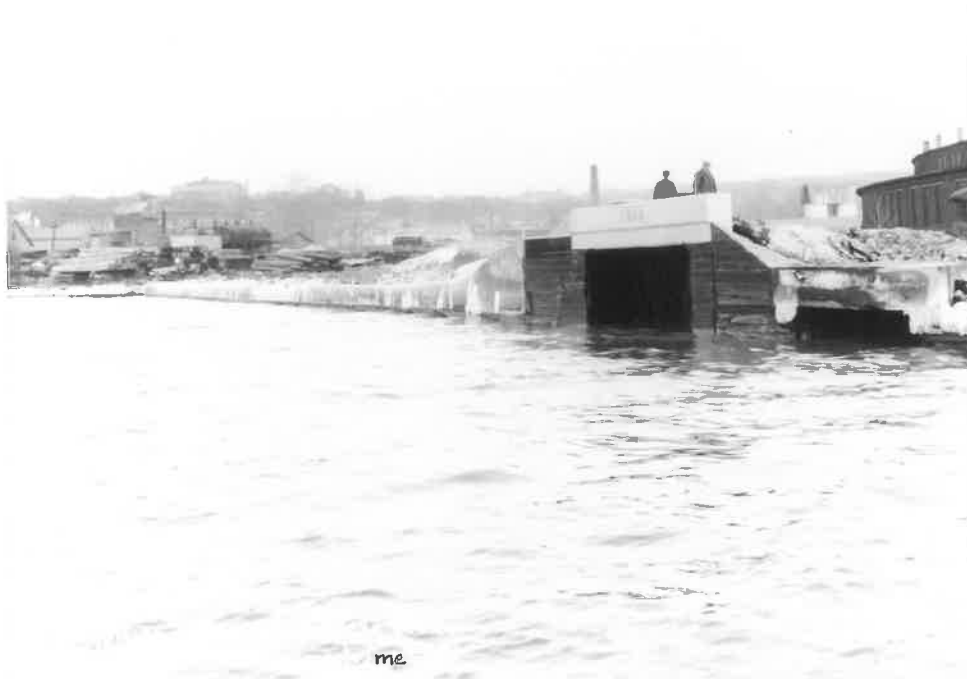
Fig. 6 This 1932 photo shows the newly constructed sewer outfall with its dated, concrete header next to the old 1894/1914 sewer outfall. The asphalt plant is visible on the far left, and the roundhouse of the Rutland Railroad is on the far right. (Source: MacAllister Photo Collection, Wilbur Special Collections, Bailey-Howe Library, Burlington, Vermont, 1932.)

Two sewer outfalls with concrete headers straddle the southern boundary of the site at the waterline (Fig. 6). The old, 1894-1914 sewer outfall is located south of the boundary line on the property of the Vermont Railway. The 1932 sewer outfall is immediately to the north.

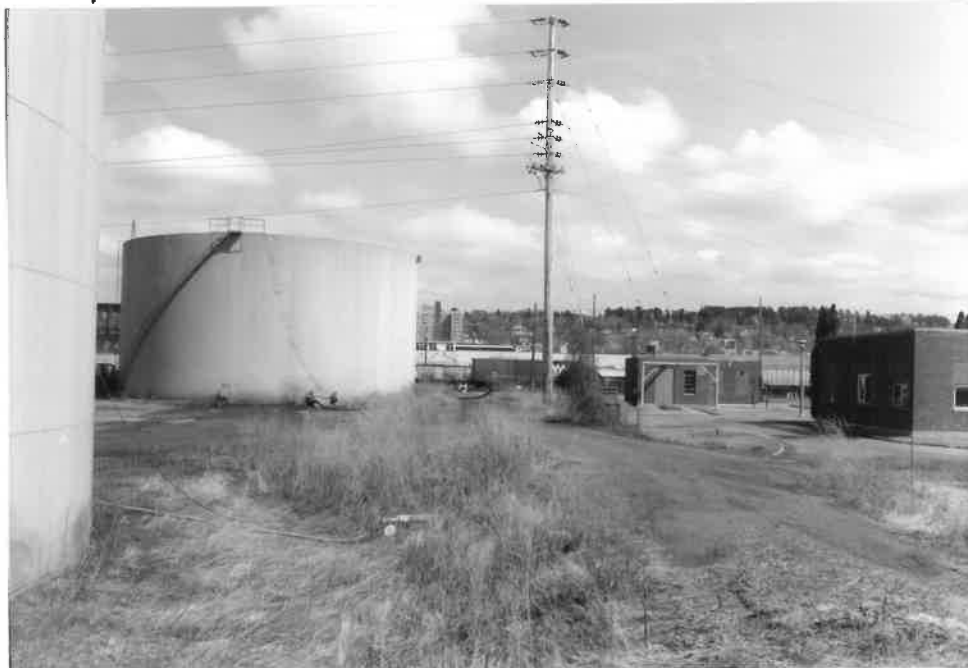
Fig. 7 This photo shows the sludge storage tanks located in the old boat slip looking east toward Battery Street. The building visible on the right is the control building. (Photo: Thomas Visser, April, 1990)

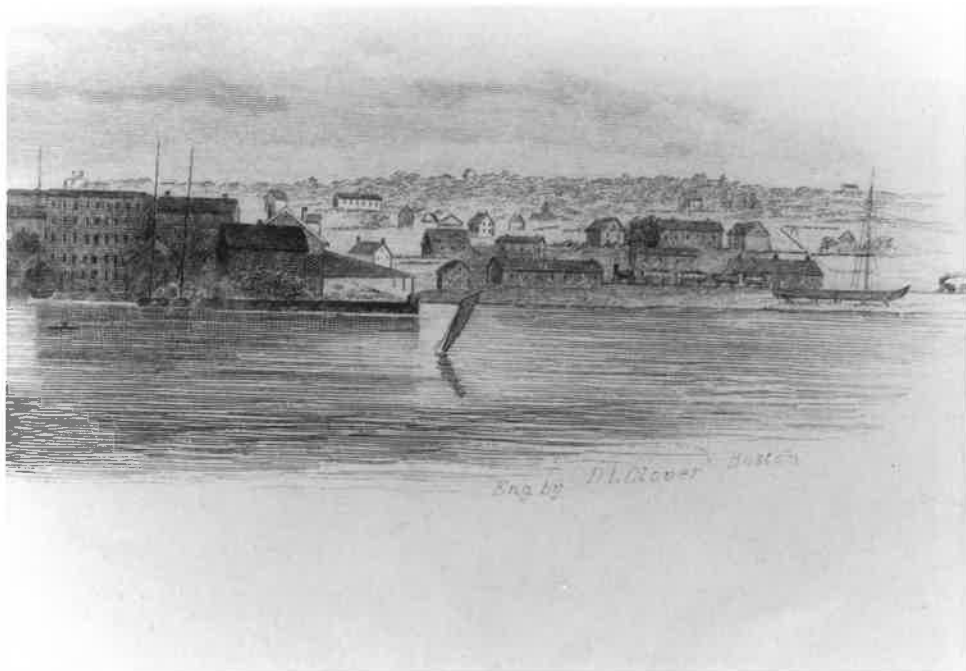
Fig. 8 In this close-up of the a mid-19th century engraving of the Burlington waterfront Madison Wharf is seen on the left near today's Perkin's Pier. The train chugs along the shoreline to the south, which has not yet been noticeably filled. Of interest to note is the dry-docked boat on the right. This rendering may represent the "boat building establishment," mentioned by one source as located south of Madison Wharf before 1858. (Source: D.L. Glover, Burlington Photo Collection, Wilbur Special Collections, Bailey-Howe Library, University of Vermont, Burlington, Vermont, [circa 1850].)

shoreline.⁷ The testimony of Mr. Richard Daley, who grew up along the Burlington water front in the 1850's, describes the railroad tracks being laid on a fill of large pieces of gravel and marble.⁸ Another man who grew up in the area, Charles E. Allen, testified that "the filling was going on from [18]51 or 2 down and as fast as they would crib and then fill in up to the crib making a bulkhead".⁹ The 1853 map by Presdee and Edwards shows the water line approximately 50 feet from the west line of Water Street and the railroad tracks running along the shoreline. A similar scene is depicted on two engravings of Burlington Harbor dating to circa 1850 and 1858 (Figs. 8 & 9). South Wharf (or Madison Wharf as it was then called) stretches into Burlington Bay as a train chugs along the shoreline past the depot.

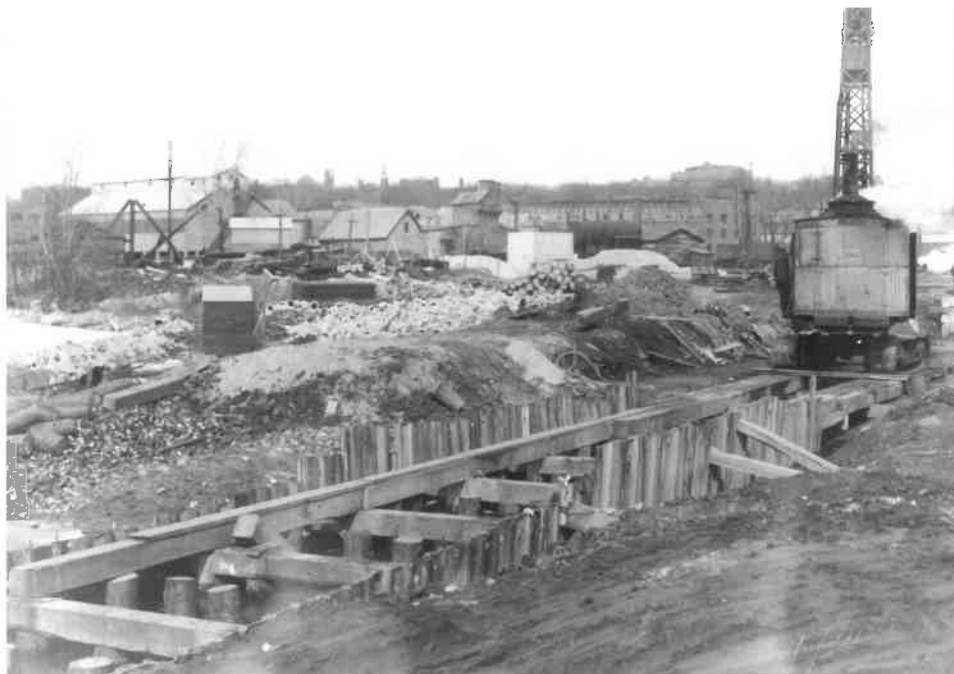
Fig. 11 This 1932 photo, taken during the construction of the main trunkline sewer, looking northeast, gives an idea of the amounts and types of debris found in the fill on the site. On the far left, a heap of old tin cans is visible along with pieces of wood and piles of sewer pipe. (Source: McAllister Photo Collection, Wilbur Special Collections, Bailey-Howe Library, Burlington, Vermont, 1932.)

Concrete, tar and asphalt were recovered, and a few fragments of "porcelain" were found in the eastern-most boring nearest the original shoreline (Fig. 11).

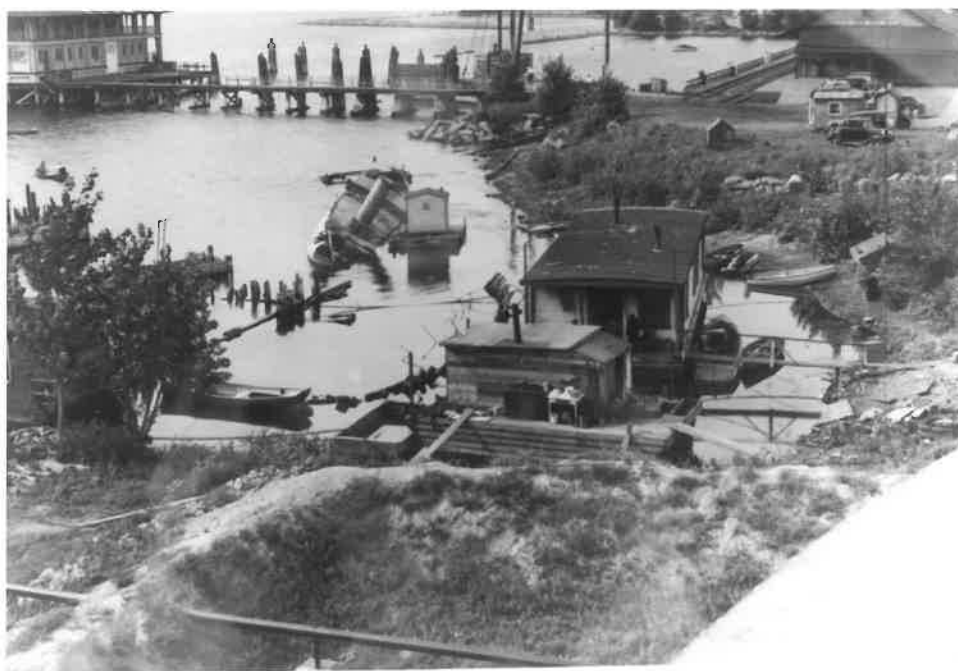
Fig. 12 In the center of this 1930's picture are one (and possibly more) scuttled boats, beached in the cove between College and Main Streets. (Source: Burlington Photo Collection, Wilbur Special Collections, Bailey-Howe Library, University of Vermont, Burlington, Vermont, n.d.)

An undated photo of the Burlington waterfront shows boats scuttled in the bay between College Street and Main Street (Fig. 12). Captain Carpenter believed the wreck of the "Hildegarde," a sixty foot sailing yacht, to be located along the shore of the Sewage Treatment Plant site. According to Carpenter, by the 1920's the yacht had been converted into a tow boat for pulling stone barges (Fig. 13). Carpenter recalled that the boat had sunk in the 1940's with one side leaning against the bulkhead, approximately fifteen feet north of the sewer outfall.²⁸ Carpenter also reported that repair work on the breakwater south of Roundhouse Point during the same period uncovered the remnants of several wrecks.

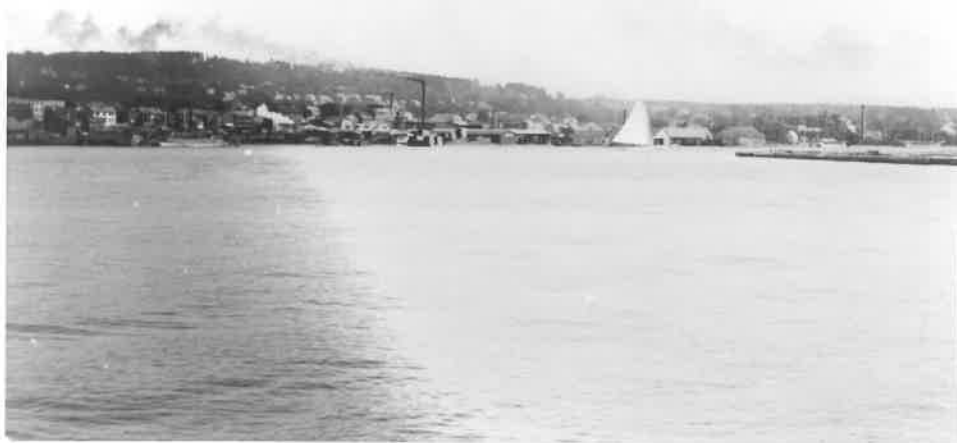
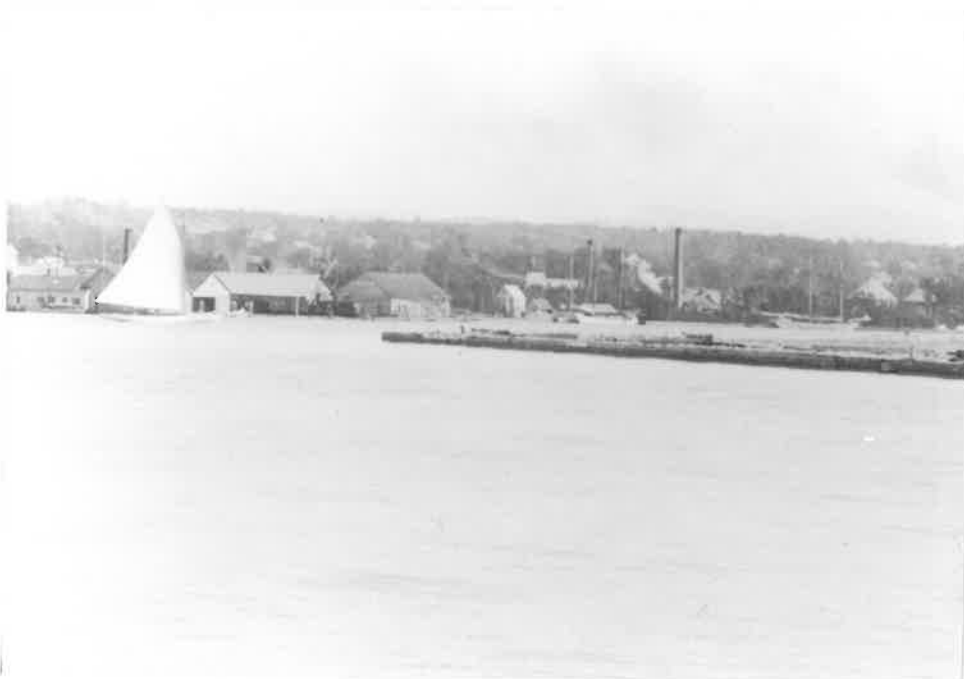
Fig. 16

Fig. 17 (Close-up) This 1906 postcard presents a scene similar to that in the Kilburn & Gates engraving but is shown from the opposite angle looking southeast. At the center of the close-up image, boats are tied up at the Beckwith Dock. Behind them, the smokestack of the plaster mill is visible. To the right (south), a schooner is tied up along the cribbing near the entrance of the barge canal. (Source: Don Baker, Burlington Photo Collection, Wilbur Special Collections, Bailey-Howe Library, University of Vermont, Burlington, Vermont, 1906).

A photo taken at approximately the same time shows the view from the other direction. Taken from the breakwater, the photo shows the chimney of the plaster mill with a boat anchored along the shore to the south; another boat is tied up to the end of the Beckwith Wharf (Figs. 16 & 17). According to an article from the Burlington Free Press dated April 13, 1872, Beckwith's docks contained "an area of two acres, with 800 feet of water front."⁴² The mill, "for the grinding of Nova Scotia plaster," used a steam engine built in 1865, acquired from the Burlington Manufacturing Company in its rolling mill. According to Sanborn insurance maps, the plaster mill had ceased operation by 1894, and the structure was not present on the 1912 map.⁴³

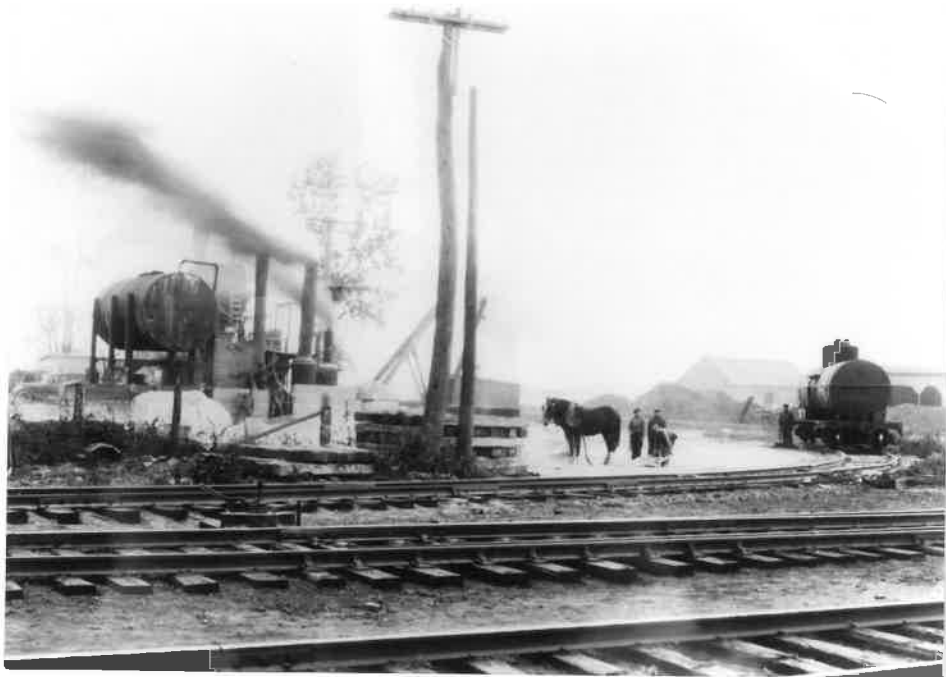
Fig. 18 This 1929 photo, looking west, taken after the construction of the asphalt plant, shows the rail spur and, behind the horse, the boat slip. The rail spur ran along the edge of the slip to the dog leg derricks behind the pole, which transferred stone and other goods between the boats at the dock and the waiting train cars. (Source: McAllister Photo Collection, Wilbur Special Collections, Bailey-Howe Library, Burlington, Vermont, 1929.)

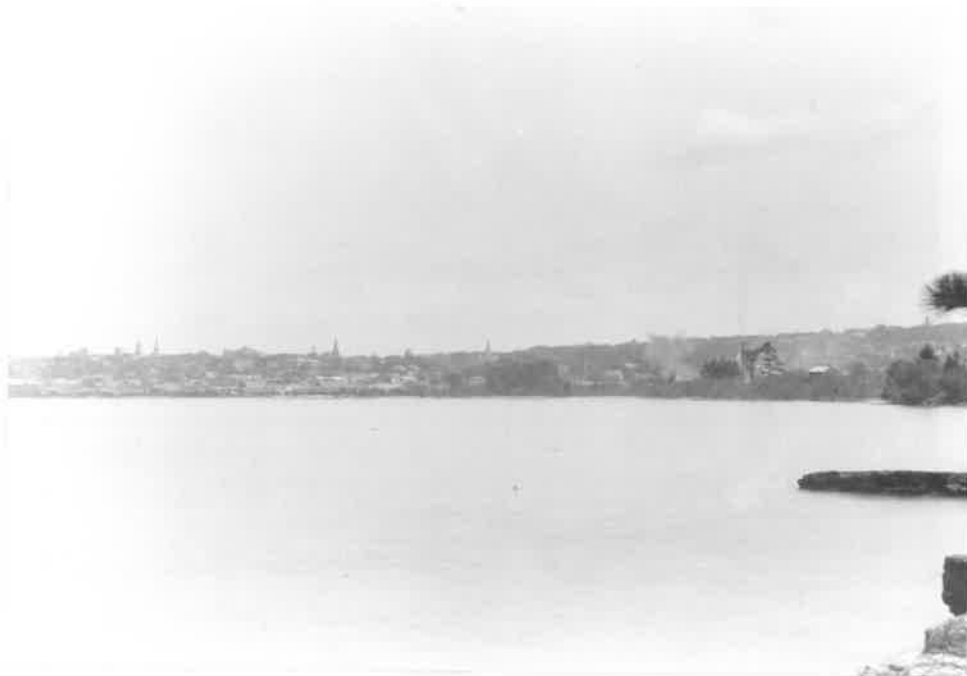
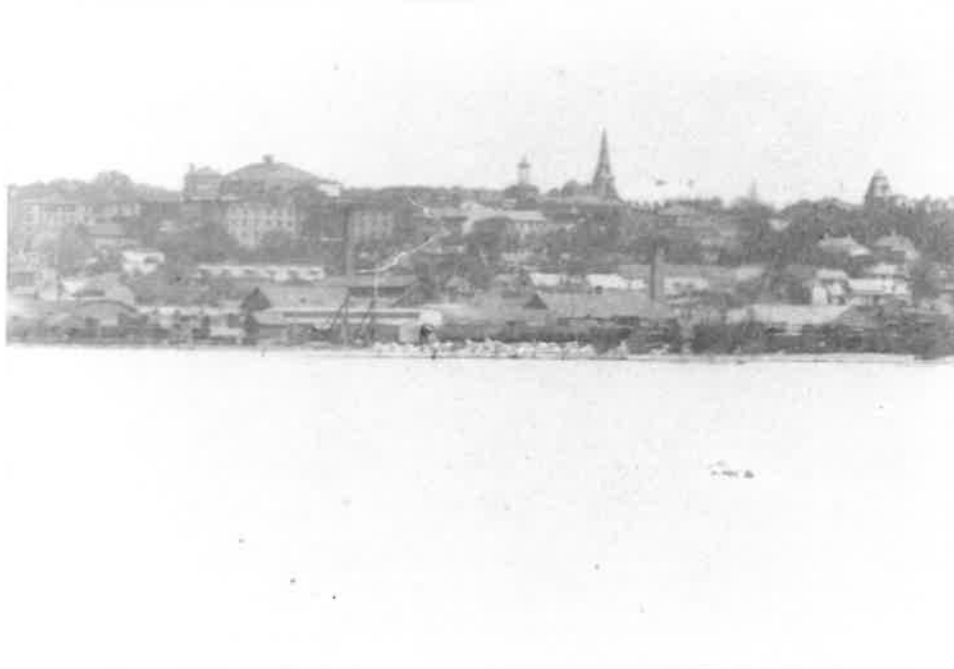
Fig. 19

Fig. 20 (Close-up) In the center of the close-up of this early 20th century photograph, taken from Red Rocks, an image is visible in the slip south of Beckwith's Wharf that may be the dog leg derricks and a boat. To the right (south) are large piles of stone or debris. (Source: Burlington Photo Collection, Wilbur Special Collections, Bailey-Howe Library, University of Vermont, Burlington, Vermont, [1910-1912]).

harbor appears to show the derricks next to the boat slip and large piles of stone, evidence of the stone crushing operations (Figs. 19 & 20). The stone crusher remained at the dock until 1904.⁴⁷

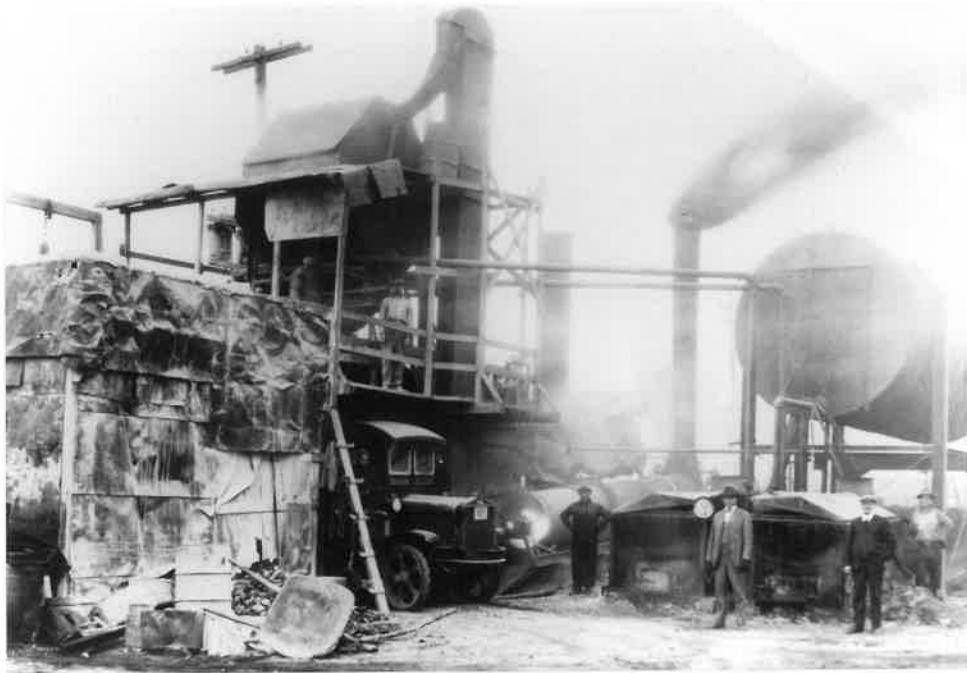
Fig. 21 This 1929 photo shows the Burlington Street Department's asphalt plant looking west. (Source: MacAllister Photo Collection, Wilbur Special Collections, Bailey-Howe Library, Burlington, Vermont, 1929.)

After the stone crusher was moved, the Burlington Street Department maintained tenancy of the land south of the slip. In 1924 an asphalt plant was built on "the Street Department dock near the Elias Lyman coal sheds" (Figs. 21 - 24).⁴⁸ This plant was the principle source of paving asphalt for the city, producing 1800 tons of cold patch and 3704 tons of hot plant mix material in 1948 alone (a 45% increase from 1947), until it burned in the fall of that year.⁴⁹

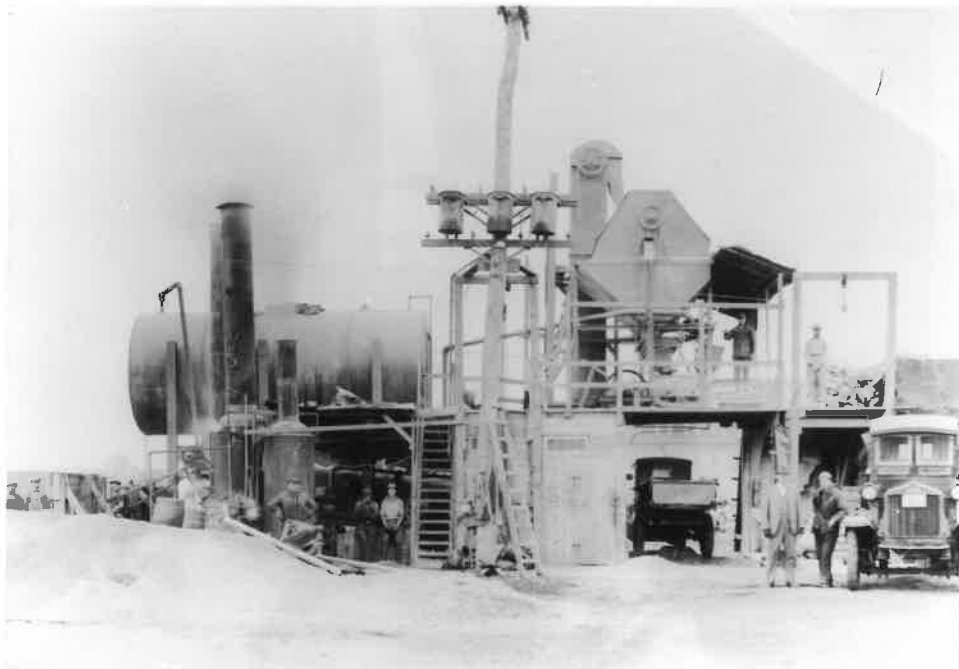
Fig. 22 This 1929 photo shows the Burlington Street Department's asphalt plant looking north. (Source: MacAllister Photo Collection, Wilbur Special Collections, Bailey-Howe Library, Burlington, Vermont, 1929.)

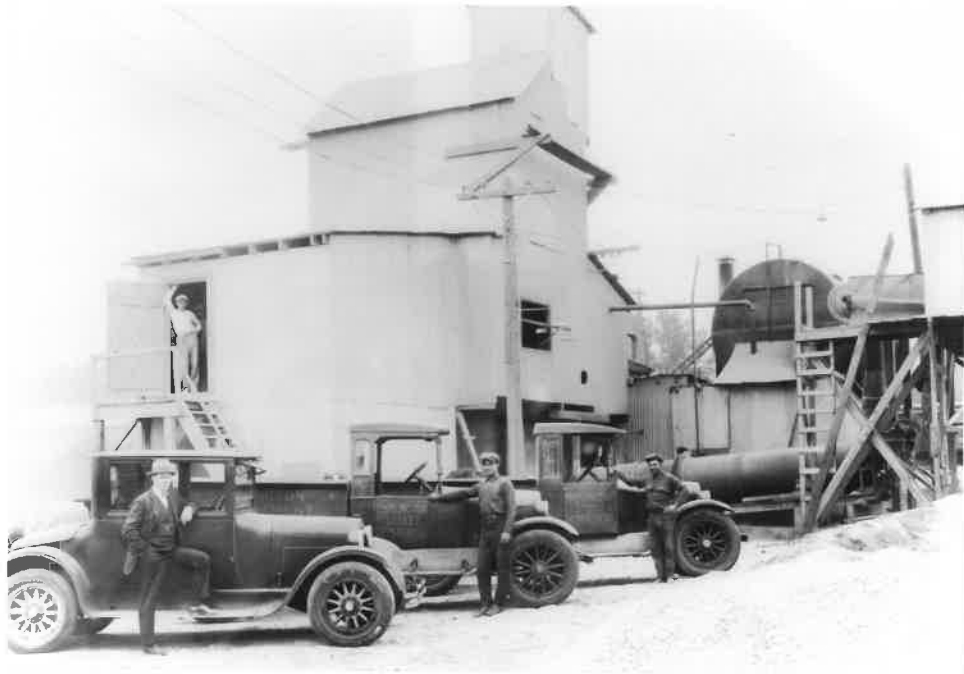
Fig. 23 This 1929 photo shows the Burlington Street Department's asphalt plant looking east. (Source: MacAllister Photo Collection, Wilbur Special Collections, Bailey-Howe Library, Burlington, Vermont, 1929.)

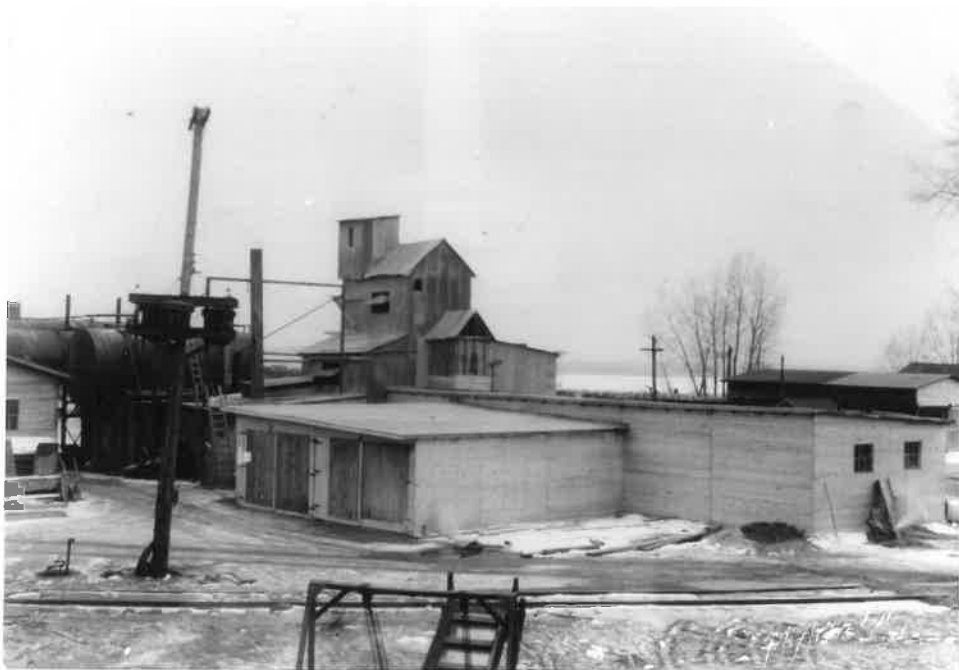
Fig. 24 This 1937 photo shows the Burlington Street Department's asphalt plant, looking west, after construction of sheds where concrete sewer pipe was cast. The original photo caption reads: "The long wing at the right has a platform through the center from which the concrete is poured from two-wheeled buggies into the steel form placed on both sides. The wing at left is the curing room where the tiles were stored for a period of 48 hours before being taken onto the job. Both buildings were equipped with steam heat." (Source: MacAllister Photo Collection, Wilbur Special Collections, Bailey-Howe Library, Burlington, Vermont, 1932.)

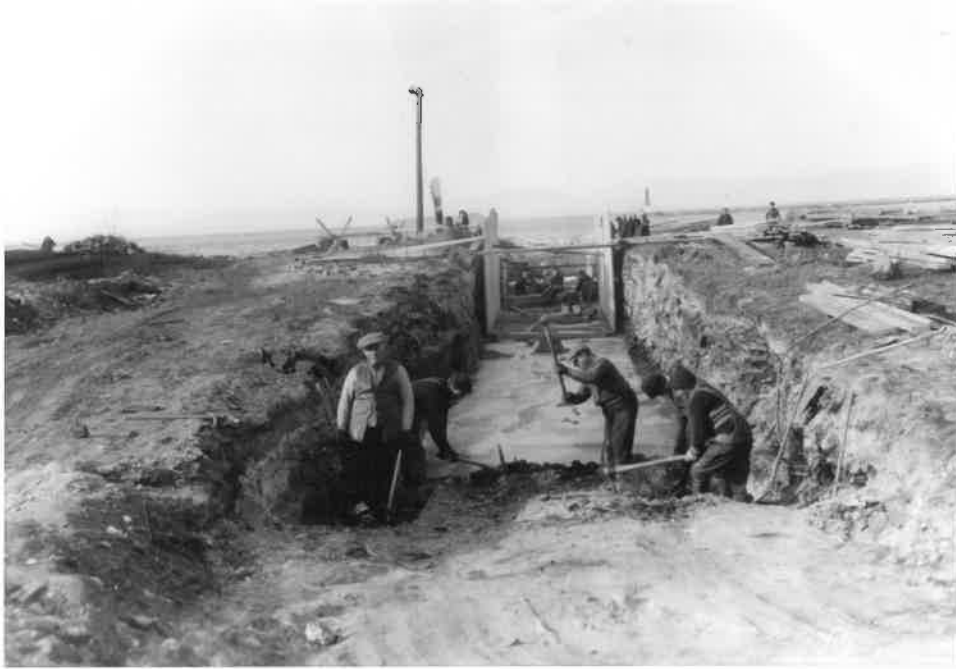
Fig. 19 In this 1932 photo, the sidewalls of the trench for the main trunkline sewer reveal the layering of fill deposits. This is especially noticeable along the left wall next to the man looking at the camera. (Source: MacAllister Photo Collection, Wilbur Special Collections, Bailey-Howe Library, Burlington, Vermont, 1932.)

The site is covered by an average of 10 feet of fill, and the surface has an average elevation of approximately 104 feet above sea level or nine feet above average lake level. Photos from the 1932 sewer construction illustrate the amounts of debris accumulated on the site and buried in the soil (Fig. 4, see above). Although no significant prehistoric archaeological deposits were noted in the boring logs, evidence of the site's historic uses were recorded. The dominant fill materials included ash, brick fragments and slag, in addition to crushed stone, wood and glass fragments, concrete, tar, and asphalt. The

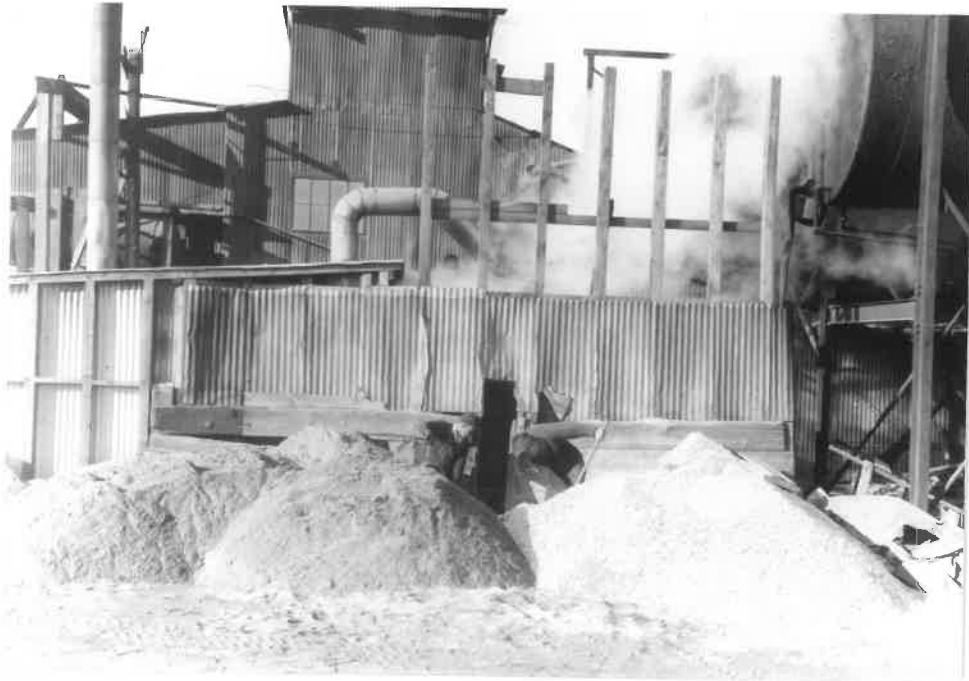
Fig. 20 This 1937 photo shows the types of possible evidence that may be found on the site remaining from the operation of the asphalt plant. The mounds on the left appear to be sand, and the pile on the right appears to be crushed stone. (Source: MacAllister Photo Collection, Wilbur Special Collections, Bailey-Howe Library, Burlington, Vermont, 1937.)

EVIDENCE of the asphalt plant would include: stone or concrete foundations, building materials, machinery, asphalt, gravel and other manufacturing by-products.

POSSIBILITY: It is probable that there are remains of the asphalt plant buried on the site because the plant burned and the area was cleared prior to construction of the sewage treatment plant. It is unknown what type of foundation the plant had. However, the footprint of the plant is still shown on the 1951 construction plans and nothing was built directly over the site. Because the plant burned there is a possibility that asphalt and other petroleum by-products are present.
