HISTORIC SITE REVIEW

Burlington Wastewater Treatment Plant Project

Department of Public Works

May 4, 1990

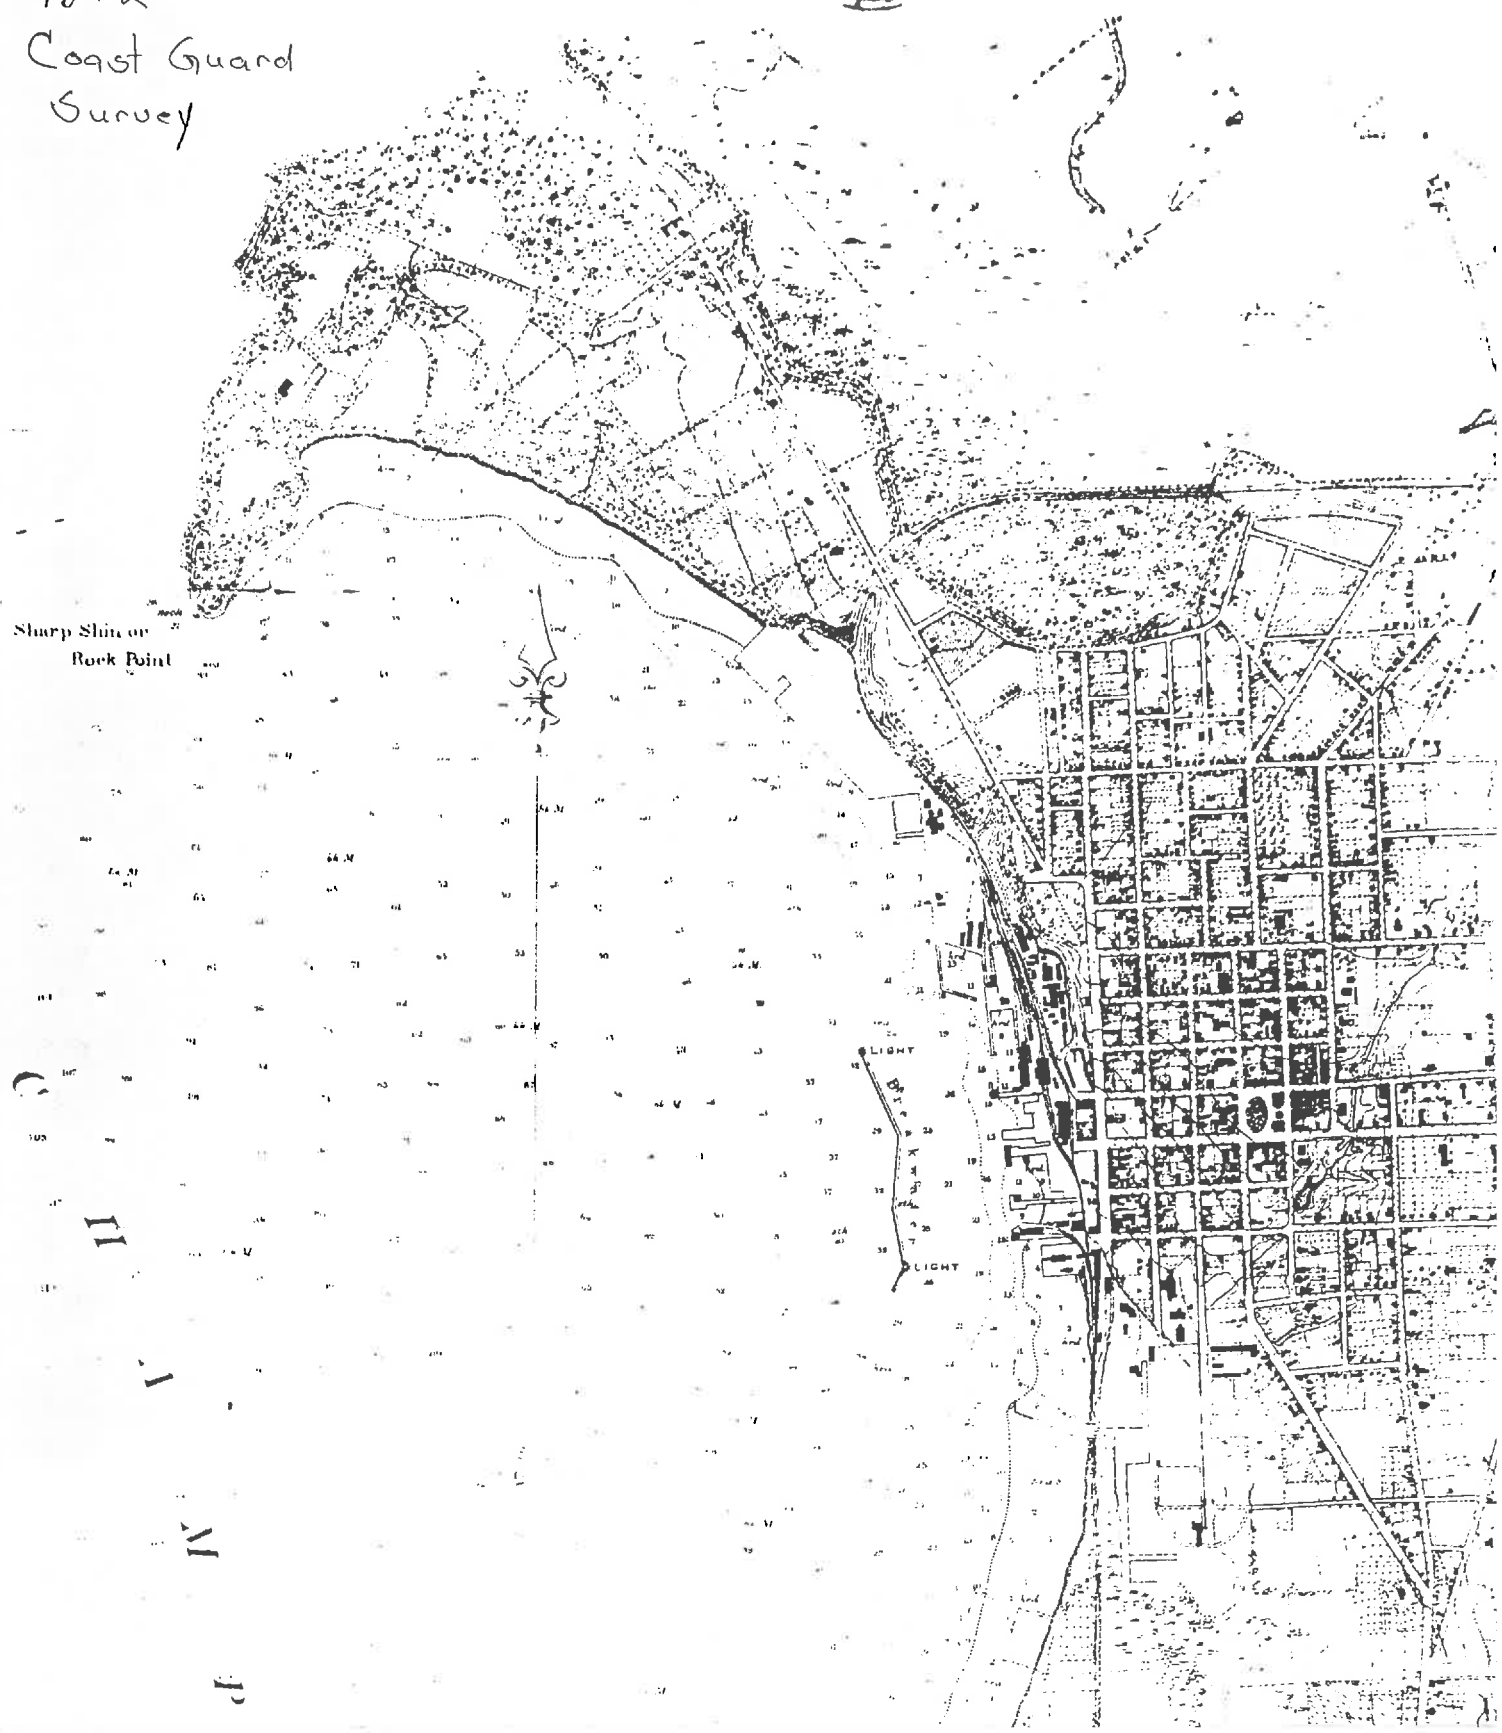
1872
Coast Guard
Survey

Ogden, H.G. and F.D. Granger. U.S. Coast Guard Survey,
Burlington, Vermont. Wilbur Special Collections, Bailey-
Howe Library, University of Vermont, Burlington, Vermont,
1872.
