Consequences of Recreational Land Use at the Green Mountain Audubon Nature Center: Soil Infiltration and runoff rates

Alysa Snyder and Nathan Toke

Geomorphology 2001

University of Vermont

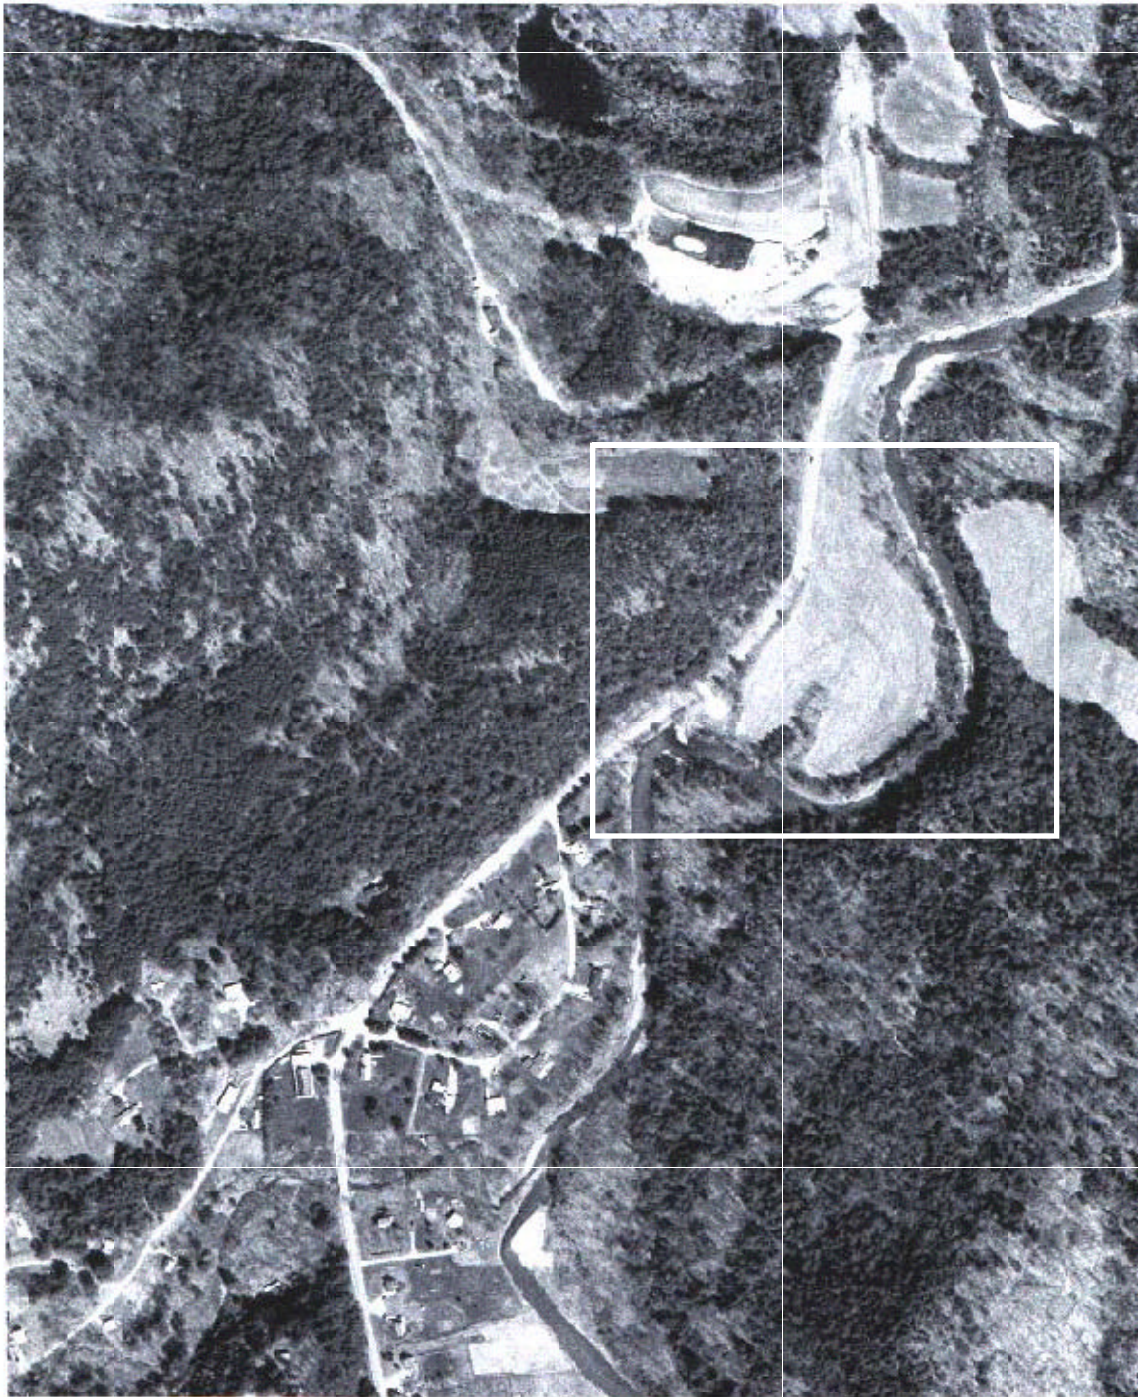
Figure 3: A photograph from the air of the River Trail area, highlighted above. The three test areas can be seen. The open field/thin forest was used as the natural constraint, the small parking lot (the very light rectangle just off Huntington road), and the trail which runs along the small stand of trees bordering the river.

We preformed our research at three sites within the River Trail area of the Green Mountain Audubon Nature Center, located in Huntington Vermont (Figures 1-3). We chose each site to represent a different type of land use: the River Trail's unpaved parking lot, a site along the trail (sloping into the Huntington River), and the edge of a forest abutting a field. At the three sites we simulated rainfall to measure infiltration and runoff rates.

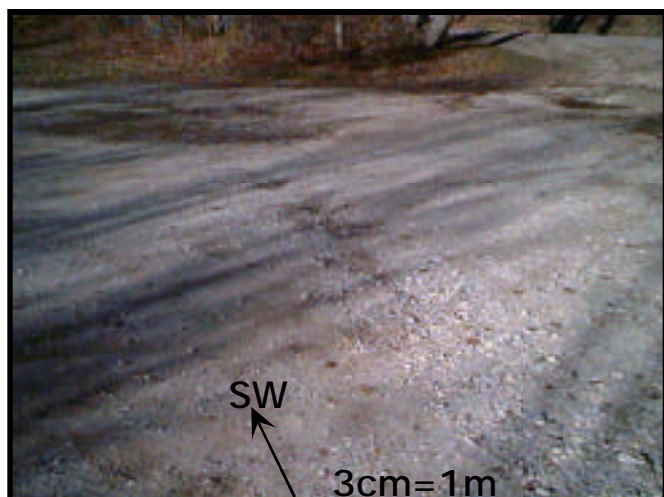
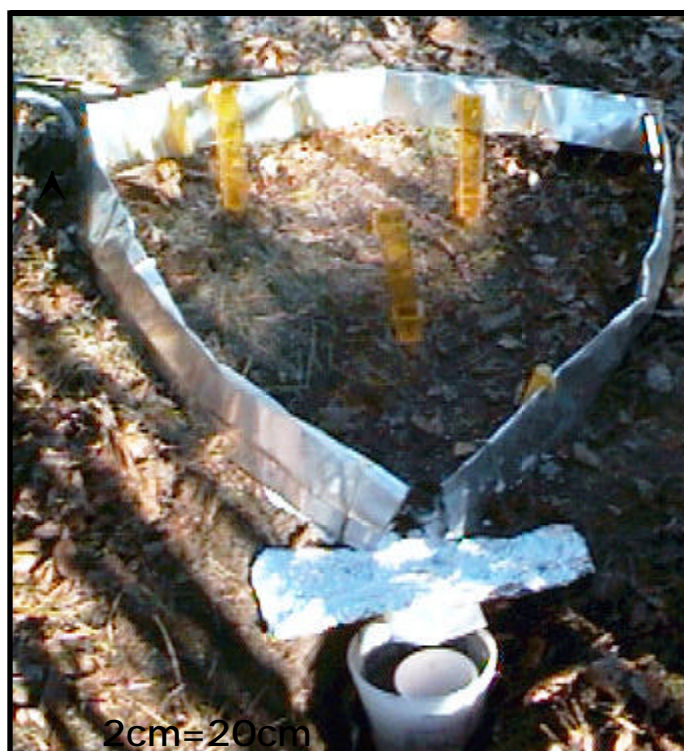
The River Trail parking lot was primarily composed of a mixture of highly compacted sand, gravel and limestone. Its slope, see countour lines in (figure 2), trended from the Huntington Road (to the Northwest) down towards the Huntington River (to the Southeast). The two trials were conducted in a plot which was set up on the southeast corner of the parking lot. The slope at this site was 3 degrees down and approximately perpendicular to the river. Between the parking lot and the river was a small portion of grass covered soil and a steep bank with some trees leading to the river.

The natural area was located to the North of the parking lot, at the edge of a forest. The plot was densely covered with grass and leaf litter, and it was surrounded by shrubs and trees. The hole dug for the collection bucket was approximately 12cm deep. The first 10cm consisted of a homogenous mixture of sand and silt. A uniform contact was observed between this layer and the one below, which was interpreted as a plow horizon. The field sloped to the East, toward the Huntington River. The dip angle of our plot was 11 degrees.

The River Trail plot was located approximately 20m East of the parking lot on a small trail that connected to the main trail, sloping South at 6 degrees, directly towards the Huntington River. The soil was highly compacted and consisted of sand and silt. The trail was eroded into a gulley with steep banks approximately 1.5 m down the trail. The first trial was conducted while the upper 1 cm of soil was heavily frosted. For the second trial, the ground had sufficiently thawed.

Soil conditions vary at each test site, resulting in different infiltration rates for each trial. Figure 5 has detailed descriptions and observations of each test site such as soil type, condition,

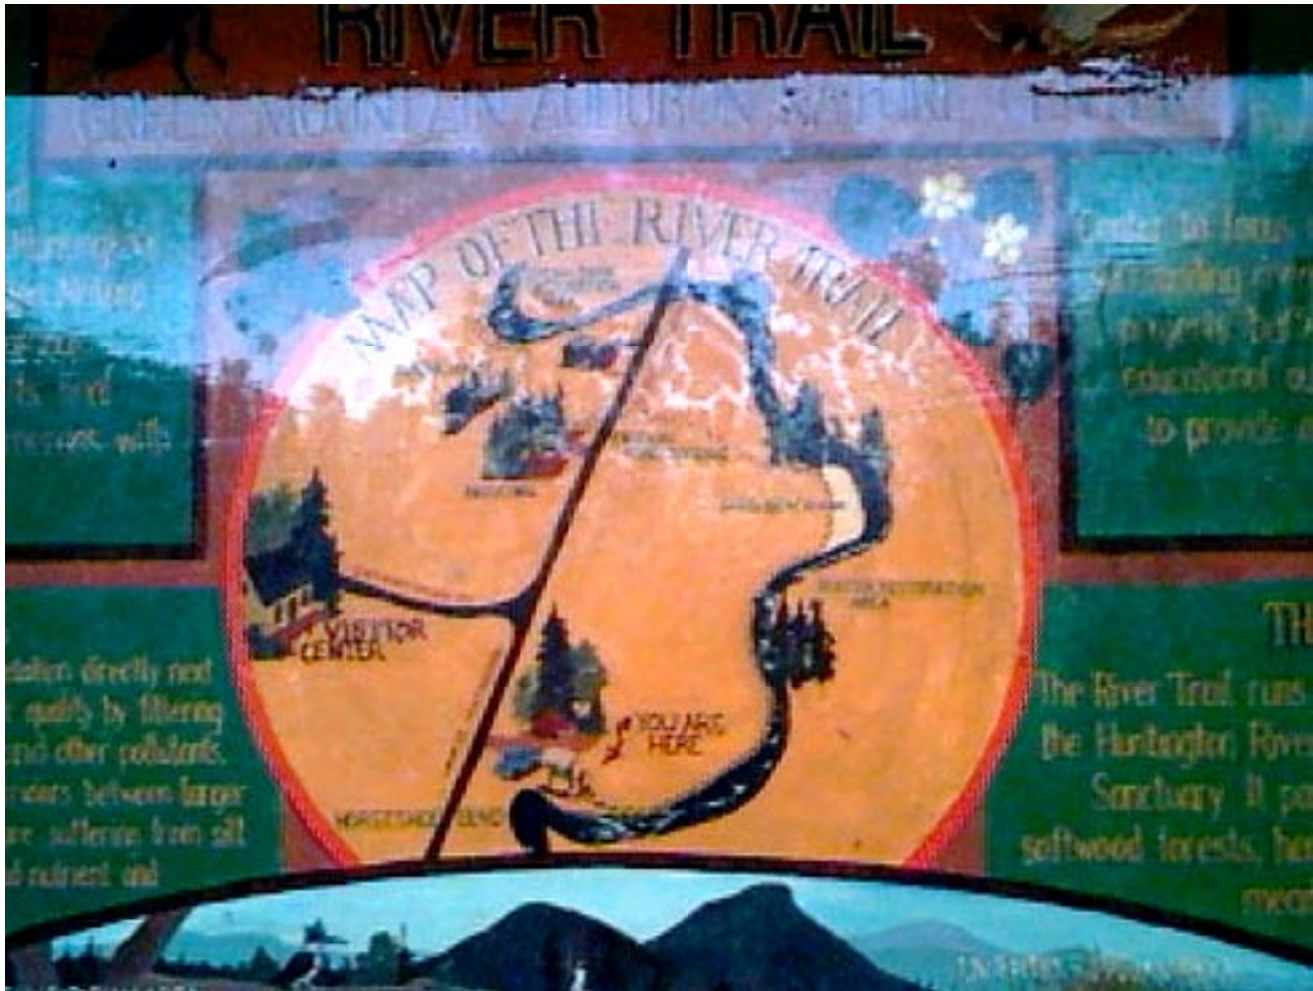
Figure 12: This sign is located at the River Trail. It describes that the River Trail runs from the Horseshoe Bend area of the Huntington River to the North End of the Audobon Nature Sanctuary. The section of land between the River Trail and the Huntington River is deemed an "unhealthy riparian zone," with uninhibited runoff of fertilizers and other pollutants washing over the eroding treeless banks into the river. The term riparian zone refers to a land and vegetation directly next to a river. This "buffer zone" protects water quality by filtering overland runoff of fertilizers, pesticides, soil, and other pollutants. Wildlife use riparian zones as places to rest, bathe, feed, and drink clean water. Many Vermont rivers are suffering from silt covered bottoms, unshaded shallow waters, and nutrient bacterial pollution due to the elimination of trees in riparian zones. The shore of the Huntington River that abutted both the parking lot and the trail experiment sites was sparsely forested, but clearly attempting to re-vegetate. Here, an interpretation can be made that that in the recent past, these shores were bare, allowing uninhibited amounts of sediments and pollutants to flow into the river. In the natural area test sight, we interpreted the existence of a plow horizon, which is evidence that this area was used as some type of agricultural growing site. Any chemicals used in this area, which did not infiltrate, likely had no healthy riparian zone to flow through, as the shores had also been cleared, and washed right into the river.
