Geomorphic Changes of Burlington, Vermont

**By Erik Engstrom and
Maury Lynch**

Searching through historic photographs and maps revealed many geomorphic changes in Burlington Vermont. This report looks into the past 200 years of change. Analysis of the College Street Gully and other related features that changed the way Burlington evolved over time.

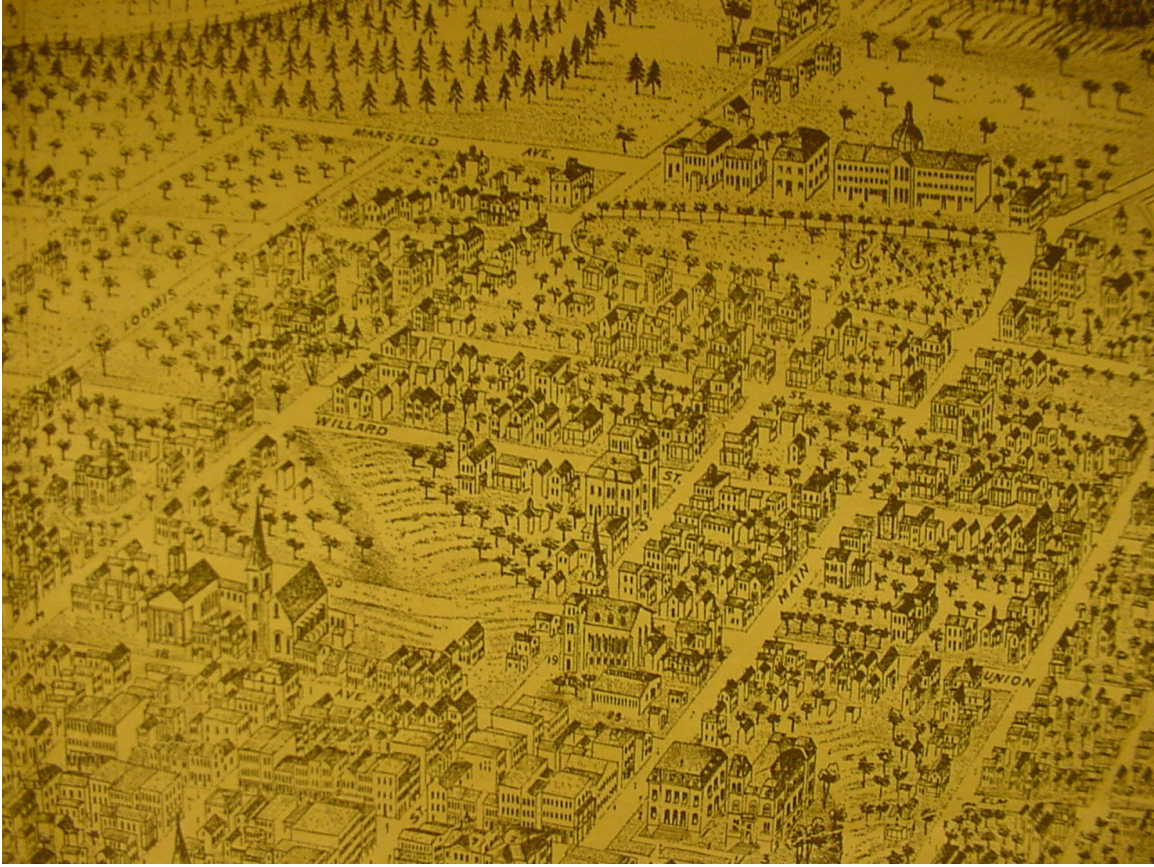
Figure 4 A Birds Eye View of Burlington in 1877. Note the Gully between Willard and Union Street

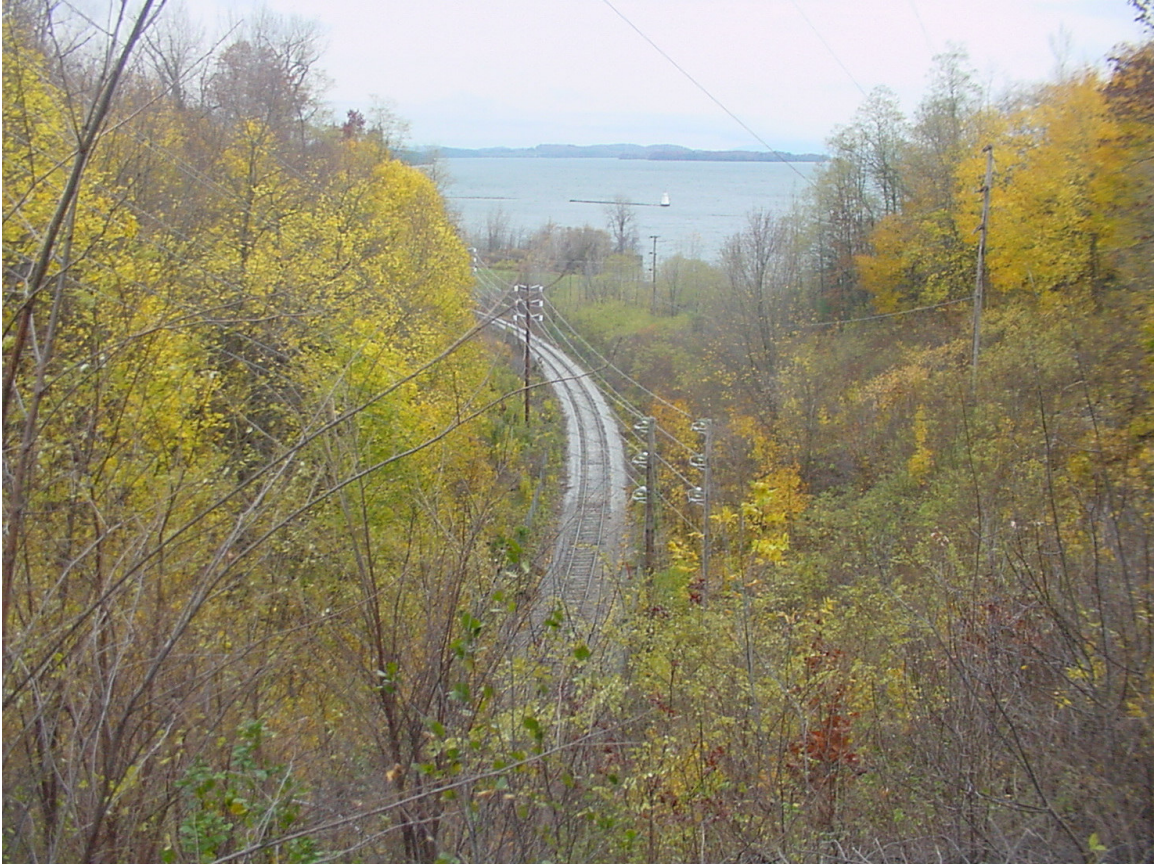
Figure 7b Shows the same view from above the tunnel shown in 7a as it stands today

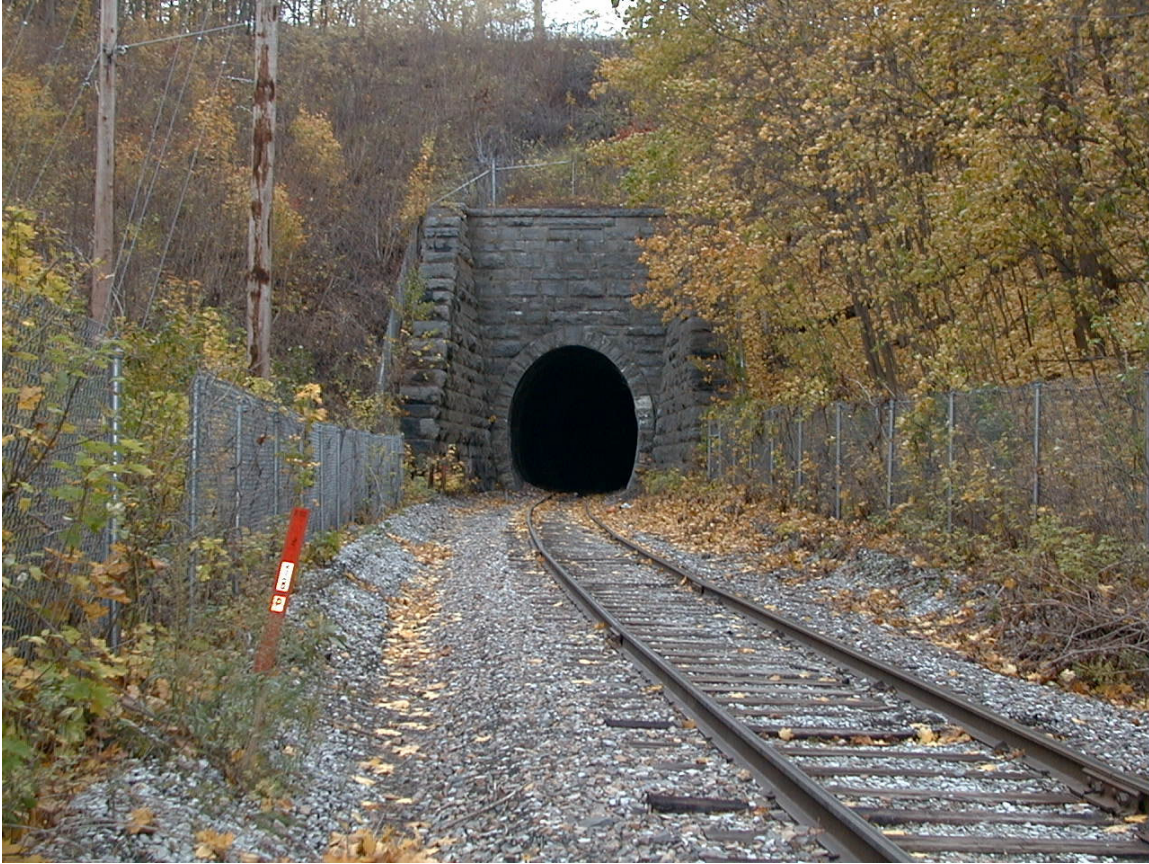
Figure 7c Shows the tunnel that stands today and is still used by trains.
