AN ANALYSIS OF THE TRINITY RAVINE AND THE AFFECTS OF DEPOSITON

Elton A. Hoyt and Taras J. Chwalk

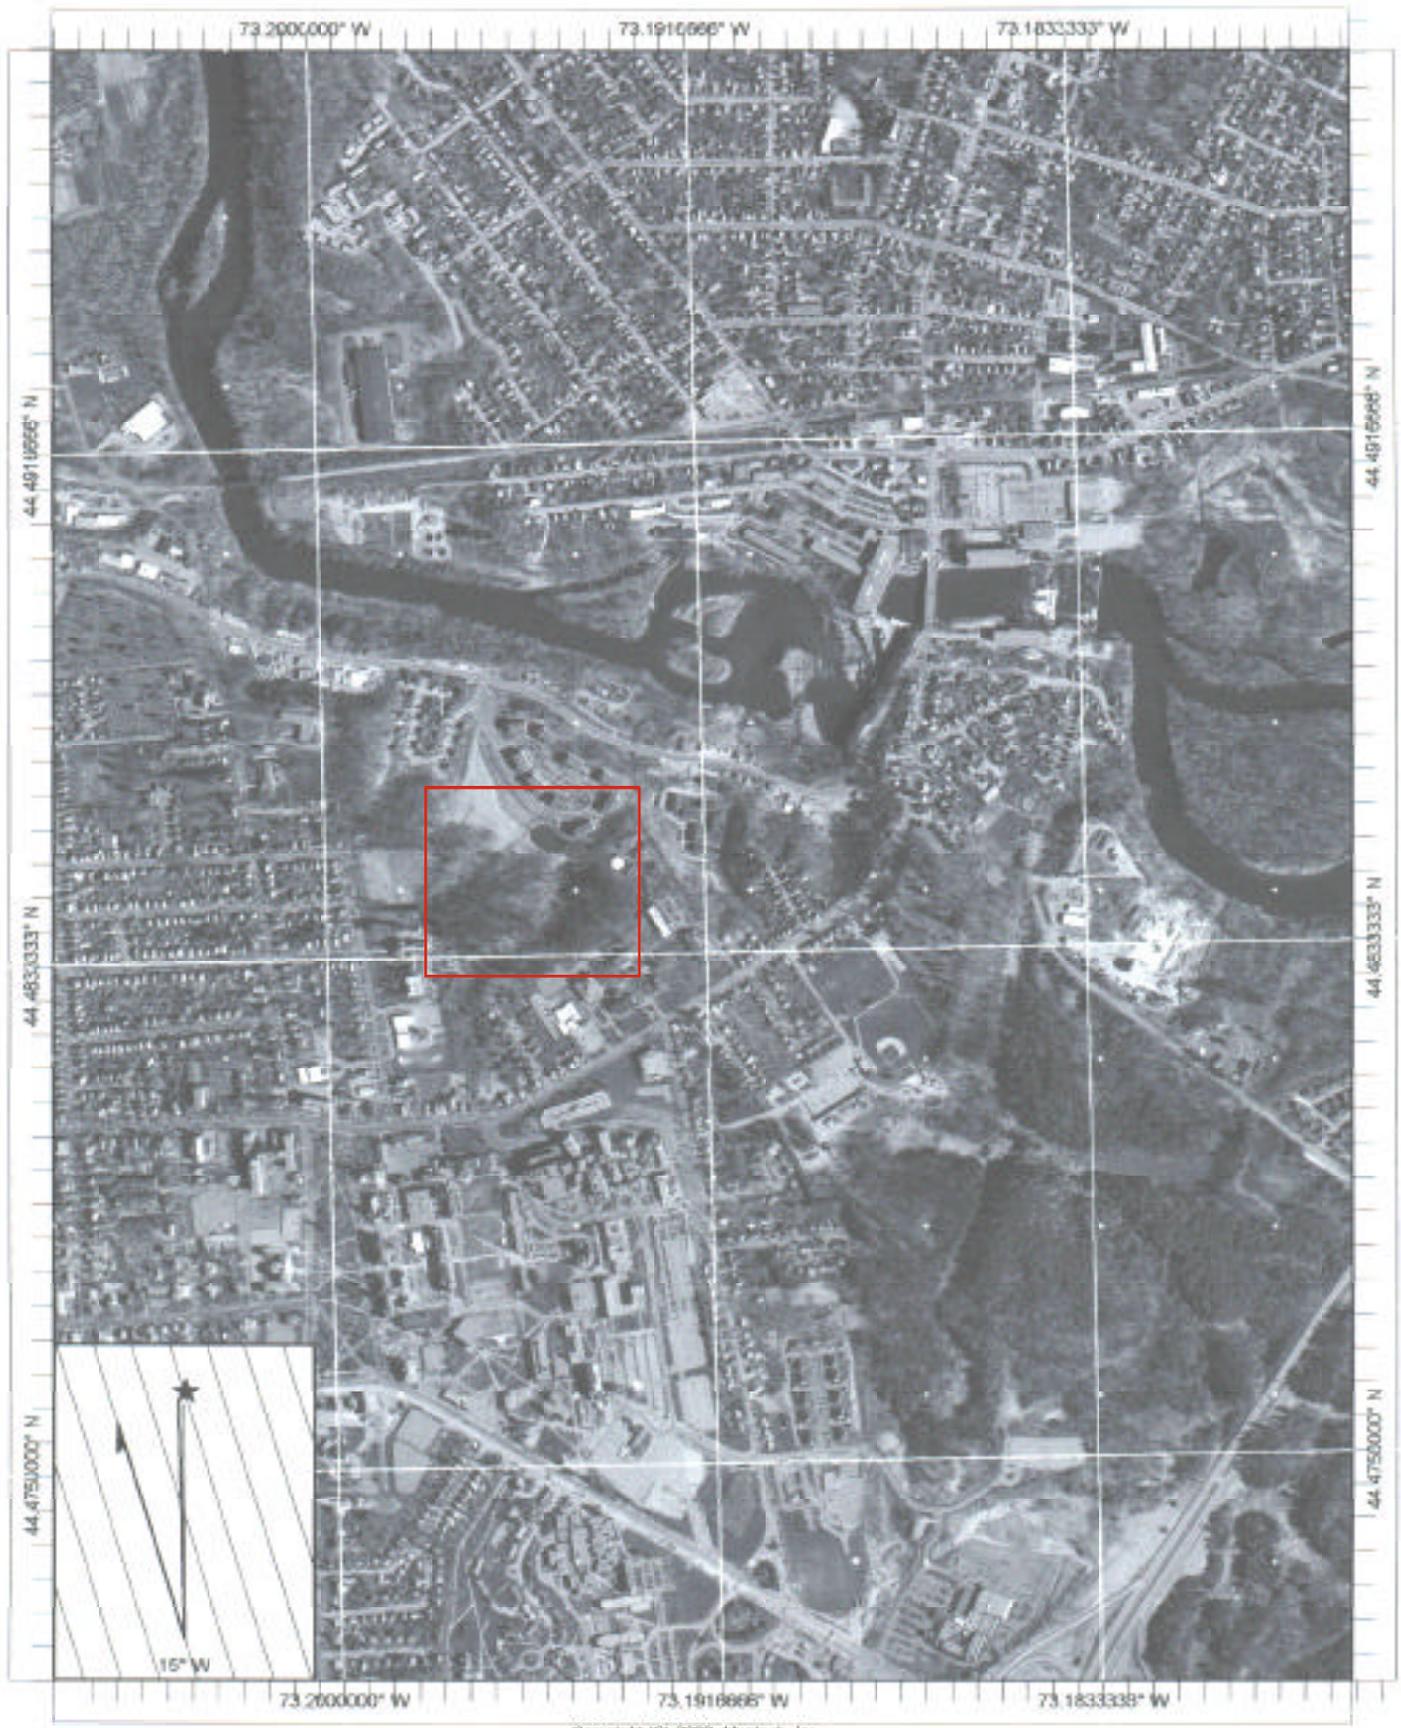
Figure 2. This figure is an aerial photograph of Burlington it displays the longitude and latitude of of the area studied. The outlined area corresponds topographically with the basin identified in figure 1.

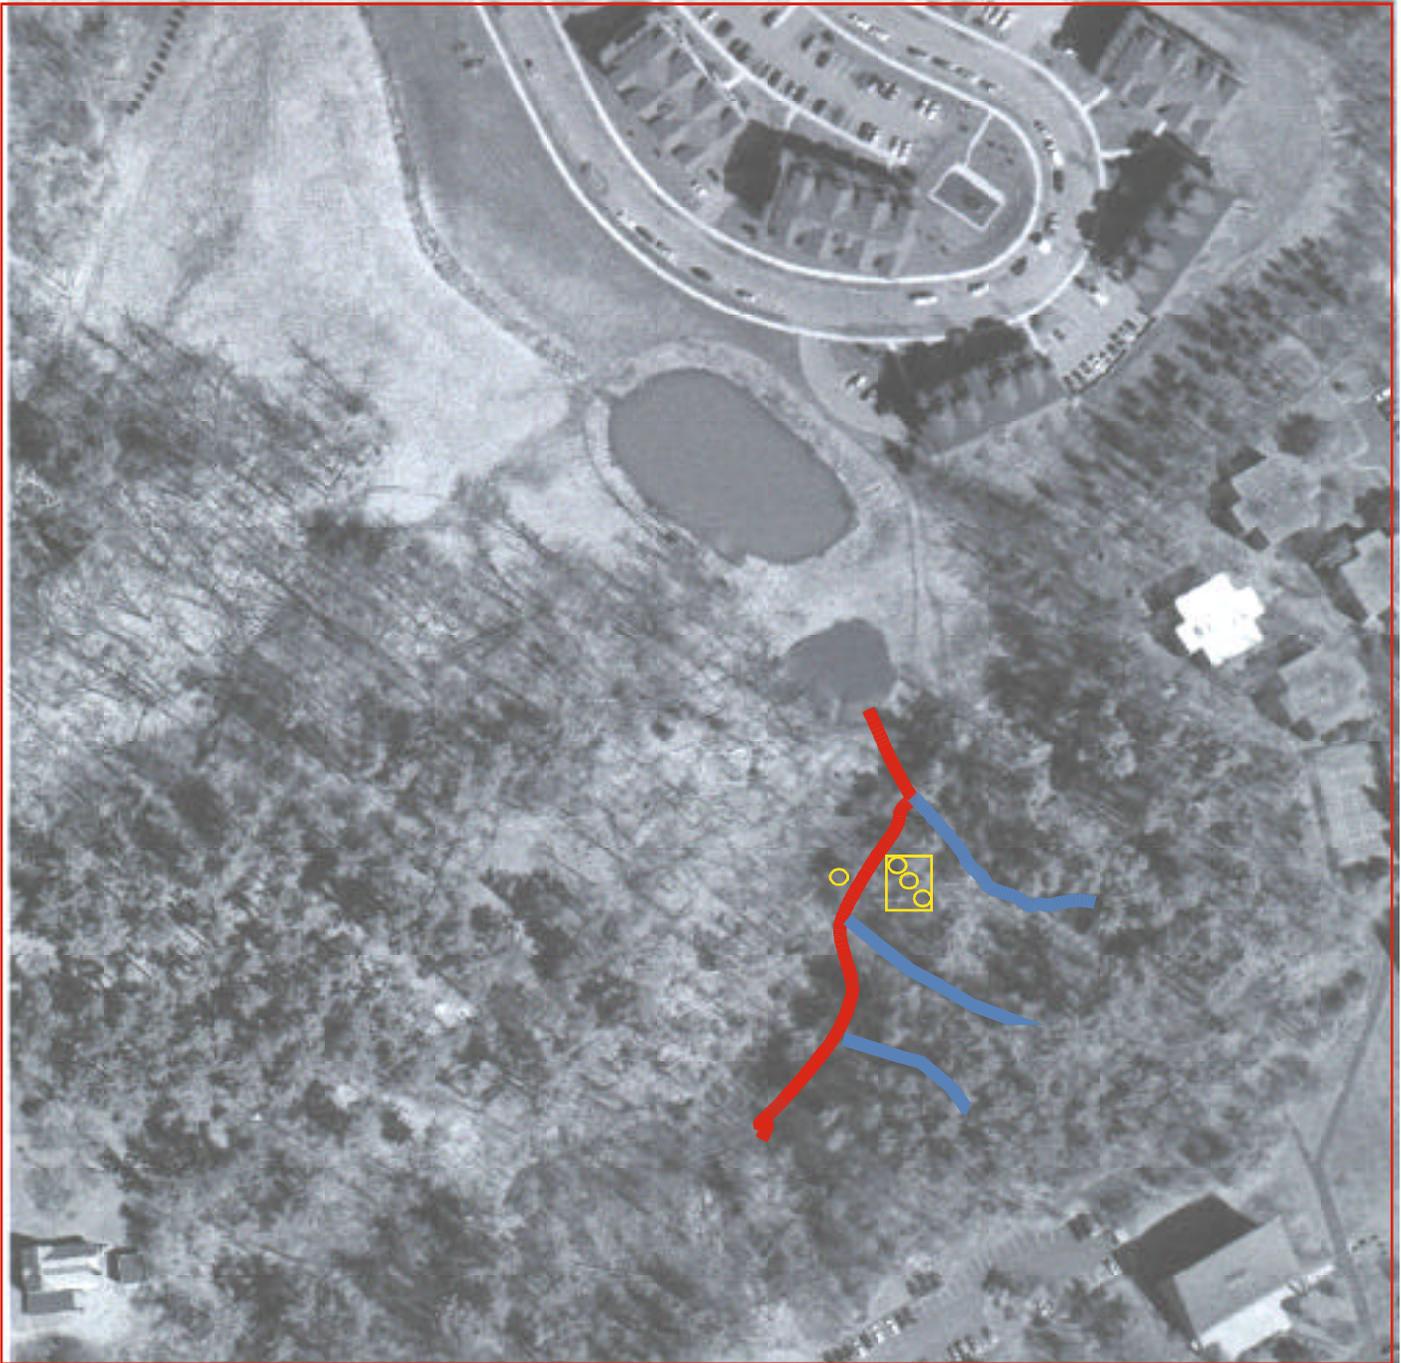
Figure 3. This is a closeup of an aerial photo of the drainage basin. The red square corresponds with the square seen on figure 2. The river and soil pits has been drawn in roughly.

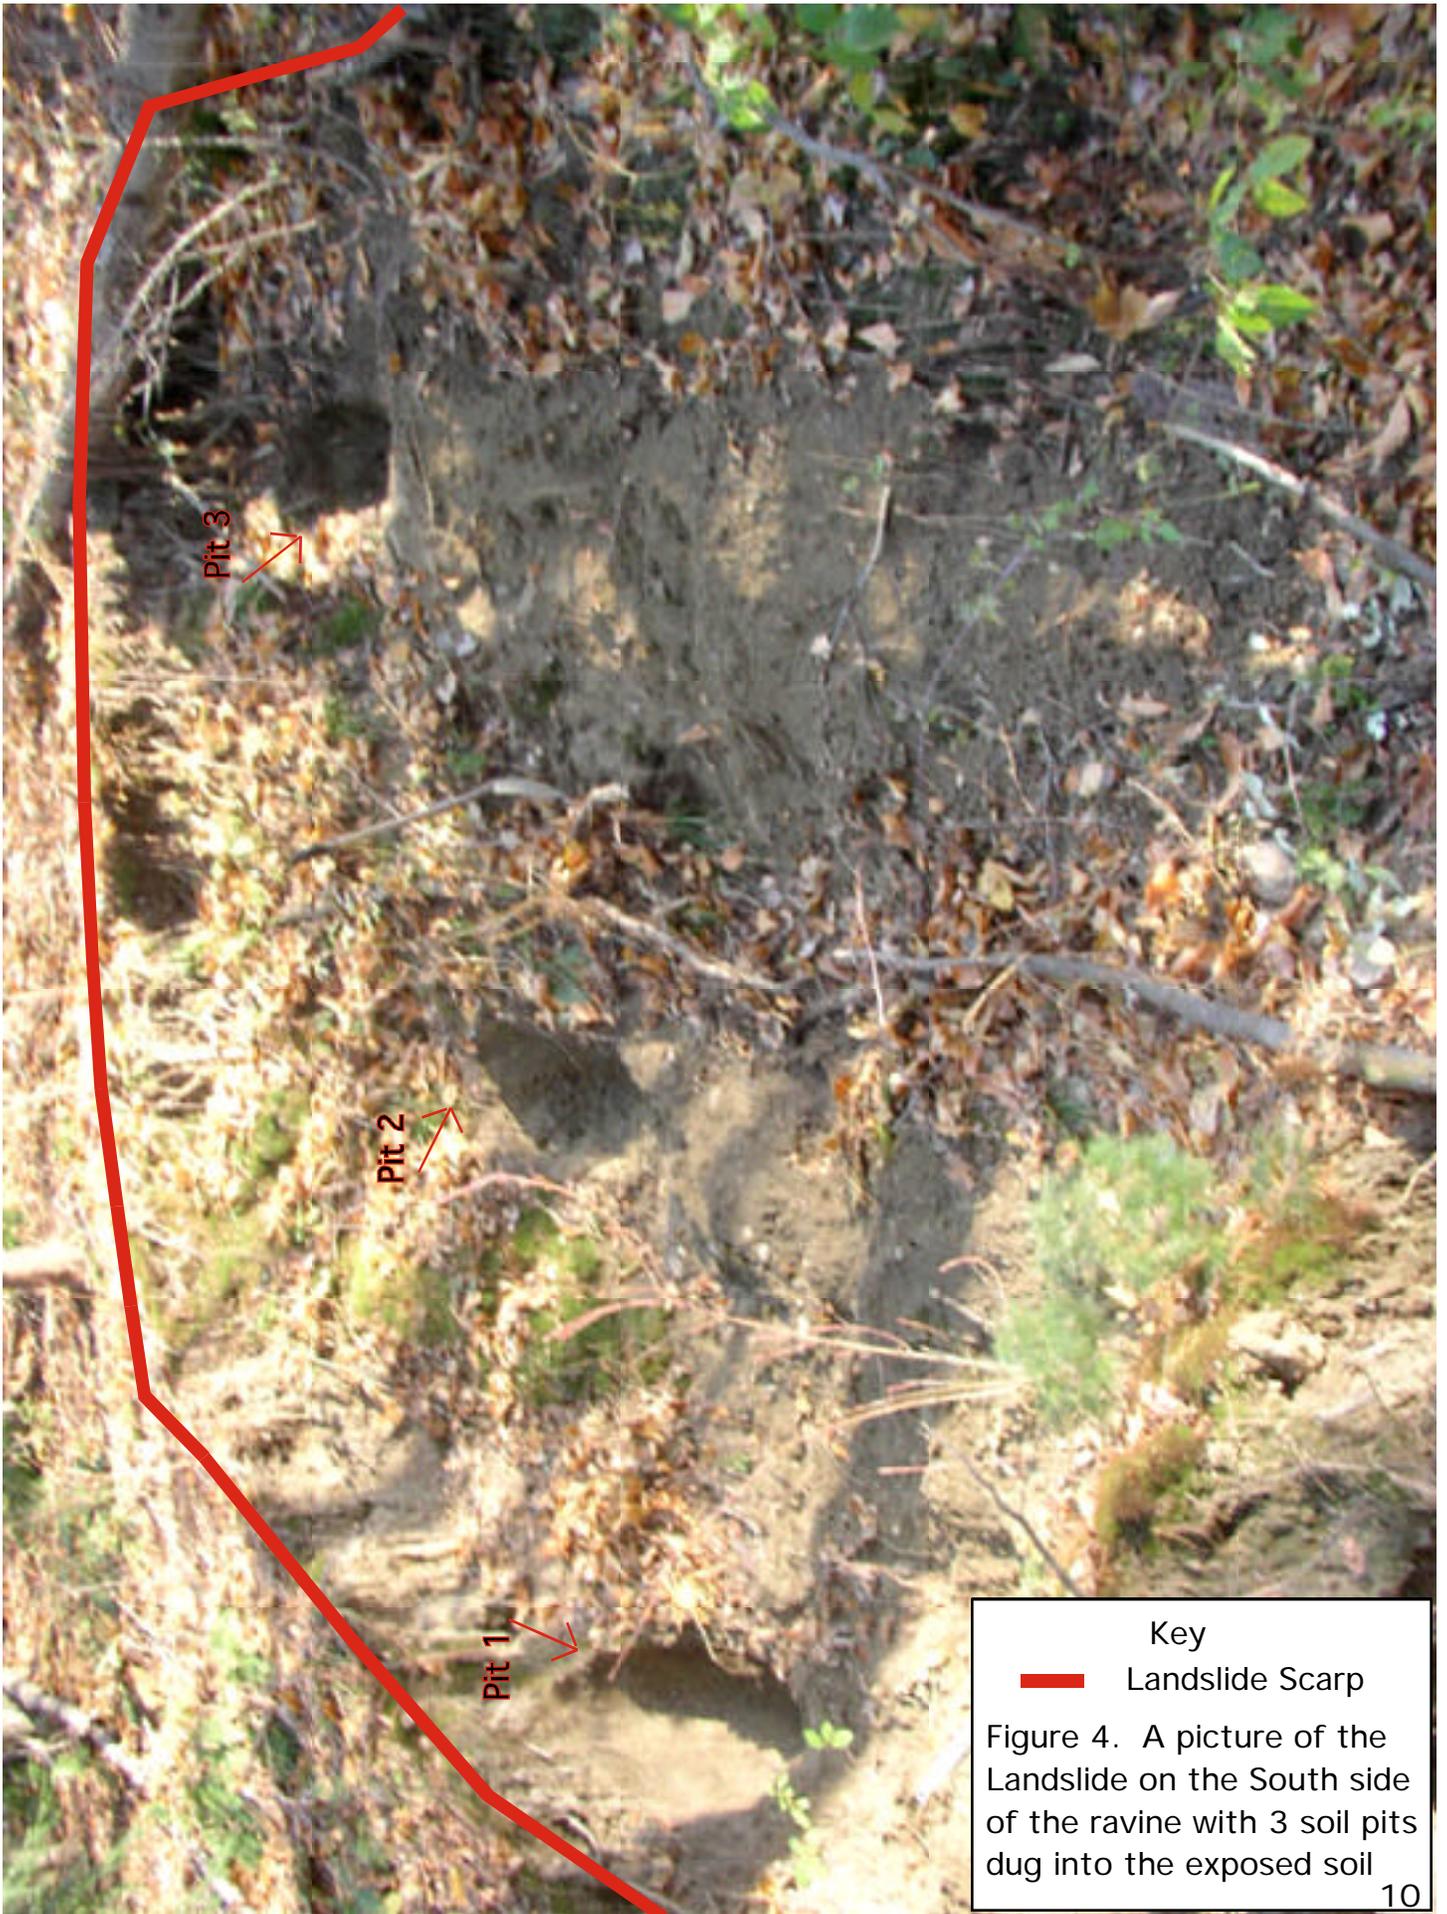
Key
— Landslide Scarp

Figure 4. A picture of the Landslide on the South side of the ravine with 3 soil pits dug into the exposed soil

All three pits on the landslide were dug in such a fashion to expose the top three meters of the landslide. The top of each pit was on a linear plane with the bottom of the next (fig. 4). The stratigraphic columns of the first three pits display vertical relief of the top three meters. Because of this fact the pits are described from bottom to top. The stratigraphy for all soil pits can be found in figure 5.
