# **Landslides and Ground Water Permeability with Respect to the Contact Point of Glacial Lake Vermont and the Champlain Sea Sediments at Town Line Brook, Winooski, VT**

Michala Peabody  
Lara Vowles

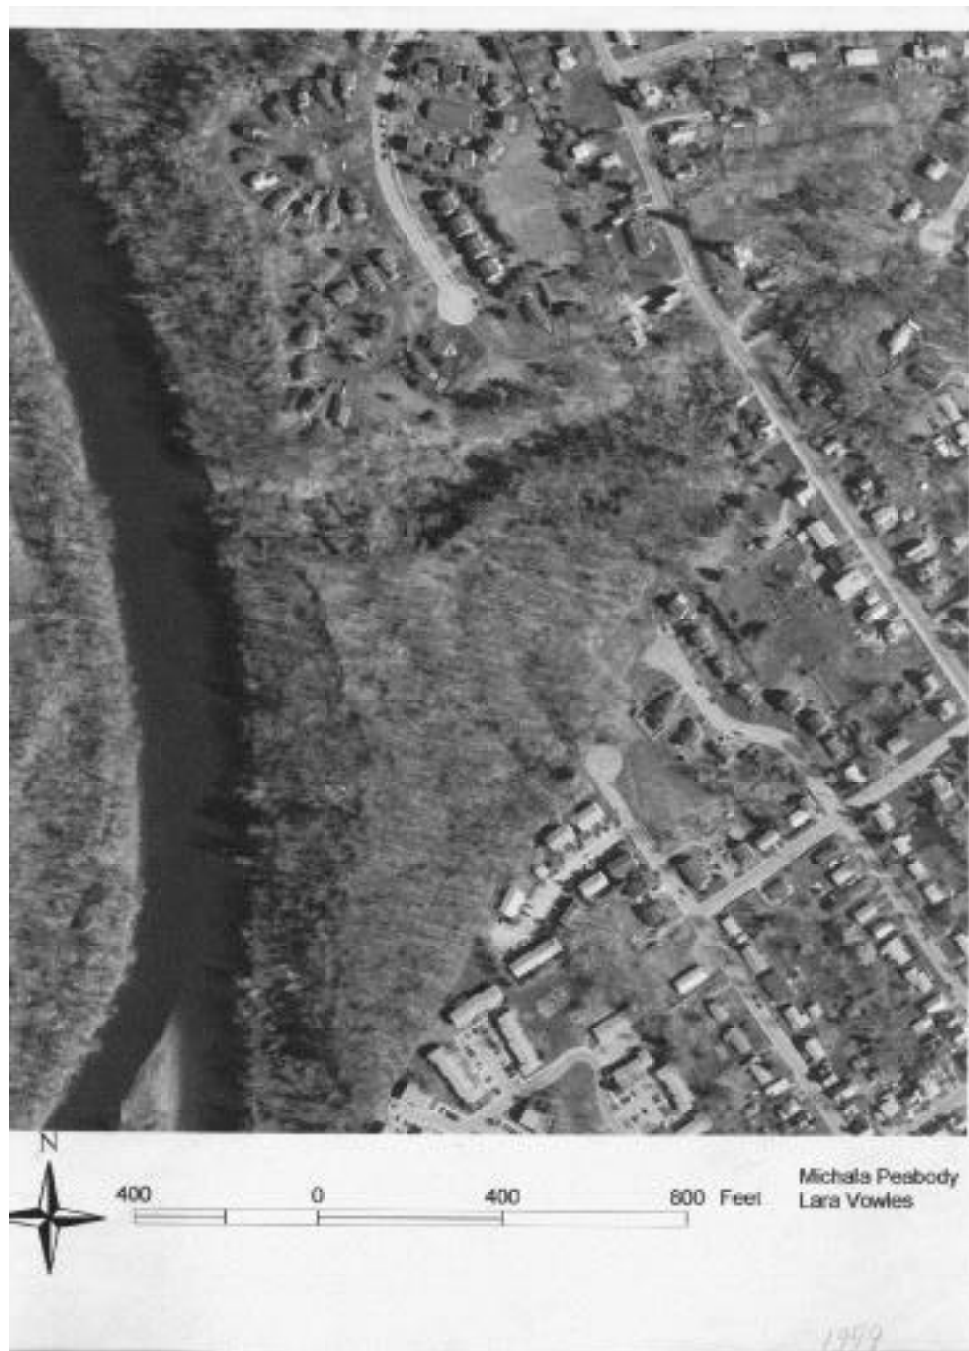
## Town Line Brook Photograph

Figure 3: This photograph depicts a present day aerial view of Town Line Brook taken in 1999.

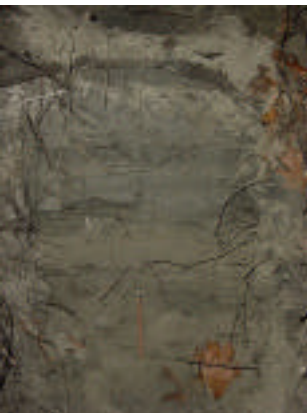
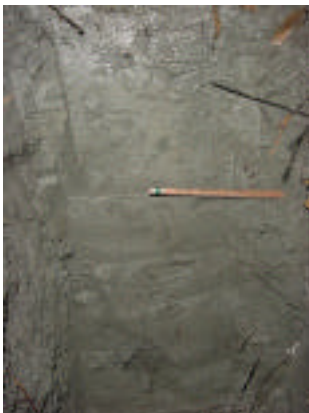
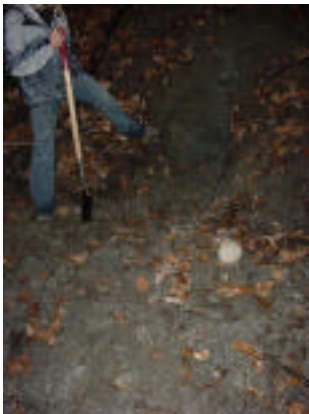
Figure 5: These photographs show the four different holes uncovered along the slope at Town Line Brook located in Winooski, Vermont. They depict a general stratigraphic column showing the differences in sediment layers and grain size. The contact also shows the mini-landslide created from our digging and excess rain.

Finding the exact contact point between the Champlain Sea and the Lake Vermont took time and involved a few very muddy articles of clothing. A cross section was created to provide a general overview of the area studied and to further understand the landslides present, noting where our holes were dug in the slope (Figure 4). Photographs of these holes providing a general stratigraphic column are provided in Figure 5.

Once uncovered, the contact continuously created small-scale landslides. The Champlain Sea sediments, visible in all four holes, mostly consisted of heavy wet layers of silt. A layer of saturated silt and clay, approximately 1-2 centimeters thick, was mixed together with a large amount of water at the contact between the Champlain Sea and Lake Vermont. The Lake Vermont sediments, located directly below this point, were very dry and hard packed layers of gray and maroon colored clay (Figure 6). The clay layers were tightly packed and prevented the water from the saturated contact layer to penetrate through causing the water to run off the side of the slope.
