1927 Flood: Then and Now

Abstract: This study surveys the 1927 flood effects in Bethel, Cambridge, Montpelier, and Winooski, Vermont. This was done through re-photographing original flood photos. A brief history of the causes of the flood is given. Also, Manning's n was calculated for the Winooski River (USGS site 04290500) using United States Geological Survey records of discharge and blueprints of the Winooski riverbed from Winooski One Hydro. A combination of factors caused the 1927 flood, including deforestation. In conclusion the landscape has rebounded since the flood, with re-stabilization of slopes and man made structures such as bridges and dams.

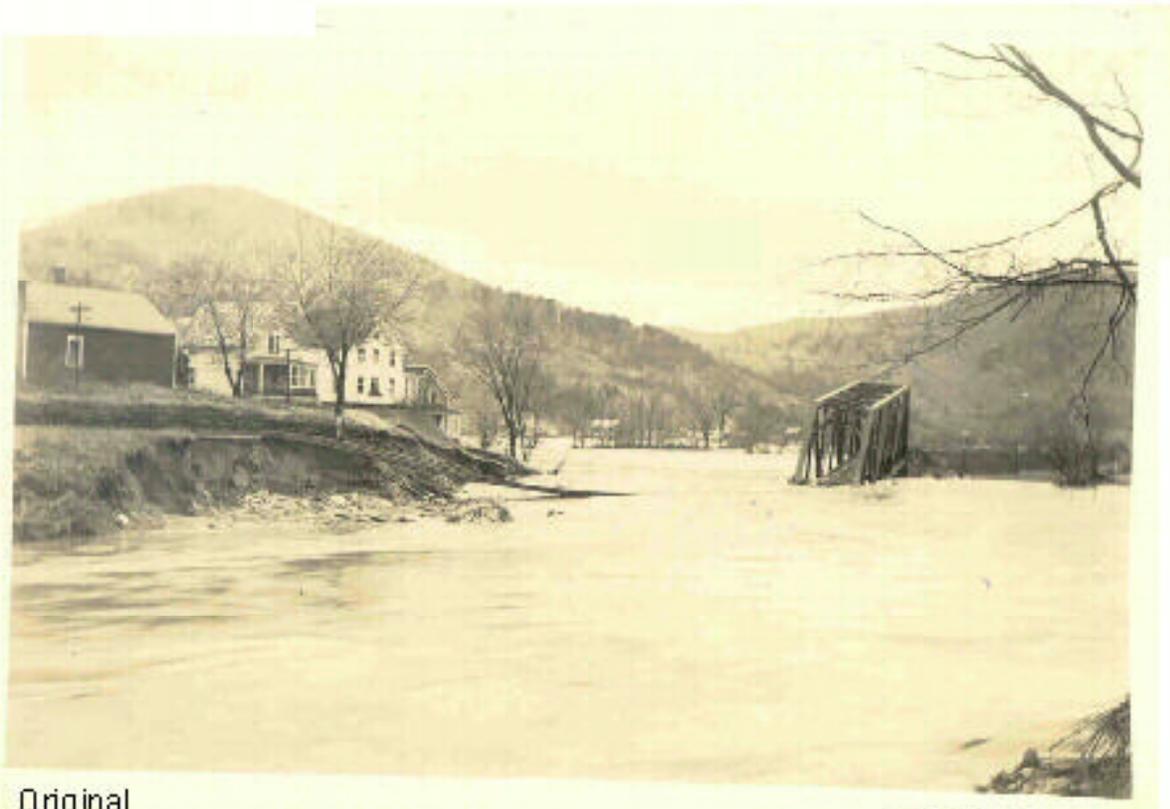
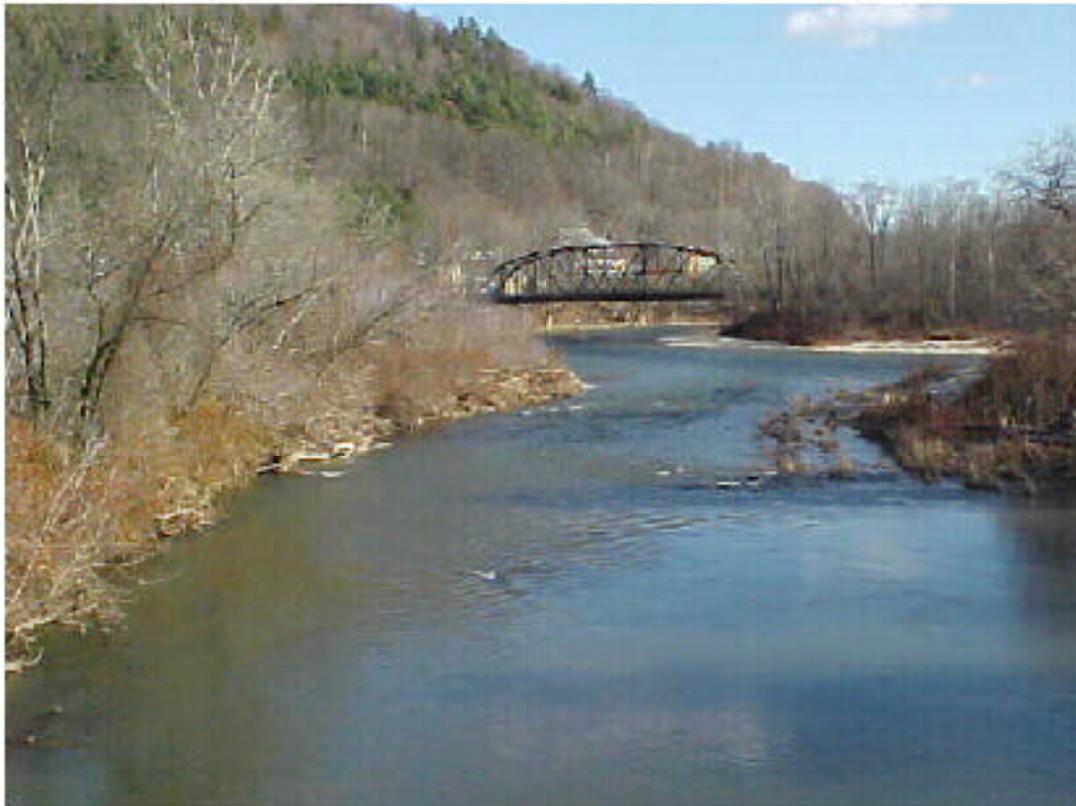
Bethel Photograph Pair 1

Figure 4. Since the flood the area has been greatly reforested, and the bridge re-built. Many of the homes seen in the original are still there, but are obscured by the trees.

In the nine photograph pairs (Figures 4 - 16) there are varying degrees of change in the landscape and varying amounts of development. Bethel's landscape has changed the most due to reforestation, this can be noted best in the image of the river with the bridge fallen in (Figure 4). The development of the area has changed so little that the houses seen in the original photograph are still there, but cannot be seen because of the new trees that have grown on the riverbanks. The most striking of the similarities in pictures is that of the railroad bridge (Figure 5), where there is still a landslide on the failing slope.

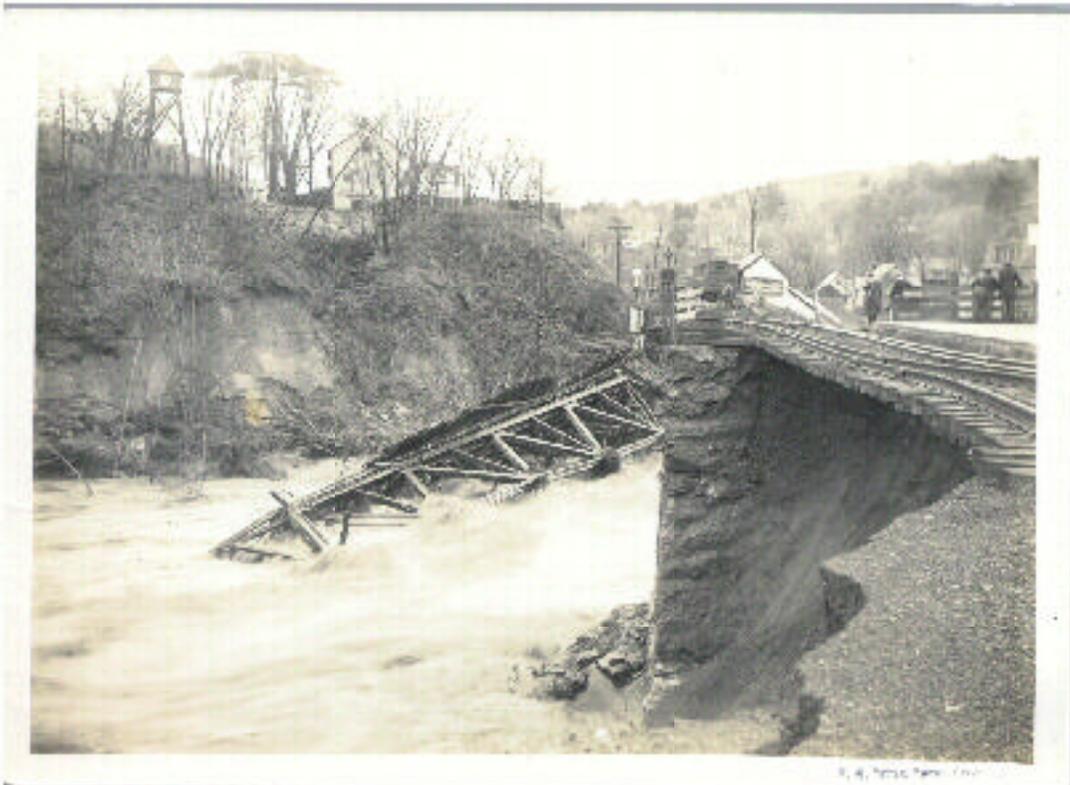
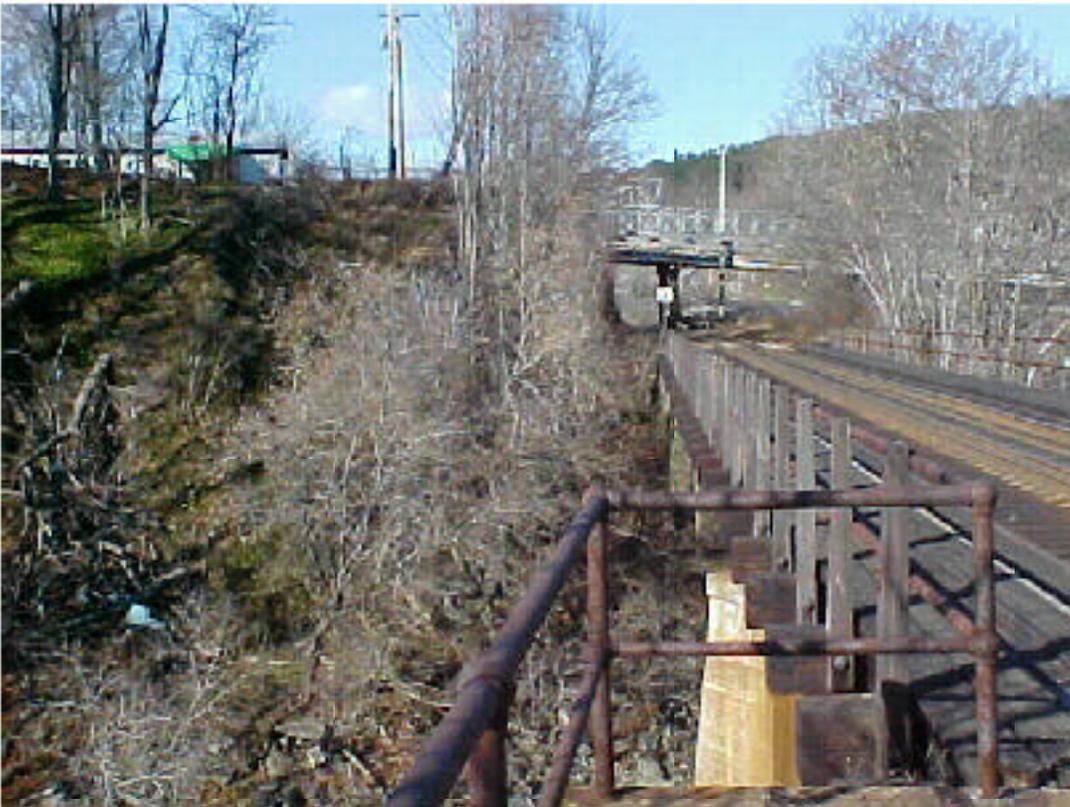
Bethel Photograph Pair 2

Figure 5. Aside from the rebuilding of the bridge little has been changed at this site. The houses still remain, there has been some reforestation. Note: The landslide is still there.

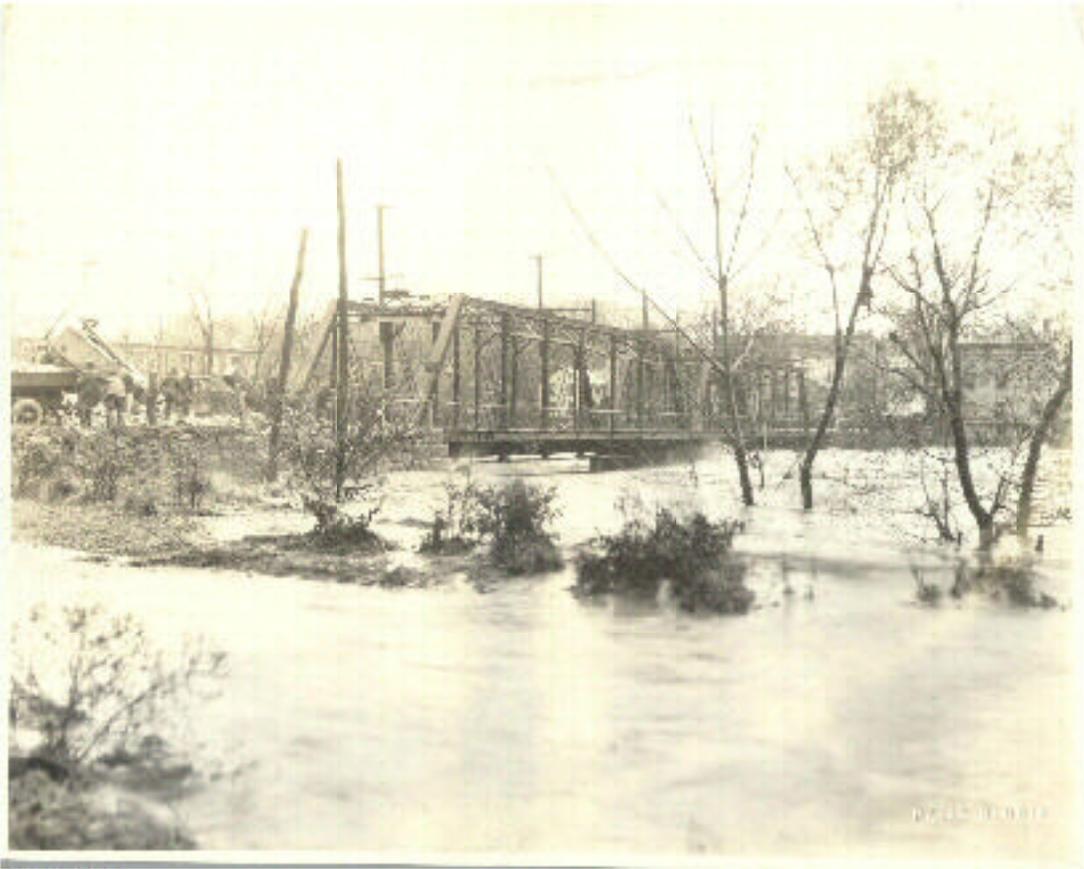
Winooski Photo Pair 1

Figure 6. There has been extensive change since this photo was originally taken. A much wider bridge has been built in place of the original, and many trees have grown back around the bridge.

around the bridge and dam is mostly human-induced. The bridge that was rebuilt is much larger and higher than the first (Figure 7), and the dam has a much greater effect on the river now than it did before. When they rebuilt the dam, they cement cast the bedrock and then placed a rubber dam on top (Thompson, personal conversation, 19 November 2003). After the flood, the mills were sold, as they had been severely damaged, this caused the rebuilding effort to constrain the river using a cement wall before the dam (Figure 2). Little reforestation has taken place in Winooski, there is only one photograph showing the re-growth of trees (Figure 6).

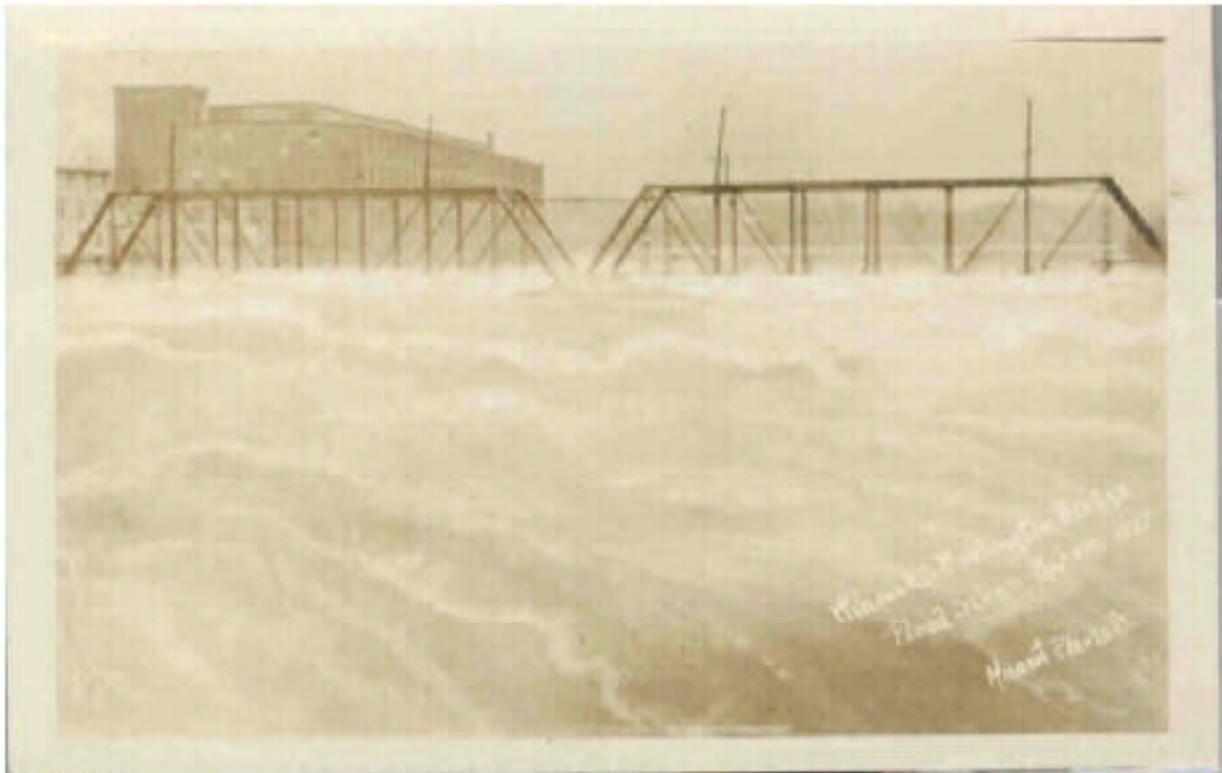
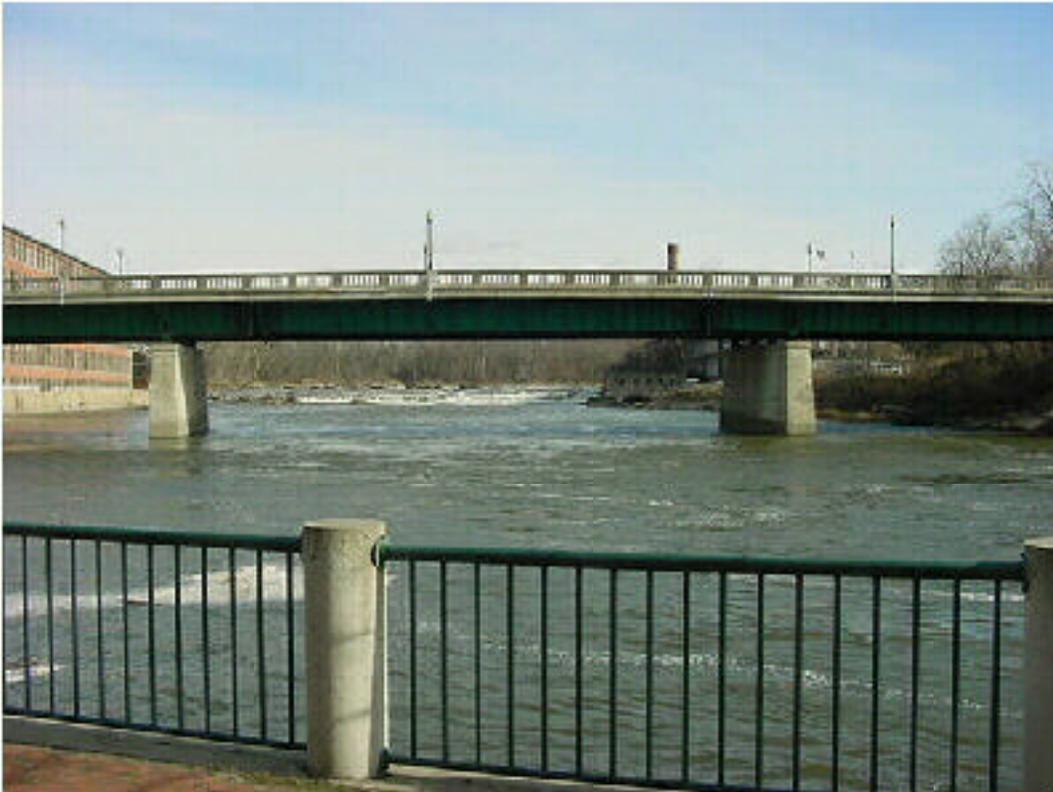
Winooski Photograph Pair 2

Figure 7. The Winooski-Burlington bridge was completely destroyed in the flood. The bridge seen in the re-photo was built in 1928 to replace the first. The flood also obliterated the dam, that too has since been rebuilt.

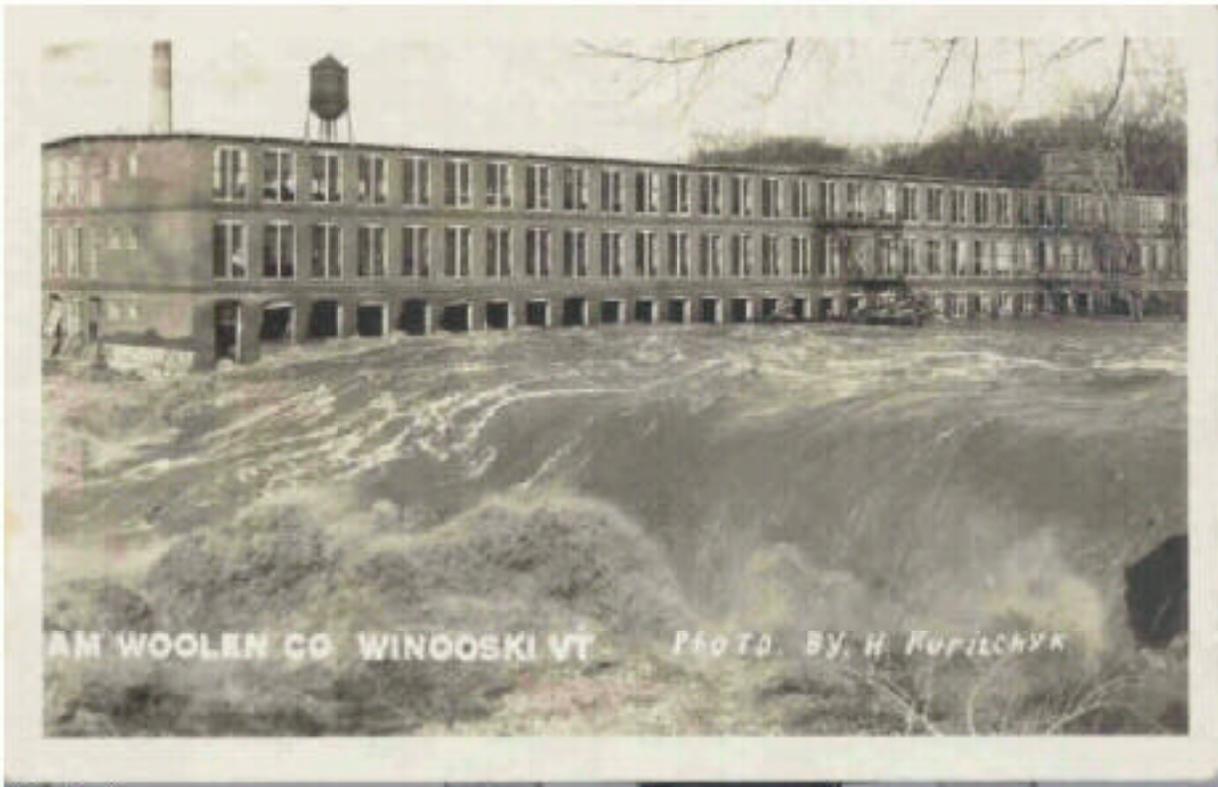
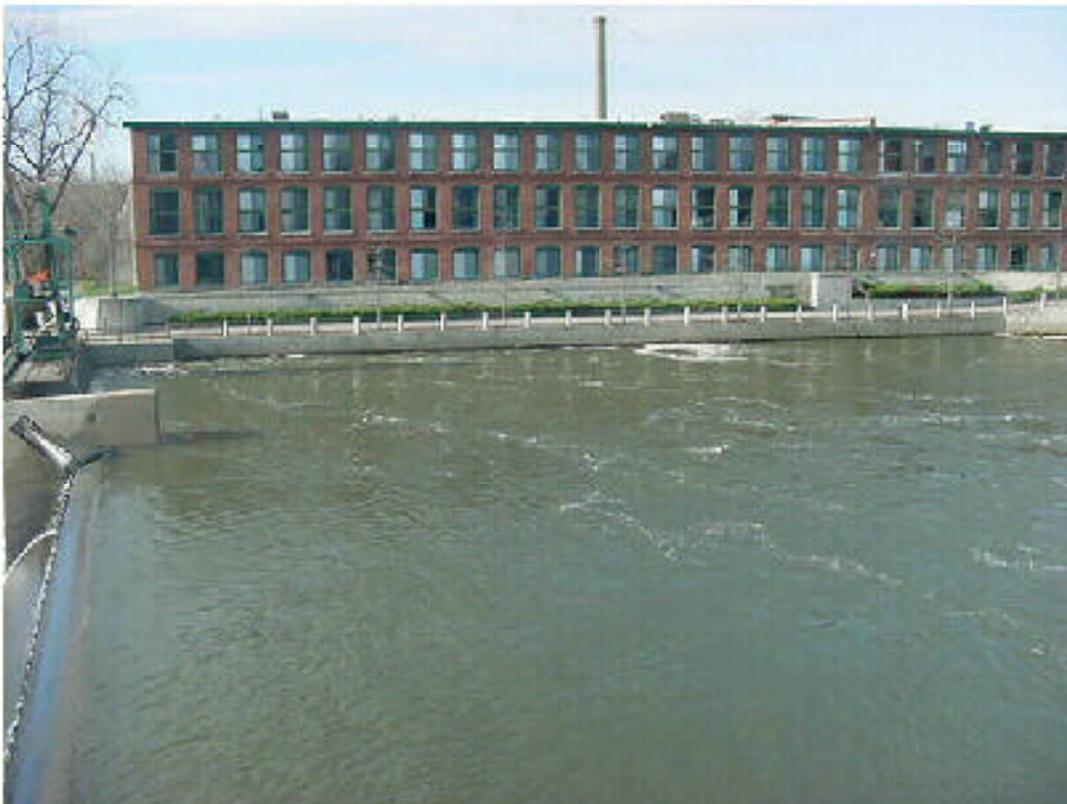
Winooski Photograph Pair 3

Figure 8. One of the many mills on the Winooski that was destroyed during the flood. It has since been rebuilt, sold, and turned into apartments.

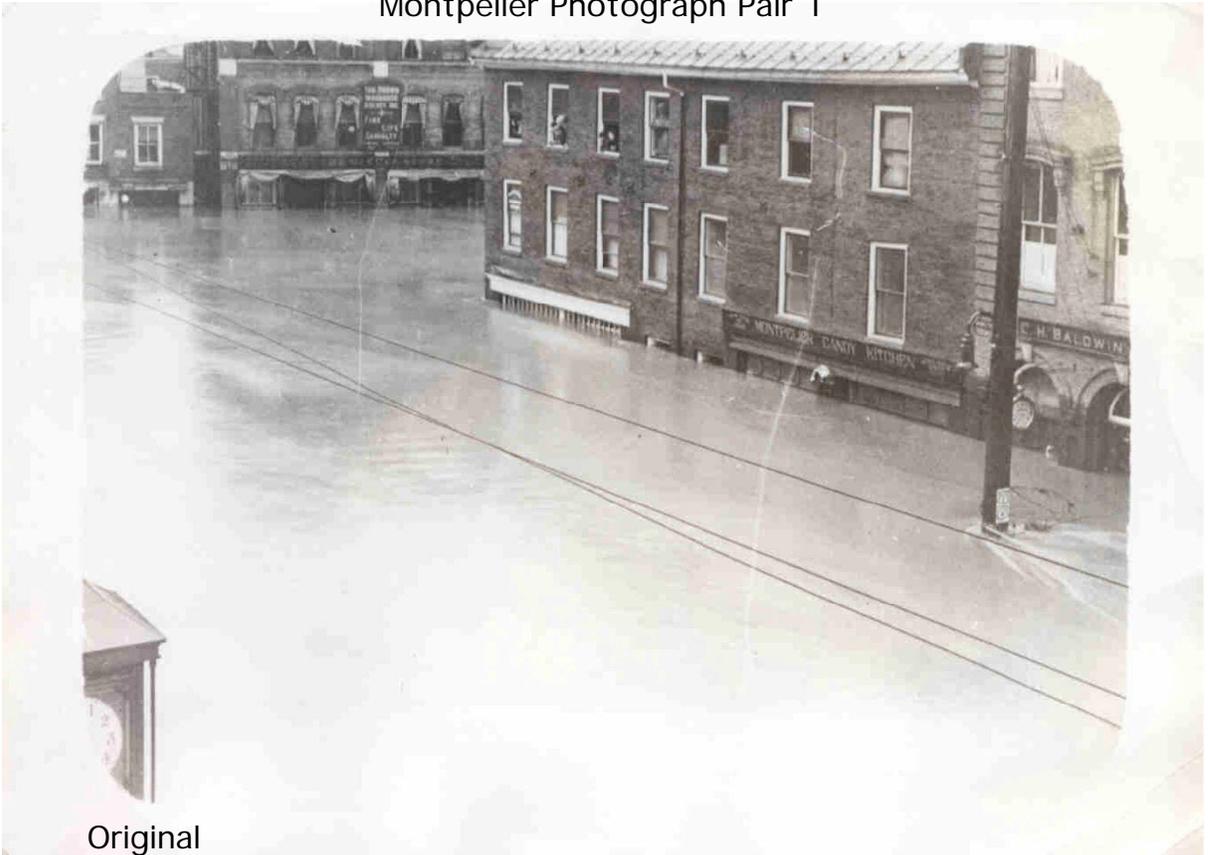
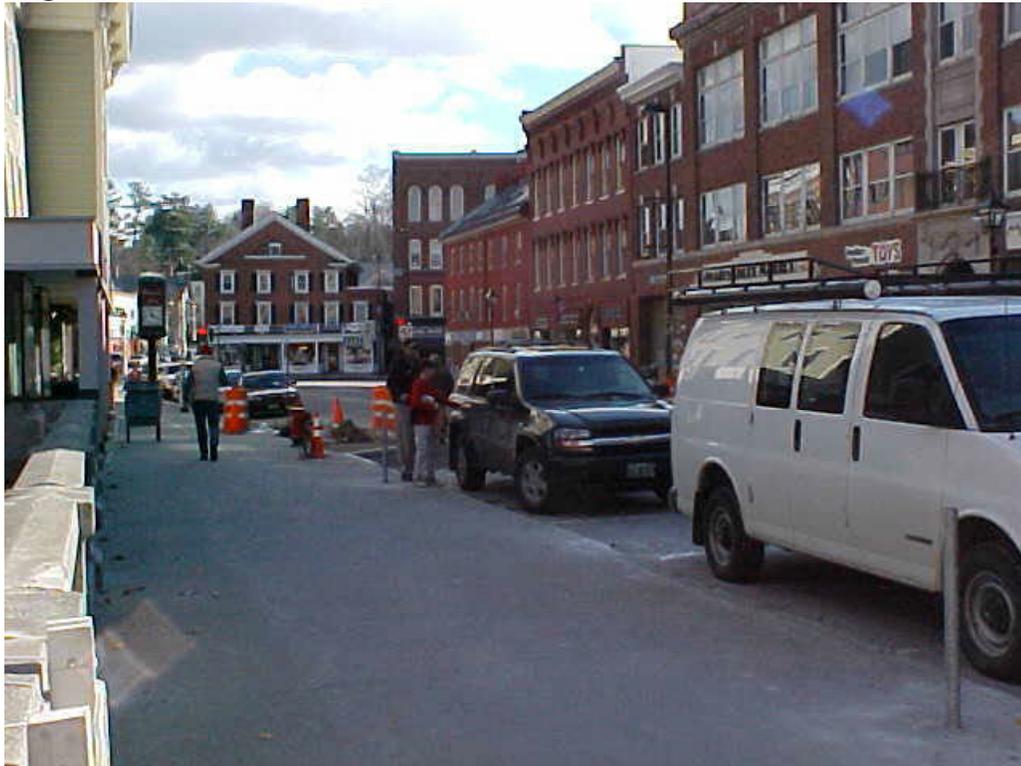
Montpelier Photograph Pair 1

Figure 9. The re-photo of this location is not exactly the same because the original photo was taken on top of a building. While little has changed at this location it gives a good idea of how high the water was.

Montpelier and Cambridge were effected in much the same way as Bethel and Winooski. The landscape has changed little since the flood, owing its major changes to development of roads. There has been some reforestation in Cambridge (Figure 11). The flood waters in Montpelier were upwards of 20 - 30 feet higher than they are today (Figure 9); this is also true for Cambridge (Figure 12).

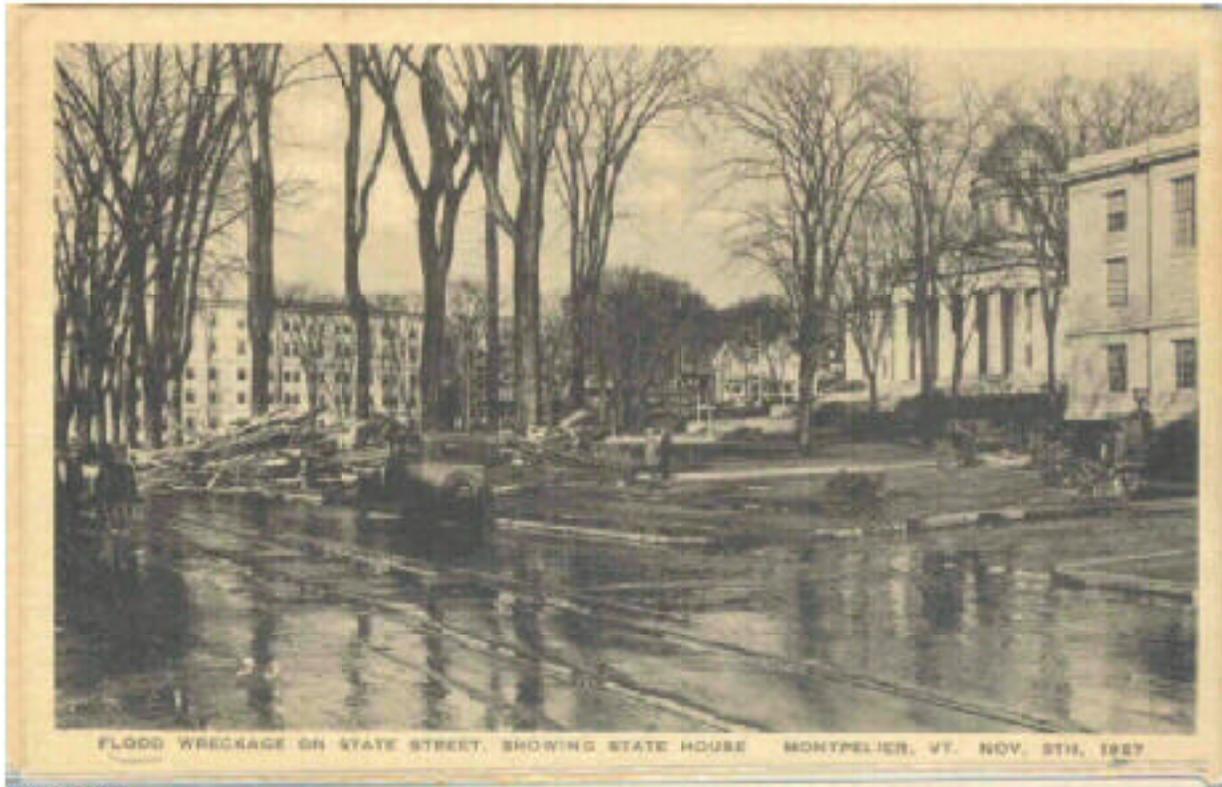
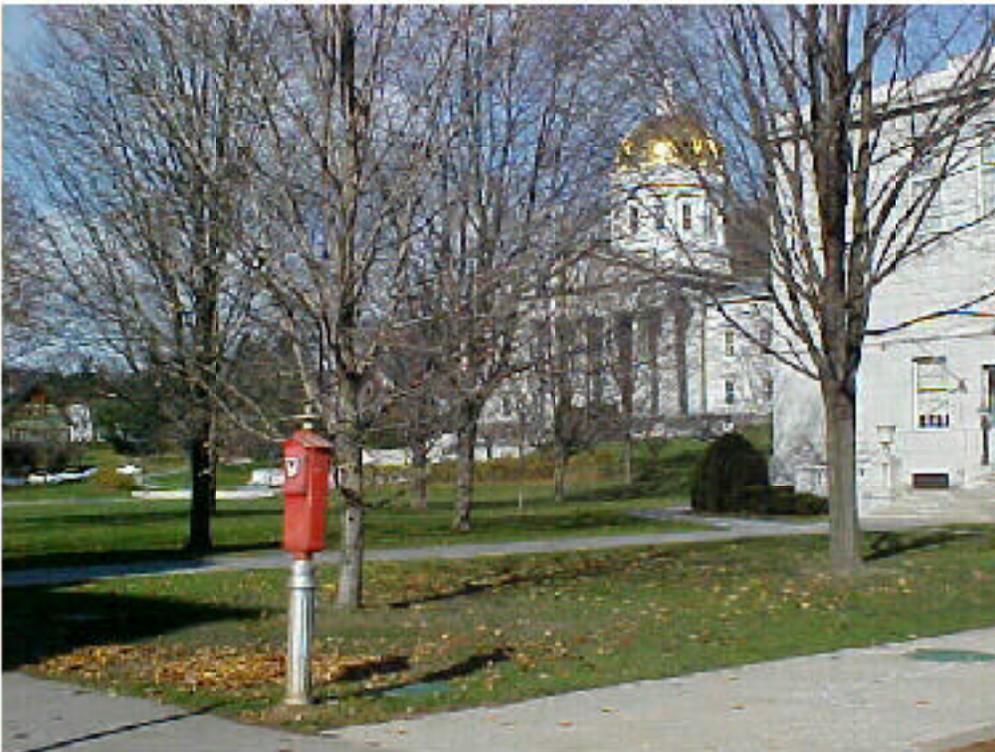
Montpelier Photograph Pair 2

Figure 10. The original and re-photo are virtually the same. There are minor differences such as the parking meter, and the building in the background has been torn down since.

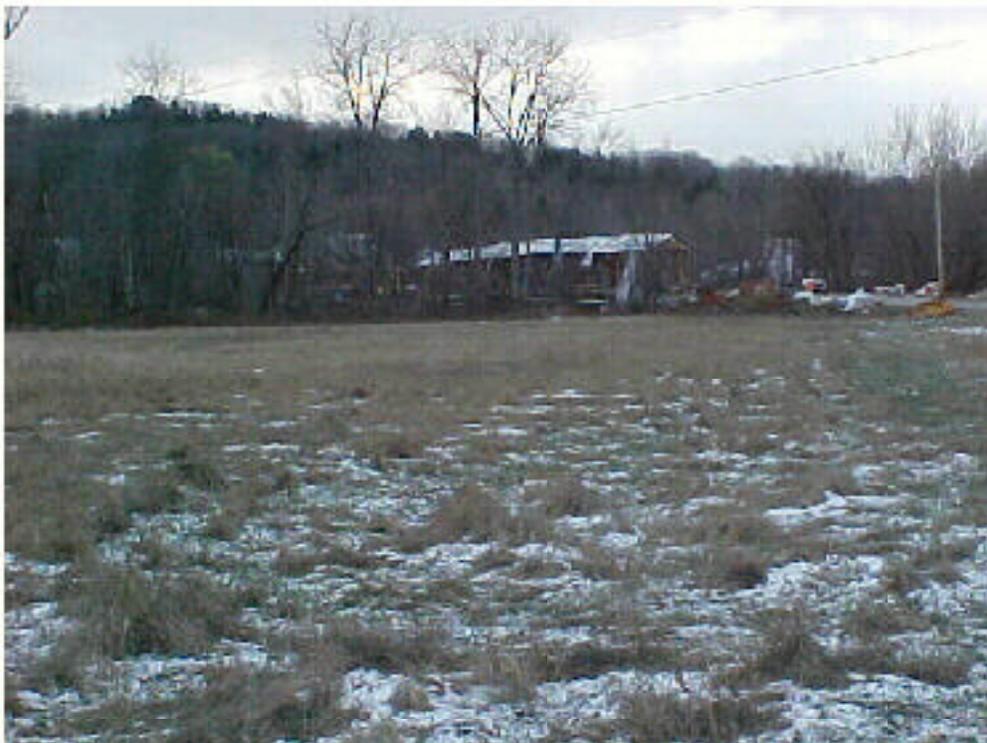
Cambridge Photograph Pair 1

'flood caused extensive destruction to the Saint Johnsbury and Lake Champlain trackage. This taken at Cambridge Junction shows how the Lamoille River washed out everything but the covered bridge.*

Figure 11. After the flood the railroad seen here was not repaired, it was later turned into a road. The bridge is now in the process of being rebuilt.

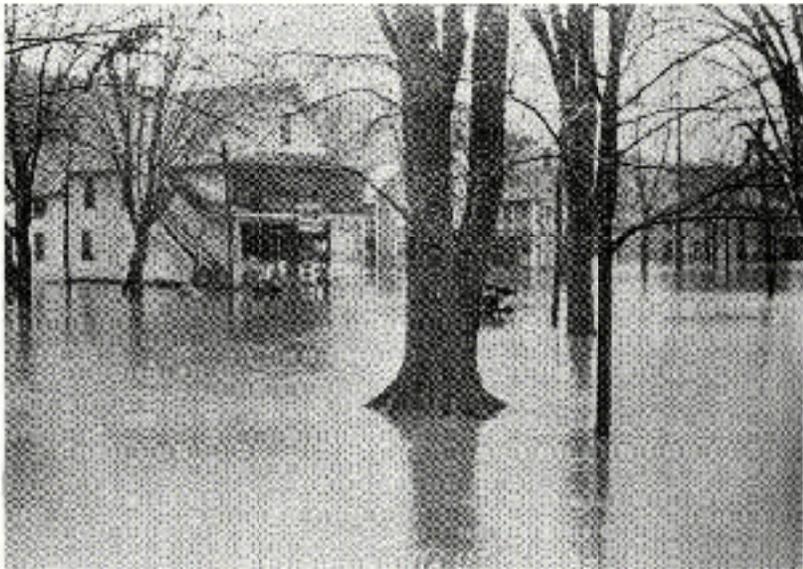
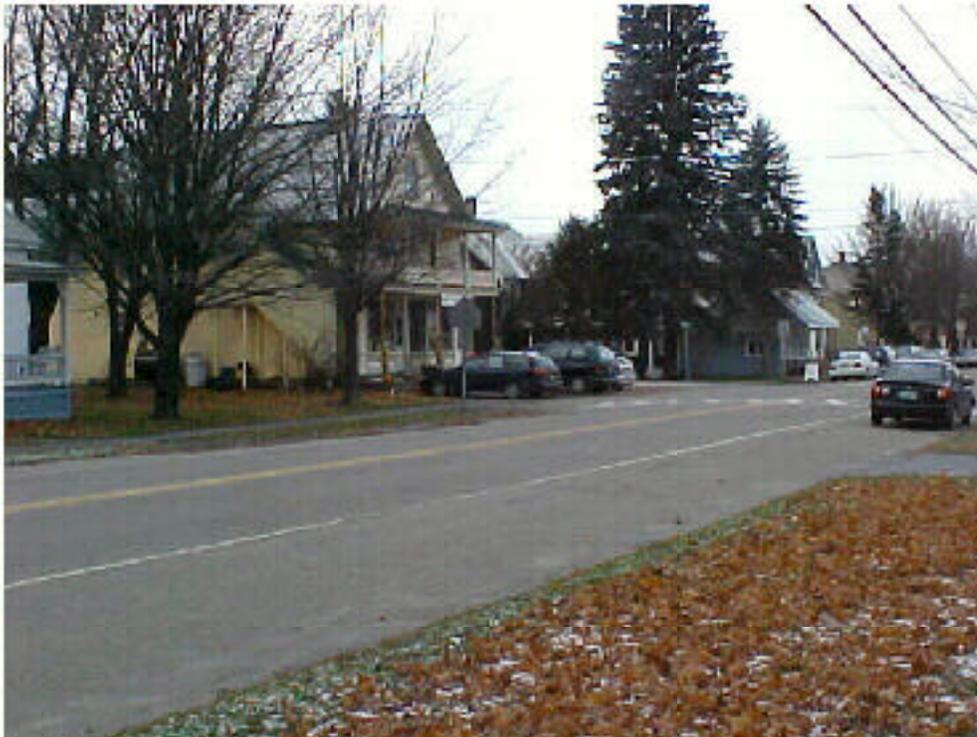
Cambridge Photograph Pair 2

Figure 12. Very little has changed since this photo was originally taken. The road has been paved, and a few of the trees have been cut down.
