# The Lee River Landslide

Meghan O'Donnell  
Jon Bevan  
Geomorphology  
December 5, 2003

## Abstract:

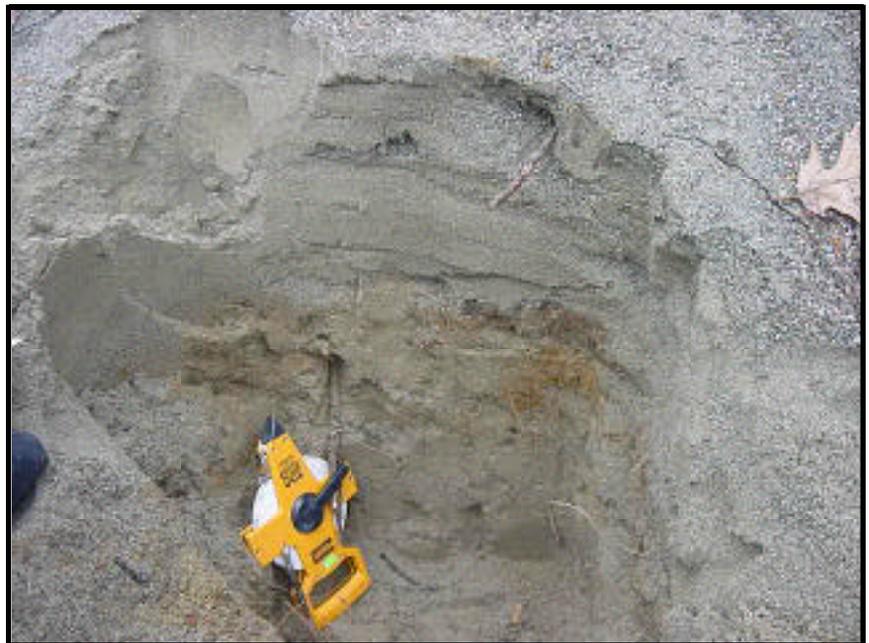
Figure 2b:

- Pit #2
- 30 meters from top of the landslide.
- Unsorted sediments primarily of medium sand grain size.
- Pockets of gravel.
- Organic debris.
- Cohesion value of 0.1 with the large disk.

The cross section of the second pit exposed stratigraphy that was different from the rest of the excavated pits. Pit 2 consisted of unsorted fine to medium grained sand, and within it approximately 2 inch size pockets of gravel intermittent with the surrounding sediment. There also was a sizable amount of organic debris found throughout the pit (Fig. 7).

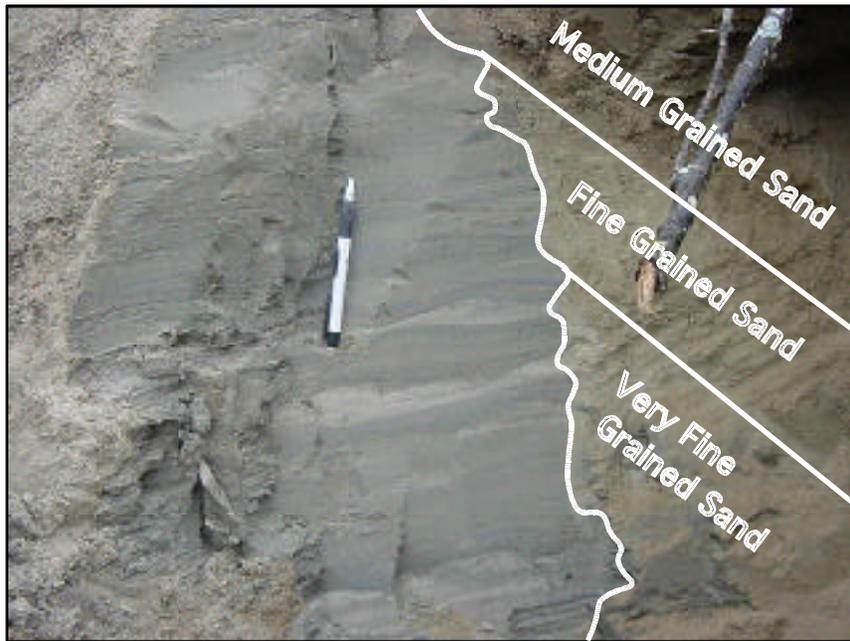
Figure 3a:

- Pit #3
- 26.6 meters from the top
- Varved layers of silt and clay.
- Northwest side of pit had characteristics of a past slide with three layers each of very fine, fine and medium grained sand.
- The medium grained sized and layer was very loosely compacted, it would fail when cut away at a high angle.
- Cohesion of 0.5 with the medium disk in the varved sediments.
- Cohesion of 0.1 with the large disk in the sand.

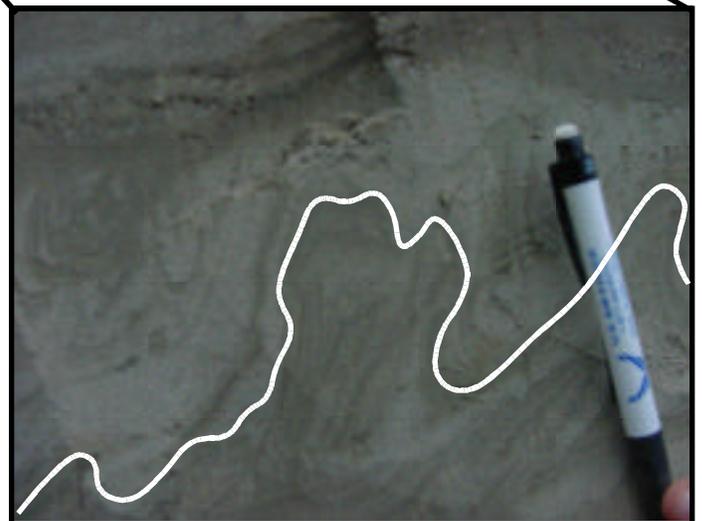
### Figure 4:

Ripple

Period of disruption

- 12.5 meters from the top of the landslide.
- Very strong overhangs the sediment located underneath it.
- Fine grained sand layers.
- First pit where ripples, cross bedding and periods of disruption were found.
- Cohesion 6.4 with the large disk.

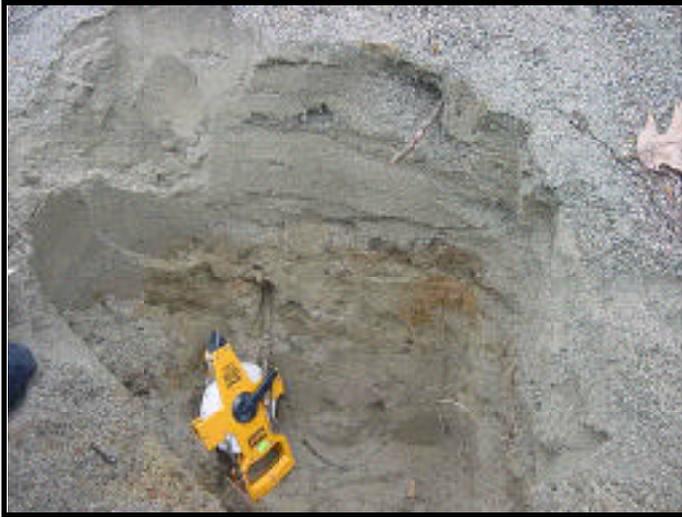
Figure 7a:  
The second soil pit. Possible sediment from recent landslide.

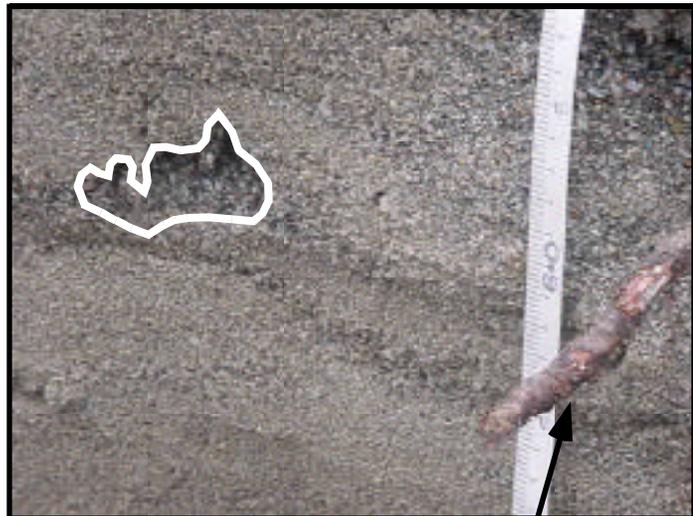
Figure 7b:  
Pockets of gravel  
can be found within  
the pit of unsorted  
material.

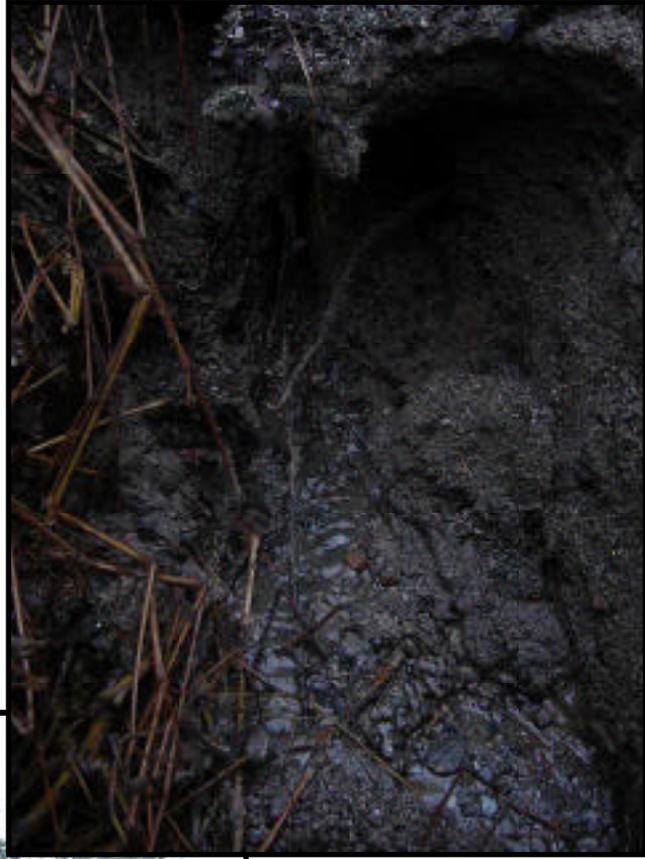
Figure 9a:

Water saturated silt and clay is present at the bottom of the landslide. Previous to investigation of the landslide there was a lot of rainfall, that could be the cause of this much saturated sediment.

Cohesion is a soil's ability to adhere to itself (Beirman, Class notes, 2003). Fine grained, and compacted sediment exhibit more cohesive properties than large grained, loose sediment, presumably because absorption of ions and water by clay minerals creates a binding structure among the particles (Kochel, et al., 1978). Our observations also show more cohesion in the dense, varved silts and less cohesion in larger grained and loose sediments. The cause for small slides on the Lee Landslide to originate is the failure of the loosely packed sandy material located higher up on the slope face. If the lower layers of silty varves were to fail, a large slide could occur. For the silt and clay to fail it must become saturated to the point it starts to have plastic characteristics. The silt and clay will lubricate the surrounding sediments because the absorption of water into the layers will continue until the grains can no longer maintain fixed in a rigid, oriented position (Kochel et al., 1978). The presence of saturated clay and silt is present today at the base of the Lee Landslide (Fig. 9a).

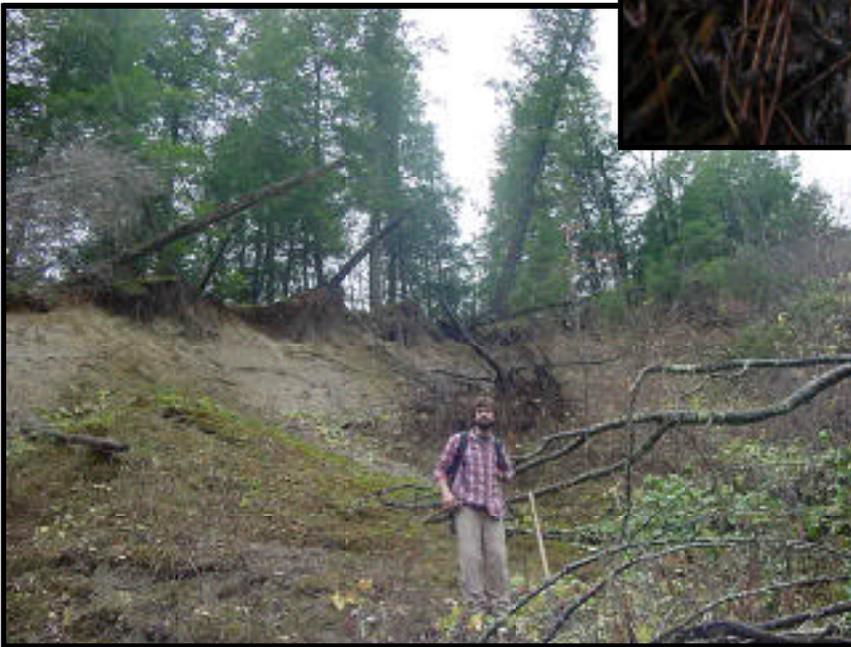
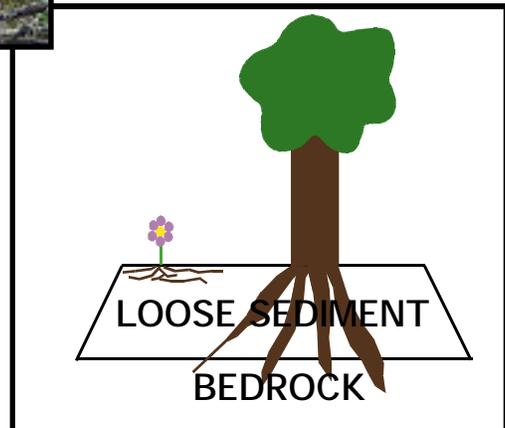
Figure 9b:

The vegetation located on the landslide did not have roots that were long enough to reach the bedrock and stabilize the slope.

If the roots of the vegetation that surrounds the possible slide zone do not reach the bedrock or fail to anchor the sediment vertically then the soil is only reinforced laterally (Gabet and Dunne, 1985-1986). There are areas of regrowth on the Lee Landslide, but sporadically in short supply and their lateral roots do not reach bedrock (Fig. 9b). These small plants do however increase the cohesion of upper sediment layers and prevent minor sliding. Larger plant species are needed to reach the bedrock underneath the sediment and completely reinforce the slope from larger slides.
