Vermont State Climate Office  
Climate Impacts Summary  
**April 2011**

*...April snowmelt and record rainfall resulted in flooding across portions of Vermont...*

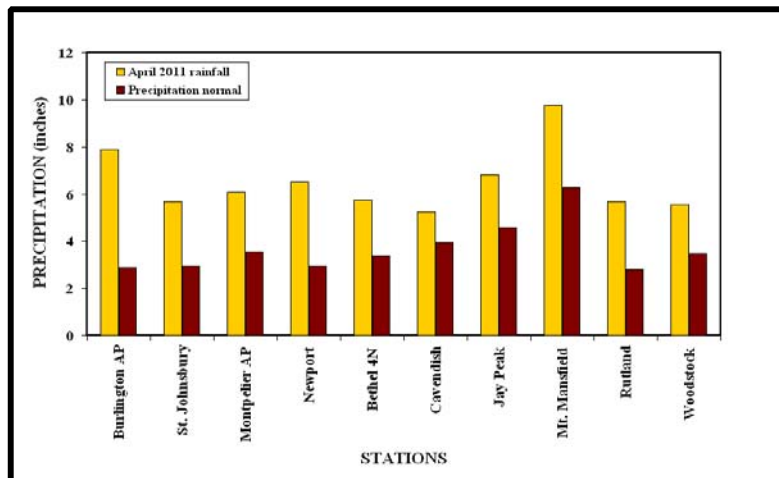
**Figure 1: April 2011 precipitation totals at selected Vermont stations relative to their most recent averaging period (1971-2000 in most cases)**

During the month of April, 2011, *the major societal impacts from our weather patterns were associated with flooding*; both river and stream flooding as well as Lake Champlain shore line flooding. By month's end, unofficial early estimates of town and state road and private or public property infrastructure damage were in the millions. This flooding was triggered by rainfall across northern Vermont which was generally 3-5 inches above the average monthly total (Figure 1).

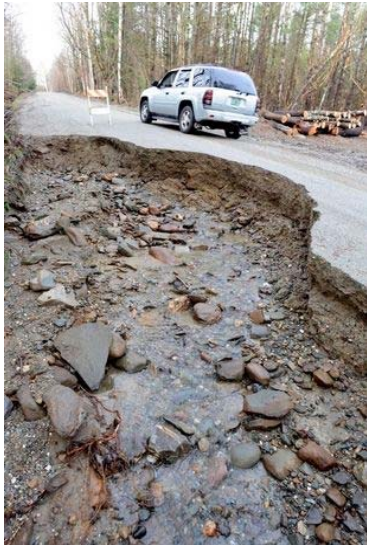
**Figure 6 Road washouts due to flash flooding between Jericho and Underhill, VT [Photo credit: The Burlington Free Press]**

Along with river flooding, flash flooding occurred on small streams in northwest and north central Vermont during the overnight hours of April 26-27 with some road washouts (Figure 6). A beaver dam added to flood waters in the area of Jericho and Underhill, with local mudslides near the northern town of Highgate. This was followed by main stem river flooding of larger rivers in the northern half of Vermont. The major impacts were field, road and basement or first floor flooding. See Table 2 for road impacts.

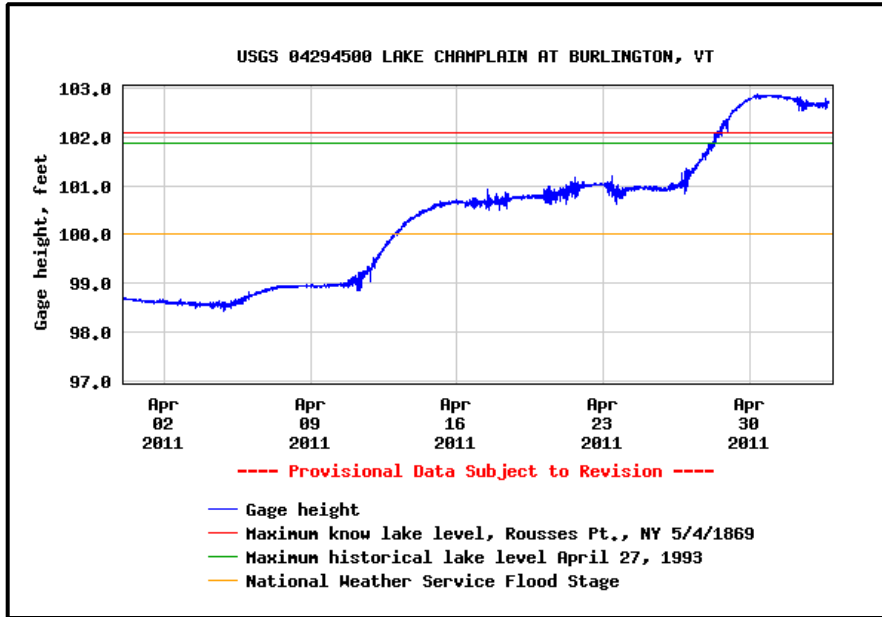
**Figure 7: USGS hydrograph showing the stage at Burlington, VT gauging station on Lake Champlain for April 2011.**

The month of April 2011 began with the lake level at the King Street Ferry dock in Burlington at 98.64 feet, well below the flood stage of 100 feet. By month's end, the lake level at this location was at a record setting 102.87 feet. The USGS gauging station at the ECHO Lake Aquarium and Science Center offers continuous monitoring of lake levels, and as the April hydrograph shows (Figure 7), there were two periods of rapid lake level rise. The first (10-15 April) was associated with runoff from snow melt due to mild weather and a rainy period. The second period between the 27<sup>th</sup> and 30<sup>th</sup> was associated with runoff from heavy convective rain.

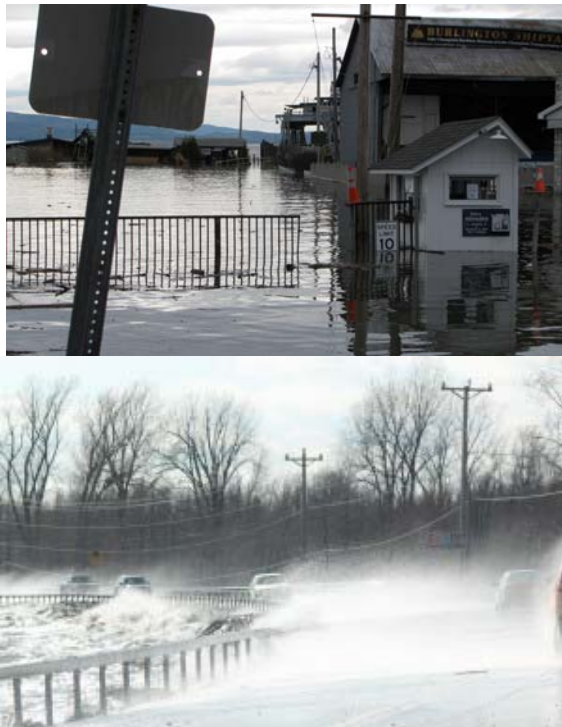
**Figure 8: King Street Ferry Dock entrance in Burlington, VT on Friday 29 April, 2011. The speed limit sign is for vehicular traffic, not boat traffic. [Photo credit: S. Hogan]**

*Major impacts were flooding of shore roads, State parks and basements of residential homes and cottages along the lake shore. Route 2 through the Champlain Islands was kept open, but limited to one lane, as barriers were installed to hold water back. Debris floating down the rivers into the lake is also a potential hazard for spring boaters.* By late April, the parking area for the ferry at the King Street Ferry dock was totally under water (Figure 8).

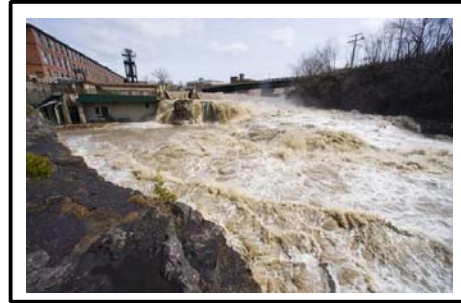
Figure 11: A marked sediment plume at the mouth of the Winooski River as it enters Lake Champlain on 27 April, 2011 [Photo credit: The Burlington Free Press].

As April drew to a close, sediment-laden rivers continued to enter Lake Champlain, producing sediment plumes, debris accumulation along the shoreline (Figures 10-12) and contributing to a new record lake level.

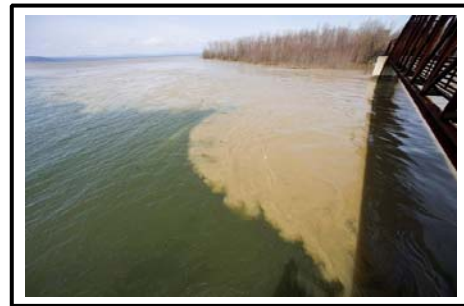
Figure 12: Debris floated or submerged on Lake Champlain. Some of it also washed up along the lakeshore. [Photo credit: Burlington Free Press, Wednesday 27 April, 2011]
