Vermont State Climate Office Initial Climate Impacts Summary August 2011

From a flash drought to the flooding rains of Tropical Storm Irene

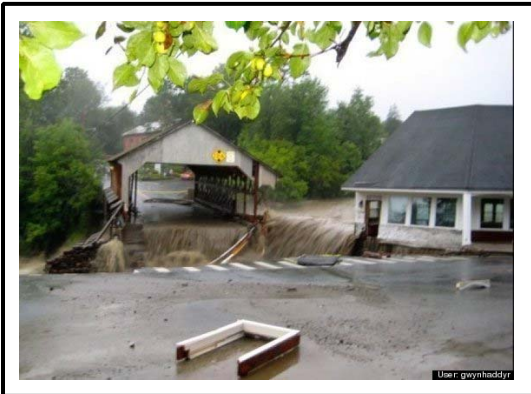
Figure 6: Covered bridge in Quechee on 28 August 2011 [Photo credit: Associated Press]

One of the most striking aspects of the Irene-related damage was the spatial extent and magnitude of the damage to the transportation sector especially in central and southern Vermont. Three historic covered bridges have been washed away or extensively damaged, including a) a 141 year old bridge in Rockingham washed out by the Williams River; b) the Quechee covered bridge that was left in "tatters" (Figure 6) and c) the Northfield Falls Cox Brook covered bridge that was severely damaged.

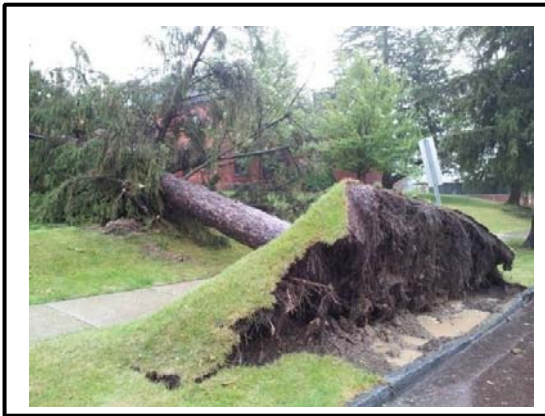
Figure 7: Downed tree in Burlington, VT on 28 August 2011. [Photo credit: Brlington Free Press]

The widespread heavy rainfall and river flooding were accompanied by wind gusts between 30 and 60 mph. The highest wind gust of 85 mph was reported on the summit of Mt Mansfield. These combination of these winds with the loose saturated soil resulted in power lines being blown down and uprooted trees which also took down power lines (Figure 7). At one point in time up to 60,000 customers were without power in Vermont. By the afternoon of 29 August, about 35,000 customers were without power. Generators were required to provide power to hospitals and those requiring assistance. In addition, up to 3000 customers had limited or no phone service.
