Vermont State Climate Office  
Climate Impacts Summary  
**June 2011**

*...June weather returned to more average conditions...*

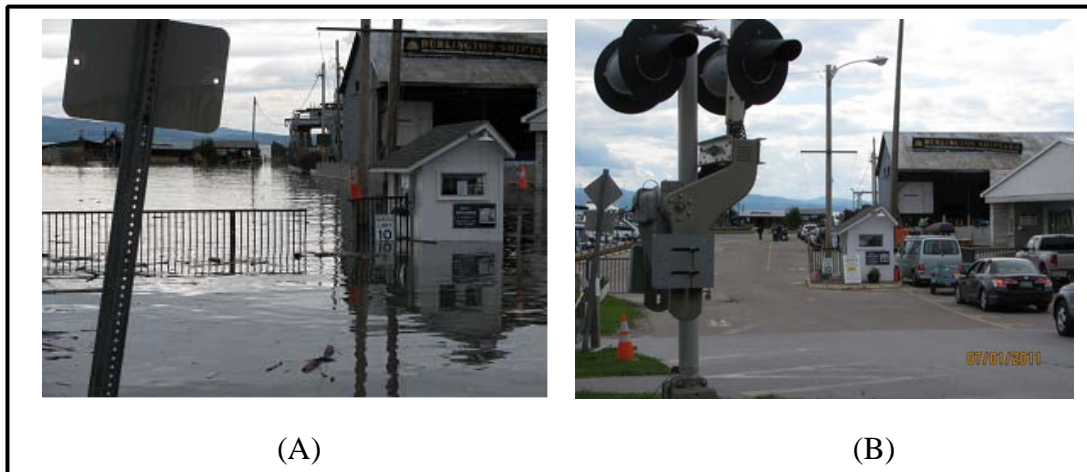
**Figure 3: King Street Ferry Dock entrance in Burlington, VT on Friday 29 April, 2011 (A) and 30 June, 2011. The ticket booth and 10mph speed limit sign are the reference markers in both figures. [Photo credit: S. Hogan]**

The average to below average precipitation received in much of western Vermont was clearly reflected in the drop in Lake Champlain levels during June. By mid-month, the USGS gauging station (Figure 2) indicated that the lake had dropped below the 100 foot flood stage. Water had receded from shoreline roads by June 11. The King Street Ferry was able to commence operations between Burlington, Vermont and Port Kent, New York (Figure 3b).

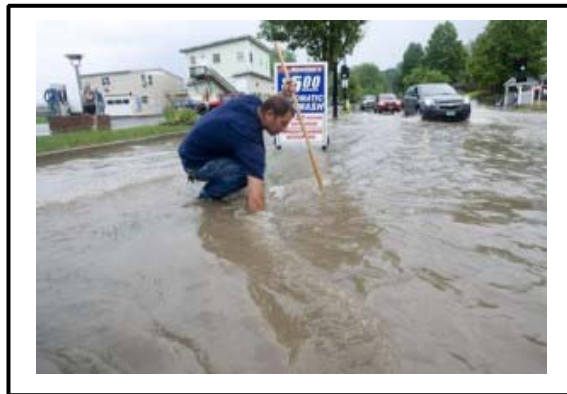
**Figure 4: Urban flooding from a thunderstorm on Riverside Ave in Burlington Vt during June 9<sup>th</sup>. [Photo credit: The Burlington FreePress]**

**During the evening of June 8<sup>th</sup>**, wind damage from a swath of thunderstorms blew down trees and power lines from west-central towns of Rutland and Pittsford (Rutland county) to Rochester and Woodstock (Windsor county). Associated winds were 70 mph at Rutland State Airport at 742 PM EDT on June 8<sup>th</sup>. More thunderstorms occurred on June 9<sup>th</sup>. During the early morning, they resulted in small hail and heavy rain in central and northern Vermont. Flash flooding was reported in the town of Shoreham (Addison county) with road and culvert washouts. There was one report of large hail (1" diameter) in the town of Killington in Rutland county. On the afternoon of that same day, thunderstorms developed and were more organized in clusters between 1:30-4:00pm, and again in the evening from 6:30-8:30pm. Most of the impacts were due to damaging thunderstorm winds (blowing down trees and power lines), hail generally smaller than 1" diameter and heavy rain resulting in the loss of electricity for up to 23,000 customers in Addison, Chittenden, Rutland (along with 1 inch diameter hail), Bennington, Orange and Windham counties. Some localized ponding of water on roads typical in the wake of thunderstorms was also observed (Figure 3).. Photograph 2 highlights this urban impact of localized road flooding from convective precipitation during the afternoon of June 9<sup>th</sup>.
