# FLOOD IMPACTS AND RESILIENCE FIELD TRIP: SUPPORTING DOCUMENTATION

LEWIS CREEK AT COTA FIELD, STARKSBORO, VERMONT  
CIROH DEVELOPERS CONFERENCE MAY 27, 2025

# Well-Connected Floodplains Enhance Resilience to Extreme Events: A Case Study in Flood Attenuation From The Lewis Creek Watershed, Central Vermont

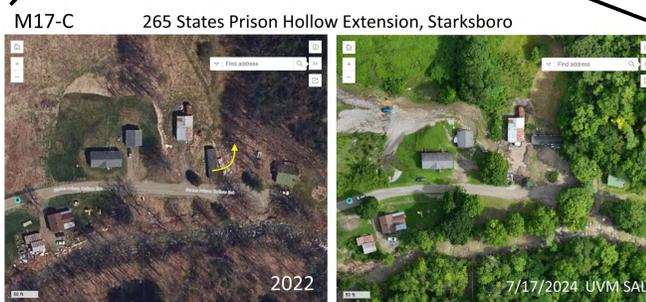
**Figure 5.** Example of damages caused by deposition and avulsions seen during the July 2024 floods at a site in the upper watershed, where the flood peak was classified as a 500-year event.

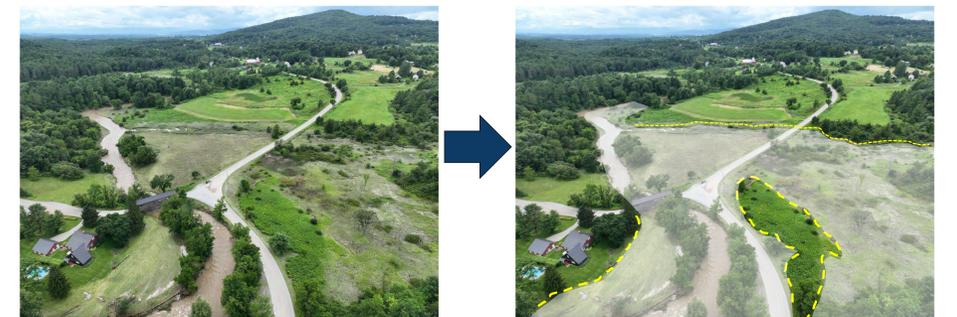
**Figure 7.** Flood inundation extents estimated from imagery provides an example of flood water storage on floodplains around the Quinlan Covered bridge on the Lewis Creek on 7/11/2024.

Lewis Creek has rehabilitated and preserved floodplains between the upstream and downstream locations that stored flood water, reduced the flow, and protected infrastructure including the Quinlan Covered bridge (Figure 7) and homes in North Ferrisburg village in the downstream watershed.
