----- FINAL REPORT -----
**A PROJECT TO EVALUATE THE EFFICACY OF A WOODCHIP BIOREACTOR
FOR DENITRIFICATION OF TERTIARY EFFLUENT FROM THE BOLTON WASTEWATER
TREATMENT PLANT (LAKE GEORGE, WARREN COUNTY, NEW YORK)**

December 2021

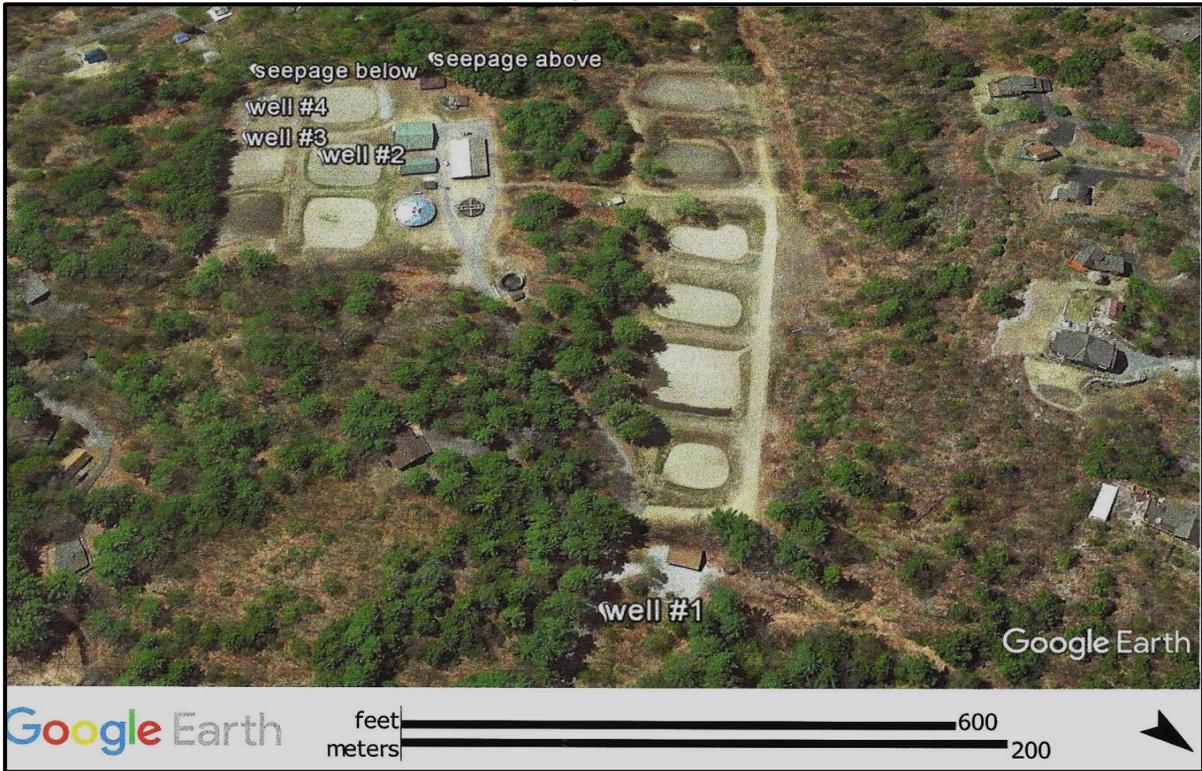
Figure 2-5.

Background. The RFWI study was conducted prior to the installation of the SPDES permit monitoring wells at the treatment plant and the scientists installed a series of driven well points and screens so that the ground water adjacent to the sand beds could be sampled (Figure 2-5).

Also shown in Figure 2-5 are the locations of 'seepages' (Aulenbach and Fillip's description) adjacent to the Bolton WWTP that were sampled. The seepages were further described in the 1983 report as an 'open ditch' constructed by treatment plant personnel to "divert run-off in this area from heading toward homes along Mohican Road".

The seepages above and below the plant (Figure 2-5) were sampled when flow was observed. And, finally, a Rhodamine-WT dye study conducted on the upper sand beds, which is described and discussed later in this chapter.

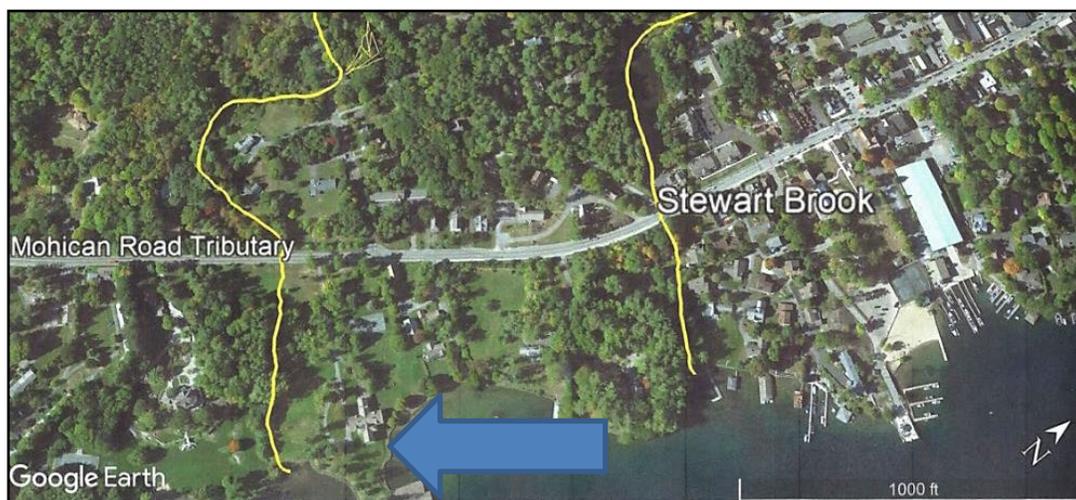
Figure 2-8.

We now ‘fast forward’ to water quality issues that occurred over an extended period in Bolton Bay during the early-to-mid 2010s, particularly in the littoral zone and shoreline adjacent to the Bixby Estate which is shown in Figure 2-8 (←). The beach along this section of shoreline was unusable for recreational purposes due to nuisance algal growth attached to submerged aquatic plants or floating above the sand (Keppler et al. 2008).

As shown in the figure above, Stewart Brook enters Bolton Bay just north of the Bixby property and Mohican Road Tributary forms the south boundary of the property as it flows into Bolton Bay.

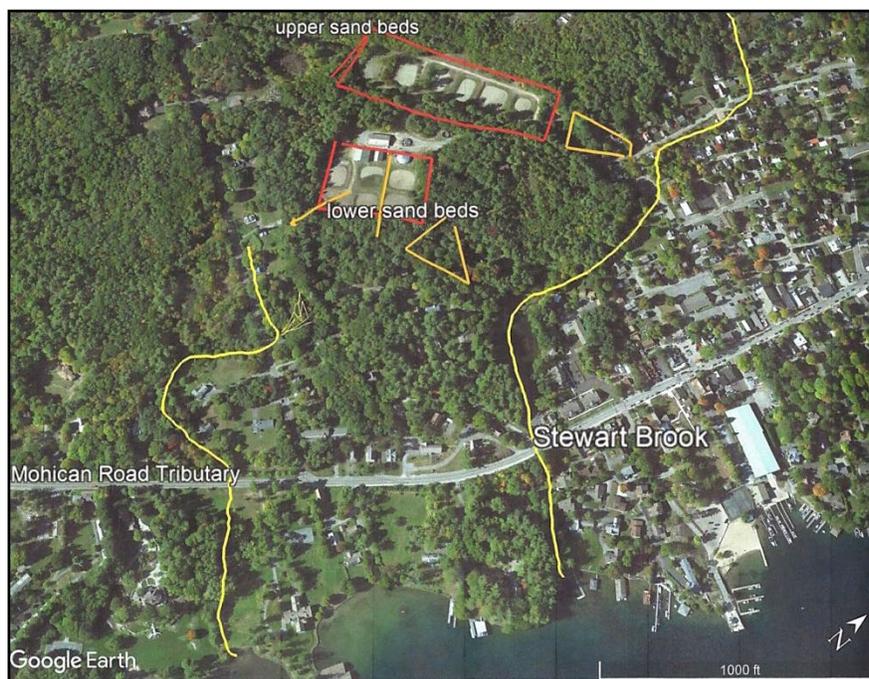
Figure 2-9.

As it turns out, the specific sand beds used for effluent disposal at the Bolton WWTP determine which watershed is affected by ground water moving down-gradient and away from the facility. As shown in Figure 2-9 below, and as determined by Aulenbach and Filip (1983), effluent discharged to the upper sand disposal beds moves with the ground water toward Stewart Brook.

As for the lower sand disposal beds, effluent discharged to beds #1 and #3 moves with the ground water toward Stewart Pond (Figure 2-9; direction of large yellow arrow), while effluent discharged into beds #2, #4, and #5 moves toward the Mohican Road Tributary (Sutherland and Navitsky 2017). And while Aulenbach and Filip (1983) had explained this same ground water movement due to a rock ledge that separated the lower sand beds, the Sutherland and Navitsky study provided conclusive evidence that the lower sand beds are connected hydraulically to the Mohican Road Tributary and Stewart Brook watersheds with a dye study. Rhodamine-WT dye applied to lower sand beds #2 or #4 appeared at the lower Mohican Road seepage area within 2 days from addition of the dye. A similar experiment in lower beds #1 and #3 was detected in the channel of a culvert that drains to Stewart Pond within 6 hours of dye addition.

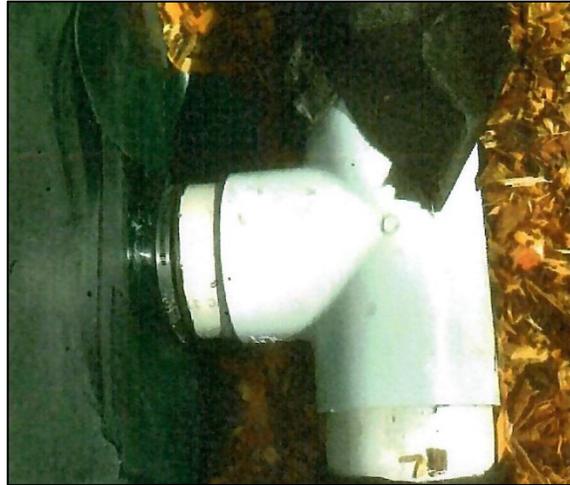
Figure 4-9. Effluent discharge header through end wall

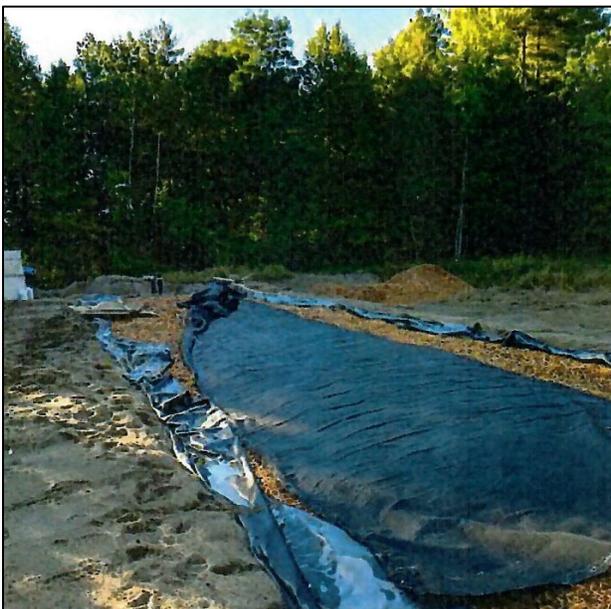
Figure 4-10. Filter fabric covers woodchips to protect from soil

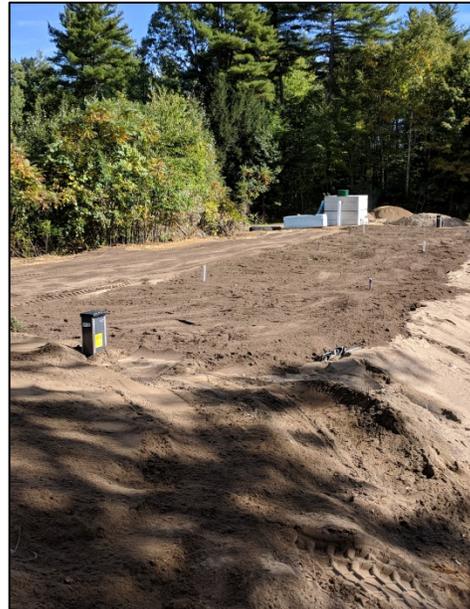
Figure 4-11. Bioreactor near completion

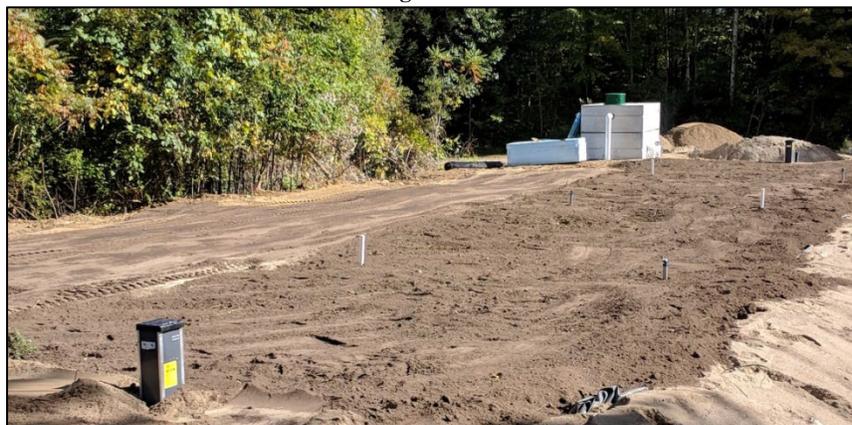
The *effluent* control structure is in the foreground of the photograph, with the *influent* control structure at the opposite end. The six (6) PVC *bioreactor monitoring wells* are shown installed at the 25-, 50- and 75-

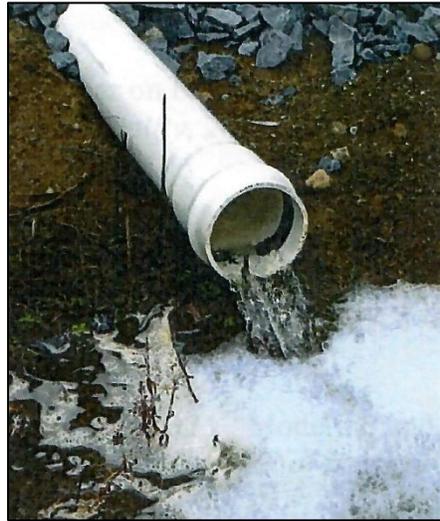
Figure 5-3.

The *bed effluent* outlet is shown discharging to one of the upper sand infiltration beds in Figure 5-3; the bed effluent is a composite of both untreated effluent from the treatment facility and treated effluent discharged by the bioreactor.

The *bed effluent* sampling site was added after the Project had been in progress for about three (3) months. The beds utilized for effluent disposal are varied on about a daily basis.

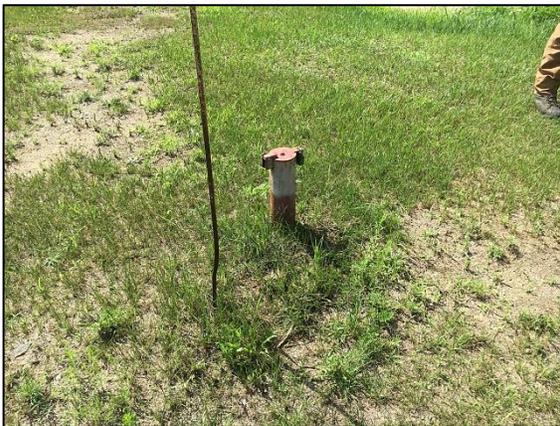
Figure 5-4.

Two (2) *ground water monitoring wells* included in the study were located down-gradient of the upper-level sand disposal infiltration beds and it made sense to include these sampling sites to evaluate the effect of the bioreactor on nitrate-nitrogen concentrations in ground water flowing toward Stewart Brook. The approximate location of both wells is shown in Figure 5-2; Figures 5-4 and 5-5 are photographs of the individual well heads for *monitoring well #3* and *monitoring well #2*, respectively.

These monitoring wells are part of the New York State Department of Environmental Conservation SPDES (State Pollution Discharge Elimination System) permit requirement for operation of the Bolton facility and are sampled monthly in fulfillment of permit conditions.

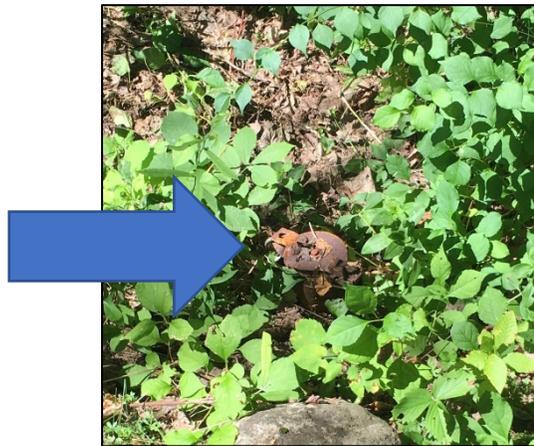
Figure 5-6.

A third monitoring well (#4) is located up-gradient of any ground water movement away from the upper-level sand beds (see Figure 5-2) and was selected as a site that would provide water quality characteristics

of ground water not impacted by the Bolton WWTP. Figure 5-6 is a photograph of the head for monitoring well #4.

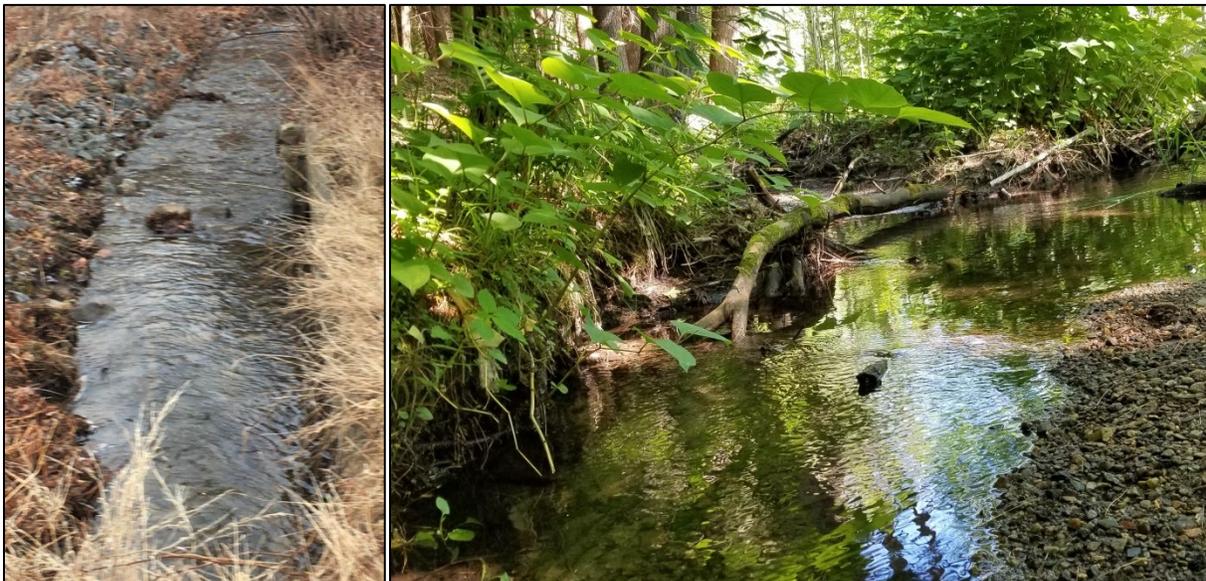
The *Brook Street* sampling site is located above the region where seepage enters the channel, and a photograph of the sampling site is shown in Figure 5-7.

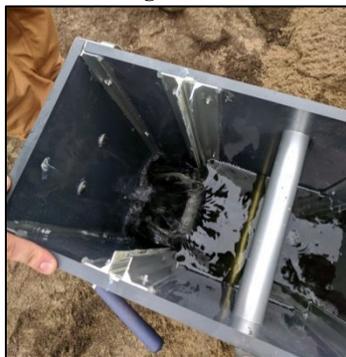
Bioreactor influent. A view looking down into this structure is presented in Figure 5-9. The channels located on either side of the structure hold panels, or stop logs, which control the amount of flow moving into the bioreactor.

A well bailer was lowered into this structure to collect enough water for the chemistry samples and the field measurements.

Bioreactor effluent. The device is similar to the influent structure presented in Figure 5-9 and also is sampled with a well bailing device.

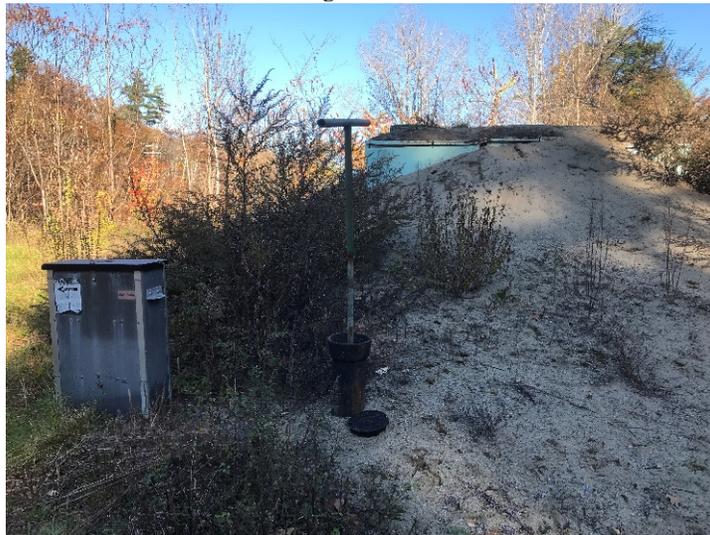
Figure 6-19.

runs parallel to the bioreactor and connects to the bioreactor discharge in a newly installed manhole specifically to allow sampling of the bioreactor *effluent*.

Flows are measured by a Greyline flow meter, an in-pipe flow meter, installed in the 6-inch PVC discharge line from the bioreactor. This combined *effluent*, consisting of a blend of both denitrified *effluent* and non-denitrified *effluent*, flows by gravity into one of four (4) active “upper sand infiltration beds”. This combined final *effluent* is the “*bed effluent*”. The use of the infiltration sand beds is an operator decision, based on how much flow is being treated (i.e., bed #8 is the largest bed and can handle a large flow volume for many days). Otherwise, beds are rotated anywhere from 3 to 4 days, depending on the season and ground water levels (i.e., bed #11 is seasonally impacted by high ground water).

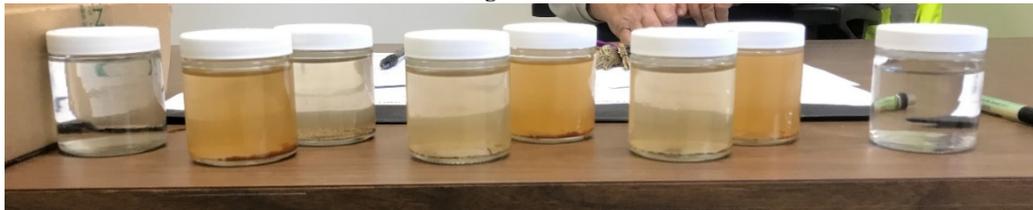
During the latter months of 2019, all bioreactor monitoring wells were exhibiting discolored water samples. Oxidation of the bioreactor monitoring wells was suspected because the influent and effluent samples were not affected by discoloration. Please refer to Figure 6-23.

In late December 2019, these monitoring well samples were analyzed for iron; levels as high as 339 mg/l were reported. The presence of iron in these samples prevented accurate characterization of the water relative to $\text{NO}_3\text{-N}$, alkalinity and DO . This situation resulted in short-term data disruption. The stainless-steel monitoring wells points were replaced by operations staff with custom 2-inch PVC wells in the same locations as the previous well points. The deeper wells were replaced but the shallower wells were never replaced and remained out of the sampling program due to the lower water levels.

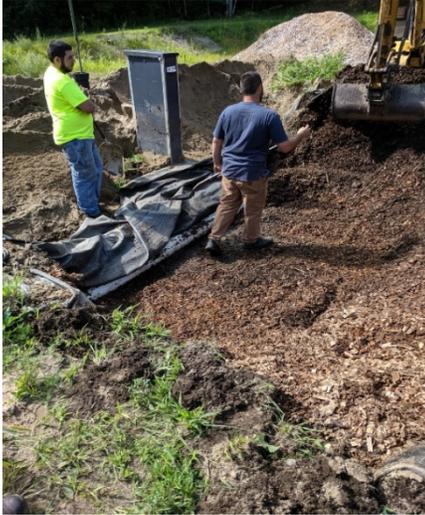
Figure 6-24.

The woodchip bioreactor pilot project began accepting *effluent* from the Bolton WWTP in October 2018. There was success from the beginning of the monitoring study (March 2019) with a 64 percent reduction in $\text{NO}_3\text{-N}$ in the first quarter of the study. However, during the second quarter, the bioreactor was taken offline on August 16, 2019, due to breaching along the bioreactor's influent face. On August 23, 2019, the cause of this breaching was found to be waterlogged and plugged wood chips within the first five (5) feet of the 100-foot-long bioreactor bed (see Figures 6-24 and 25).

- In late August 2019, the Bolton WWTP woodchip bioreactor was taken offline due to surface accumulation of influent along the leading edge of the bioreactor. Plugging of the front end of the woodchip matrix was suspected. On August 23, 2019, Town personnel and a private contractor carefully excavated the front end of the bioreactor. The first six (6) feet of woodchips were removed, and replacement woodchips were installed. The removed woodchips appeared to have heavy organic accumulations and the integrity of the woodchips had broken down. At this same time the filter fabric around the influent pipe was removed. With the addition of new wood chips, the bioreactor heavy waterproof liner was reinstalled, and the bioreactor resumed its original condition. Figures 6-24 and 6-25 detail the operation and the condition of the bioreactor. It was interesting to note that the degradation of the woodchips was only noted in the first six (6) feet or so of the woodchip matrix.

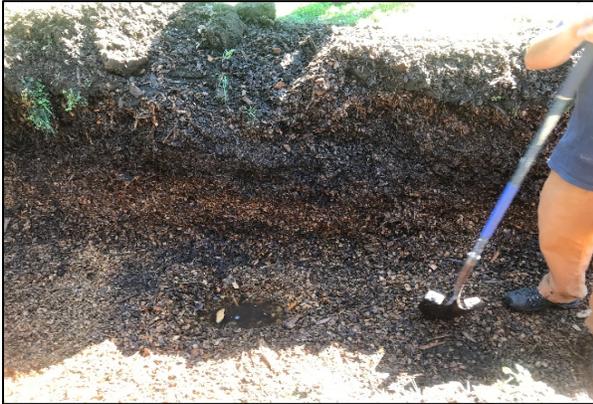
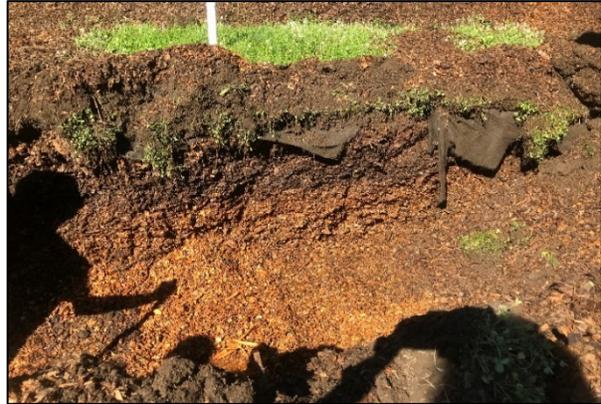
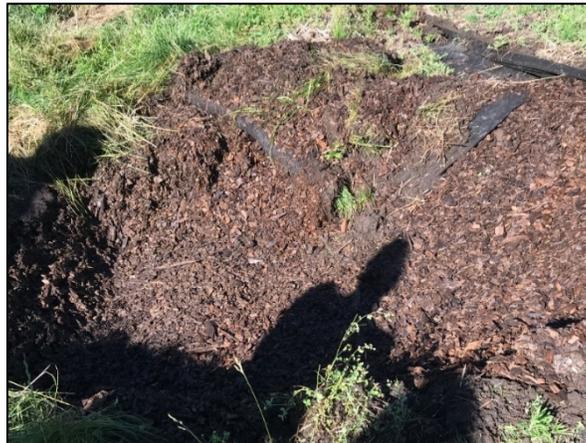
- At the start of the excavation (Sta 0+05), the first 2 feet of woodchip depth consisted of a very dense material with a low percentage of large wood chips and a high percentage of fine material. The material was a dark brown/black color, possibly indicating degradation. The bottom 6 inches were clean woodchips with a brighter tan/orange color; there was a higher percentage of whole wood chips and there was 4 inches of standing water in the bottom of the trench. Please refer to Figures 6-26 through 6-29; photographs taken on June 23rd, 2021).

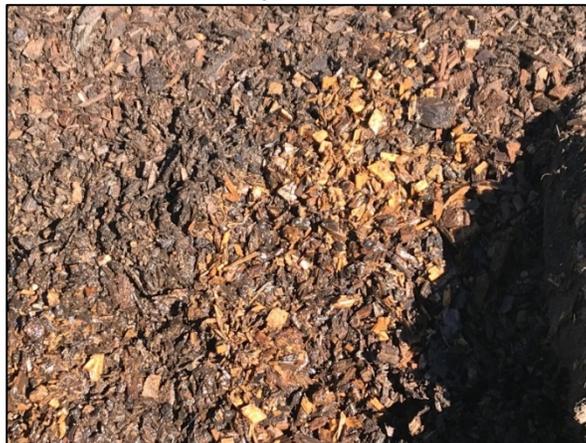
- There was a change in the woodchips at Sta 0+15. There was more color in the woodchips, and less fines and dirt. The woodchips appeared to be smaller in size than original but were more intact. There was about 12 inches of clean woodchips at the bottom of the trench.
- At Sta 0+50, the depth of the good woodchips started 12 to 15 inches from the surface, which was the greatest depth of good condition woodchips in the bioreactor. Please see Figure 6-30.

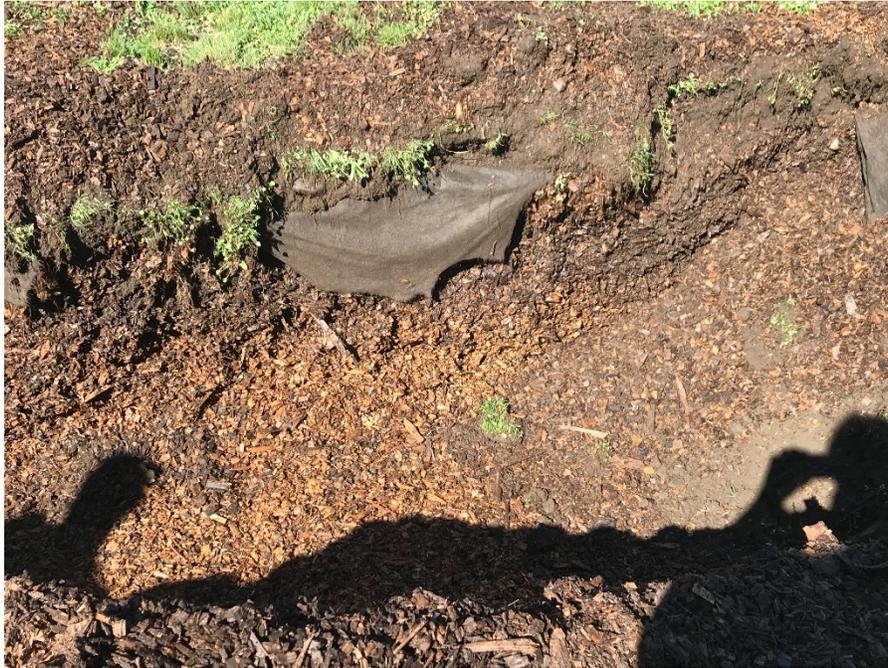
- There was a clear gradient of the boundary between the apparently degraded woodchips in the upper layer and the cleaner, intact woodchips in the lower layer of the trench; this started at a depth of 42 inches at Sta 0+05 and rose to a depth of 12 inches at Sta 0+50, then decreased to a depth to 36 inches at Sta 0+85.

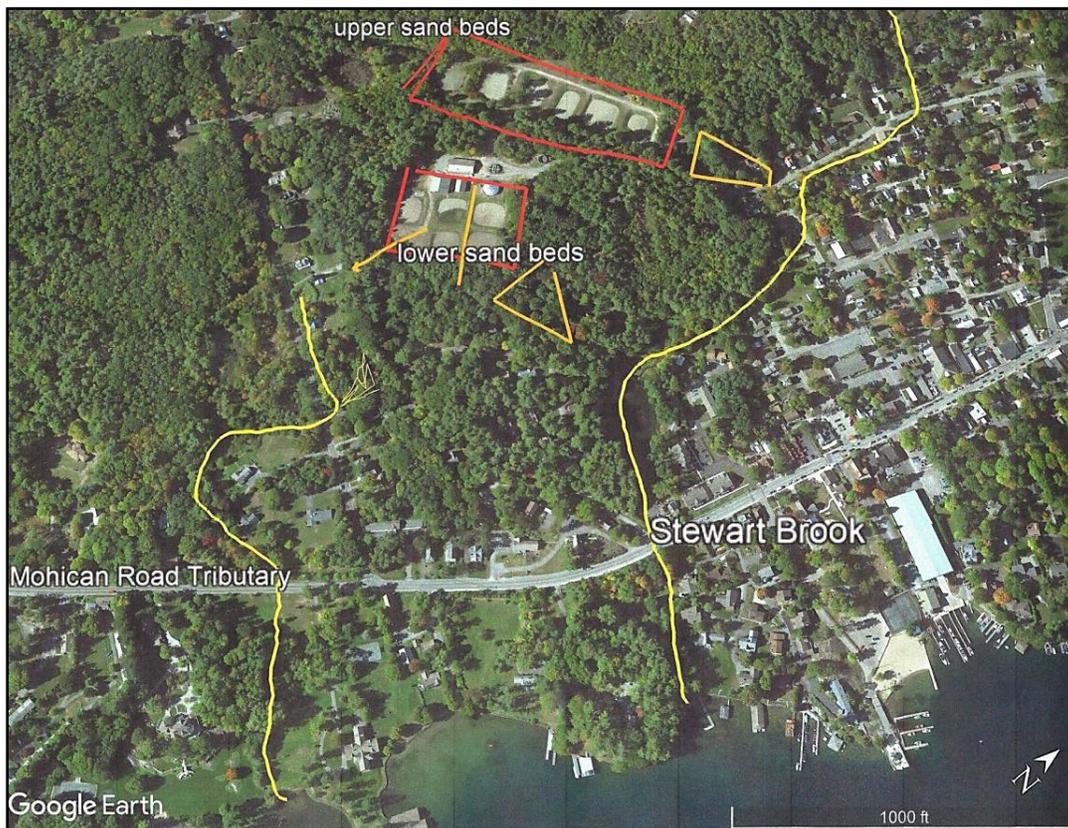
RFWI scientists conducted an early 1980s study and reported that ground water leaving the region of the WWTP flows in different directions depending upon which sand infiltration beds were used for effluent disposal. Treatment plant effluent discharged to the upper beds (utilized only during the ice-free seasons) moved down-gradient in a north-northeast direction and entered Stewart Brook near the intersection of Brook Street and Goodman Avenue. Aulenbach and Fillip (1983) established the connectivity of the upper infiltration beds to Stewart Brook by conducting a Rhodamine-WT dye study. The connectivity of the upper infiltration beds with Stewart Brook is hand-drawn in the upper portion of Figure 8-1 below.

The subsurface drainage characteristics of the lower infiltration beds were described by Aulenbach and Fillip as being more complex, also shown in Figure 8-1. They described these beds as bisected in an east-west direction by a subsurface ridge of bedrock (yellow line at lower sand beds) that resulted in treatment plant effluent applied to the north lower sand beds traveling toward Stewart Pond, while effluent applied to the south lower sand beds traveled toward Mohican Road. The data presented in their 1983 report

substantiates the movement of ground water toward Mohican Road but failed to provide solid evidence of ground water movement toward Stewart Pond when treatment plant effluent was applied to the two (2) northern lower sand beds. Sutherland and Navitsky (2017) confirmed this movement of ground water down-gradient from the lower infiltration beds to Stewart Pond using separate Rhodamine dye studies.

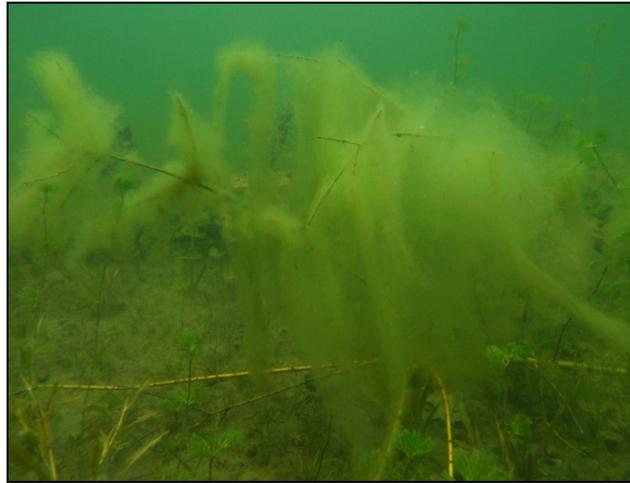
Figure 9-1.

The benefits to ecosystem services by the reduction of nitrate-nitrogen loadings would be a reduction in algae growth and a reduction in the productivity of the Bolton Bay and Lake George. As can be seen from the Figure 9-1, the algae growth in Bolton Bay is excessive and can alter the natural ecosystem.

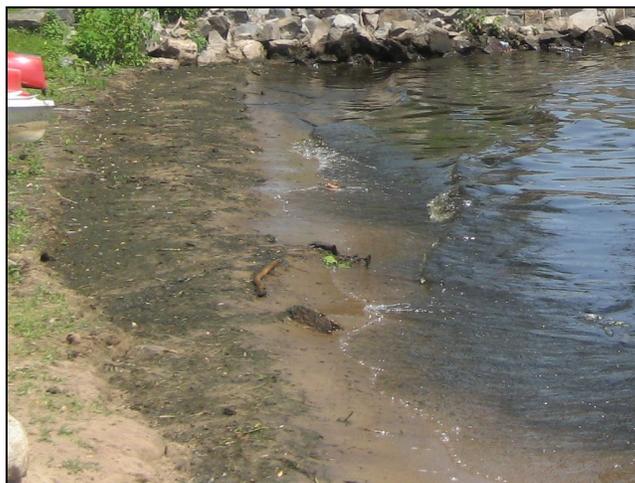
Figure 9-2.

Although there may be no market value for the native submerged aquatic vegetation, it has ecosystem services because it provides habitat for valuable fish populations, among other things. Other ecosystem services include the recreational enjoyment of Lake George, which has a water quality classification by the New York State Department of Environmental Conservation of Class AA-Special meaning that its primary use is for contact recreation. But as seen in Figure 9-2, this primary use is being impacted in Bolton Bay by excessive algae that can wash up on beaches impacting swimming enjoyment.

<u>Page</u>
Figure 9-1	An underwater photograph of littoral zone algae growing on and adjacent to attached macrophytes in Bolton Bay, Lake George	137
Figure 9-2	A photograph of excessive algae that have washed up along the shoreline of Bolton Bay, Lake George	137
Figure 10-1	A conceptual diagram of the linkage between the Bolton WWTP effluent and eventual water quality impacts on Stewart Brook when the installed “green technology” woodchip bioreactor is processing some portion of the total daily effluent volume released from the facility	146
