Green Infrastructure Operation &
Maintenance Summit

DEC's Best Management Practice Verification Program

Helen Carr, Jordyn Geller, Rachel Wood

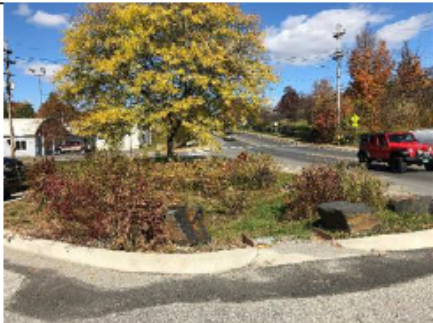
BMP Type	Bioretention		
Project Name	Northfield Stormwater Mitigation Site Construction (Central Street and Main Street)		
BMP System Name	Kenyon		
Project ID	83	BMP ID	143
Project Type	Bioretention		
Project Completion Date	11/21/2016		
Partner(s)	Central Vermont Regional Planning Commission		
Town(s)	Northfield		
Inspection Date and Time	10/15/2019; 12:44 PM		
Inspector	Helen Carr, Rachel Wood, and Jordyn Geller		
Date of Last Rain Event	10/14/2019		
Does BMP Exist?	Yes		
Project Location	Lat: 44.15037 Lon: -72.65594		
BMP Photo
