Ahead of the Storm's Wholistic Stewardship Approach

Presented By: Jessica Louisos, MS, PE

Ahead of the Storm

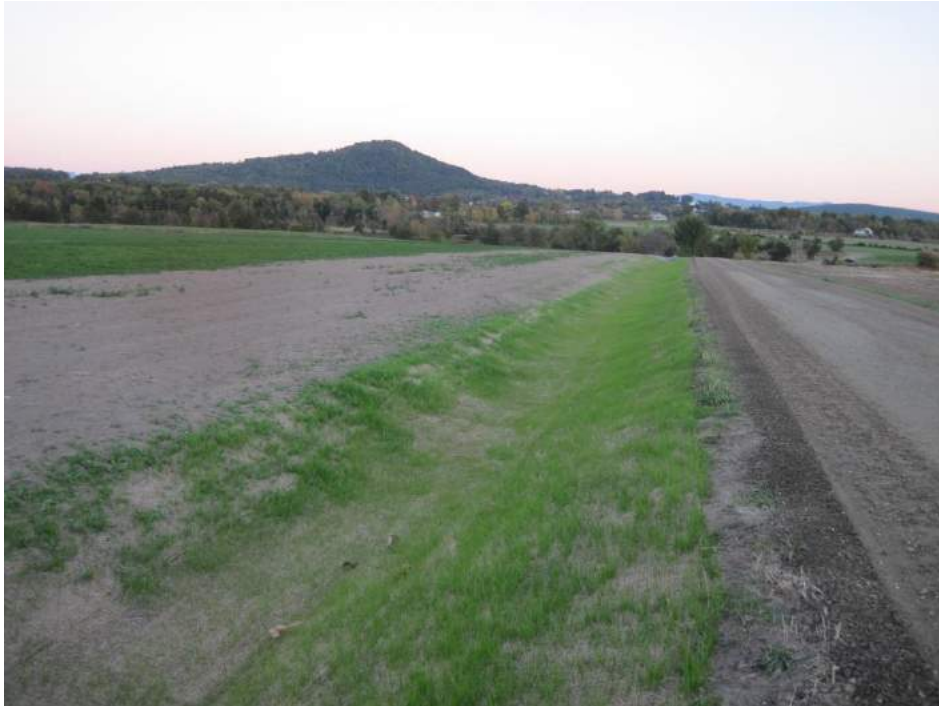
Reconstructed grass swale, East Thompson Point Road, Charlotte, Vermont, Summer 2016

Grass-line if Slope $< 5\%$

Water quality sampling results showed high phosphorus and sediment levels in Thorp Brook just downstream. Working with the landowner, the roadside swale was excavated to be larger and have a "U" shape instead of a "V" shape to reduce erosion, and a three-cell bio-retention area was added by installing stone filter berms to slow water and capture sediment and nutrients. This design was created to account for more frequent and...

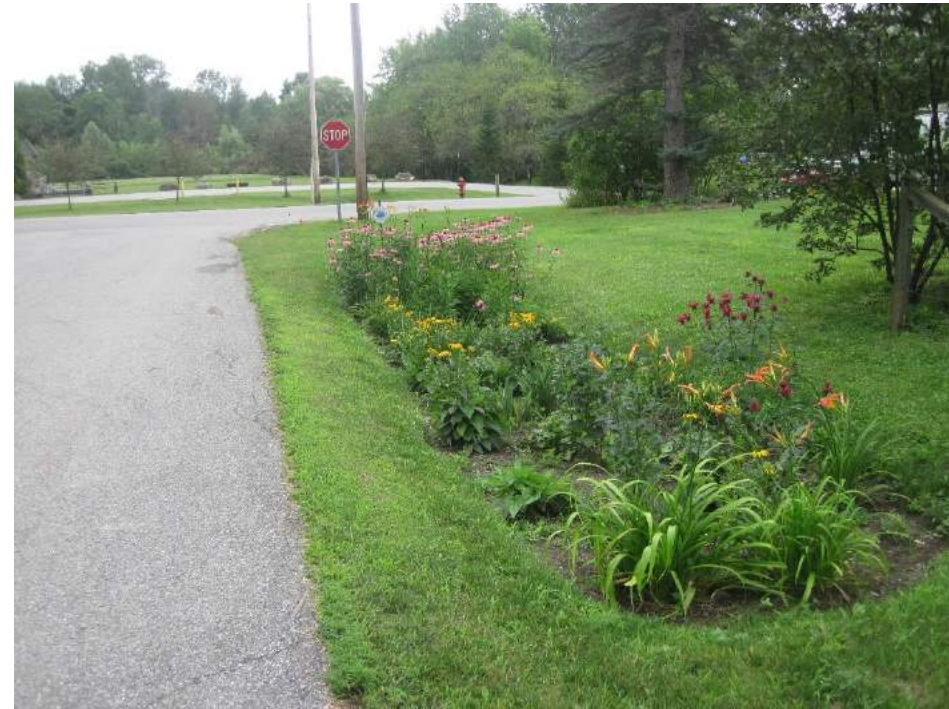
Swale with Raingarden, Woodbine Road, Shelburne, 2017

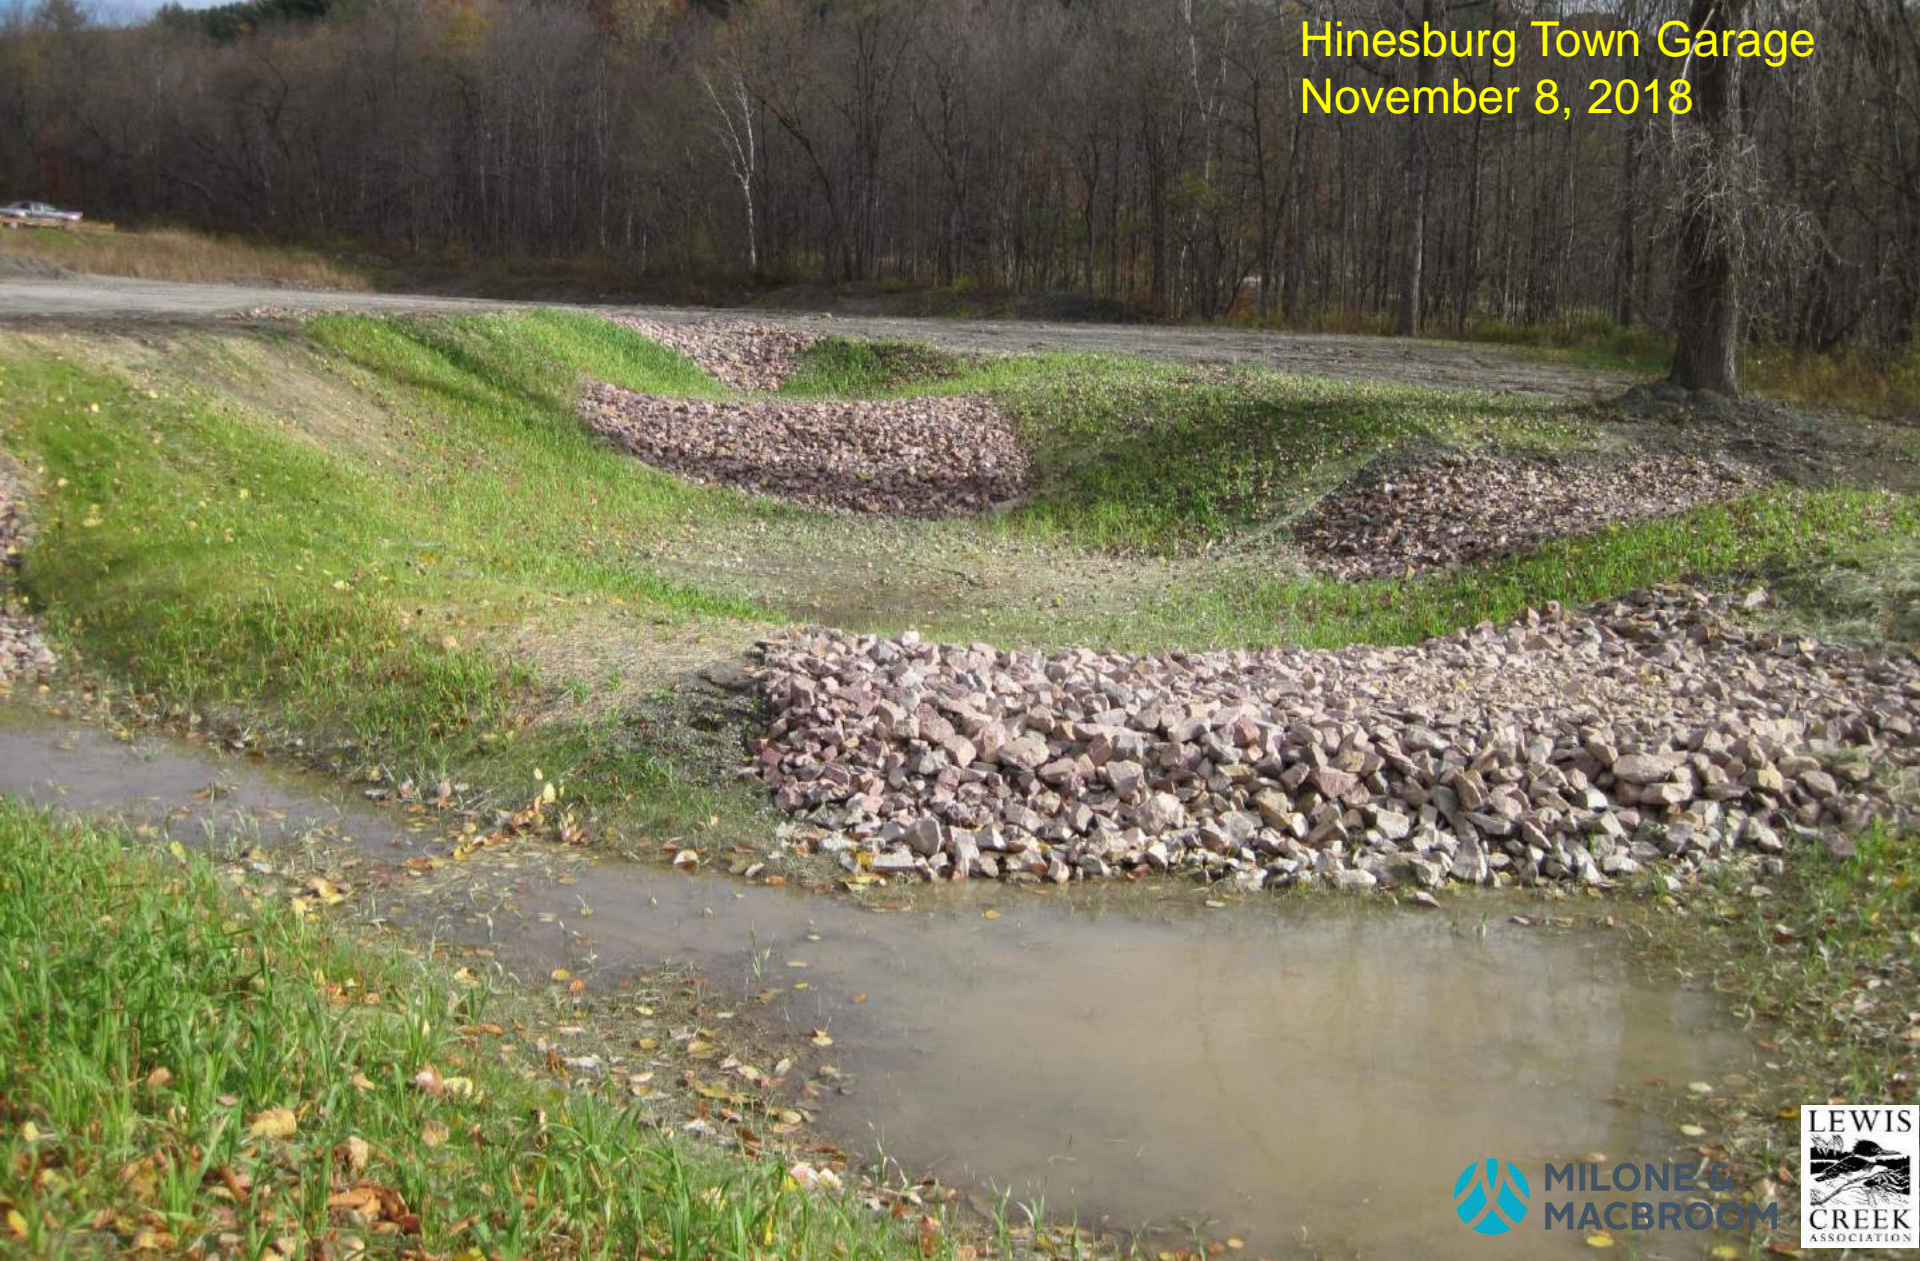
Infiltration Basin

Hinesburg Town Garage
November 8, 2018

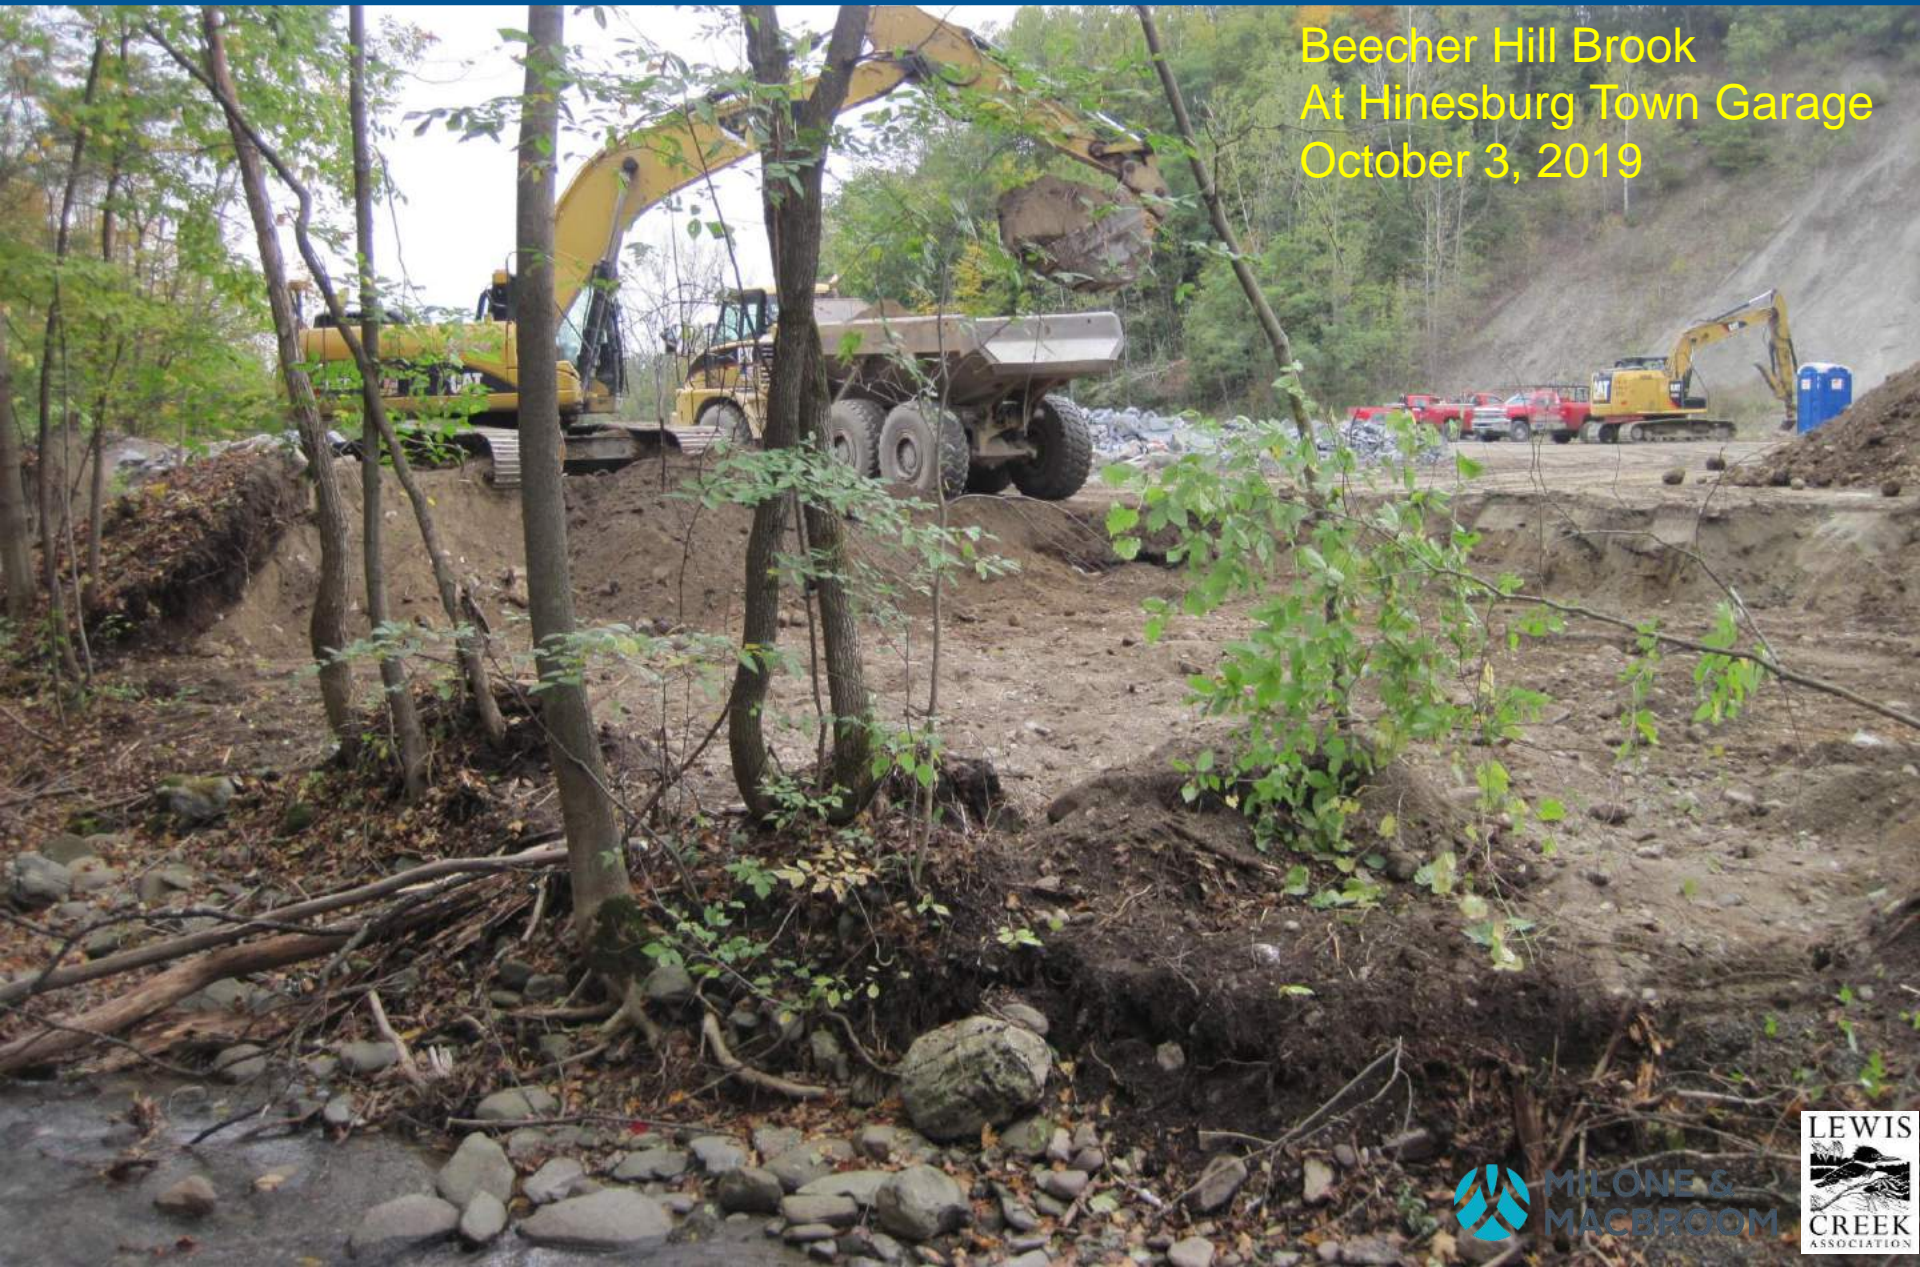
Floodplain Reconnection

Beecher Hill Brook
At Hinesburg Town Garage
October 3, 2019
