Reducing Wildlife Mortality on Roads in
Vermont:
Determining Relationships Between Structure
Attributes and Wildlife Movement Frequency
Through Bridges and Culverts to Improve
Related Conservation Investments

Paul Marangelo, Senior Conservation Ecologist
The Nature Conservancy – Vermont Chapter

Research Project
Reporting on SPR-A 332 (2017-2019)

Final Report 2019-15

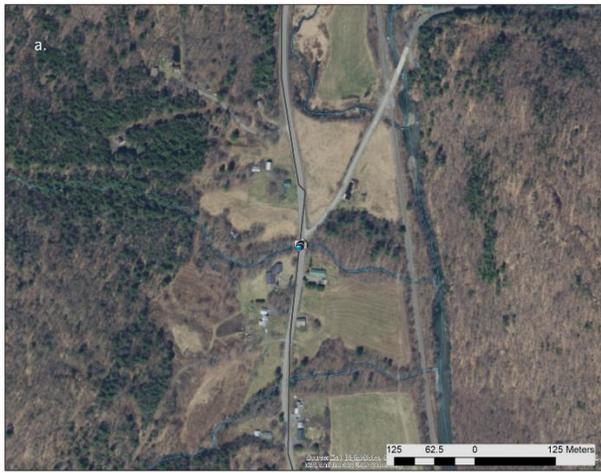
Figure 7. Illustration of the process used to identify likely movement pathways. a) visual identification of forest cover of orthophotos that provides likely movement habitat across a road corridor; b) LIDAR hillshade layer was used to confirm location of riparian corridor; c) polygon of most likely movement pathway was hand digitized from interpretation of a) and b). Site 21a-10, Braintree.

To assess the influences of nearby development on use of transportation structures by wildlife, we created an index of development influence at each site by 1) identifying likely movement pathways through each site based on contiguous forested habitat within the riparian corridors at each site (Figure 7). Likely movement pathways were hand-digitized from a visual assessment of orthophotos and LIDAR-based hill-shade data layers for pathway identification; 2) creation of a 50m buffer around each dwelling unit (derived from an E911 spatial data layer for VT) within 300m of a culvert or bridge; 3) intersecting these buffers with the movement pathways (Figure 8); 4) calculation of the ratio of the area of intersection of 50m buffer around each residence with the area of the movement pathway. We plotted this index against through-passage frequencies of sites from both Phase 1 and Phase 2 of this project (Figure 9). Because most sites with a development index > 0.1 had through-passage frequencies at or near zero, we selected 0.1 as a threshold to use to identify sites where development likely suppresses through-passage frequencies (Figure 10). This threshold created development index-based site groupings for through-passage frequency data that had significantly different means ($p=0.0314$; Wilcoxon rank sum test, Figure 11)). We therefore excluded all sites from subsequent analyses on the effects of structure design on through-passage where the development index was > 0.1.

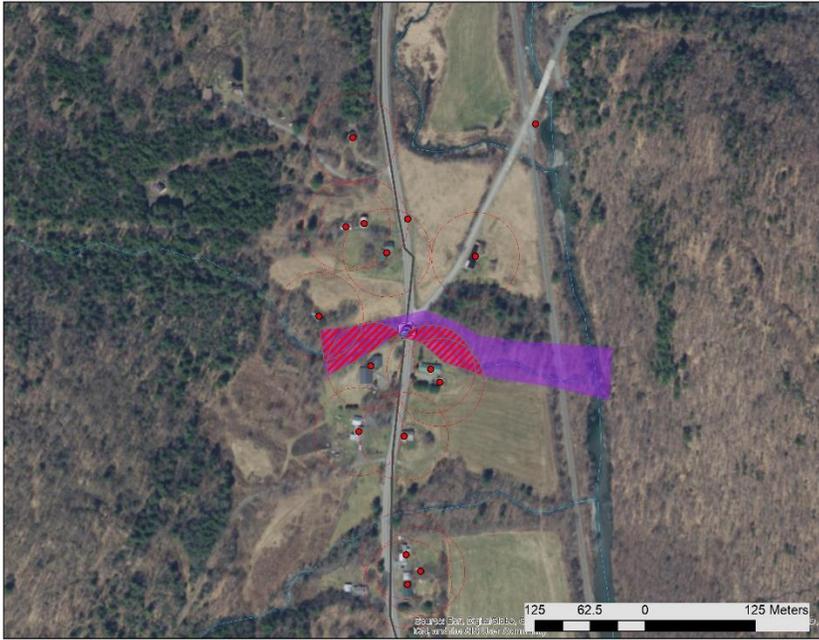
Figure 9. Illustration of the intersection of the most likely movement pathway with 50m residence buffers considered “influenced by development”. Development index for this site was the proportion of the “influenced by development” within a “most likely movement pathway” to the total pathway area (Site 12a-10, Braintree).

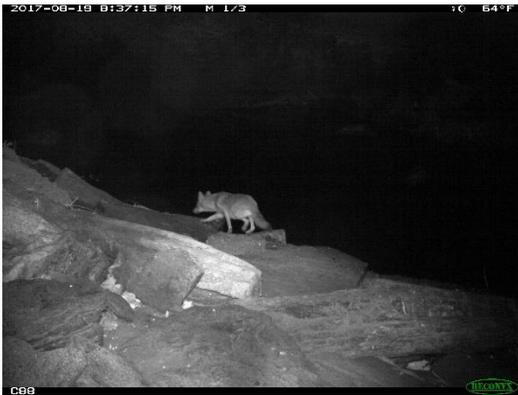
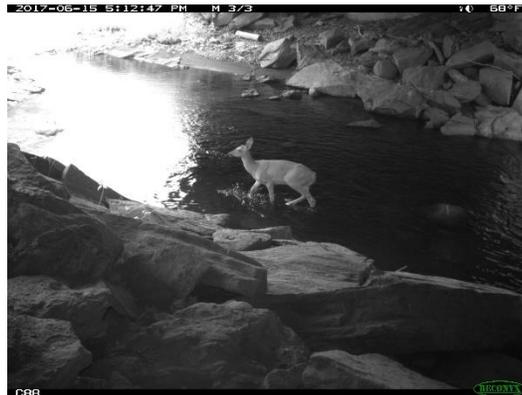
Figure 17. Illustration of secondary movement surface at site 113-19, Vershire. Most species used the riprap bank, while deer used a “wet streambed” secondary movement surface composed mostly of sand/gravel.

Through-passage frequencies were enhanced at a small number of sites by the existence of viable secondary movement surfaces (Figure 17). Most often, secondary movement surfaces were wet stream bottoms with substrate of gravel, cobble, and sand, and were used by deer. For example, Site 113-19 in Vershire hosted, in addition to the movement of other focal species over the rip-rap streambanks (bobcat, fisher, coyote, small weasel), deer moving over the inundated stream-bottom under the bridge span. Through-passage frequency at this site is likely higher than what otherwise would have been recorded over the main “riprap” movement surface, which deer typically avoid.

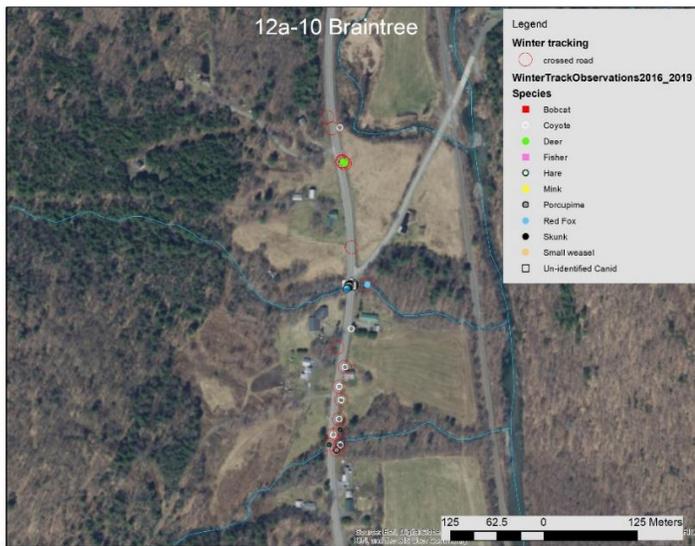
Figure 22. Map of focal species road crossings at Site 12-10, (Braintree). This site had only 1 deer through-passage during the project and had a relatively high development index. Road crossings denoted by red circles. Red circles without a species identifier represent crossings of non-focal species.

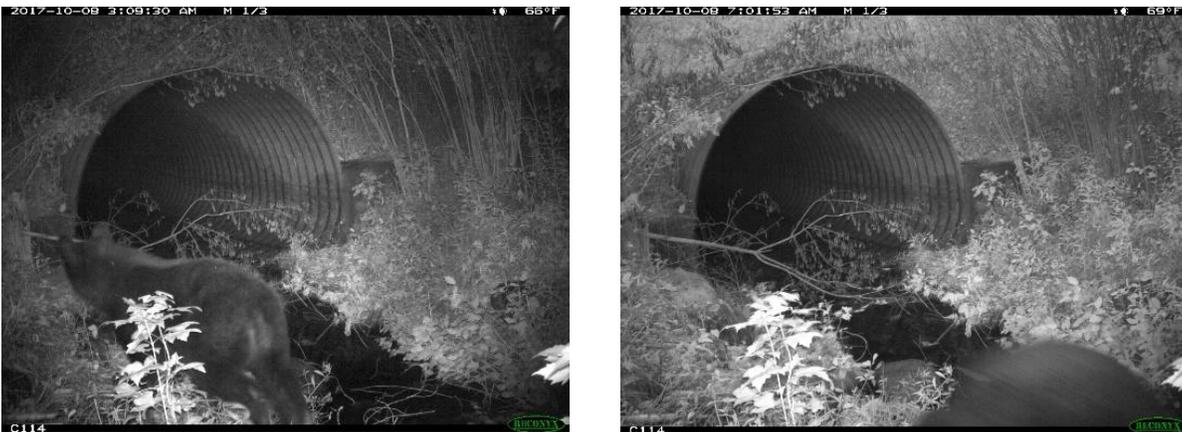
Figure 24. Bear bypassing a culvert while apparently moving towards crossing US 7 in Sunderland, with photo from return trip (Site 7-19-5, *squash pipe*). This culvert was regularly used by bobcat for through-passage.

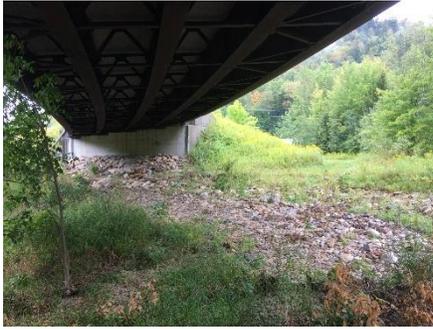
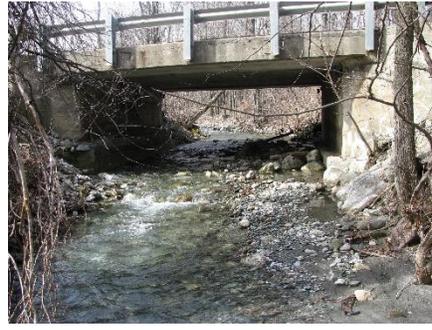
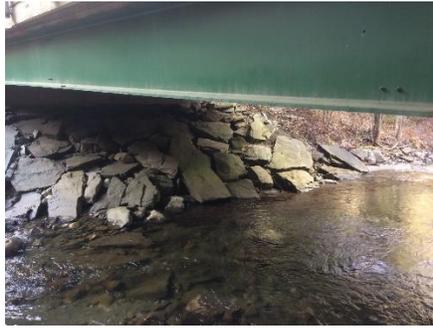
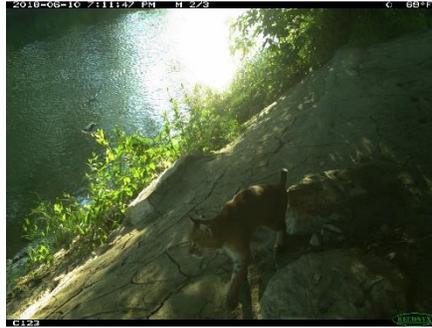
Figure 25. Examples of the variety of movement surface types that *spans* can provide. Upper left: “even floodplain” under valley-spanning bridge (9-25b, Searsburg). Upper right: “dry streambed” in a *span with footing shelf* where nearly all through-passages occurred on the streambed, which was typically entirely dry during summer months. Lower left: “riprap” streambank movement surface commonly found under many *spans* (not a project site). Lower right: “even streambank” of fine sediments under a *span* that does not cross an entire river valley (Union Street, Brandon, VT).

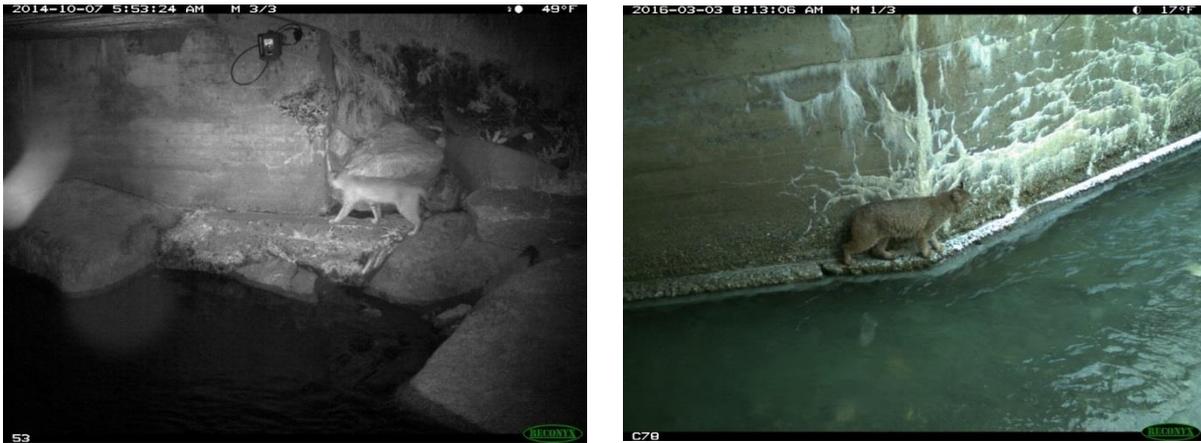
Figure 26. Bobcat through passages at span with footing shelves structure design types (Site 114-20 (left) and 4a-13 (right)).

Spans constructed on shallow ledge often feature exposed concrete footings, which create level dry “shelves” that wildlife use for movement. Older structures that are dramatically undersized for their stream can still support wildlife movement via footing shelves (Sites 4a-13 and 114-20 from Marangelo and Farrell (2016); Figure 26), even when the structure otherwise offers no other movement surface due to perpetual inundation. These structure types are relatively scarce, but illustrate how the offering of a dry, level, movement surface can create opportunity for wildlife through-passage in a structure that would otherwise be unusable. Footing shelves as narrow as 6” were used by species such as bobcat (Figure 26). Results from these structures suggest that shelves constructed specifically to provide a usable movement surface in any type of structure can offer benefits of increased through-passage, given suitable site characteristics.

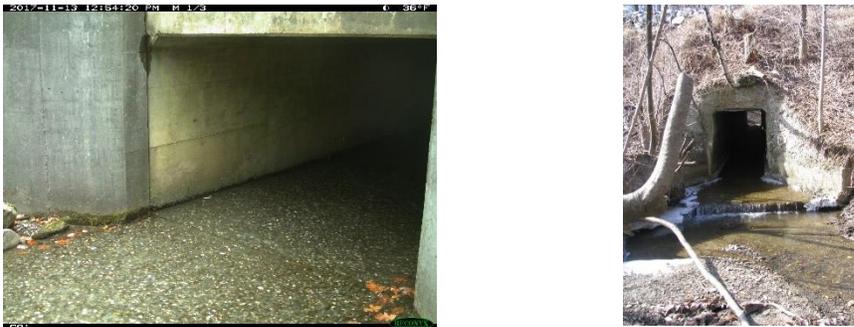
Figure 27. Examples of old box culverts with “sheetflow concrete” movement surface. Site 30-22 (West Townshend) and 15-76 (Cambridge, Marangelo and Farrelll 2016).

These structures typically receive use by only species that tolerate wet movement surfaces. Their bottoms are flat and unless they host an intermittent stream, feature a movement surface characterized by the sheetflow of water over flat concrete under nearly all flow conditions “sheetflow concrete” (Figure 27). These structures are especially abundant throughout Vermont.

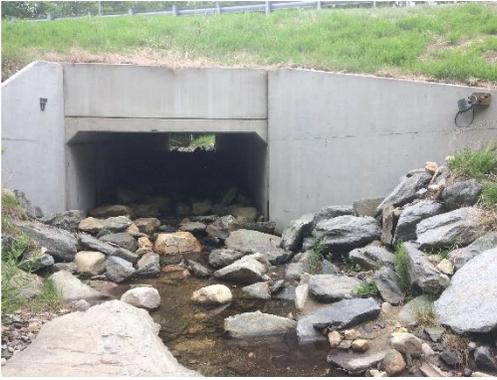
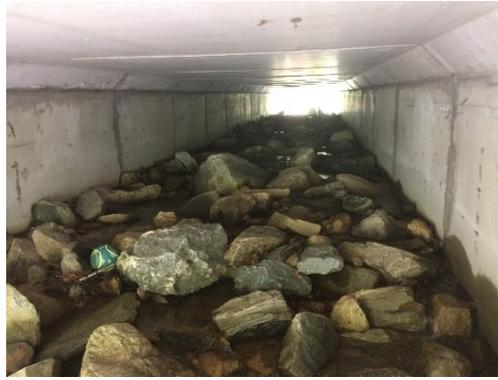
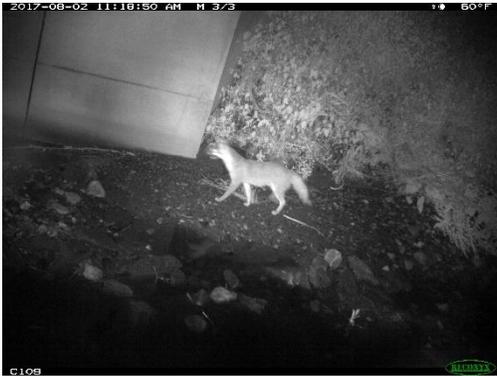
Figure 28. Examples of different movement surface development in *new precast box culverts*. Upper right and left: High water velocity during high streamflow events precludes the retainment of fine particles within the structure, resulting in a movement surface predominantly composed of boulder-sized particles. Site 30-47, Winhall. Lower left: movement surface of finer particle substrate. Site 100-47, Wilmington.

We were not able to adequately assess wildlife use of these structures, because all hosted large construction footprints that were cleared of all vegetation 5-7 years ago and are just starting to recover. The cleared construction sites offered little cover for wildlife, and thus these sites were seldom used by focal species. However, these structures are likely to offer superior wildlife through-passage opportunity once woody vegetative cover regenerates on old construction footprints, as long as stream processes allow for the development of dry substrate fine enough to be tolerated by hooved species such as deer. Structures that need to accommodate high gradient streams are appear to be an exception, offering inferior dry movement surfaces of very coarse substrate (boulders and large cobble, as exemplified by Site 30-47 (Figure 28), that are not suitable for deer or moose (AU movement guild). In situations where it is desirable to maximize wildlife movement opportunity, specific wildlife-movement design features should be considered at high-gradient sites, such as specific movement shelves separate from the culvert bottom or especially large structure width/bankfull width ratios that can accommodate some development of floodplain-like features within the structure, approaching those more commonly found on bridge spans (>1.5, Figure 17).

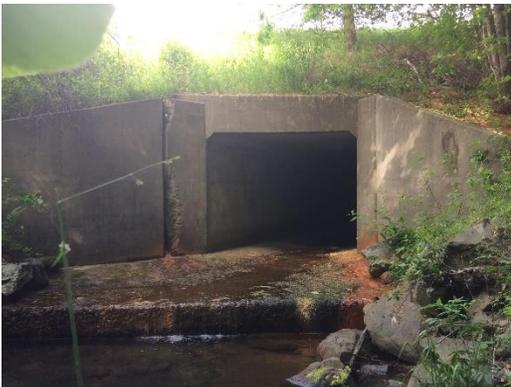
Figure 29. Example of a *V bottom box culvert*, with “dry concrete” movement surfaces along culvert walls. Site I91-17-2, Putney.

These structures are very rare – we found only 2 suitable for game cameras. By channeling water into the center of the culvert, they offer superior dry movement surface availability compared to the wet flat bottoms of typical of *old box culverts* (Figure 29). Project data probably does not reflect the potential of this design type for encouraging wildlife through-passage, as both structures studied were much longer than most wildlife prefer (both were over 235 feet long). Since newly constructed box culverts are likely to feature embedded designs, and are thus more likely to have more favorable movement surfaces than dry concrete (Figure 11), the relevance of “V bottomed box culverts” to the management of road corridors for increased permeability for wildlife appears questionable.

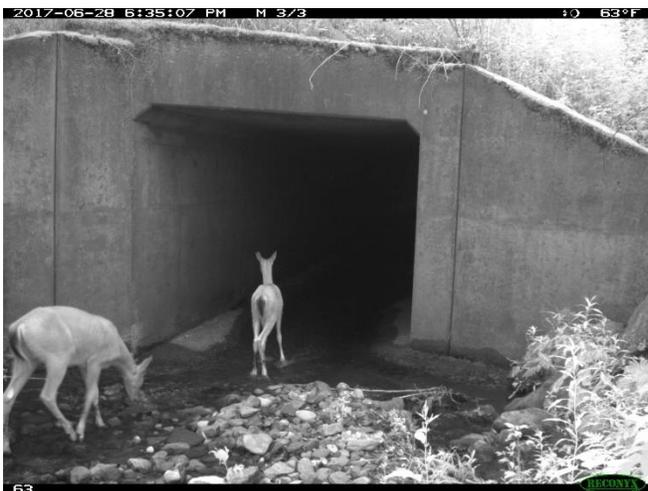
Deer at entrance to I91- in Putney (*V bottom box culvert*). Did not enter the structure.

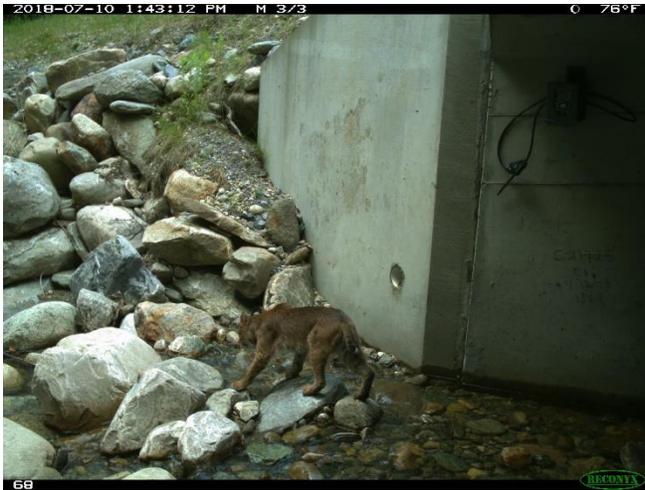
Bobcat at *new precast box culvert 125-19, Ripton* (only through-passage recorded for this site)

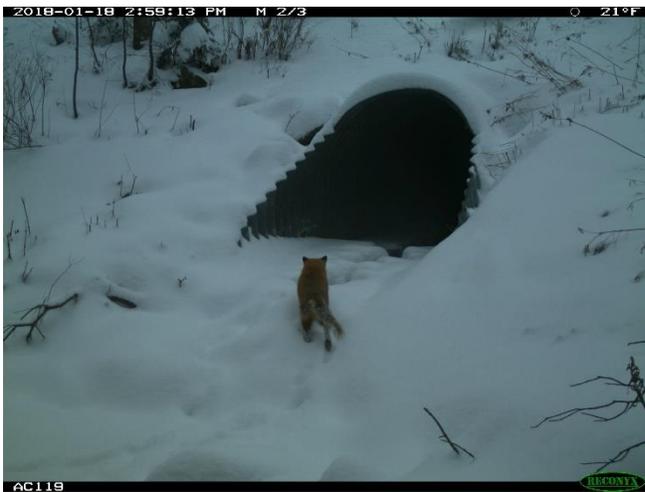
Fox approaching *pipe culvert 9-17, Woodford* (did not enter)
