China Erosion and Sedimentation materials

Yellow River Decade: Examining silt at the Sanmenxia Hydropower Station

Epic landslide erosion from mountain roads in Yunnan, China – challenges for sustainable development

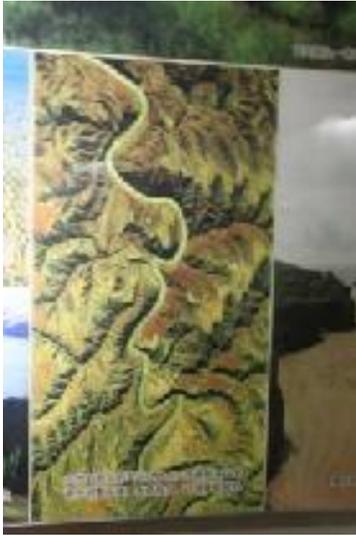
A topographic map of the Yellow River Basin

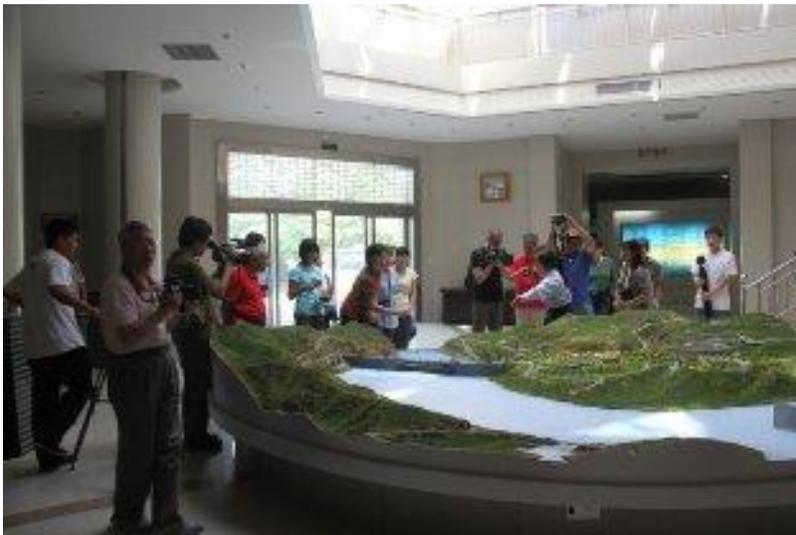
A model of Sanmenxia

The tour guide told us that Sanmenxia Dam was China's first large-scale water management project constructed on the Yellow River and was now honoured as "The Great Yellow River Dam." The dam is located in the northeast of the Sanmenxia district in Henan province, neighbored to the north by Shanxi Province and to the west by Shaanxi Province, in an area known as "The Golden Triangle." The first ground was broken in April 1957 and in only about four years the bulk of the dam's construction was virtually complete.

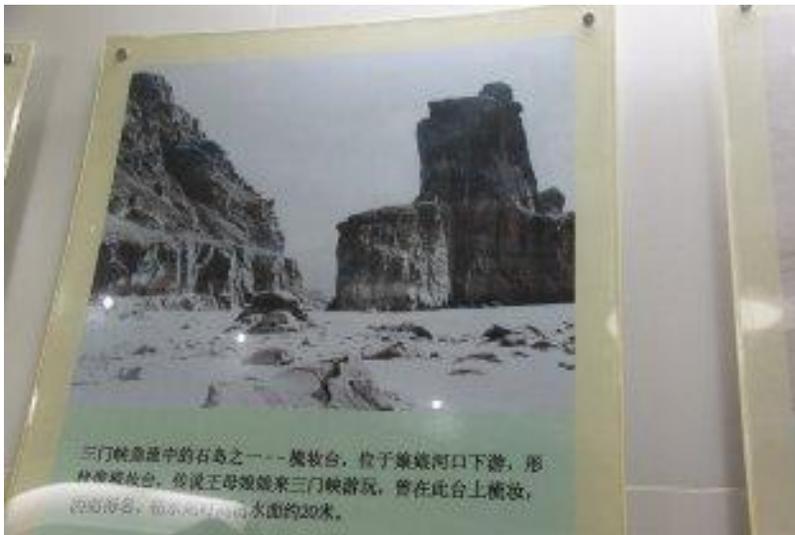
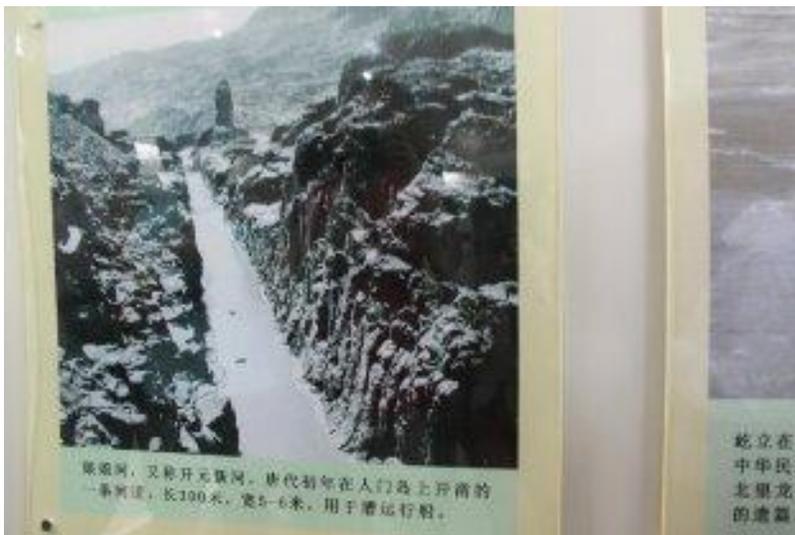
The “dressing table”, which has since been inundated by water.

The canyon pictured is no more.

These two photos of what was called the Sanmenxia “dressing table” or “dresser” are extremely rare, as they show the which now rests at the bottom of the reservoir. They are also the sole remaining record of what the area looked like before the dam’s construction. Photos are the only reference we have of the “Goddess River Gorge”, whose sheer cliff faces were also inundated after the dam’s construction.

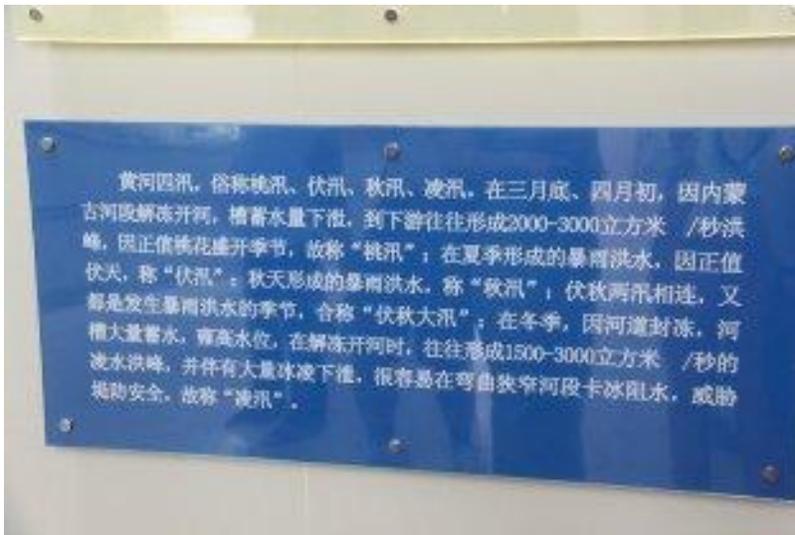
Information of the four flood periods of the Yellow River.

In this highly biased exhibition centre, surprisingly we did obtain some new information: From the two photographs we learned that the Yellow River floods four times a year, with the silt content rising sharply during flooding months.

The four flood periods of the Yellow River are named Spring flood, Summer flood, Autumn flood and Winter Flood. The names of the floods are pretty self-explanatory; however, what wasn't obvious from the exhibition was whether the construction of Sanmenxia Dam had affected the annual flood cycle.

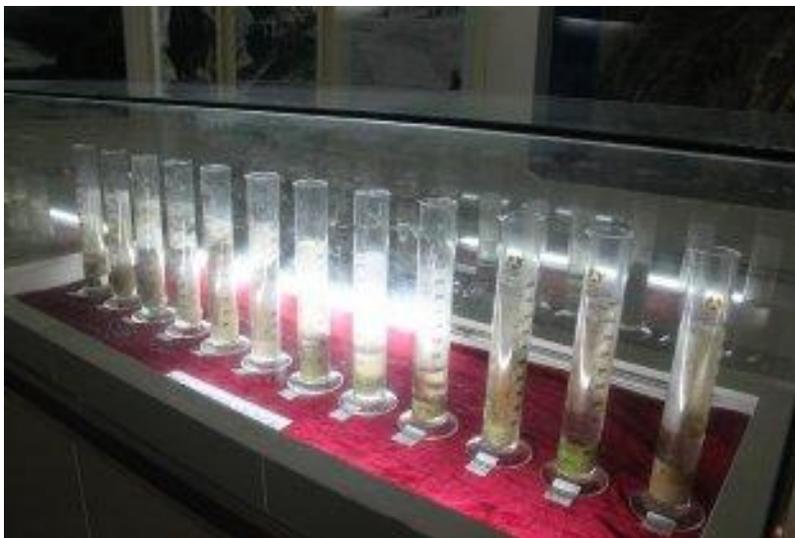
Samples of river water.

Examining the row of twelve test tubes in this display case, I had an inspiration. Originally, we chose to come on this trip to take a number of water samples and examine the differences in water quality between them. However, several experts we spoke to felt that in reality, this method of fieldwork would not offer any significant insights. This is because there was nothing profound about the sites or periods where we were taking

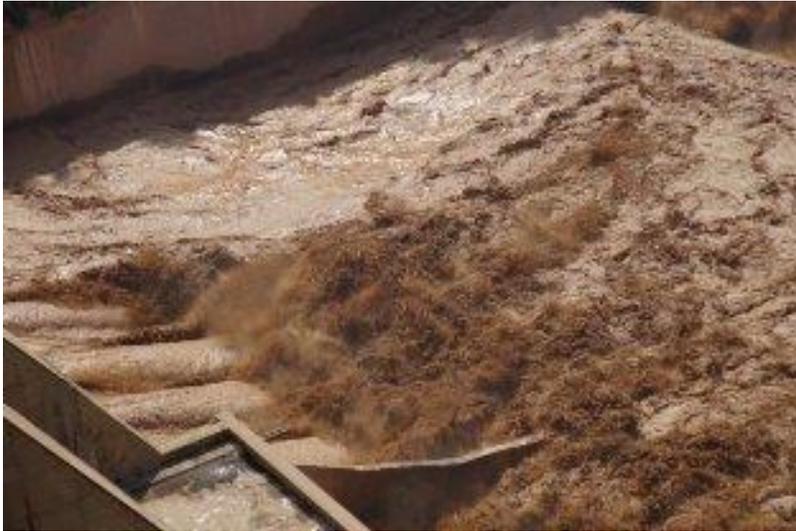
The overwhelming force of the silt

As expected, the advice of Huang Wanli and Wen Shanzhang, and barely a year into the engineering project, 1.5 billion tonnes of silt had already been deposited into the reservoir. Once the project began generating power, it not only failed to contain the silt, but also created problems on the upper reaches of the Wei River. At this location a dam had been built that steadily raised the height of the riverbed, leading to increased flooding and the salinization of more than 50 million mu (8.3 million acres) of farmland on the Guanzhong Plain.

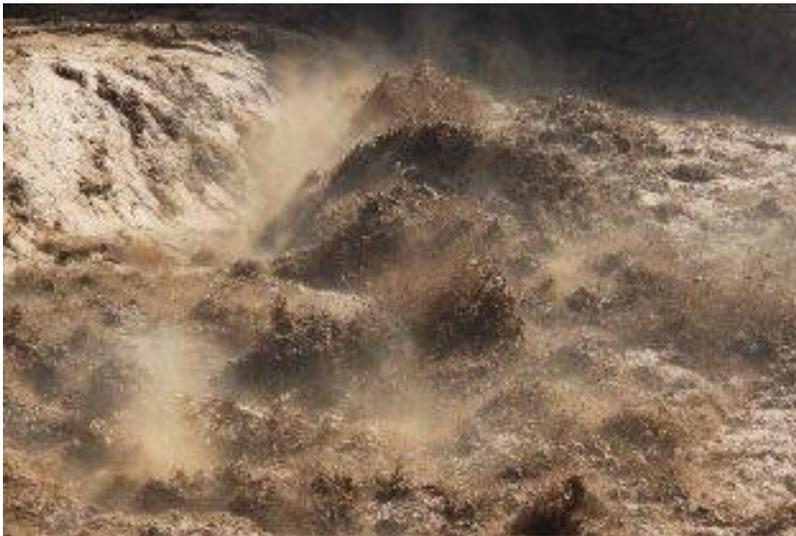
Silt in the reservoir.

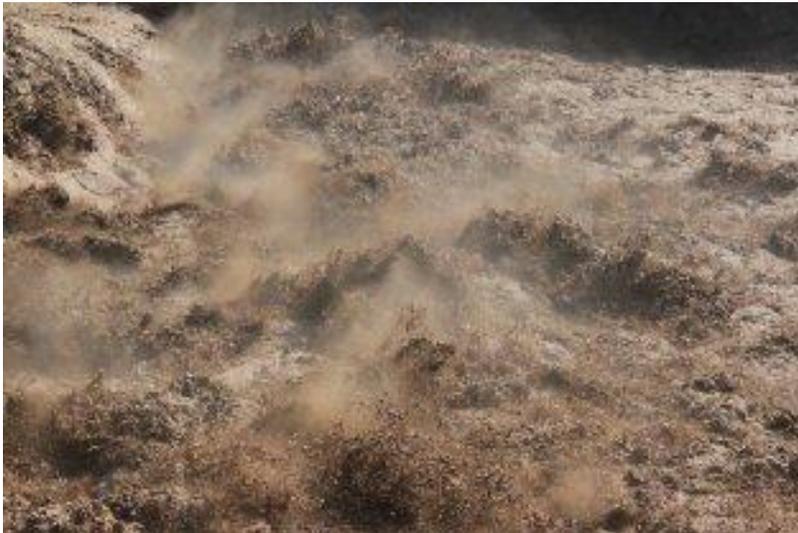
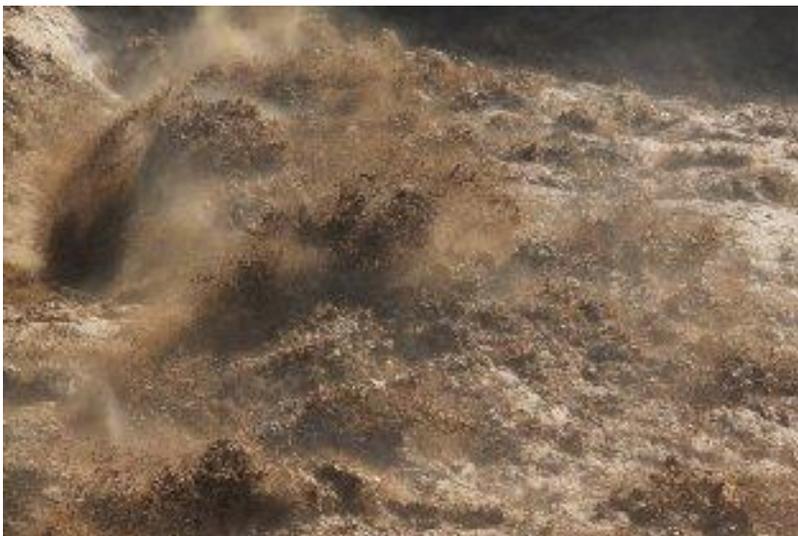
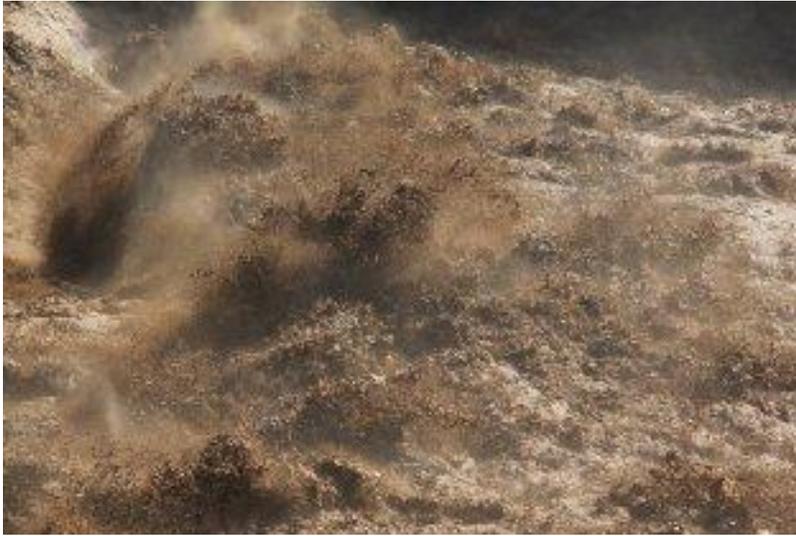
A world of silt

The howling silt

Silt, silt and more silt!

Qi Pu tells us that the process of flushing the accumulated silt out of the reservoir involves draining its contents and then using upstream floodwaters to wash away any remaining sediment. This not only sends the existing build-up of silt further downstream but also brings new deposits of silt from upstream. As a result, the silt discharged from the dam is dense, comprised of both accumulated silt and newer silt from upstream.

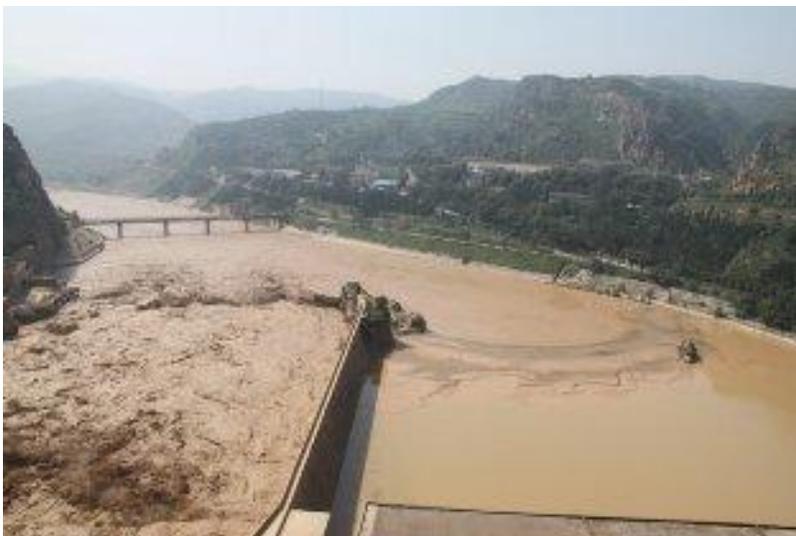
In this photo, the Sanmenxia Power Plant is not generating electricity, but discharging sediment.

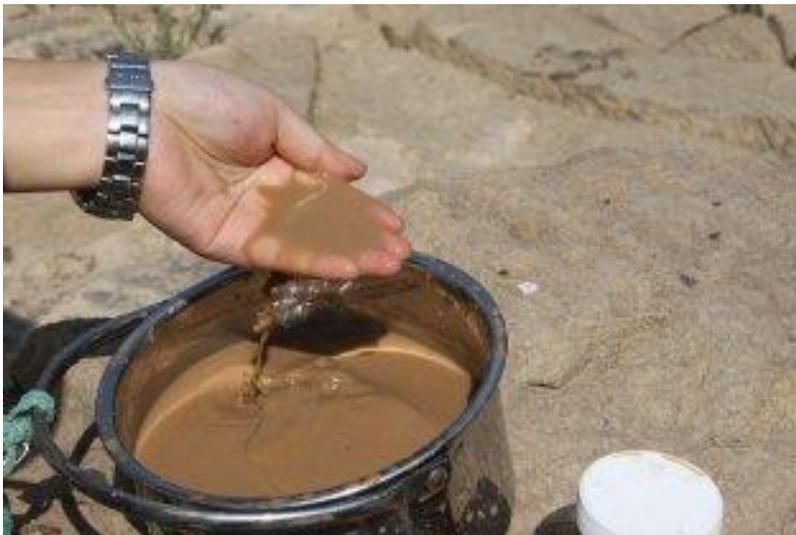
A water sample from Sanmenxia Reservoir.

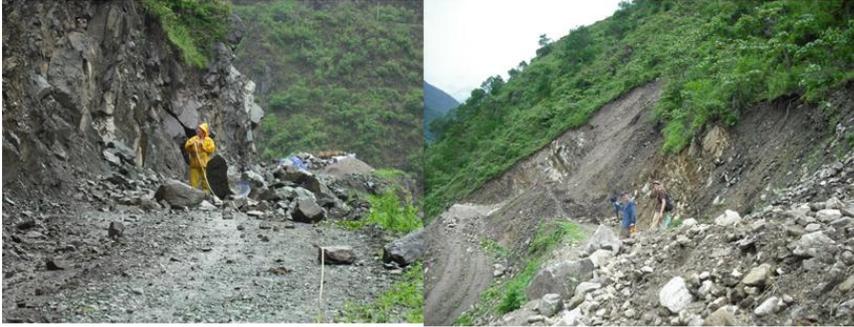
Figure 2. The highest landslide erosion occurred along a 1 yr old road (DXD) leading to a remote village and a future hydropower plant just south of Daxingdi, Yunnan, China.

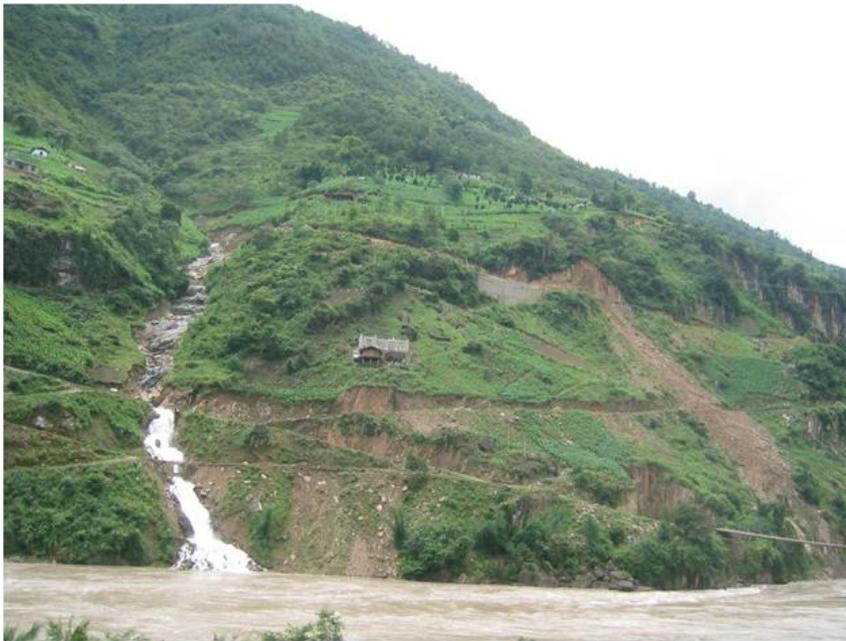
Figure 3. Road leading to a mountain village on the west side of the Salween River about 45 km south of Fugong. Upper portion of the road had (SFG1) the lowest landslide erosion of all surveyed segments, while the lower portion of the road (SFG2) had fewer numbers of, but larger, cutslope failures. Landslide erosion rates were significantly higher at SFG2 compared to SFG1 – 3.5 times higher for fillslope and 4.4 times higher for cutslope failures. Access bridge across the river is in the lower right corner of the photo.

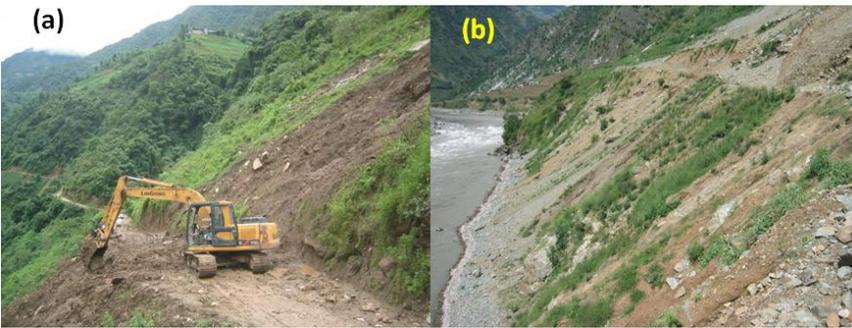
Figure 7. (a) A section of the FG2 road several kilometers north of Fugong that was temporarily closed by a landslide; and (b) secondary road to a small mountain village near Daxingdi (not included in our landslide survey) that was abandoned during construction because of excessive landslides.
