Assessment and Analysis of the Breeding Barn at Shelburne Farms

David C. Fischetti¹, Douglas W. Porter², Ronald W. Anthony³

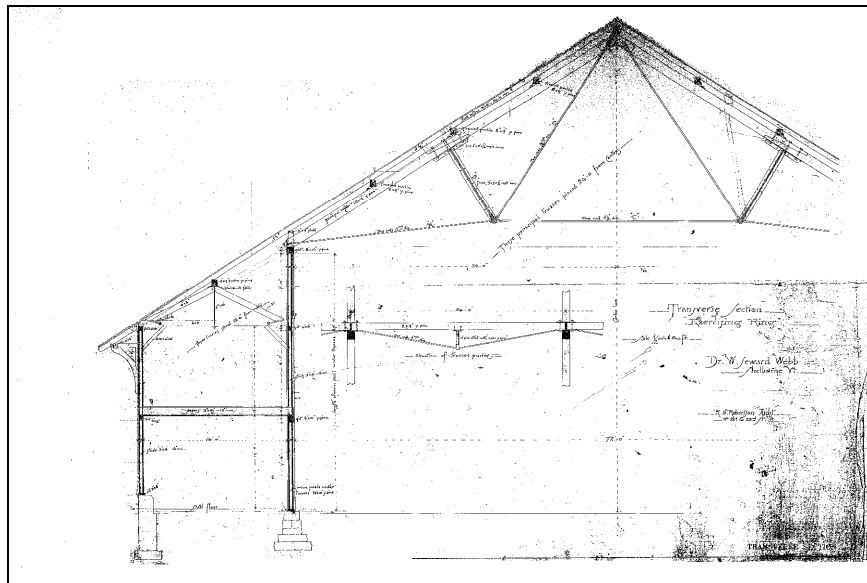
Figure 3. Robertson's earliest drawings of the roof frame omitted the iron cross-tie braces at plate level.

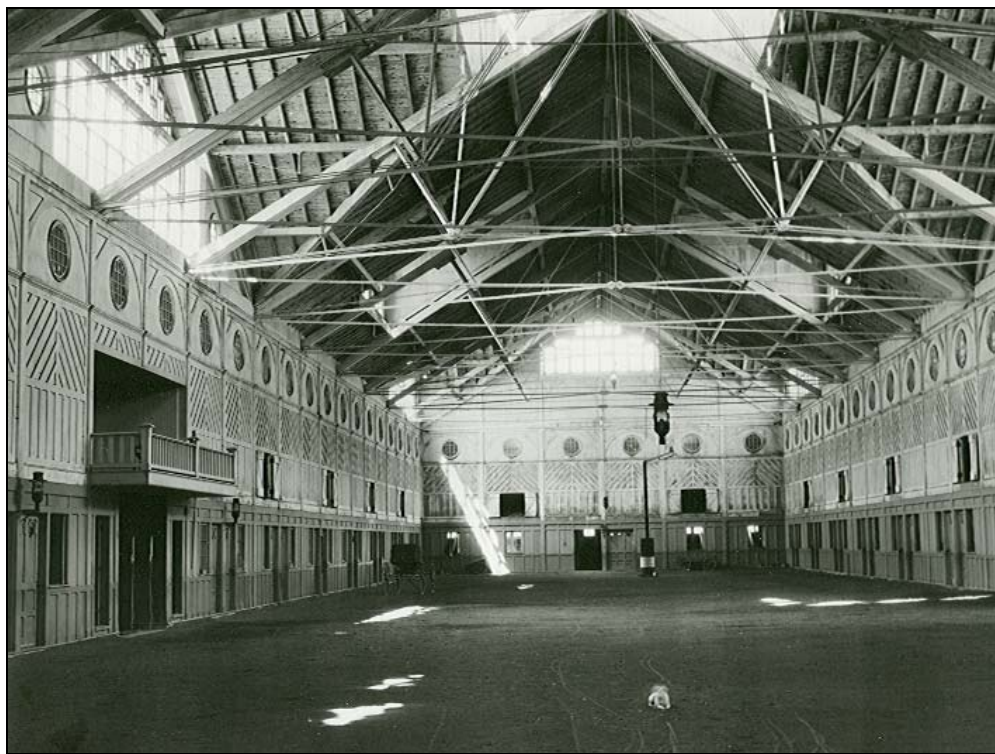
Figure 4. Barn interior.c1900 showing the roof frame of the riding ring, including iron cross-brace ties.
Shelburne Farms Archives. All rights reserved. May not be reproduced without permission.

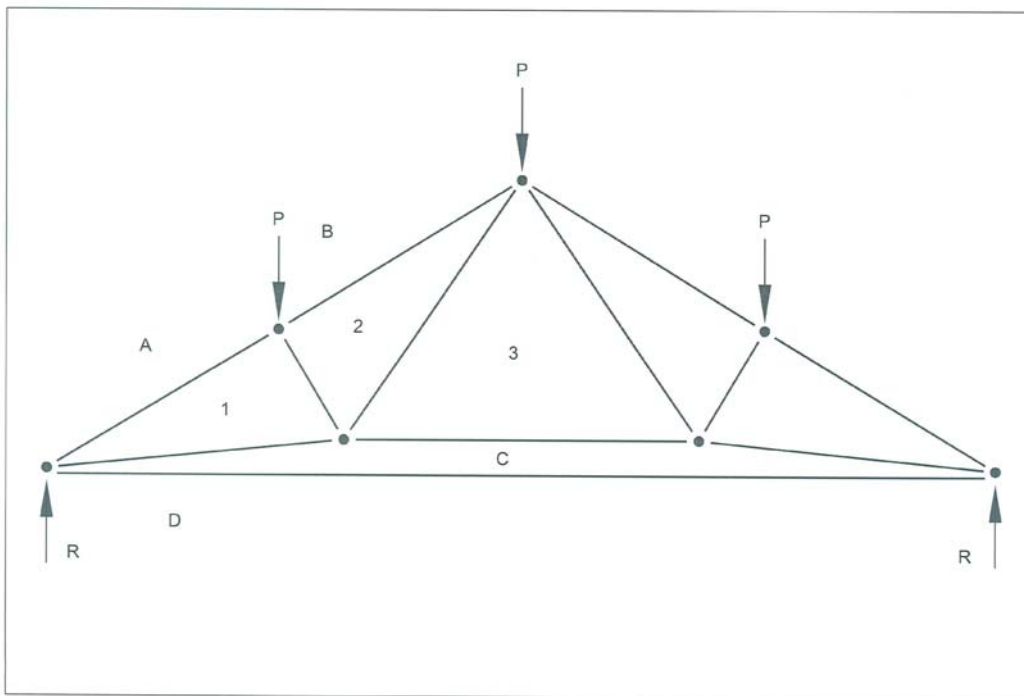
1. The truss members are connected together with frictionless pins.
2. Truss members are straight and the axis of the members intersect at joints.
3. Deformations under load do not excessively change the basic truss geometry.
4. Loads and reactions are applied only at joints (Figure 9).

Figure 9. This shows the placement of the unit loads for the load test with the loads located at joints.

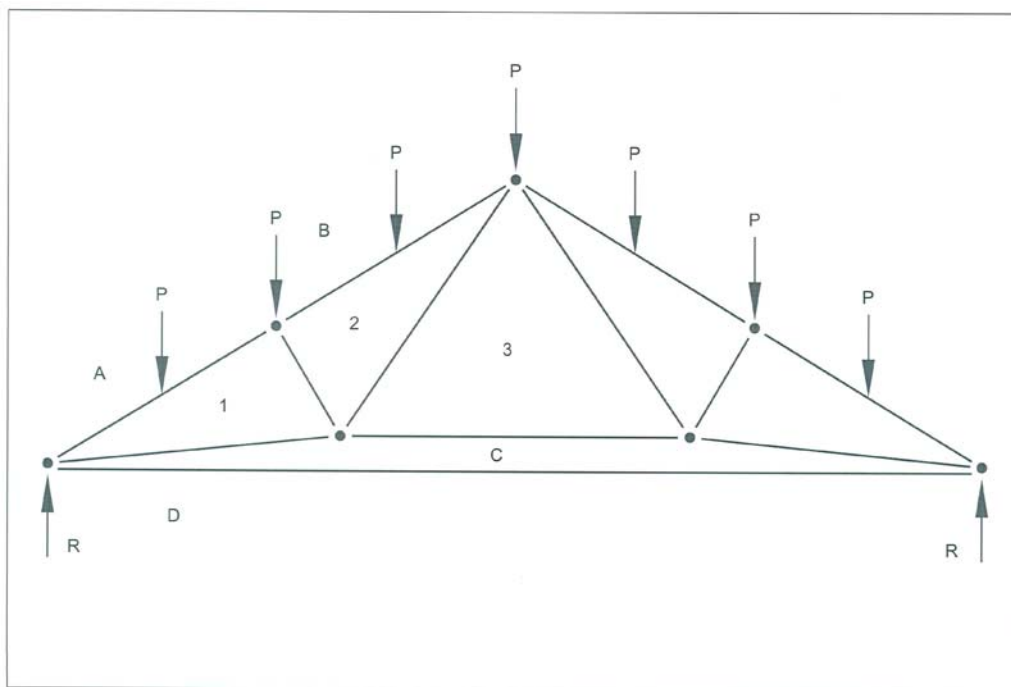
Apparently, the truss in the riding ring evolved from a simple truss analyzed by graphical means, to one with purlins located between joints (Figure 10), to a system combining a truss with a horizontal tie (Figure 11). The wrought iron angles used to bolster the spliced top chord is an interesting detail. These may have been added as an afterthought, sometime during design, to reinforce the top chord acting as a two-span beam supporting purlins at the midpoint of both spans. Although it certainly was possible to obtain southern pine in twelve-meter lengths to produce a two-span continuous top chord, the designers chose to

Figure 10. This shows the placement of the unit loads for the load test with the loads located at purlins.
