Structural Repair of the Breeding Barn at Shelburne Farms

STRUCTURAL REPAIR OF THE BREEDING BARN AT SHELBURNE FARMS

VOLUME II: APPENDICES

THE STRUCTURAL REPAIR OF THE BREEDING BARN AT
SHELBURNE FARMS

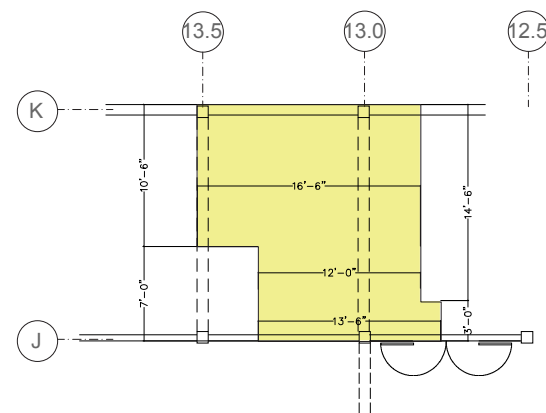
A REPAIR AREA, 12.5 - 13.5 JK
APPROX. 260 SF

- SCARF REPAIRS OF AISLE FLOOR LEDGER AS NEEDED
- REPLACEMENT IN-KIND OF JOISTS AND BRIDGING AS NEEDED
- REPLACEMENT IN-KIND OF FLOOR DECKING AS NEEDED

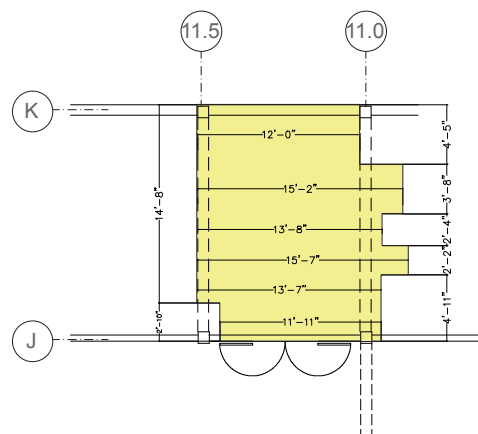
B REPAIR AREA, 11.0 - 11.5 JK
APPROX. 237 SF

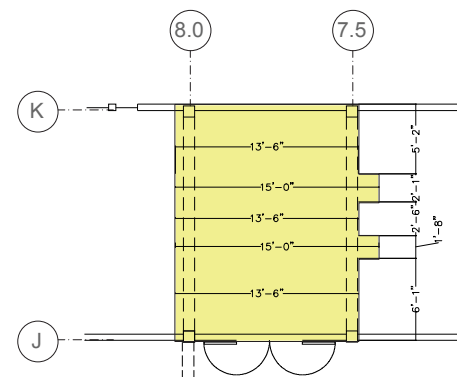
C REPAIR AREA, 7.5 - 8.0 JK
APPROX. 241 SF

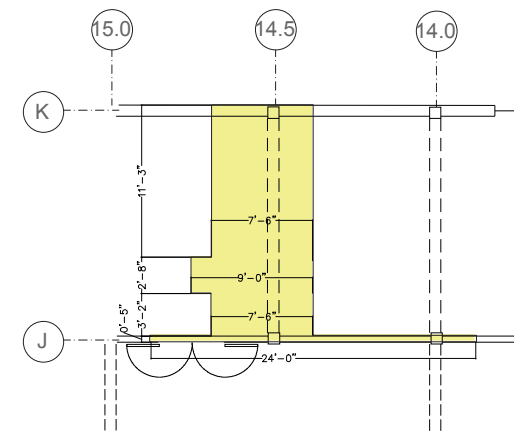
D REPAIR AREA, 3.5 - 5.0 JK
APPROX. 142 SF

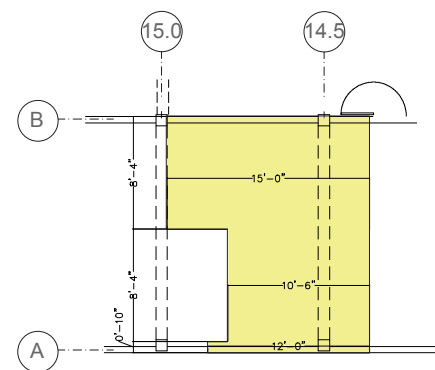
E REPAIR AREA, 14.5 - 15.0 AB
APPROX. 221 SF

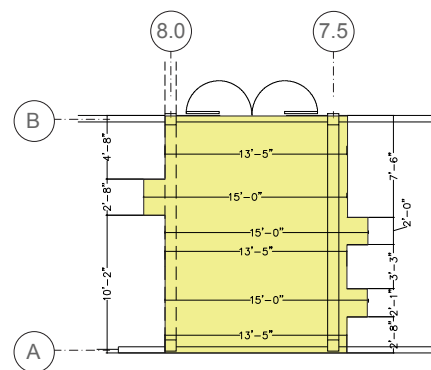
F REPAIR AREA, 7.5 - 8.0 AB
APPROX. 243 SF

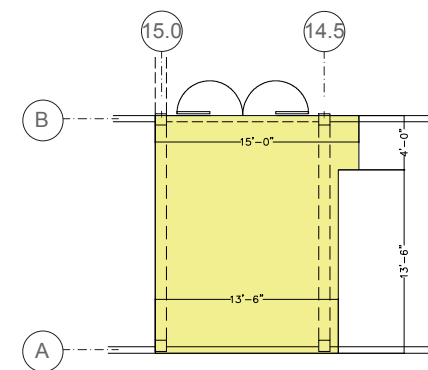
G REPAIR AREA, 14.5 - 15.0 AB
APPROX. 221 SF

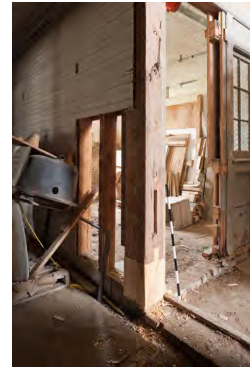
B2.0 PHOTO DETAILS
N.T.S.

POST NO.	DESCRIPTION	REPAIR LENGTH*
B2.0	COVERED UP WITH METAL, ASSUME 8" OF DECAY	0 (12")
B2.5	GOOD CONDITION, FULL LENGTH	NO REPAIR
B3.0	GOOD CONDITION, FULL LENGTH	NO REPAIR
B3.5	DECAYED AT BASE, UP 10"	0 (16")
B4.0	DECAYED AT BASE, UP 6"	S + CL ONLY
B4.5	POST BOTTOM HAS BEEN REPLACED BUT THE LENGTH IS 2" TOO SHORT	117" (153")
B5.0	SOFT ON THE OUTSIDE UP 8", NO DECAY	S + CL ONLY
B5.5	DECAYED AT THE BASE, UP 6"	40" (69")
B6.0	DECAYED AT THE BASE, UP 10"	35" (65")
B6.5	DECAYED AT THE BASE, UP 10"	30" (63")
B7.0	SOFT ON THE OUTSIDE UP 2", FAIR CONDITION	S + CL ONLY
B7.5	DECAYED ON BOTTOM, CORNERS BROKEN OFF, REPAIR WITH 6FT LONG NEW TIMBER	32" (62")
B8.0	DECAYED AT THE BASE, UP 8"	S + CL ONLY
B8.5	DECAYED AT THE BASE, UP 8"	0" (27")
B9.0	GOOD CONDITION, FULL LENGTH	NO REPAIR
B9.5a	EXCELLENT CONDITION, FULL LENGTH	NO REPAIR
B9.5b	EXCELLENT CONDITION, FULL LENGTH	NO REPAIR
B10.0	EXCELLENT CONDITION, FULL LENGTH	NO REPAIR

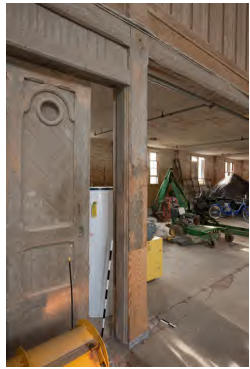
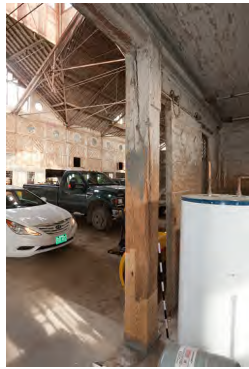
B10.5 PHOTO DETAILS
N.T.S.

B10.5	DECAYED AT THE BASE, UP 10"	20" (36")
B11.0	DECAYED, UP 8"	S + CL ONLY
B11.5	DECAYED ON BOTTOM, CORNERS BROKEN OFF, REPAIR WITH 5FT LONG NEW TIMBER	24" (60")
B12.0	DECAYED AT THE BASE, UP 6"	S + CL ONLY
B12.5	DECAYED AT THE BASE, UP 8"	0 (18")
B13.0	DECAYED AT THE BASE, UP 8"	36" (56")
B13.5	DECAYED AT THE BASE, UP 8"	37" (67")
B14.0	DECAYED AT THE BASE, UP 8"	36" (56")
B14.5	POST BOTTOM HAS BEEN REPLACED BUT THE LENGTH IS 2" TOO SHORT	156" (192")
B15.0	DECAYED AT THE BASE, UP 8"	38" (58")
B15.5	DECAYED AT THE BASE, UP 10"	0 (24")
B16.0	GOOD CONDITION, FULL LENGTH	NO REPAIR
B16.5	GOOD CONDITION, FULL LENGTH	NO REPAIR
B17.0	COVERED UP WITH METAL, ASSUME 4" TO 6" OF DECAY	NO REPAIR
C2-17.0	GOOD CONDITION, FULL LENGTH	NO REPAIR
D8-17.0	FAIR CONDITION, FULL LENGTH	NO REPAIR
F17.0	FAIR CONDITION, FULL LENGTH	NO REPAIR
G2-17.0	DECAYED AT THE BASE, UP 10"	20" (48")
H2-17.0	DECAYED AT THE BASE, UP 12"	9" (16")

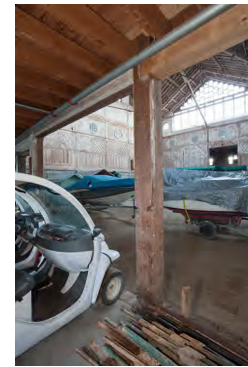
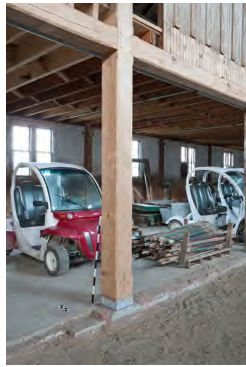
J4.5 PHOTO DETAILS
N.T.S.

- MAJOR REPAIR AT B4.5, B14.5, J4.5, AND J12.5, IN WHICH COLUMN REPAIR EXTENDS INTO SECOND FLOOR AISLE FRAMING
- SEE SHEETS 17-18 FOR MAJOR COLUMN REPAIR DETAILS
- MINOR REPAIRS AT B4.0, B5.0, B6.5, B7.5, B11.0, B12.0, J3.5, J7.0, J8.0, AND J12.0: WHITE OAK SHIMS AND CHAZY LIMESTONE ONLY, WITH NO SCARFED REPAIR
- SEE SHEETS 11-16 FOR PHOTO DETAILS OF ALL COLUMN REPAIRS
- SEE SHEET 10 FOR TYPICAL COLUMN REPAIR DETAILS
- THIS DRAWING SET IS BASED ON A SURVEY MADE BY THE OWNER'S REPRESENTATIVE IN 2010. THEY ARE INTENDED AS DOCUMENTATION OF WORK DONE AND ARE FOR REFERENCE ONLY.

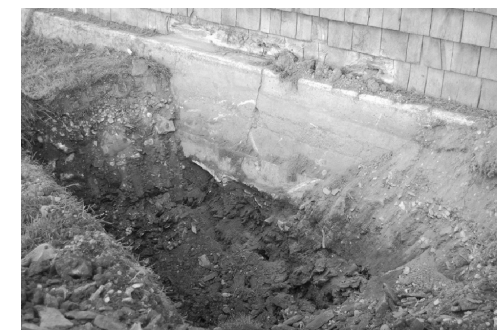
NOTE: REPAIRS TO THE STONE WALL ARE NOT INCLUDED IN THIS PHASE OF THE PROJECT.

IN THE NEXT PHASE OF THE PROJECT THE EXISTING CONCRETE FARGING FROM THE EXTERIOR FACE OF THE STONE WALL WILL BE REMOVED AND THE WALL WILL BE RE-BUILT. THE EXTENT OF THIS WORK IS INDICATED ON SHEET 514.

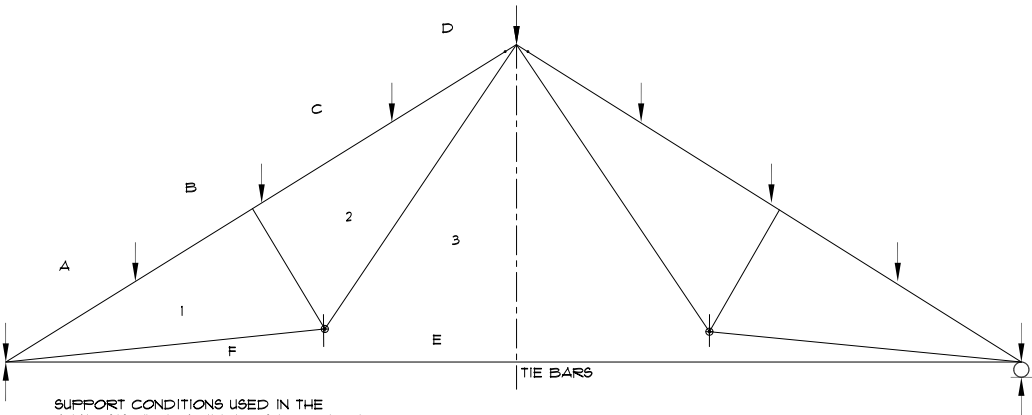
3 CASE 3
S3.8 SCALE 3/16" = 1'-0"

LOAD TESTING OF THE TYPICAL TRUSS INDICATES THAT THIS LAYOUT REPRESENTS MORE ACCURATELY THE PERFORMANCE OF THIS COMPOSITE TRUSS SYSTEM. NOTE THAT VARIATIONS IN THE RESULTS OF THE TESTING MAY HAVE BEEN BASED ON DIFFERENCES IN THE GEOMETRY OF THE WROUGHT IRON COMPONENTS WHICH HAVE NO MEANS OF ADJUSTMENT.

LOAD TESTS INDICATE THAT LOAD CASE 3 DESCRIBES BEST THE TRUE ACTION OF THE COMPOSITE TRUSS.

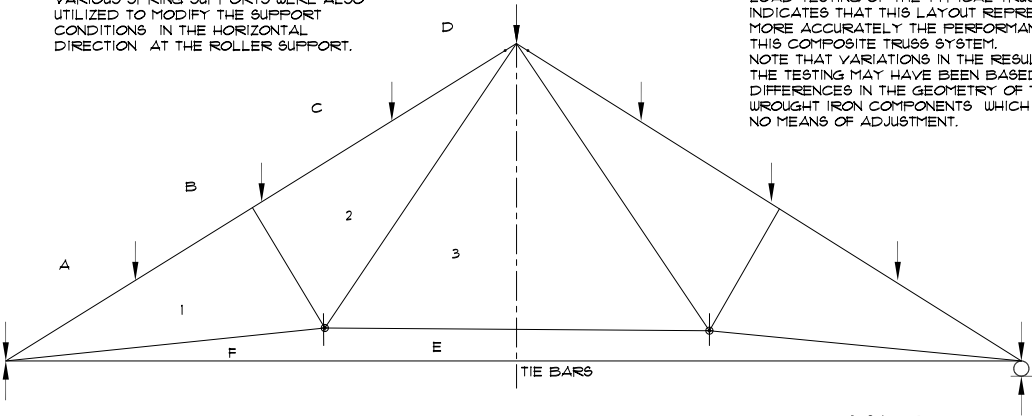
2 CASE 2
S3.8 SCALE 3/16" = 1'-0"

HISTORICAL RESEARCH INDICATES THAT THE TIE BARS WERE MOST LIKELY AN ADDITION TO THE ORIGINAL TRUSS CONFIGURATION, POSSIBLY A RETROFIT TO OFFSET HORIZONTAL DEFLECTION OBSERVED AT THE TOP OF THE SIDE WALL 10x10 POSTS.

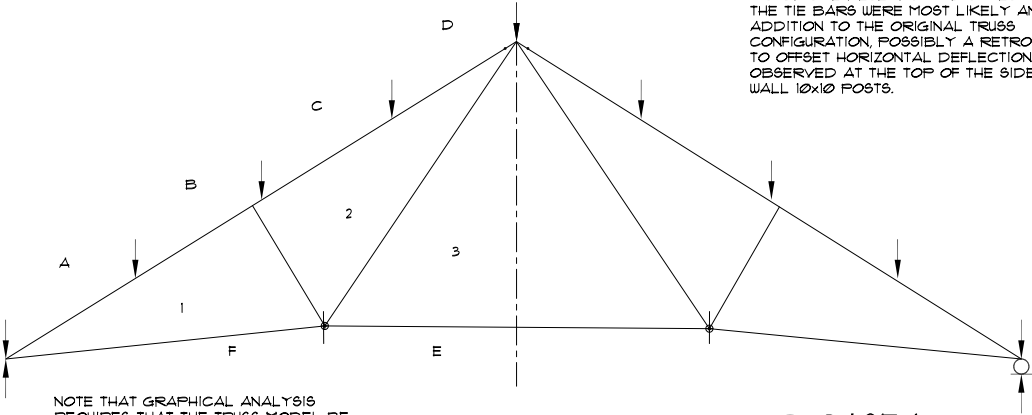
1 CASE 1
S3.8 SCALE 3/16" = 1'-0"

NOTE THAT GRAPHICAL ANALYSIS REQUIRES THAT THE TRUSS MODEL BE LOADED ONLY AT JOINTS (PANEL POINTS). THE FURLIN POINT LOADS PLACED BETWEEN THE JOINTS CAUSE BENDING IN THE TOP CHORD WHICH MAY NOT HAVE BEEN ACCOUNTED FOR IN THE ORIGINAL ANALYSIS.

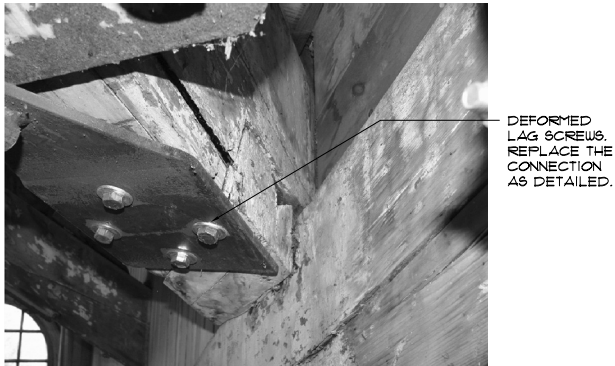
2 VALLEY RAFTER 1 NORTH AT EAST WALL,
NOTE DEFORMED LAGS SCREWS
PI.1 NOT TO SCALE

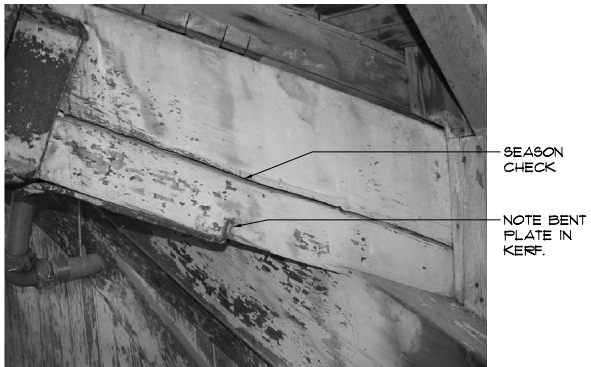
4 VALLEY RAFTER 1 SOUTH, SEASON
CHECK IN THE SOUTH FACE
PI.1 NOT TO SCALE

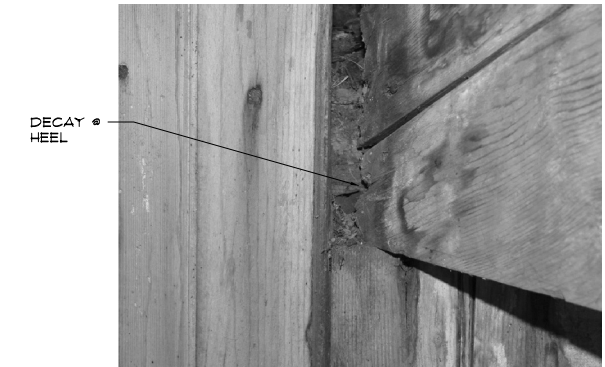
6 HEEL OF VALLEY RAFTER 4.5 NORTH
AT THE NORTH WALL SHOWING DECAY
IN THE RAFTER AND TOP PLATE
PI.1 NOT TO SCALE

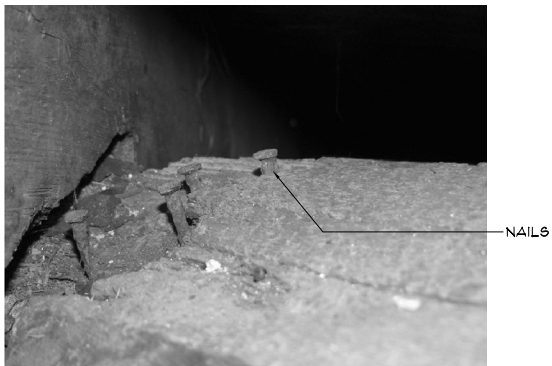
7 HEEL OF VALLEY RAFTER 4.5 NORTH,
NOTE CORRODED NAILS NOT FULLY
SECURING THE RAFTER TO THE TOP PLATE
PI.1 NOT TO SCALE

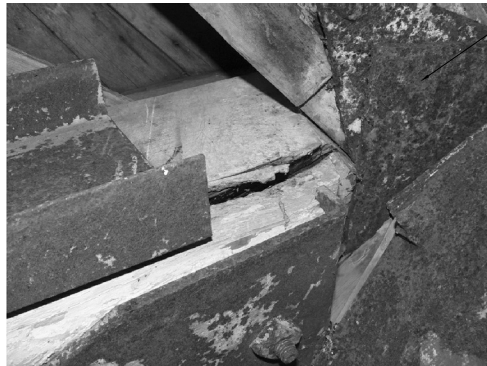
1
P1.4

VALLEY RAFTER 17 NORTH,
ABOVE DRILLING LOCATION
D12 WITH A SPLIT END

REMOVE
EXIST. STEEL
CONNECTIONS.

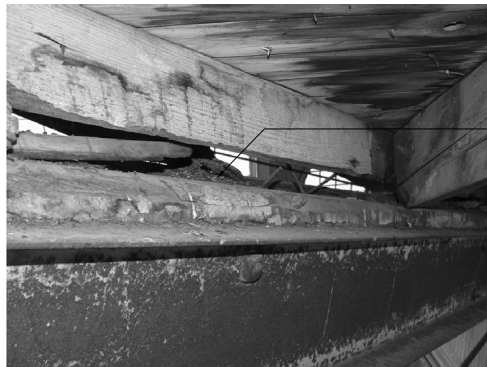
4
P1.4

DECAY

VALLEY RAFTER 17 SOUTH
BELOW DRILLING D23

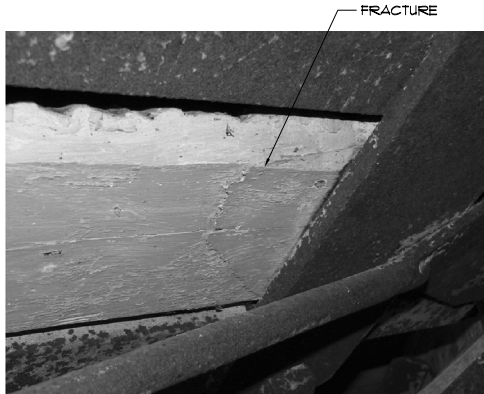
2
P1.4

FRACTURE

FRACTURE NEAR THE APEX OF
VALLEY RAFTER 17 NORTH BELOW
THE END SPLIT SHOWN IN 3/P1.3

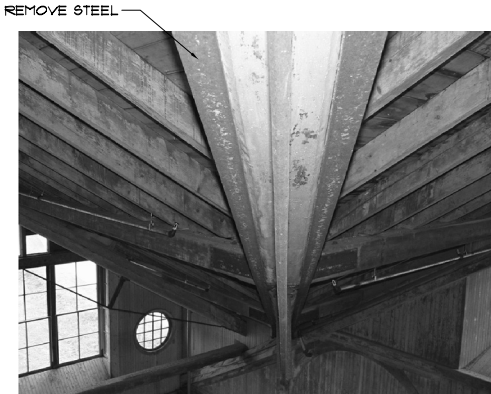
VALLEY RAFTER 17 SOUTH AS
VIEWED FROM THE APEX

REMOVE STEEL

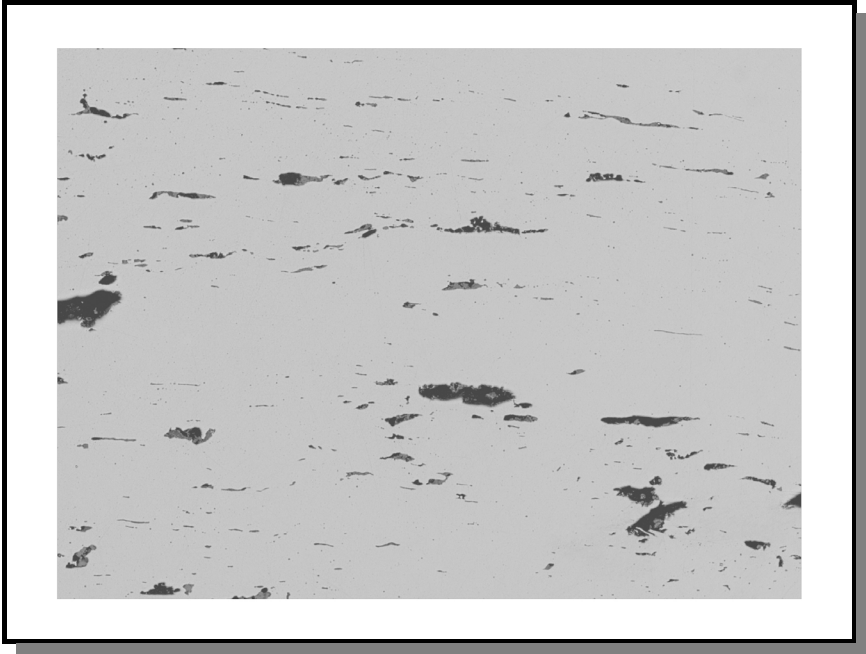
FIGURE 1

SFBB-1
Large oriented oxide inclusions.

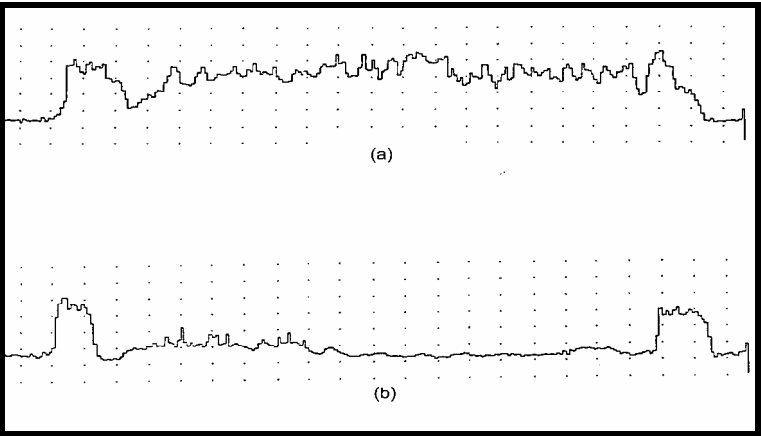
Figure 4. Results from resistance drilling showing (a) solid wood and (b) wood with internal deterioration.

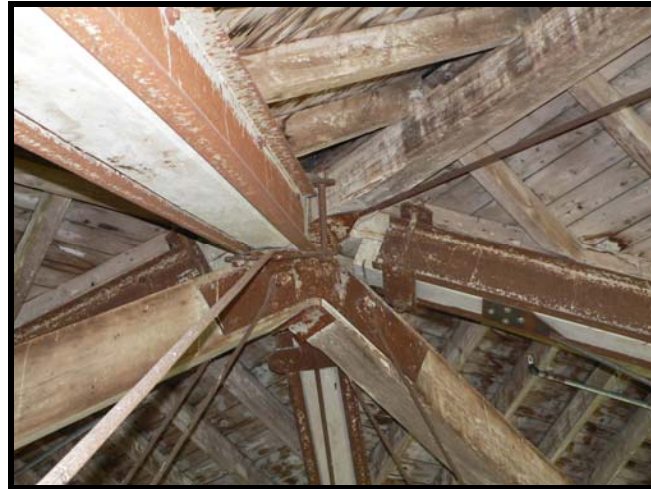
Figure 6. Apex of valley rafters showing steel side channels, east end of the Barn.

The timbers that make up the valley rafters are generally in good to excellent condition. Each of the rafters was subjected to resistance drilling along its length to generate a schematic of the location and approximate extent of deterioration. Some of the rafters have deterioration on the upper face of the timber that penetrates to various depths, a condition called channelizing. Two of the valley rafters have severe deterioration of the heel where they bear on the interior wall.

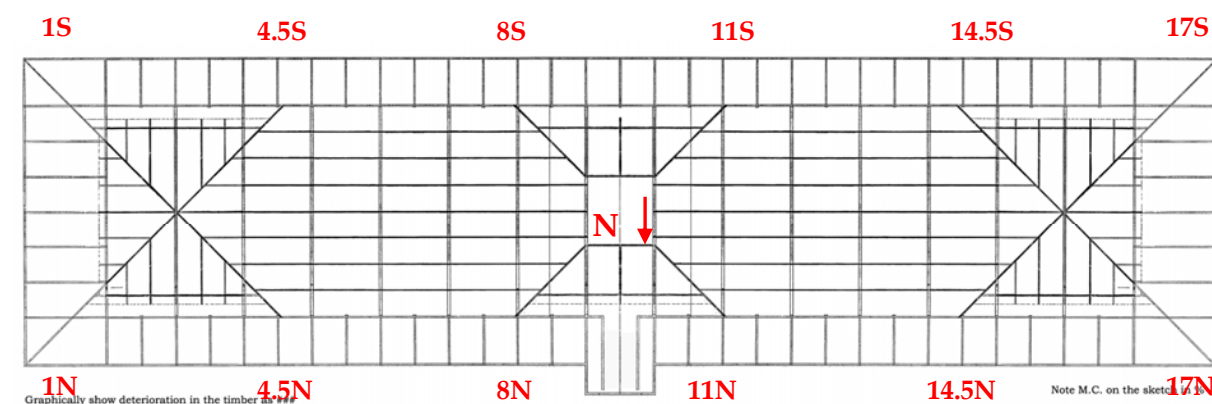
Figure 7. Plan view showing valley rafter designations.

Table 1 provides a general summary of the findings by rafter. Conditions identified in red should be priorities for engineering analysis and / or repair. The numbering of the valley rafters, shown in Figure 7, is based on the grid system used by other team members. Schematics of each valley rafter are color-coded to provide the reader with a visualization of the deterioration found. The choice of colors is subjective and is done only for the purpose of distinguishing the level of deterioration found. Areas colored green indicate no deterioration found. Areas in yellow exhibited minor channelizing (approximate depth of two inches or less) at the top of the rafter or minor deterioration elsewhere in the cross section. Orange areas indicate either local failure or deeper channelizing. Areas colored red on the schematics should be considered a priority for the structural engineer.

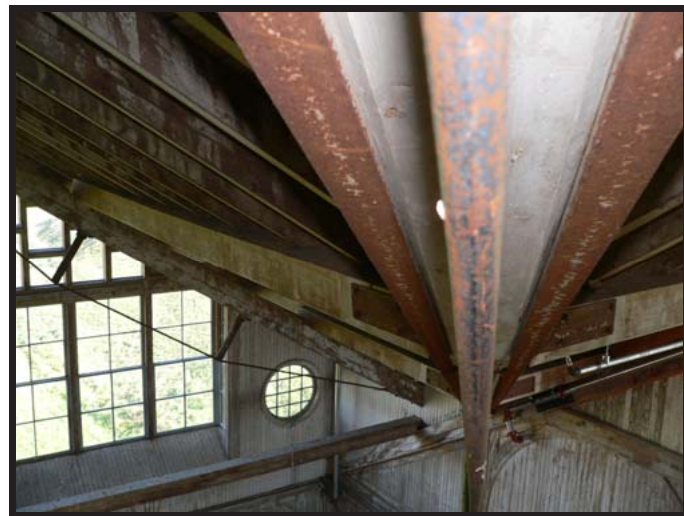
This rafter, located at the east end of the Barn, is in good condition, as indicated by the green color along its length in Figure 8. The timber, seen from above in Figure 9, appears free of large checks, splits or slope of grain. The steel bar that appears along the center of the timber is the lower chord of the queen post truss illustrated on the bottom of Figure 8. The connector plate on the bottom of the queen post truss near the east wall has deformed lags, likely indicative of shifting loads over time (Figure 10).

Figure 9. Valley Rafter 1 North viewed from the apex.

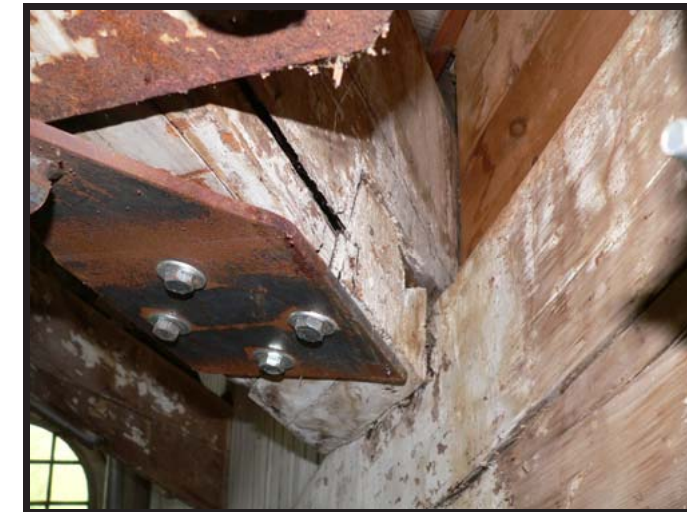
Figure 10. Valley Rafter 1 North at east wall; note deformed lags.

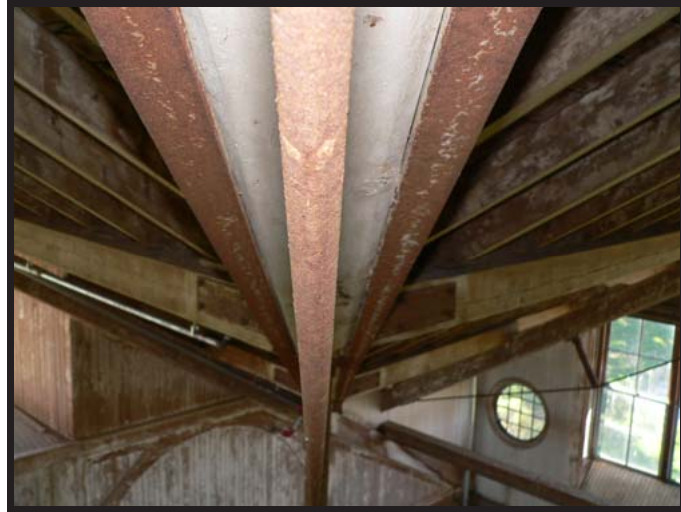
This rafter is in good condition, as indicated by the green color along its length in Figure 11. The timber, seen from the apex in Figure 12, appears free of splits or slope of grain. The seasoning check shown in Figure 13 is typical for large cross-section timbers that dry in service and does not represent a failure in the timber.

Figure 12. Valley Rafter 1 South viewed from the apex.

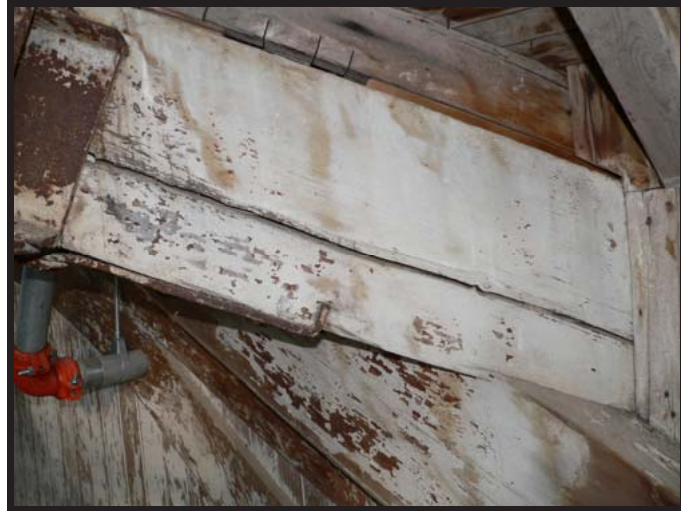
Figure 13. Valley rafter 1 South, drying check on the south face.

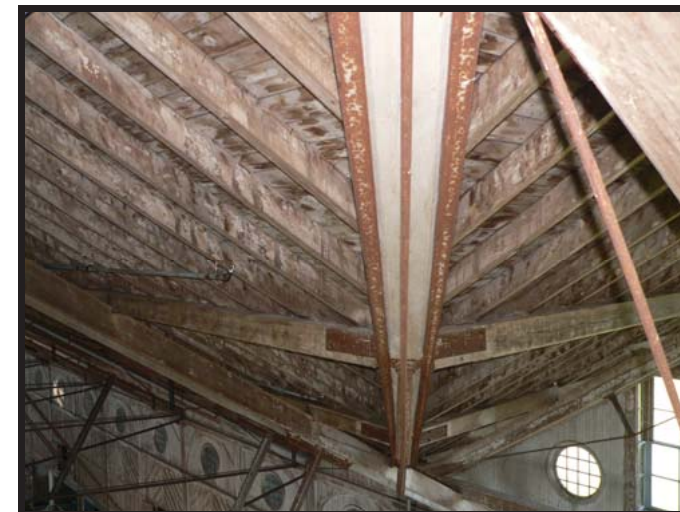
Much of this rafter is in good condition (Figure 14). The timber, seen from the apex in Figure 15, appears free of splits or slope of grain. However, there is possible minor deterioration in the vicinity of Truss 4 (T4 on Figure 14) and some crushing of the timber has occurred. A more serious condition exists at the heel of the rafter, where it bears on the top plate of the north wall (Figure 16). The rafter is severely decayed and is secured to the top plate by four nails that are not in full contact with both the rafter and the top plate (Figure 17).

Figure 15. Valley Rafter 4.5 North viewed from the apex.

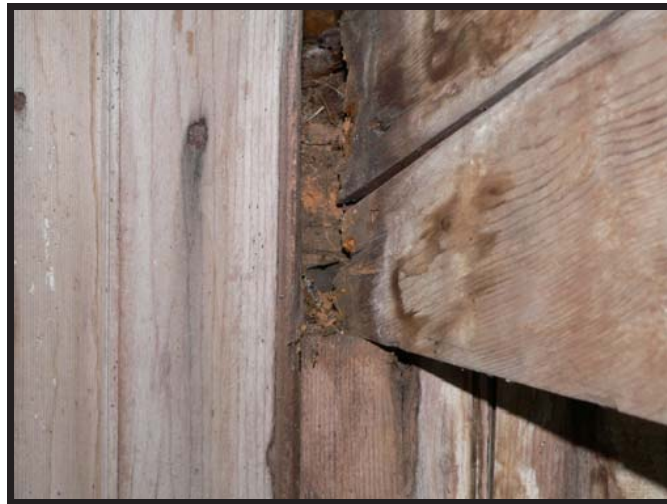
Figure 16. Heel of Valley Rafter 4.5 North at the north wall showing decay in rafter and top plate.

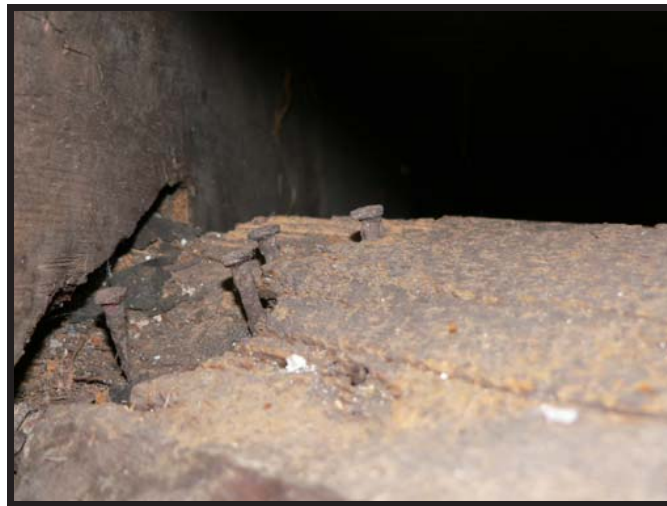
Figure 17. Heel of Valley Rafter 4.5 North; note corroded nails not fully securing the rafter to the top plate.

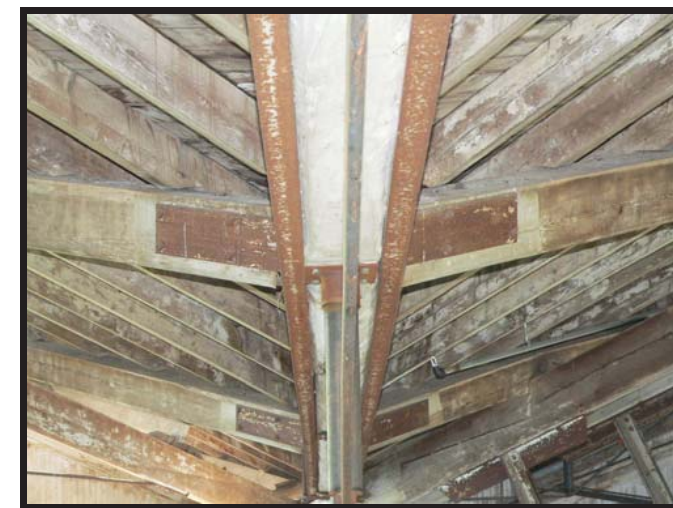
This rafter is in good condition, as indicated by the green color along its length in the schematic shown in Figure 18. Although the general appearance is good (Figure 19), and no deterioration due to decay was found using resistance drilling, this timber has severe slope of grain as indicated by the seasoning check shown in Figure 20. Severe slope of grain will reduce the load-carrying capacity of the timber.

Figure 19. Valley Rafter 4.5 South viewed from the apex.

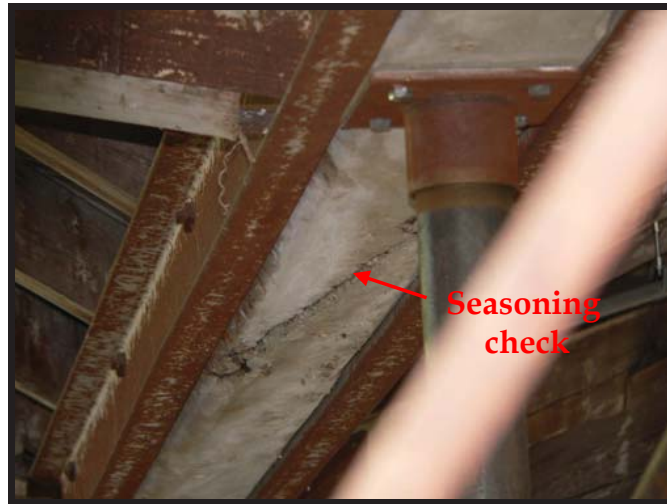
Figure 20. Seasoning check indicating severe slope of grain (1.5" in 10") in Valley Rafter 4.5 South.

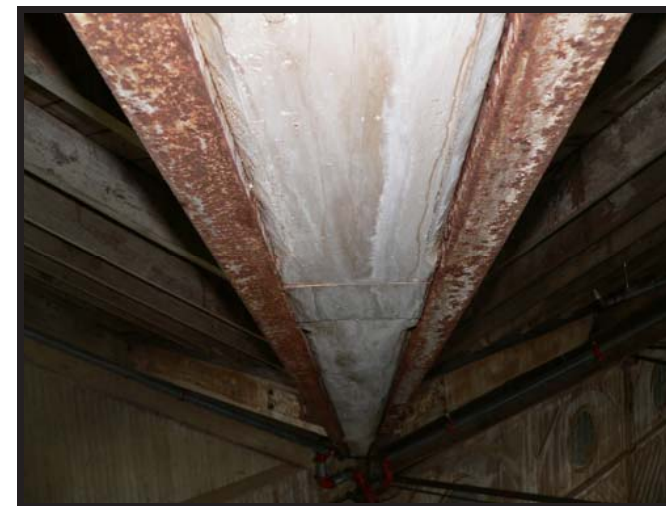
As shown in Figure 21, this rafter has minor channelizing along the lower length of the rafter. Viewed from below, no deterioration is visible (Figure 22). Resistance drilling and probing revealed deteriorated wood on the upper surface of the timber from just above the lower queen post to the heel of the rafter. The deterioration, some of which can be seen in Figure 23, does not dramatically reduce the cross section of timber.

Figure 22. Valley Rafter 8 North viewed from mid-length.

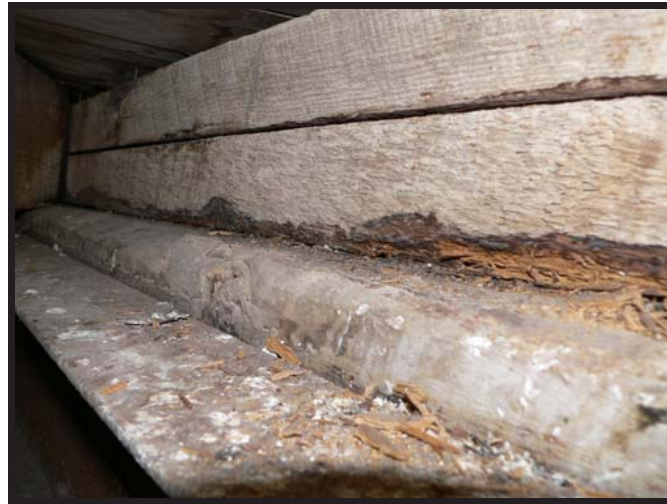
The likely cause of the decay is leaks in the roof that have since been repaired. So long as the moisture content of the timber is below 20 percent, the decay typically cannot be active. Proper maintenance of the roof covering is the key to keeping the timbers in the valley rafters dry. As with any of the deterioration found, the structural engineer should verify that the loss of cross section does not compromise the load-carrying capacity of the timber sufficiently to warrant reinforcement or replacement.

Figure 23. Valley Rafter 8 North at drilling location D84.

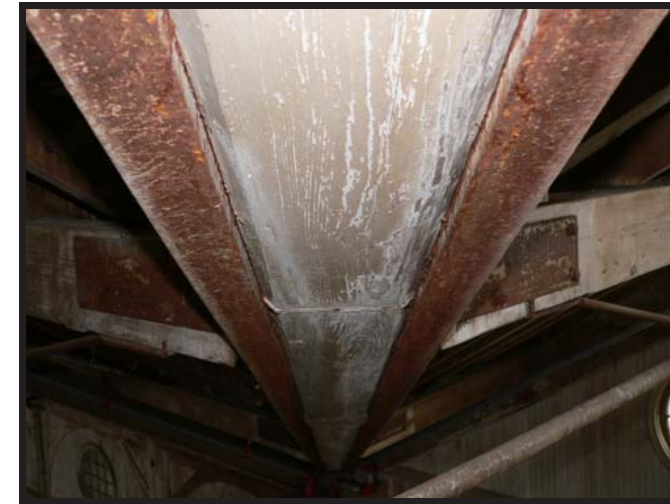
Figure 25. Valley Rafter 8 South viewed from apex.

As shown in Figure 24, this rafter also has minor channelizing along the lower length of the rafter. Viewed from below, no deterioration is visible (Figure 25). Resistance drilling and probing revealed deteriorated wood on the upper surface of the timber from just above the lower queen post to the heel of the rafter.

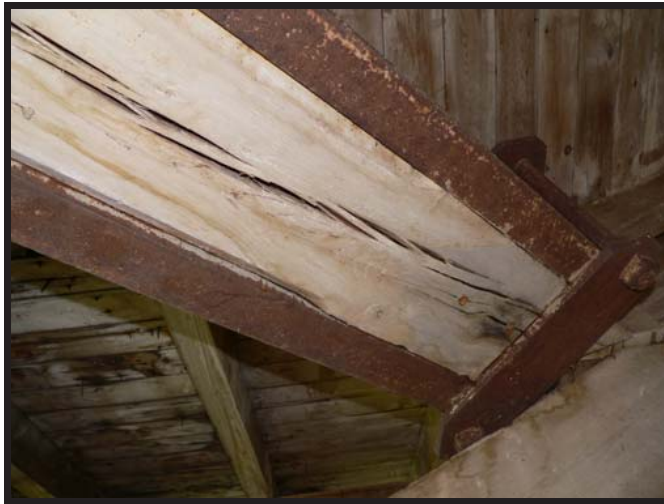
This rafter is in good condition, as indicated by the green color along its length in Figure 26. The timber, seen in Figure 27, has seasoning checks but minor slope of grain. The seasoning checks visible in Figure 27 are typical for large cross-section timbers that dry in service and do not represent a failure in the timber.

Figure 27. Valley Rafter 11 North showing seasoning checks.

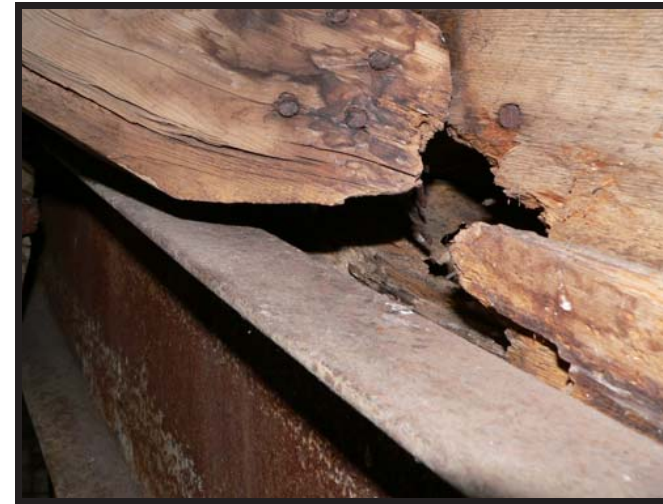
As shown in Figure 28, this rafter also has minor channelizing along the lower length of the rafter. Resistance drilling and probing revealed deteriorated wood on the upper surface of the timber from just above the lower queen post to the heel of the rafter. The area below the upper queen post has severe decay with significant loss of cross section (Figure 29). Additionally, the upper purlin is severely twisted where it meets the valley rafter (Figure 30).

Figure 29. Top of Valley Rafter 11 South near drilling D74

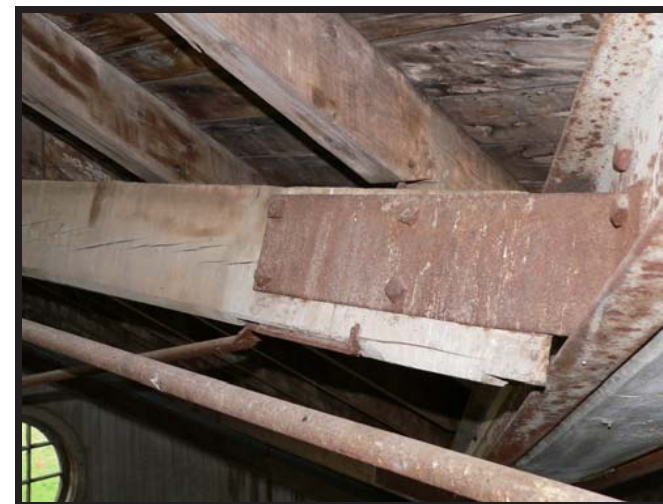
Figure 30. Upper purlin twisted at junction with Valley Rafter 11 South.

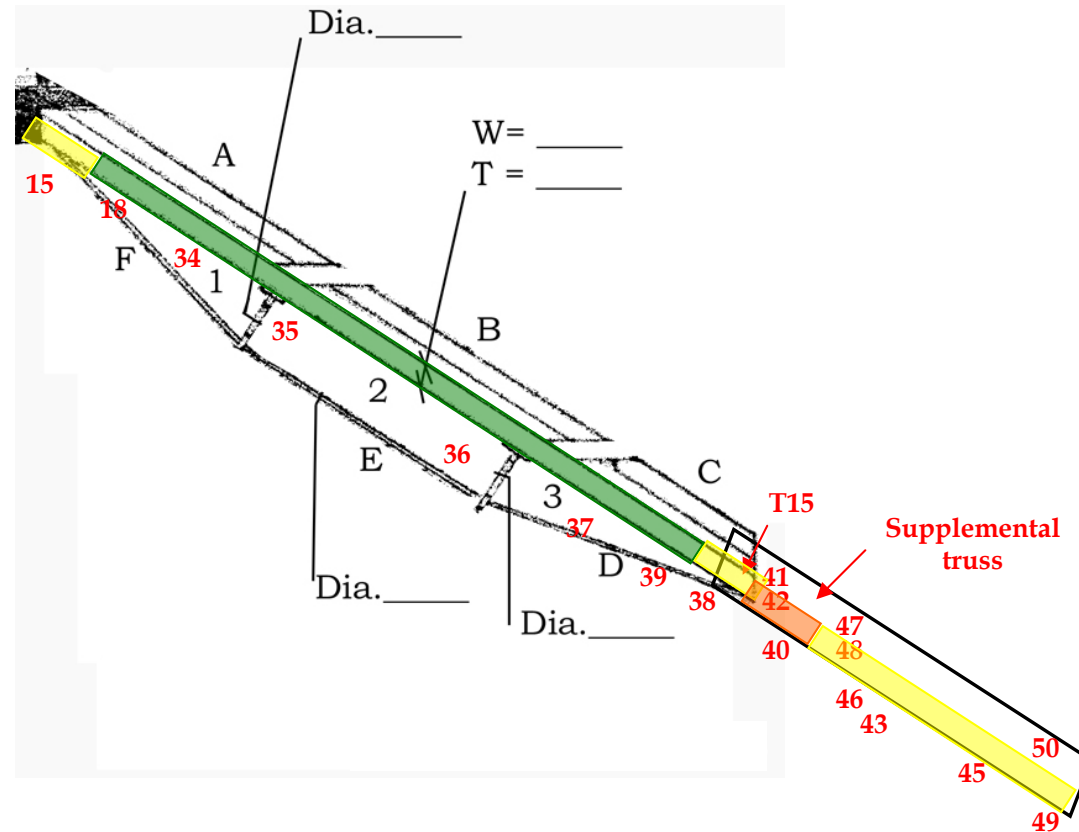
As shown in Figure 31, this rafter has minor channelizing along the lower length of the rafter. The upper length of the timber is in good condition (Figure 32); however, drilling near the apex (location D15) was inconclusive and it is possible that minor channelizing is present. Resistance drilling and probing revealed deteriorated wood on the upper surface of the timber from below the lower queen post to the heel of the rafter. There is a failure of the valley rafter at the supplemental truss (Figure 33). The heel of the rafter, where it bears on the top plate of the north wall, is decayed (Figure 34).

Figure 31. Inspection results from Valley Rafter 14.5 North

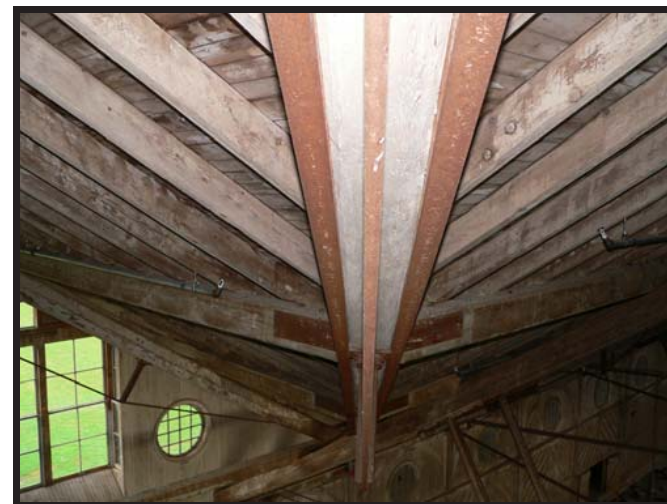
Figure 32. Valley Rafter 14.5 North from peak viewed from the apex.

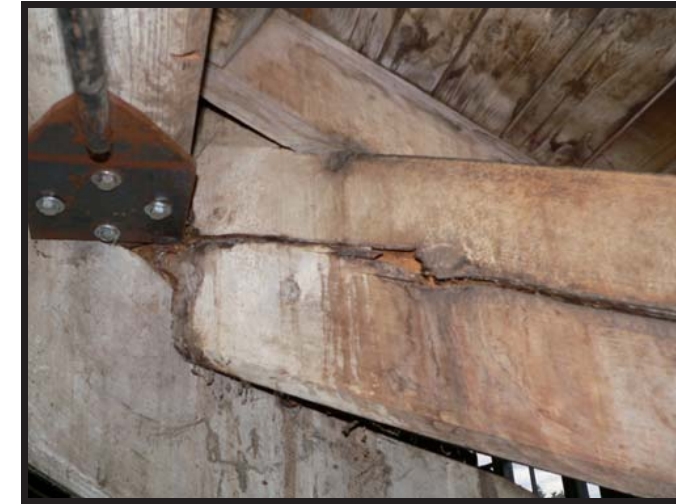
Figure 33. Failure in Valley Rafter 14.5 North, east of supplemental truss.

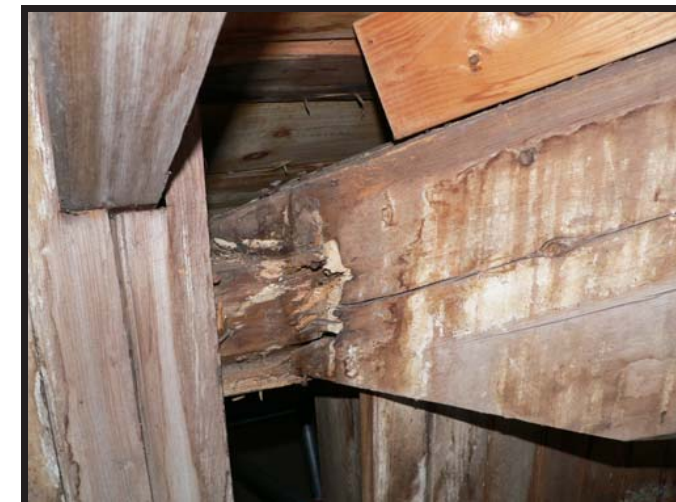
Figure 34. Valley Rafter 14.5 North showing decay in the rafter and the top plate of the interior wall.

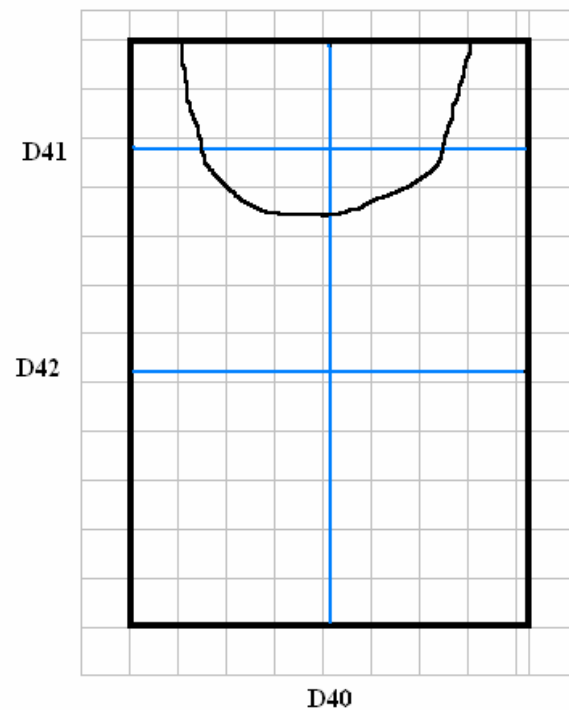
At a few locations on some of the valley rafters, transverse resistance drillings were conducted to establish the decay pattern that produced the channelizing. Figure 35 is a diagram of the drilling results from locations D40, D41 and D42 (which are shown on the schematic in Figure 35). The diagram is an approximation of the width and depth of the channel due to decay as indicated by the three drillings. Due to the loss of section in the timber, this is referred to as deep channelization.

Figure 35. Diagram showing channelization pattern in Valley Rafter 14.5 North near the supplemental truss.

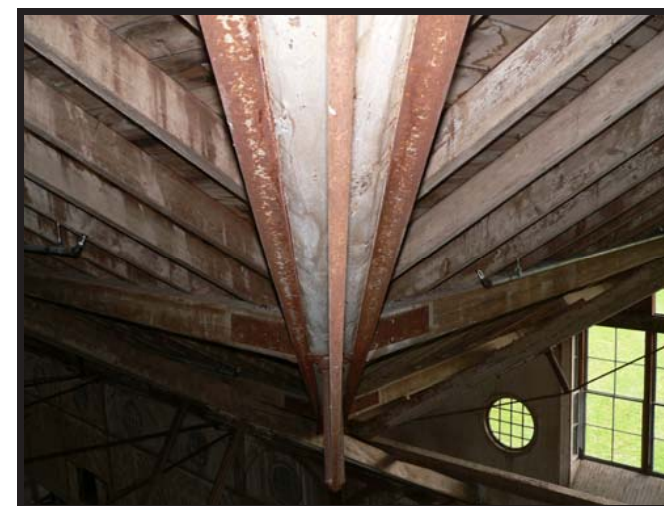
This rafter has minor channelizing along the intermediate length of the rafter (Figure 36). The upper length of the timber above the upper queen post is in good condition (Figure 37). The heel of the rafter, where it bears on the top plate of the south wall, is decayed (Figures 38 and 39).

Figure 37. Valley Rafter 14.5 South viewed from the apex.

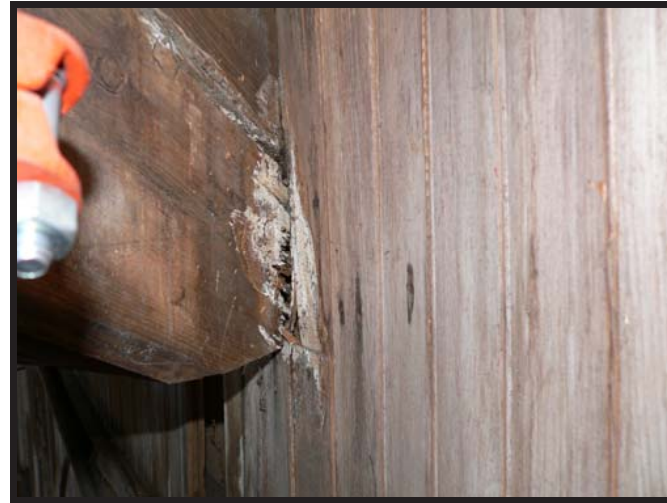
Figure 38. Valley Rafter 14.5 South where it meets interior wall.

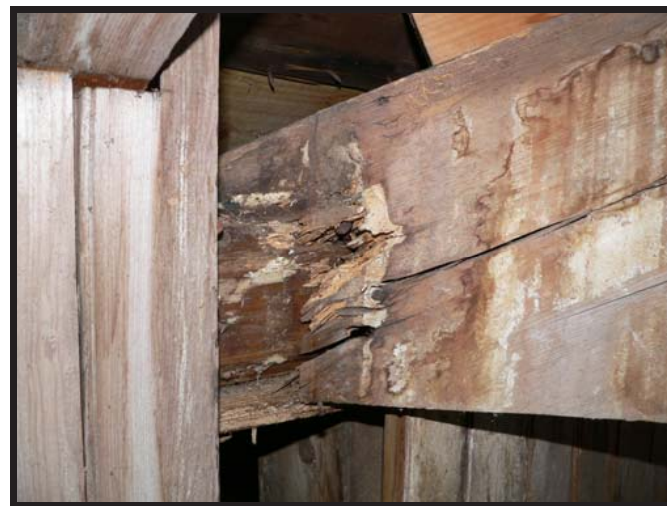
Figure 39. Valley Rafter 14.5 South at the top plate of the interior wall.

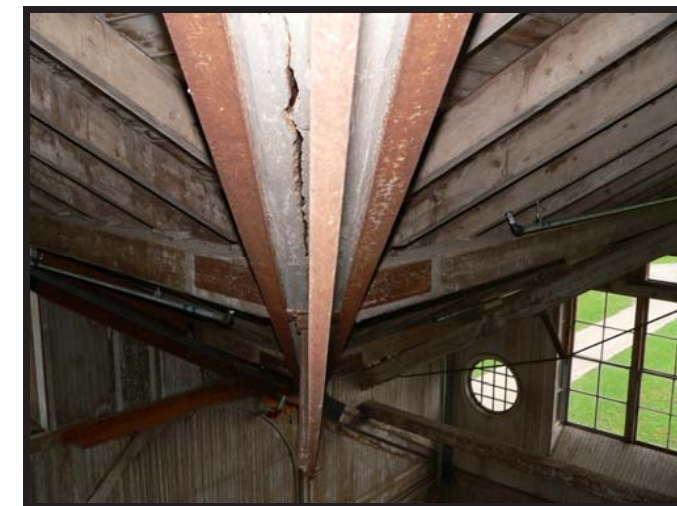
This rafter has minor channelizing along the intermediate length of the rafter (Figure 40). A seasoning check is visible on the bottom face of the timber (Figures 41 and 42). The wood spacer between the valley rafter and the roof rafter above has deteriorated along much of its length. Between the queen posts the deterioration has extended into the top of the timber in the valley rafter, resulting in channelizing (Figure 43). The timber has an end split at the apex of the valley rafter (Figure 44). The split may have affected the capacity of this connection as a fracture is visible on the bottom of the timber just beyond the steel connector plate (Figure 45).

Figure 41. Valley Rafter 17 North viewed from the apex.

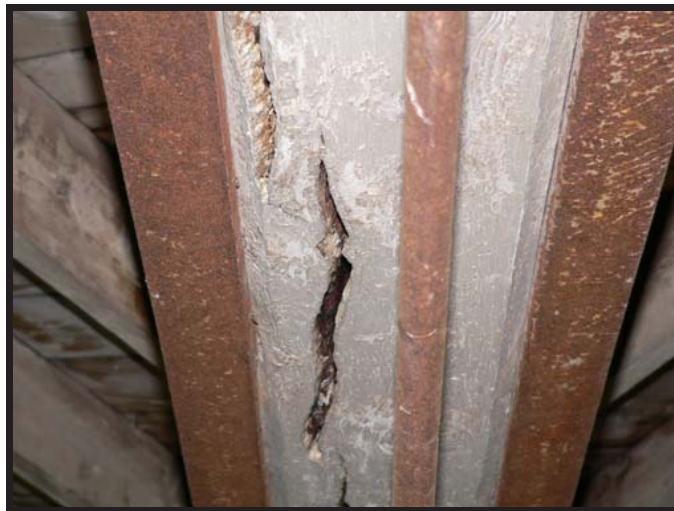
Figure 42. Seasoning check in Valley Rafter 17 North.

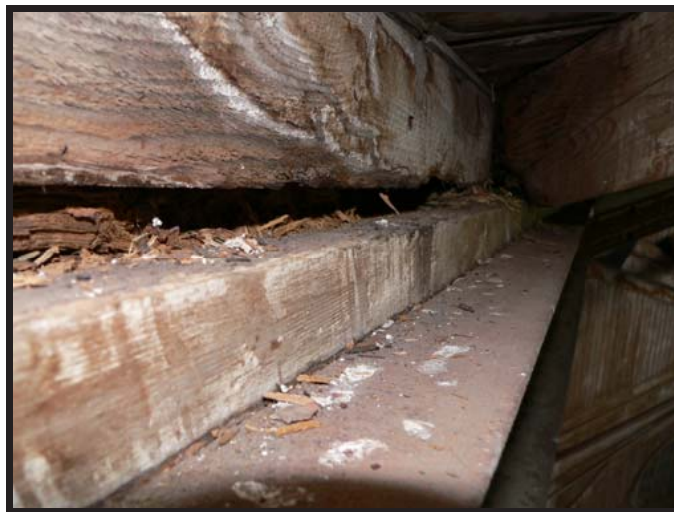
Figure 43. Valley Rafter 17 North below drilling location D8.

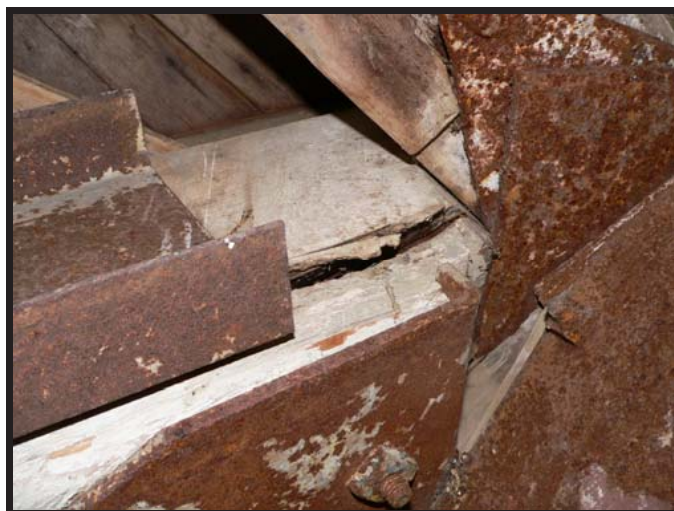
Figure 44. Valley Rafter 17 North, above drilling location D12 showing end split.

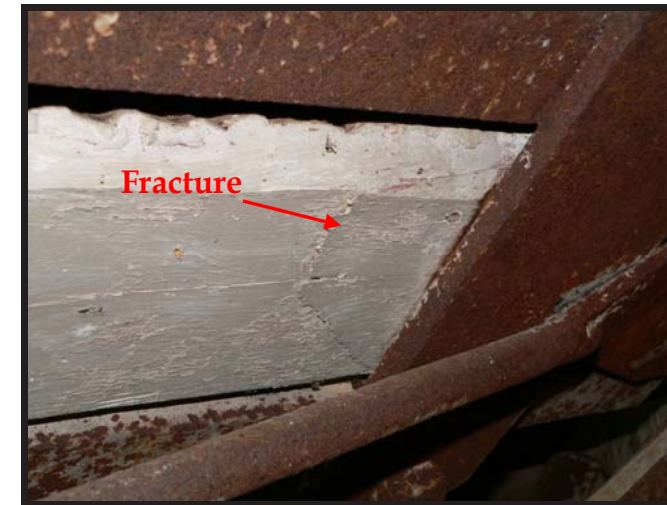
Figure 45. Fracture near the apex of Valley Rafter 17 North below the end split shown in Figure 44.

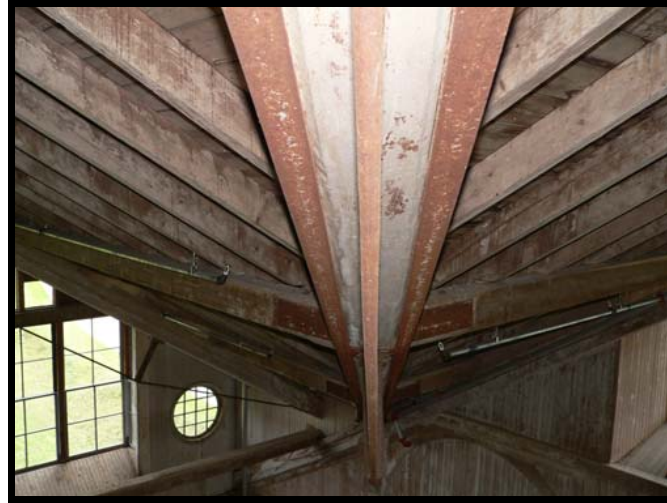
As shown in Figure 46, this rafter has a range of channelizing along the lower length of the rafter. Resistance drilling and probing revealed minor channelizing between the queen posts that progressively increased to the heel of the rafter. The upper length of the timber is in good condition (Figure 47). The wood spacer between the valley rafter and the roof rafter above has deteriorated along much of its length (Figure 48).

Figure 47. Valley Rafter 17 South viewed from the apex.

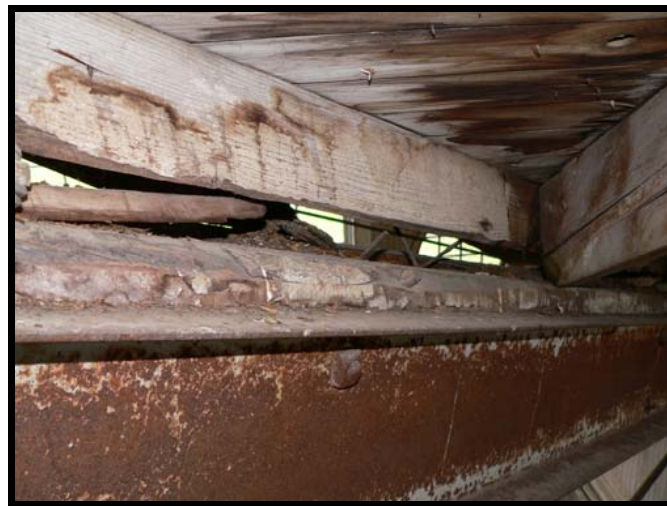
Figure 48. Valley Rafter 17 South below drilling D23.

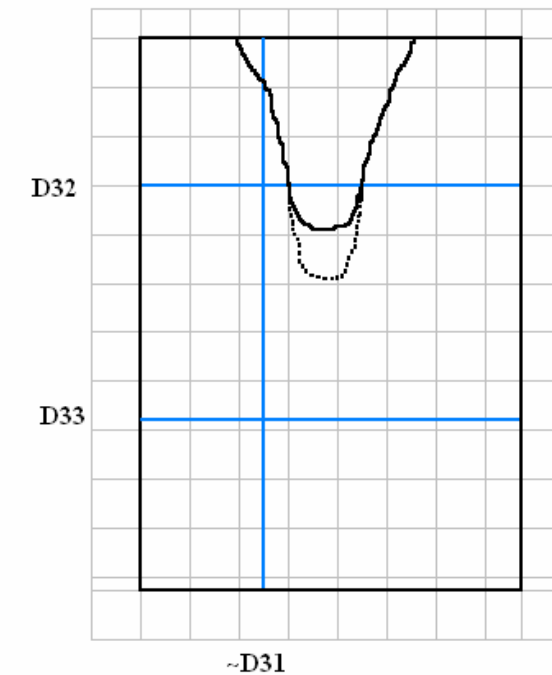
Figure 49 is a diagram of the drilling results from D31, D32 and D33 (which are shown on the schematic in Figure 46). The diagram is an approximation of the width and depth of the channel due to decay as indicated by the three drillings. Due to the depth of the decay pocket this is also referred to as deep channelization. Compare this pattern to that shown in Figure 35.

Figure 49. Diagram showing channelization pattern in Valley Rafter 17 South. Dotted line indicates likely pattern of the decay pocket, since only three drillings were conducted.
