Structural Repair of the Breeding Barn at Shelburne Farms

STRUCTURAL REPAIR OF THE BREEDING BARN AT SHELBURNE FARMS

VOLUME II: APPENDICES

THE STRUCTURAL REPAIR OF THE BREEDING BARN AT
SHELBURNE FARMS

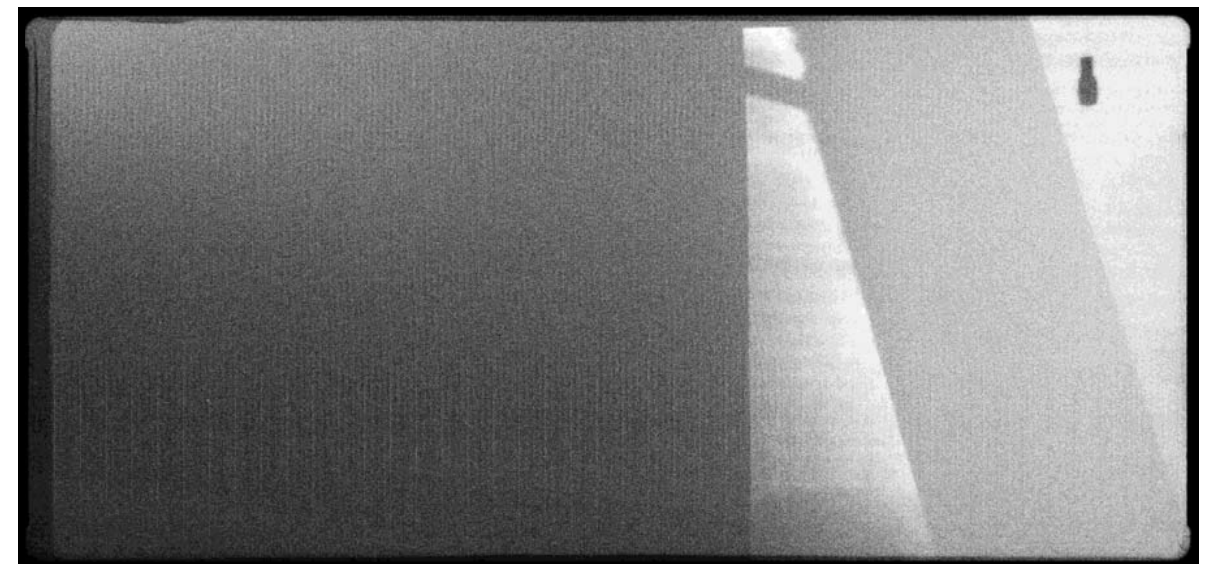
The radioscopy system was configured to examine a post-beam connection. The placement of the imaging plate and x-ray source are shown in Figure A. The resulting radiograph is shown in Figure B. The large steel plate is clearly visible as is an iron rod. With further data collection and data interpretation it would be possible to determine the connection details as well as the condition of the wood and steel components of these types of connections.

Figure B. Radiograph corresponding to the setup shown in Figure A.

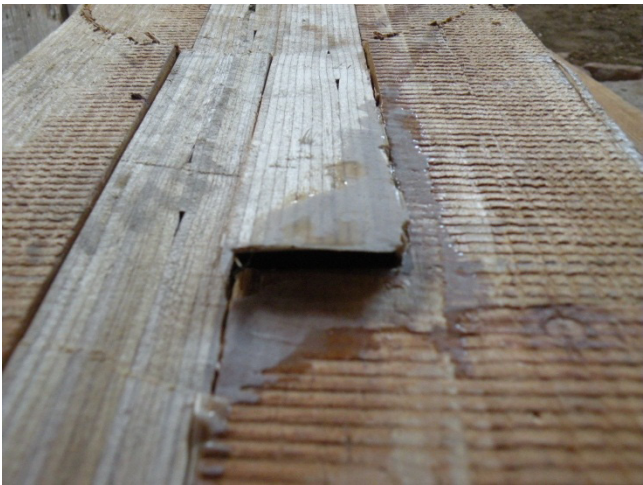
Not all of the LVL Dutchman specimens performed as well as the one described above. Figure 5 is another LVL Dutchman repair specimen (#2); one that failed at a load not significantly lower than the solid timber controls but failed in a manner that indicated that the repair was inadequate. This can be seen by the separation of the two sections of LVL with the section on the right in Figure 5 forced out of the notch as the load was applied. The bond quality between the timber and the LVL and between the sections of LVL was poor. In fact, it was easy to remove the LVL sections from the notch after cutting through the specimen (Figure 6).

Figure 5. Poor-quality LVL Dutchman repair specimen after failure.

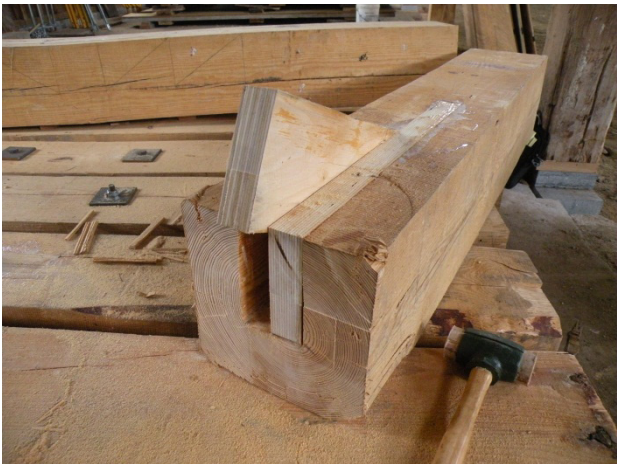
Figure 6. Poor bond as indicated by easy removal of the Dutchman.

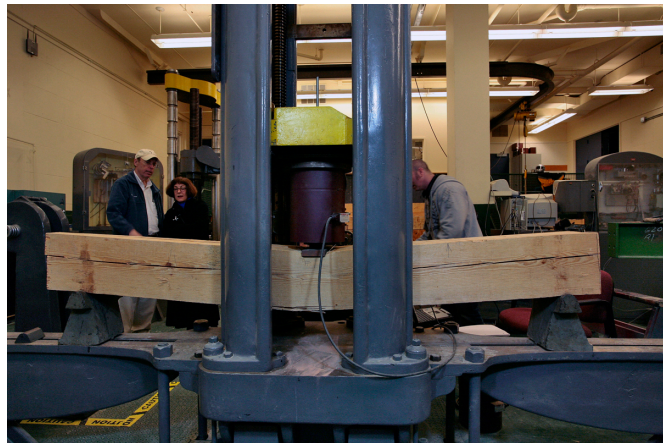
SAMPLE NO: 2 (10 1/4 x 10)
SAMPLE TYPE: LVL dutchman
MODE OF FAILURE: Compression failure at load cell followed by tension failure shortly after at about 44,600 lbf; accompanied by shear failure (sample right). On opening the joint, it was clear that adhesive was never applied to the Dutchman, but only to the mortise. The lvl was easy to remove in pieces once the timber had been cut across the repair

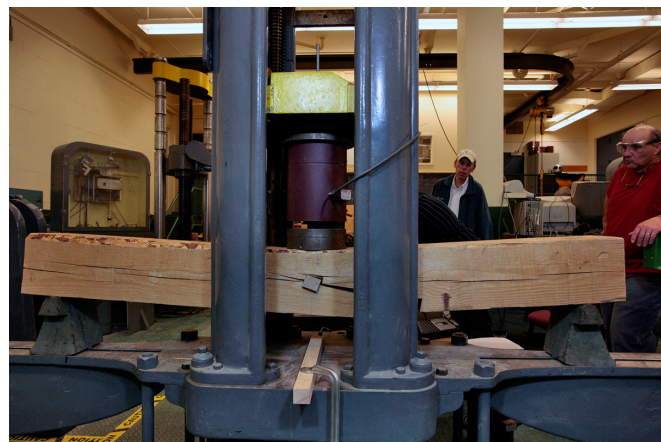
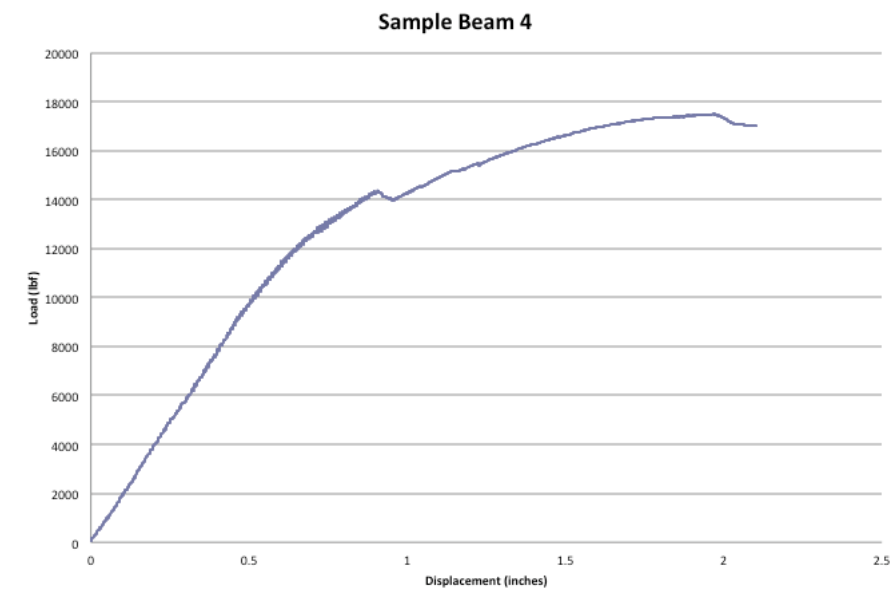
SAMPLE NO: 3 (10 1/8 x 10 3/16)

SAMPLE TYPE: Scarf (single key, nearly square in section)

MODE OF FAILURE: Opening of joint on tension side accompanied by rolling of the key and failure of the upper half of joint at 15,600 lbf

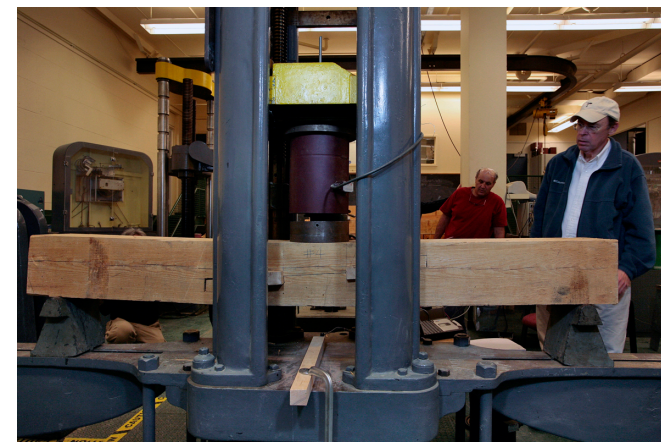
SAMPLE NO: 4 (10 x 10)

SAMPLE TYPE: Nosed scarf

MODE OF FAILURE: Shear failure at lower cog housing at 17,500 lbf

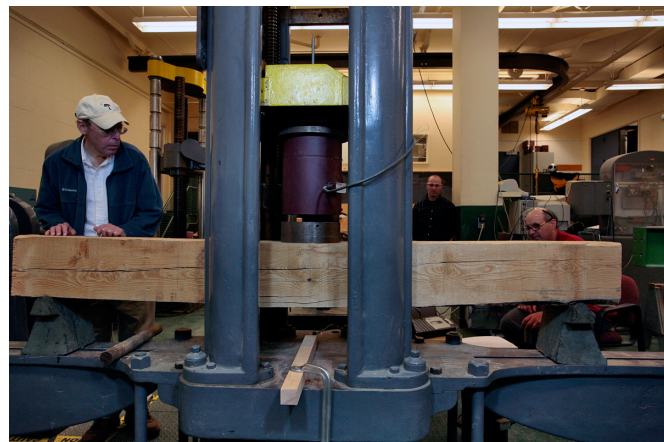
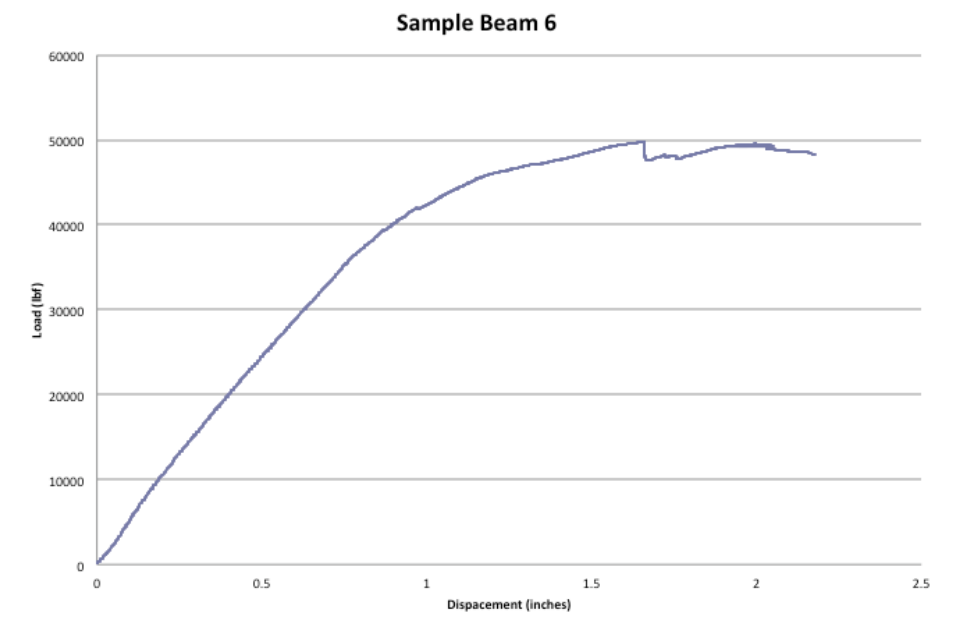
SAMPLE NO: 5 (9 7/8 x 10)

SAMPLE TYPE: LVL dutchman

MODE OF FAILURE: Compression failure followed by tension failure at load cell at 45,800 lbf.

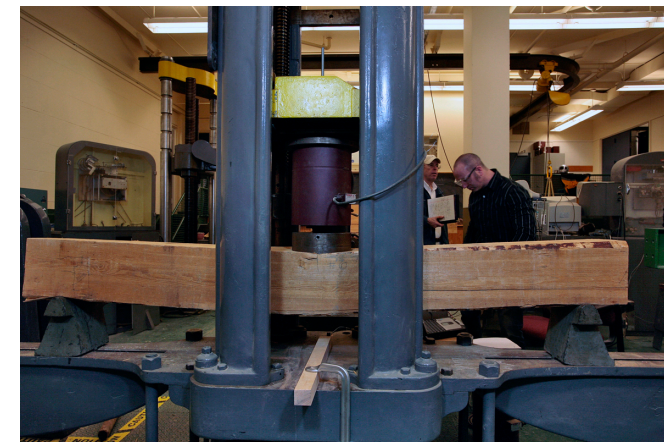
SAMPLE NO: 6

SAMPLE TYPE: Control

MODE OF FAILURE: Compression failure followed by tension failure at load cell at 50,000 lbf.

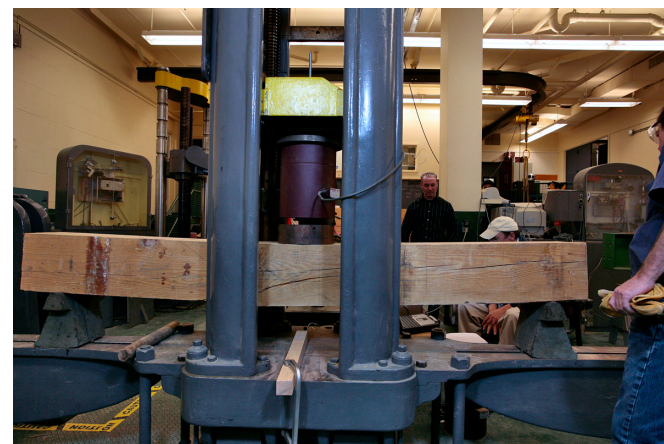
SAMPLE NO: 7 (10 x 10 1/16)

SAMPLE TYPE: LVL dutchman

MODE OF FAILURE: Tension failure initiated in lower third of sample depth at about 47,500 lbf. Glue joints at top surface began to open at about 48,000 lbf. A second crack below the neutral axis but originating at about the same level as the bottom of the trench appeared at 53,000 lbf.

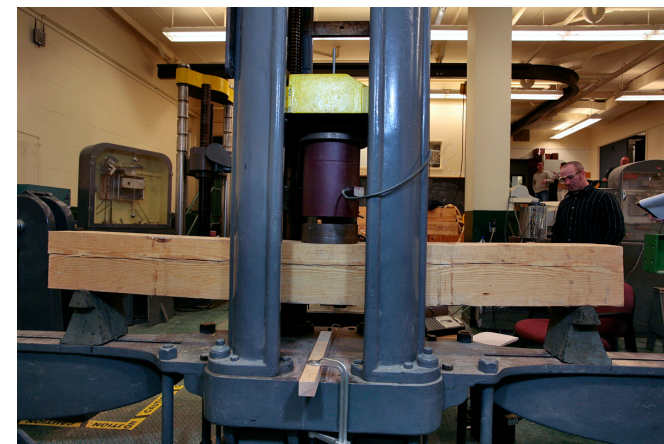
SAMPLE NO: 8 (10 1/16 x 10 1/8)

SAMPLE TYPE: Control

MODE OF FAILURE: Shear failure (sample left) initiated at about 35,000 lbf. Separation of heartwood at approximately 40,000 lbf

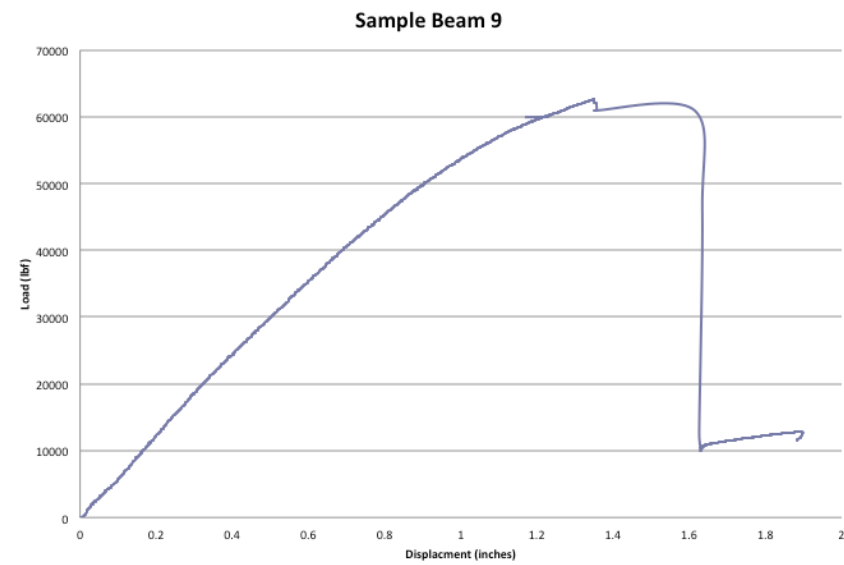
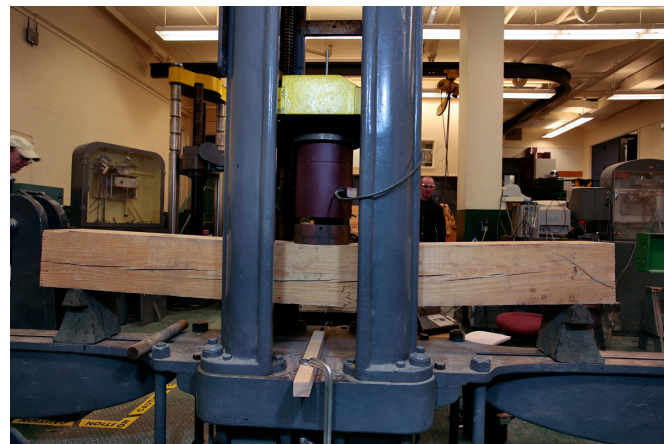
SAMPLE NO: 9 (10 x 10 1/16)

SAMPLE TYPE: LVL dutchman

MODE OF FAILURE: Glue joints at top surface began to open @ 56,000 lbf, with abrupt failure in tension @ 62,000 lbf.

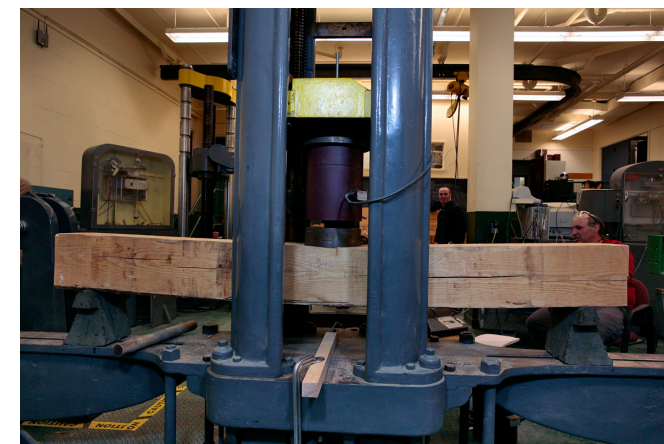
SAMPLE NO: 10 (10 x 10)

SAMPLE TYPE: LVL dutchman

MODE OF FAILURE: Glue lines opened @ 48,000, with compression failure in cheeks below load cell initiating @ 53,500 lbf, failure in shear (sample right) @ 54,000 lbf

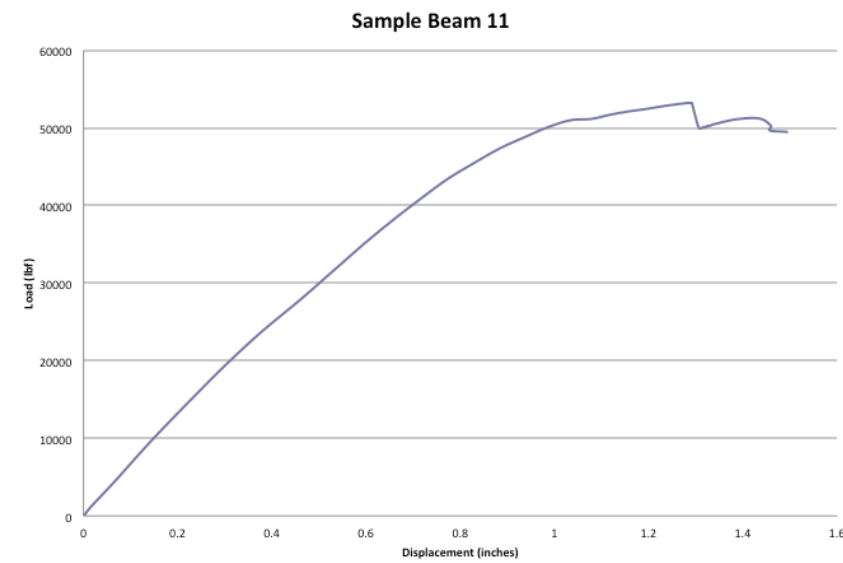
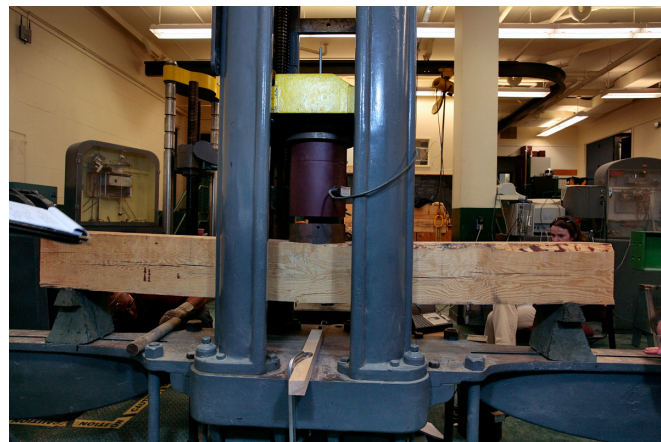
SAMPLE NO: 11 (9 7/8 x 9 15/16)

SAMPLE TYPE: LVL dutchman

MODE OF FAILURE: Shear cracks appeared at ends of sample @ 50,000 lbf, with tension failure initiating @ 51,000 lbf, complete @ 52,500 lbf

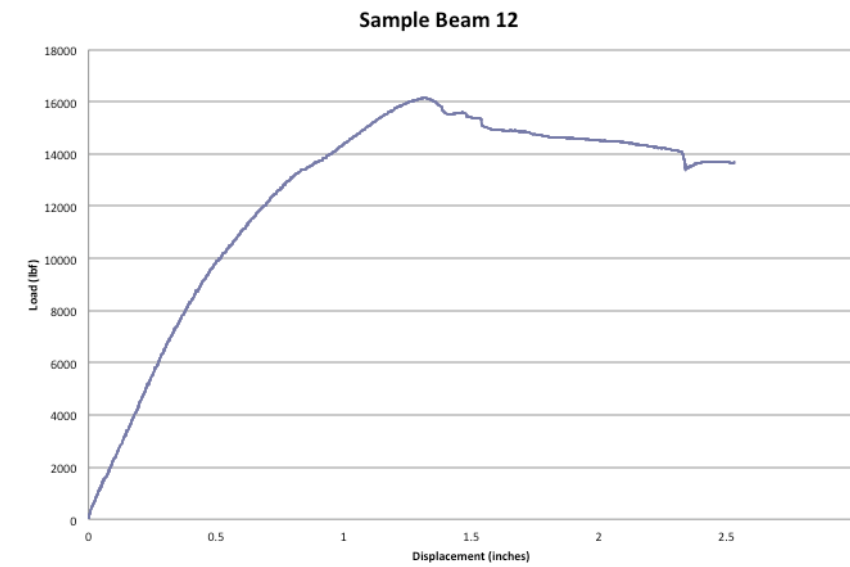
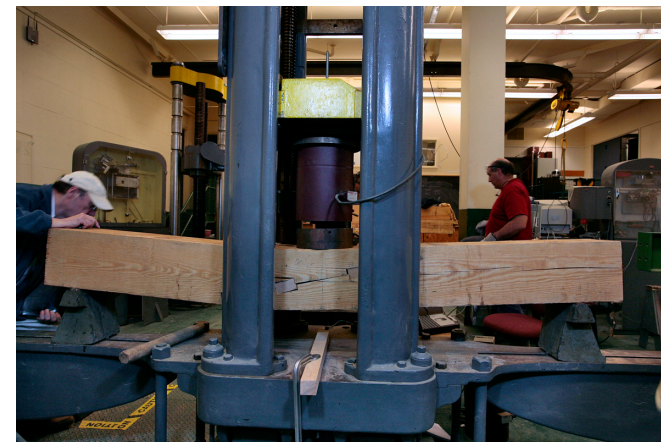
SAMPLE NO: 12 (10 x 10)

SAMPLE TYPE: Scarf (2 keys)

MODE OF FAILURE: Noticeable opening of joint on tension side at about 8,000 lbf, rolling of lower shear key by about 12,000 lbf. Compression failure around washers (top surface), shear crack opened in upper key and forward of it at about 15,000 lbf. Ceased to carry additional load at just over 15,000 lbf.

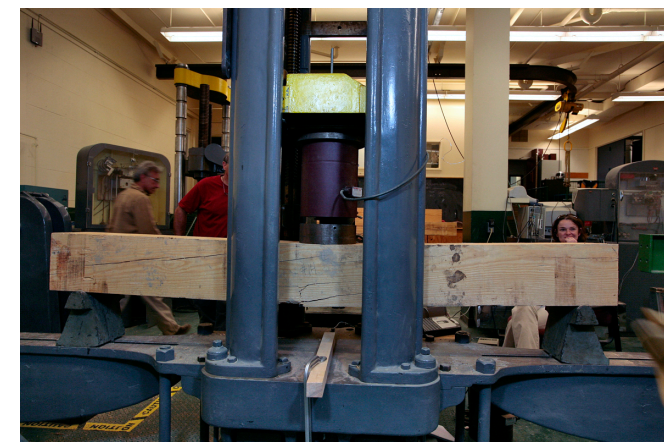
SAMPLE NO: 14 (10 1/16 x 10 1/16)

SAMPLE TYPE: Control

MODE OF FAILURE: Slope of grain steeper than other samples. Failure in tension initiating @ 38,000 lbf, ultimate failure @ 49,000 lbf

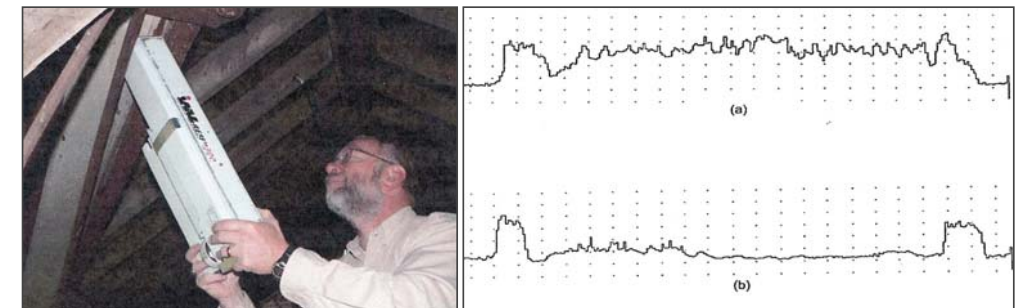
Figure 3: Resistance drilling was done to characterize the extent of deterioration in decayed frame members, left. At right, the top graph depicts sound timber (a), while the graph at bottom depicts timber with internal deterioration (Anthony, 2006).

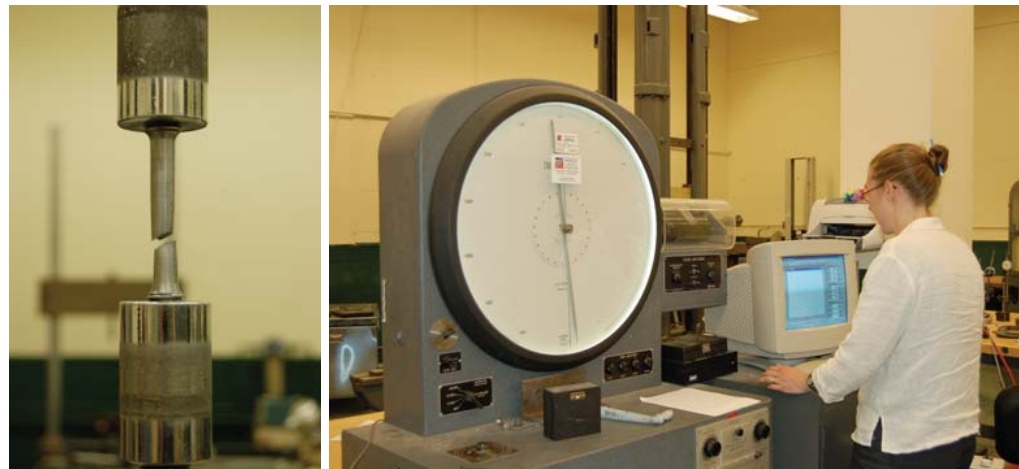
Figure 5: Tension tests (ASTM A 370-97a) were conducted on iron samples, yielding average peak stress values of approximately 319,820.7 KPa.

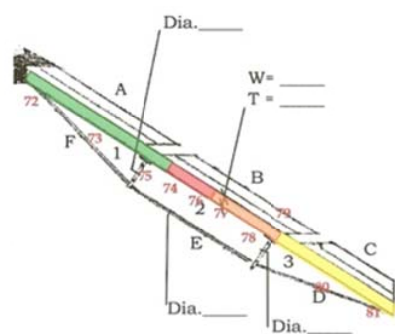
Figure 7 – Graphic presentation of resistance drill results for the valley member at B11.0. The color coding indicates various levels of damage requiring a specific level of repair as established by the project team.

Of the twelve timbers examined, five were found to have substantial section losses due to decay. Most of the losses appeared as decay channels located in the upper half of the timber section and probably the result of water leaking through the roof and finding its way into drying checks. Results of resistance drilling tests were expressed graphically and in tabular form, indicating the extent of section

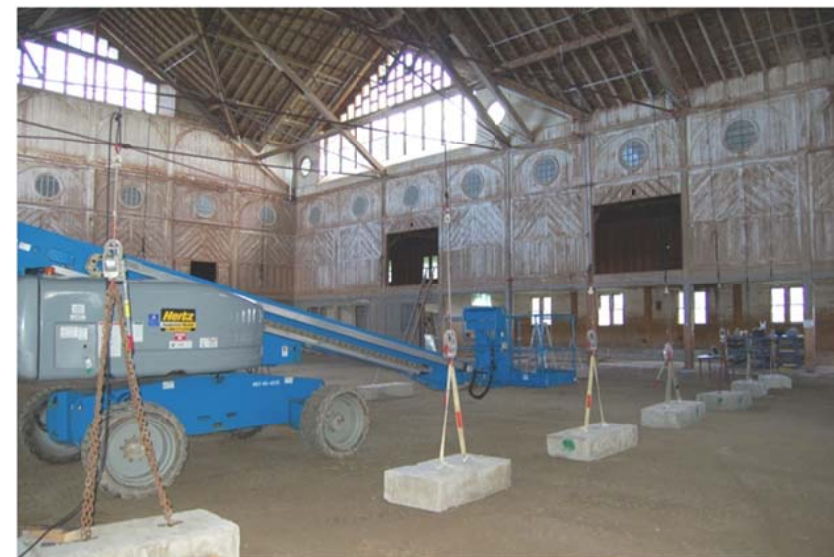
Figure 8 – Two trusses were load tested. Loads were applied at purlins, and changes in strain were recorded. Results were compared to computer models of the truss.

Strain gauges were used to measure changes in strain in bottom chord elements. In both loading scenarios, measured strains were substantially lower than values based on the original model, lending credence to the thesis that R. H. Robertson added cross-brace ties to the basic truss configuration sometime during construction, thus reducing horizontal and vertical deflection and reducing the stresses in both the original wrought iron elements and timber top chord. The addition of 1.91 cm thick by 7.62 cm high cross-brace ties to the building, apparently during construction, provides another path for the tensile force to be resisted (Figure 9). By including the ties in the analysis of the building cross section, the center tie bar of the truss becomes a zero force member (Fischetti, et al 2007).

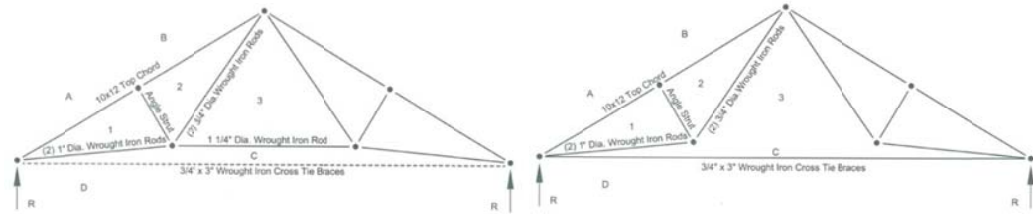
Figure 9 – Analysis of the primary truss indicated overstresses in bottom chord elements, particularly in the iron rod at the center (left). Adding the cross-brace tie, which Robertson apparently did sometime during construction, reduced stresses in iron and timber elements (right).

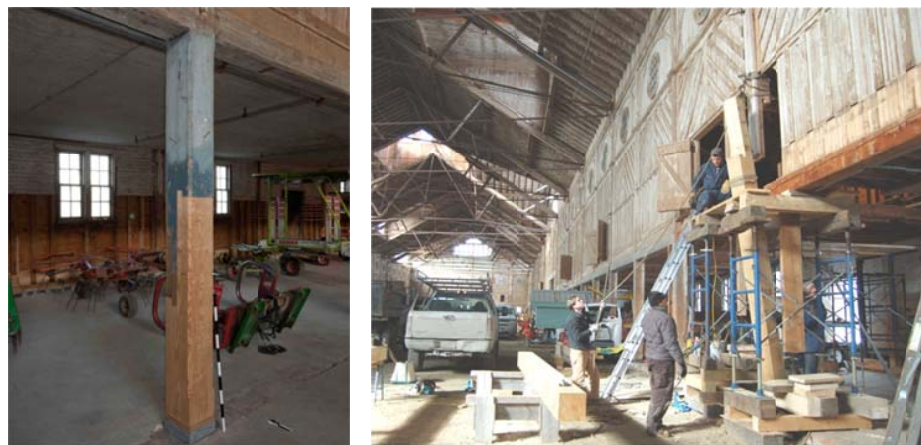
Of the 70 columns surrounding the riding ring, 60 of them were significantly decayed at the bases, partly due to installation of concrete floors in the mid-20th century, and damaged by agricultural machinery. Repairs typically included the scarfing of new column bases to replace decayed material, and the addition of sheet lead damp proofing, a limestone plinth block (matching the historic limestone piers), and white oak shims nested across the entire width of each column base. The scarf form used for most of the repairs replicated an historic form found in the building (Figure 10). By jacking three to four columns at a time, framers were able to bring aisle girts and plate timbers to a nearly level position.

Figure 10 – Columns were repaired by scarfing in new timber to replace decayed portions, using a nosed scarf form found elsewhere in the barn. New column bases were placed on limestone plinths and white oak shims, elevating them above a mid-20th century concrete floor (left). In four cases, column splices were made at the aisle level, requiring renewal of girt joinery and, in this case, replacement of the girts on either side (right).

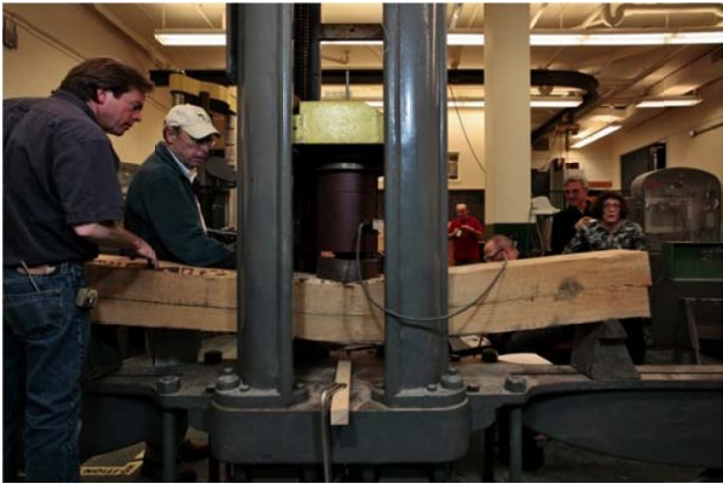
The tested repairs included nosed, keyed, and bolted scarf joints, and laminated veneer lumber (LVL) dutchman repairs installed in slots cut into simulated deteriorated timbers. The ultimate bending strength, modulus of elasticity, and mode of failure was recorded for each test. Results were compared to solid timber control specimens. Based on the results (as well as the ability to implement the repair *in situ*), the LVL dutchman repair provided the optimum repair strategy for long unsupported spans. Scarf joints were acceptable where they receive support from other parts of the frame, or where bending moments are low.

Figure 12 – Full size samples were tested to compare the performance of repaired timber to undeteriorated timber.

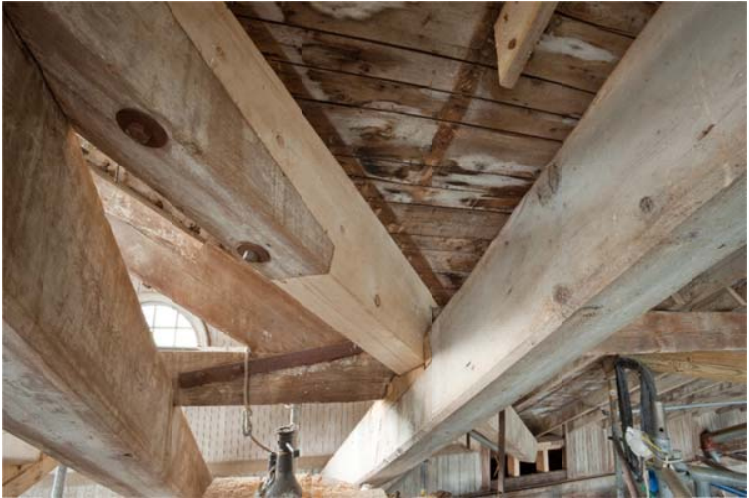
Figure 13 – New timber was scarfed into the valley member at J14.5 where both timbers receive support from truss rafters. The length of the replacement timber is approximately 6.4 m.

For valley members intersecting the plates at grid coordinates B14.5 and J14.5 (see Figure 11 for grid coordinates), decay in the lower third of the length of the members (near their intersections with trusses at gridline 15.0) was repaired by scarfing in new timber (Figure 13); scarf joints were located near intersections with trusses and were reinforced with bolts and structural washers. For valley members intersecting the plates at grid coordinates B11.0 and B8.0, scarf repairs were made within 2 m of the plate timbers, where the bending moments are low. The valley member intersecting the plate at grid coordinate J11.0 was replaced in an earlier repair campaign by three butt-joined timbers bolted to the steel channels. This assembly was replaced with a scarfed member (installing a single full-length timber was not feasible without removing a portion of the roof) with the scarf joint located near the lower queen

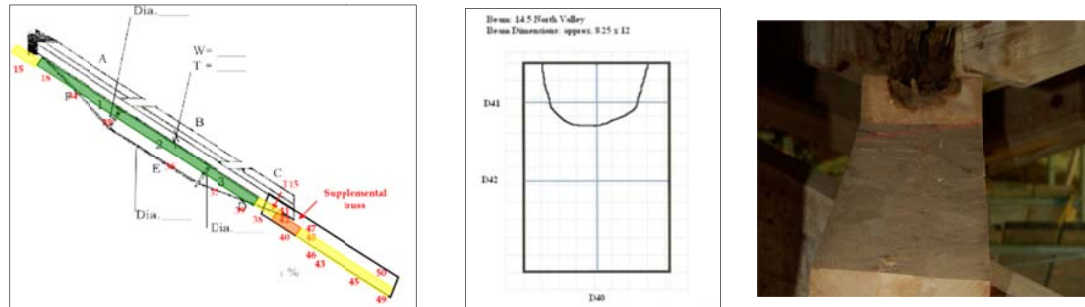
Resistance drilling was focused on valley members, where decay was extensive and timbers could not be visually inspected effectively because of the framing on top surfaces and steel channels bolted to the sides. In most cases, drilling results corresponded well to actual conditions and the drill survey proved to be a powerful tool in anticipating the extent and types of the repairs. For example, the results of the drill survey at J14.5 indicated a timber that was essentially sound over two-thirds of its length, with significant decay occurring near the intersection with the truss at gridline 15.0 and continuing through to its intersection with the plate. In the figure, the graphic is color-coded to indicate varying levels of deterioration along the length of the member. The section drawing approximates the size and shape of the decay channel at a particular drill site, and is based on drill results, the factors contributing to decay at this location, and the investigator’s experience and judgment. The photo, taken while repairs were underway, indicates the close correspondence between the graphic and actual conditions at that particular drill site (Figure 15).

Figure 15 – The color-coded graphic indicates the portion of the valley member at J14.5 most severely affected by decay (left), and the section drawing roughly indicates the size and shape of the decay channel near the intersection of the valley with the rafter at gridline 15.0 (middle). The photo (right), taken during construction, demonstrates a close correspondence between the section drawing based on drill results and actual conditions.

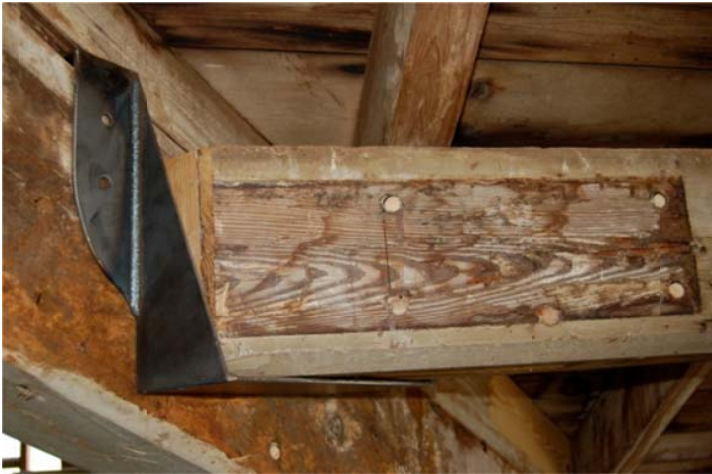
Figure 17 – Purlins are supported on custom-made bridles that replicate original ironwork. Where it was necessary to extend purlins, loose tenons were installed and blocks added to brace the valley timber.

On completion of woodwork repairs, missing truss work was reinstated and purlins were reconnected to valley members. All of the valley members at the lantern location (at the center of the barn) required new truss work. Truss rods and pipe struts were fabricated in steel (the originals are of wrought iron) to match the profiles and dimensions of the originals. The iron bridles that connected purlins to valleys were lost when the steel channels were installed, and purlins appear to have been shortened to make room for the steel. Ghosts left on the woodwork allowed fabricators to replicate original bridle profiles, and extra-deep replacement bridles (to engage the shortened purlins) were fabricated of 4.76 mm steel plate (Figure 17). Blocks were installed at purlin ends to provide bracing for the valleys, and roof loads were returned to valley members.

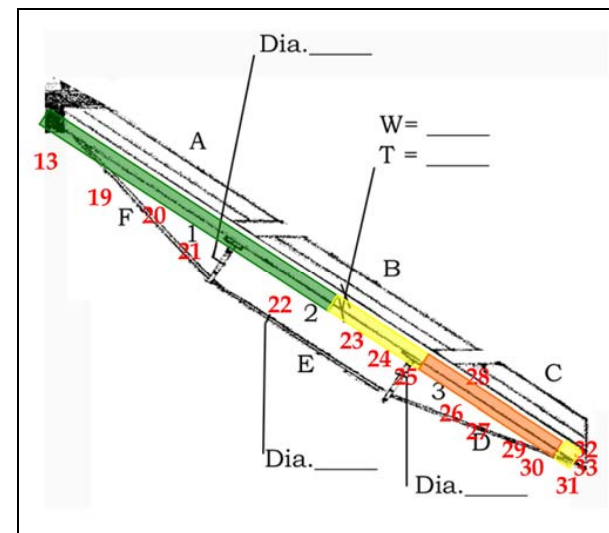
An example of one of the valley rafters is shown in Figure 5 and the corresponding resistance drilling findings are shown in Figure 6. Approximate resistance drilling test locations are marked by the drilling number on the schematic. As shown in Figure 6, this rafter has a varying extent of channelizing along the lower length of the rafter. Resistance drilling and probing revealed minor channelizing between the queen posts that progressively increased to the heel of the rafter. The upper length of the timber was found to be in good condition and is indicated as such by the green color.

Figure 6. Resistance drilling results for Valley Rafter 17 South. Numbers in red indicate drilling locations.

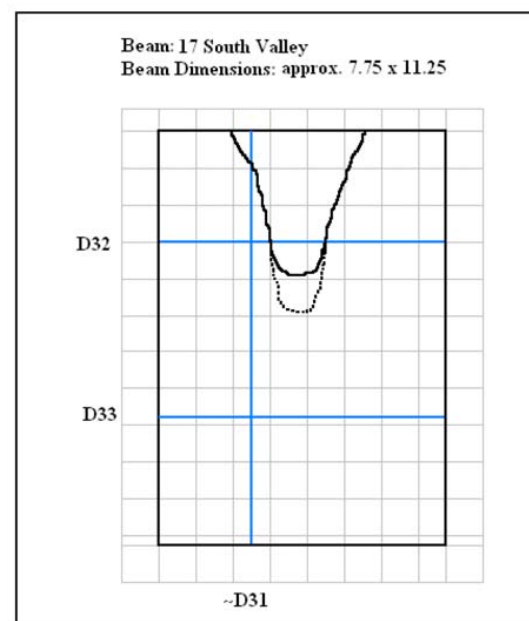
Figure 7 is a diagram of the drilling results from drillings 31, 32, and 33 (which are shown on the schematic in Figure 6). The diagram is an approximation of the width and depth of the channel due to decay as indicated by the three drillings. A decay pocket of this depth was referred to as deep channelization.

Figure 7. Diagram showing channelization pattern in Valley Rafter 17 South. Dotted line indicates likely pattern of the decay pocket, since only three drillings were conducted.

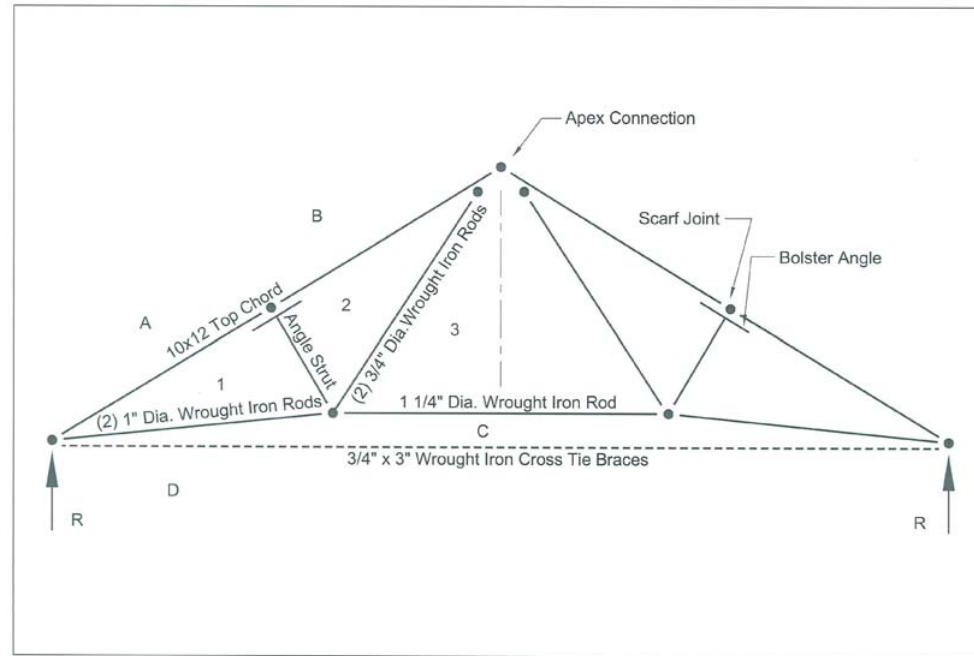
The preliminary analysis of the primary truss was performed with a 146.5 kg/m² snow load and 73.2 kg/m² dead load. The analysis indicated that there are overstresses in the top chord as well as the rods which extend from the heel supports to the queenpost struts. It is possible that the overstress in the 0.254 m x 0.305 m top chord is a result of the original designer analyzing the truss using graphical means (force diagram and string polygon) first developed in the United States by Col. Stephen H. Long in the 1840's. This method of

Figure 8. This image shows the location of the bolster angles and the connection arrangement at the apex.

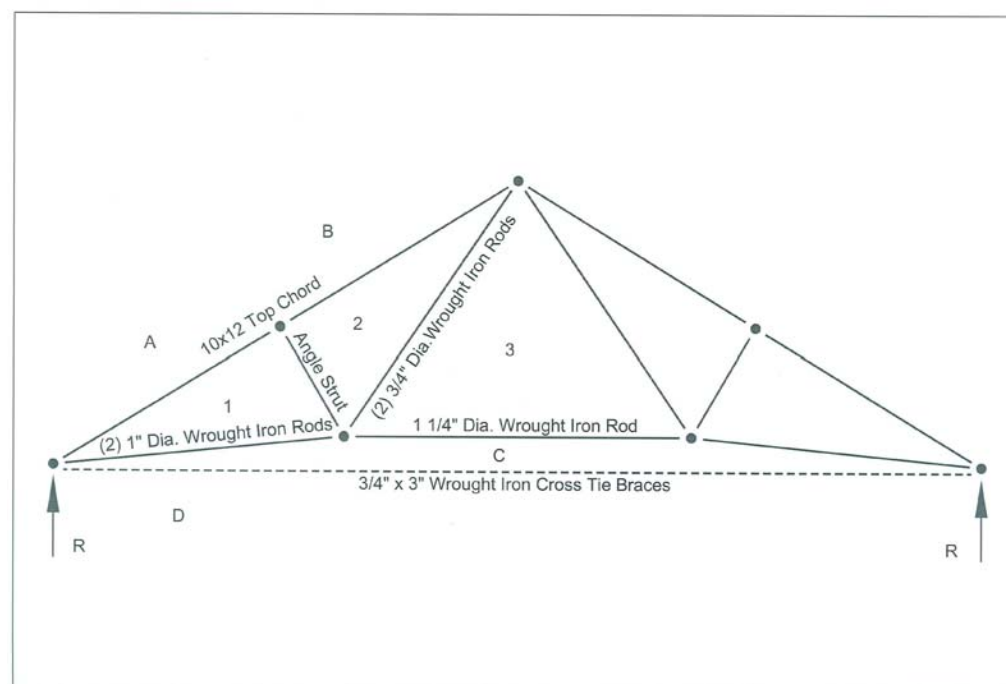
Figure 11. Analysis of the truss with the cross braces included, causes member C3 to revert to compression.

The addition of 1.91cm thick by 7.62cm high cross-brace tie rods to the building, apparently during construction, provides another path for the tensile force to be resisted. By including the tie rods in the analysis of the building cross section, the center tie bar of the truss becomes a zero force member (Figure 11). Analysis of the roof truss by the computer using the appropriate section properties and material stiffness shows that immediate horizontal deflection under dead load only would have been a total of five centimeters. This deflection of the trusses would have manifested itself in bending of the 25.4cm x 25.4cm post from a point at the horizontal chord of the roof trussed above the side aisle to the 20.32cm x 25.4cm girt (sill) at the heel of the truss, a distance of almost two and a half meters. Certainly, a horizontal movement of two and a half centimeters would have been observed in the post for a distance of only two and a half meters in height. If the annex had already been built or partially framed, it would have provided some restraint, pushing most of the deflection towards the posts along the north side of the building which certainly would have been observed by workmen.

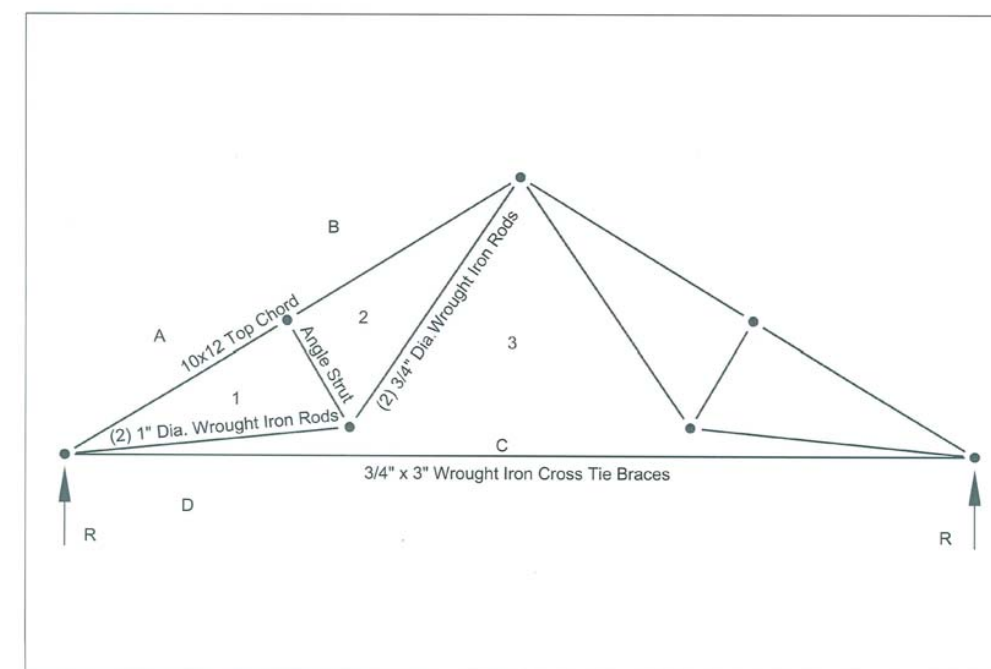
Figure 12. Testing and analysis indicates that the roof system acts as an A-frame with trussed rafters.

The answer was to provide additional ties to limit the movement which is natural to a truss with a raised bottom chord. In providing these ties R. H. Robertson transformed the building cross section into a tied A-frame with trussed rafters (Figure 12).
