Structural Repair of the Breeding Barn at Shelburne Farms

STRUCTURAL REPAIR OF THE BREEDING BARN AT SHELBURNE FARMS
VOLUME I: REPORT NARRATIVE

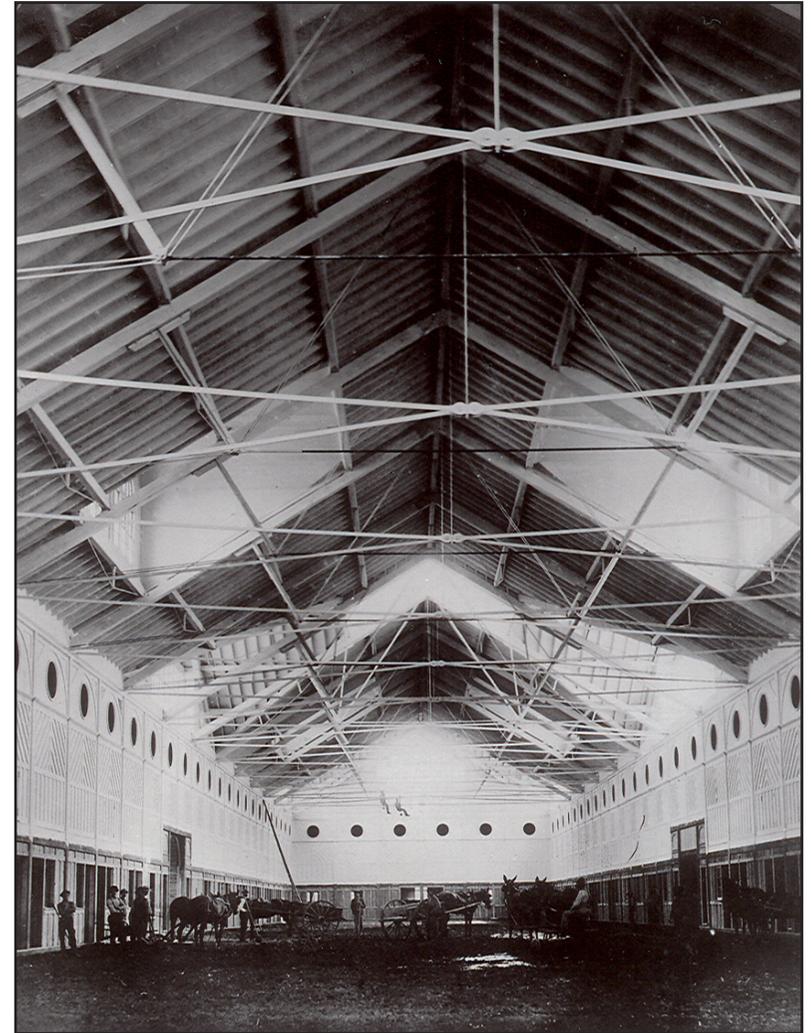
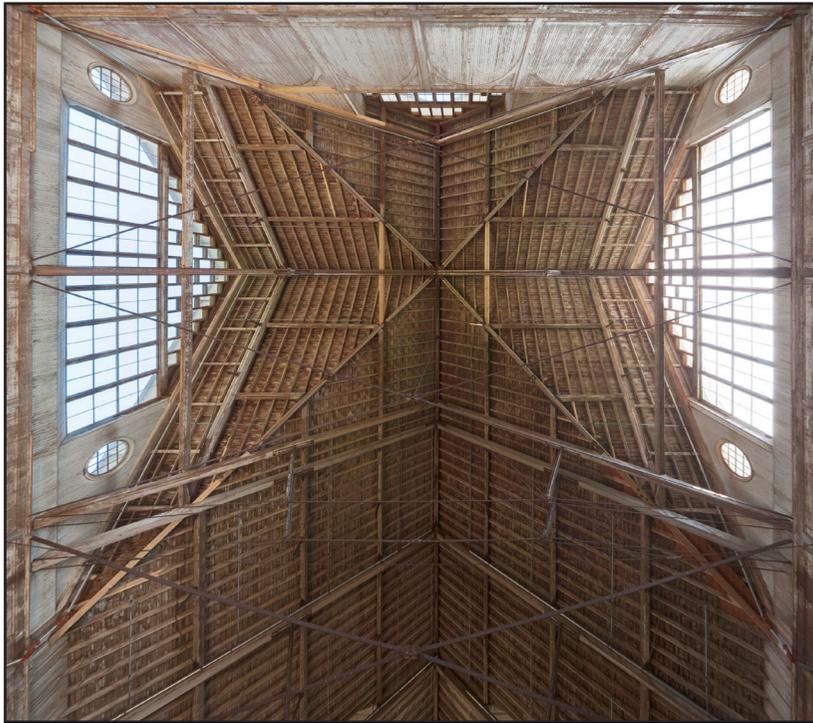
on the lantern valleys were removed. Steel channels were added to either side of the valley members at the lantern and at dormers at east and west ends of the riding ring. Addition of the steel channels necessitated removal of the iron bridles that carried purlins, and some of the purlins were shortened to make room for the steel. Following installation of the steel channels most of the purlins were tied to valley rafters using bolted bent plates, except at dormer locations. Here purlins were removed and never replaced, leaving long top chord elements located at the centers of each major dormer pair unbraced.

Sometime after initial construction of the barn trusses were added on the inboard sides of east and west dormer pairs (left). Truss construction differs from the original configuration, though the quality is very high. Location of the additional trusses away from columns required additional structure in the riding ring walls (right). Steel channels were added to valley members ca. 1930. Purlin bridles were replaced with bent strap connections (bottom right).

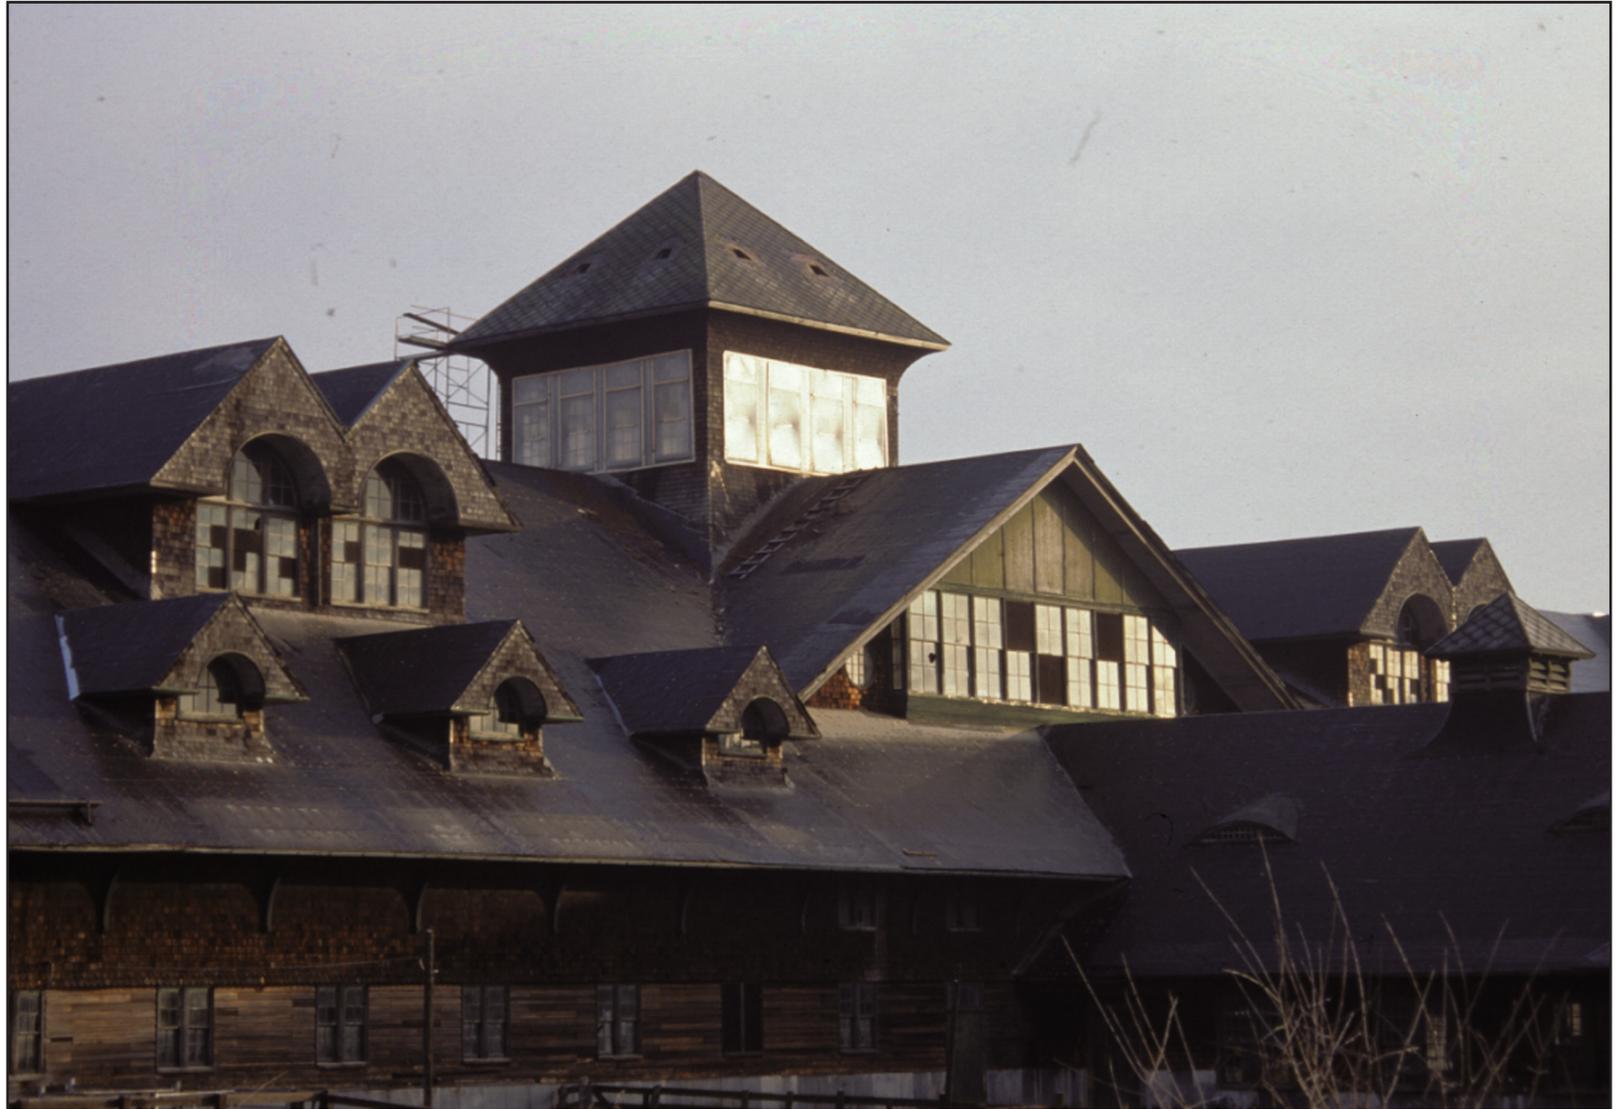
The Breeding Barn during emergency stabilization in 1994.

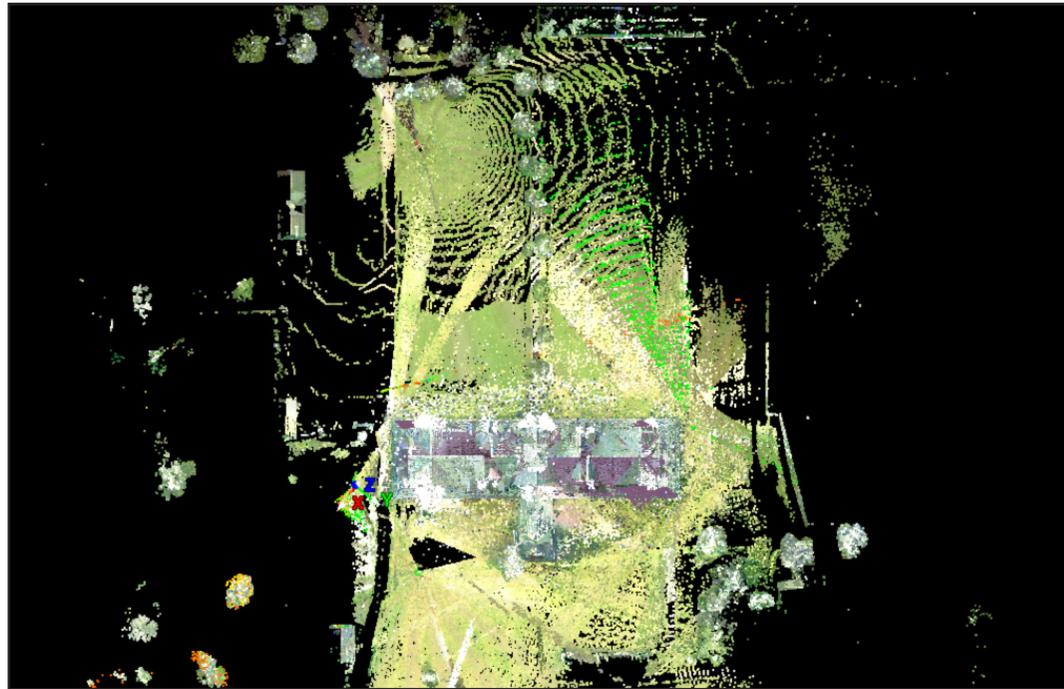
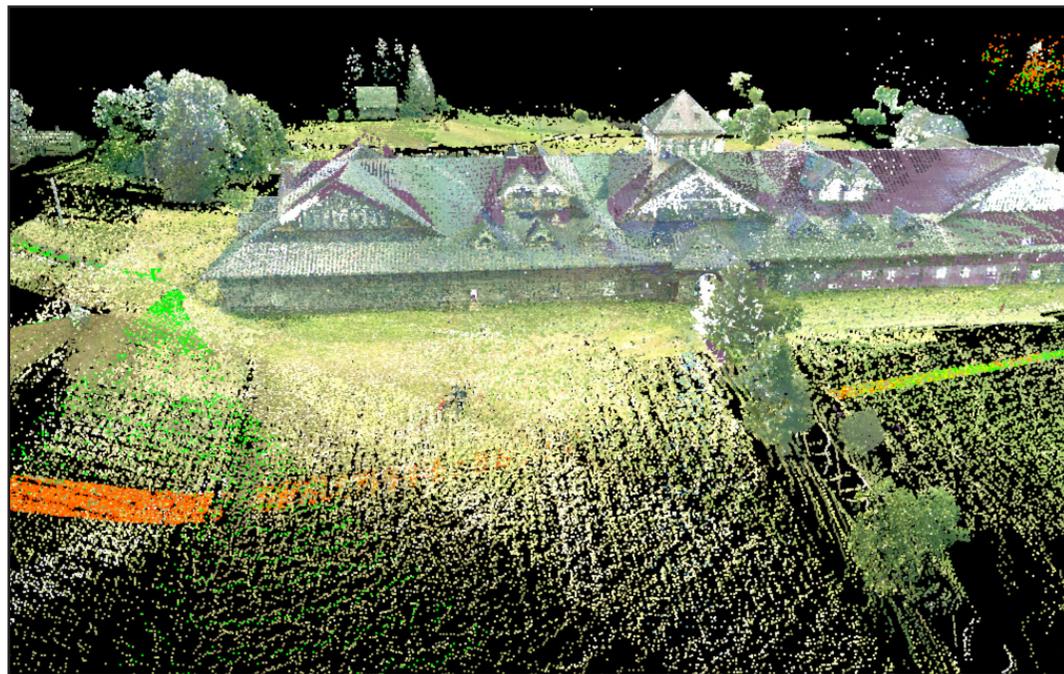
Data cloud images of the Breeding Barn site (top) and north façade (bottom).

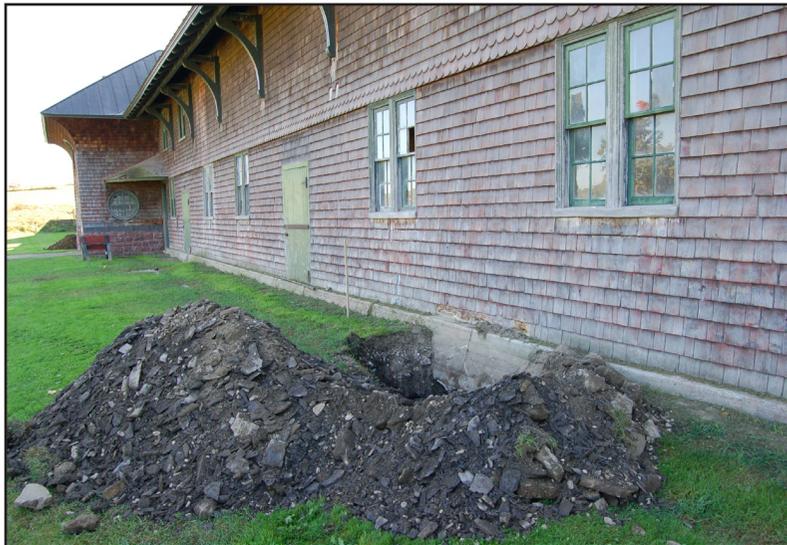
Foundation settlement has been minimal. Test pits were dug on north, south and west sides of the main block to inspect subsurface conditions. In general, foundation stonework was placed bedrock or ledge at vary-

ing depths (typically 3-5 feet). Working with a consulting engineer and geotechnical faculty at the University of Vermont, foundation construction was documented, site soils were characterized, strength-in-shear was determined, and building loads were calculated [Appendix E]. It was determined that original foundations are substantial enough to support required loads.

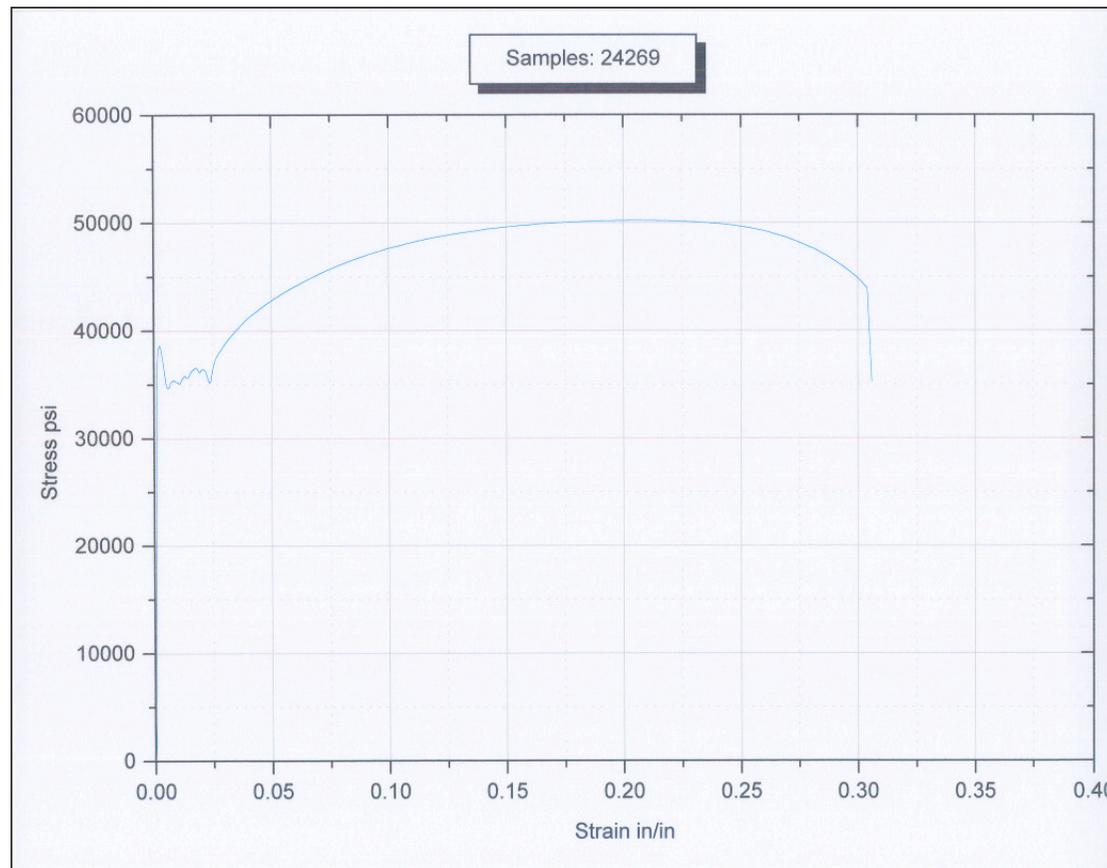
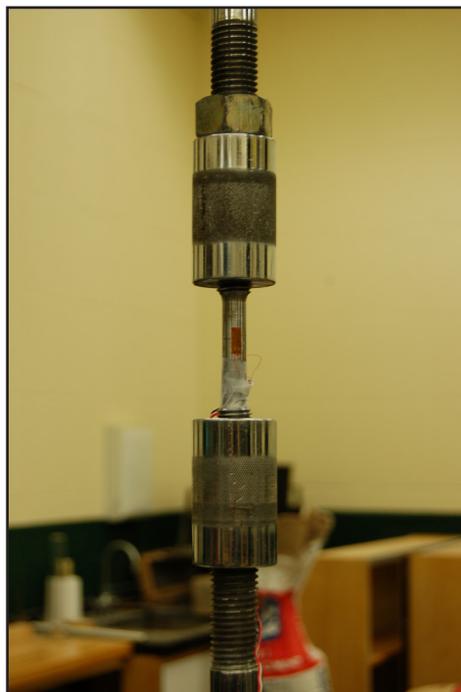
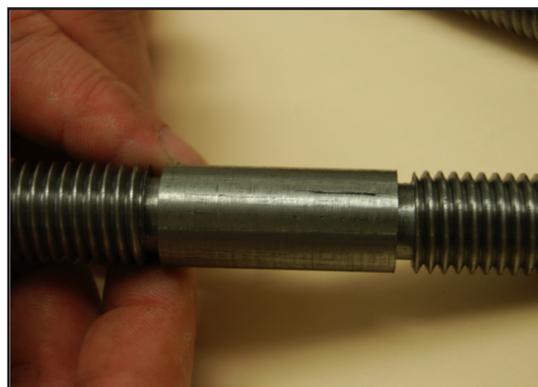
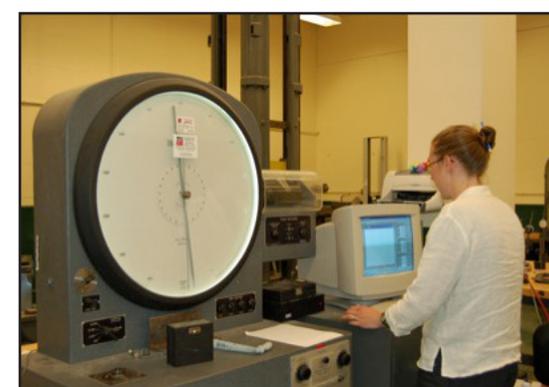
tension elements were generally in good condition, and that heel connections were intact and in good condition. Samples were obtained from iron truss rods that were shortened when trusses were added at east and west dormer locations. The samples were large enough for conducting strength-in-tension tests (ASTM A 370-97a) of the iron at the Materials Lab in the School of Engineering at the University of Vermont. Values obtained for the four samples tested indicated an average yield strength of about 33.2 ksi, an average maximum tensile strength of 47.3 ksi and a MOE of 30.2 Mpsi, which compare relatively well to design values in period codes and design manuals.¹⁴

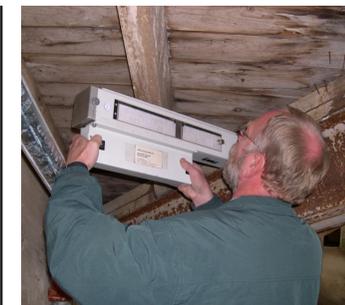
The investigator is using a resistance drill to locate and measure voids in a valley member (top). Note the steel channels that prevent drilling except at the top and bottom of the member. The sample resistograph strip (bottom) indicates a void about 4½-inches in width near the middle of the member. Graphic presentation of resistance drill results for the valley member at 11.0 South (left). The color-coding indicates levels of damage.

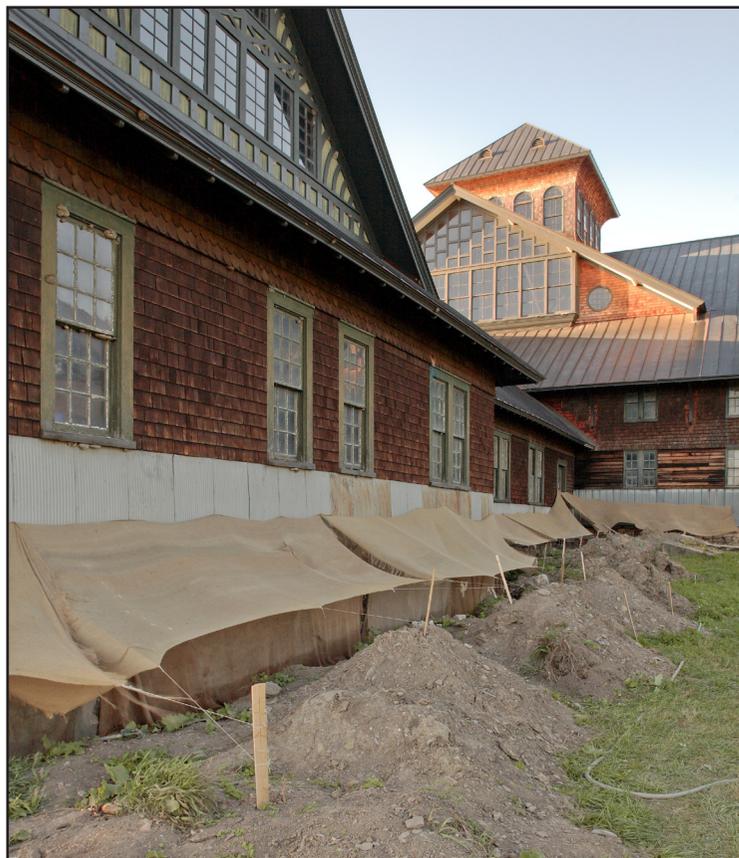
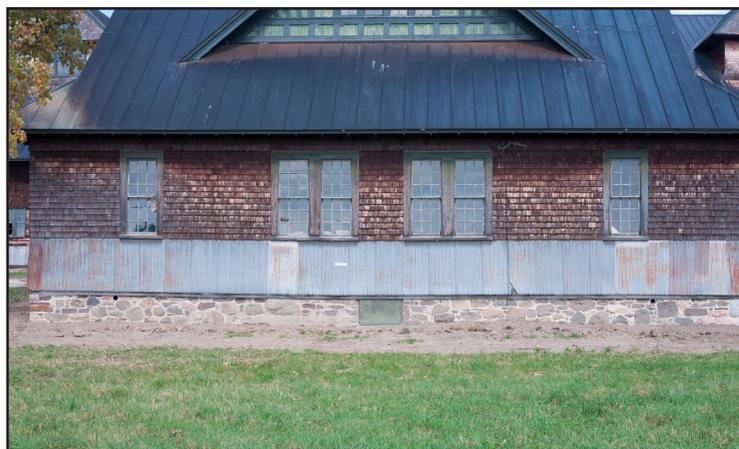
Repointing of foundation stonework involved cutting damaged joints to provide key for the replacement mortar. Burlap was used to control drying.

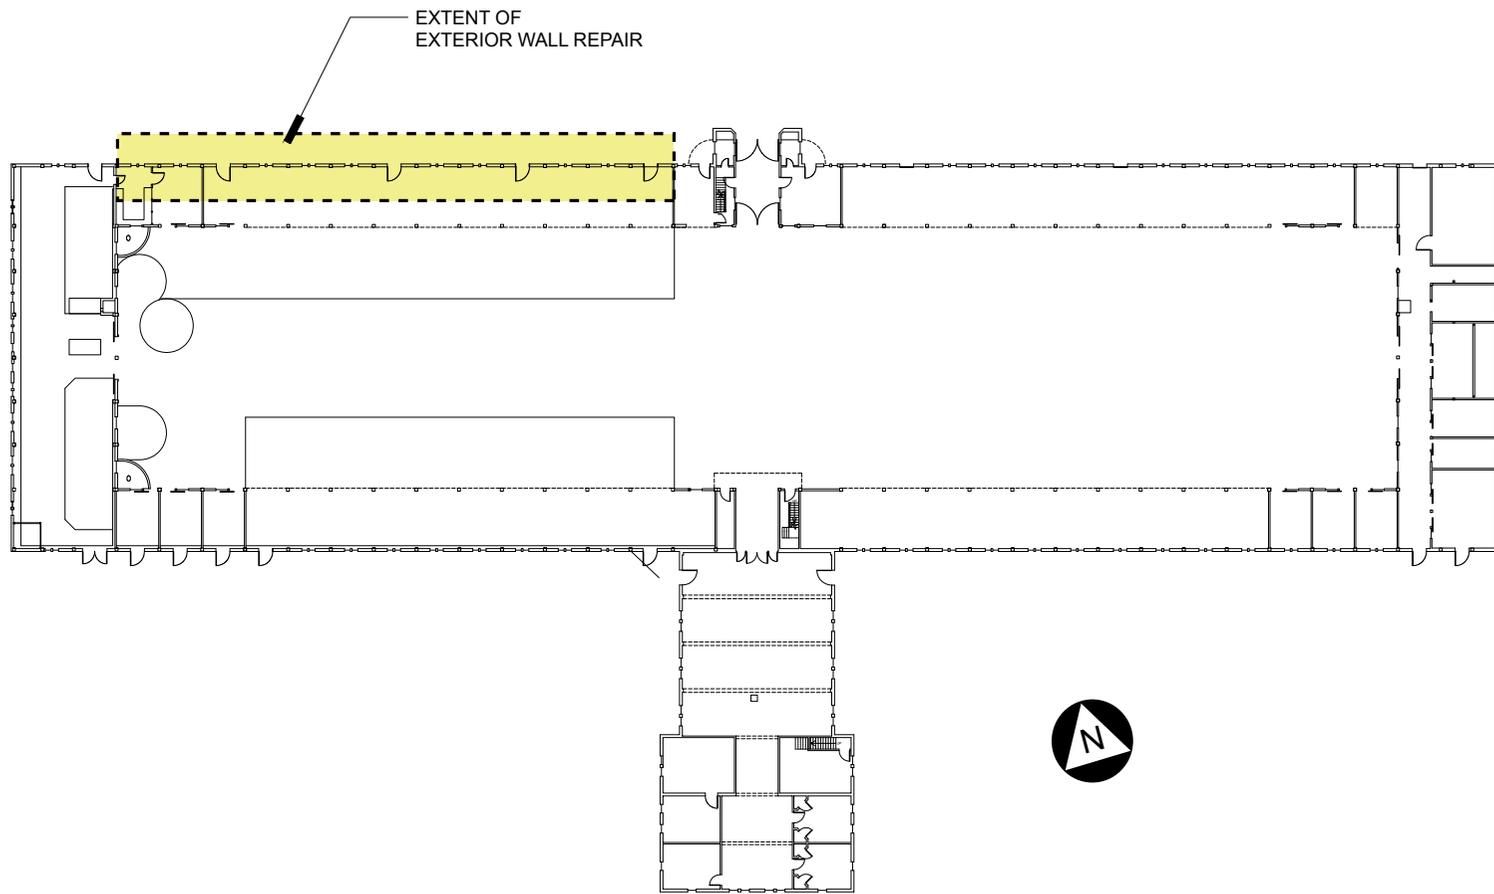
B1
3 FOUNDATION REPAIR, KEYED FIRST FLOOR PLAN
SCALE: 1/32" = 1'-0"

First floor plan highlighting location of foundation and perimeter wall repairs

Spot repointing of the south, east, and west foundation walls was completed in 2008. Walls were excavated to a depth of approximately 18 inches to address subsurface deterioration. Excavation of the east wall, where the grade is highest, reached a depth of three feet. Spalling and deteriorated mortar was removed; joint depths were adequate to achieve proper keying of the replacement mortar. Stonework at the northwest corner of the building that had been struck by farm machinery was partially dismantled and relayed.

In 2009, replacement stone was obtained from the historic quarry³¹ for reinstatement of the stone foundation wall on the northwest façade. Following cribbing of the northwest wall, the concrete counterwall was removed from the interior and exterior of the building to a depth of approximately six inches below grade. Subsurface concrete was retained to preserve as much of the

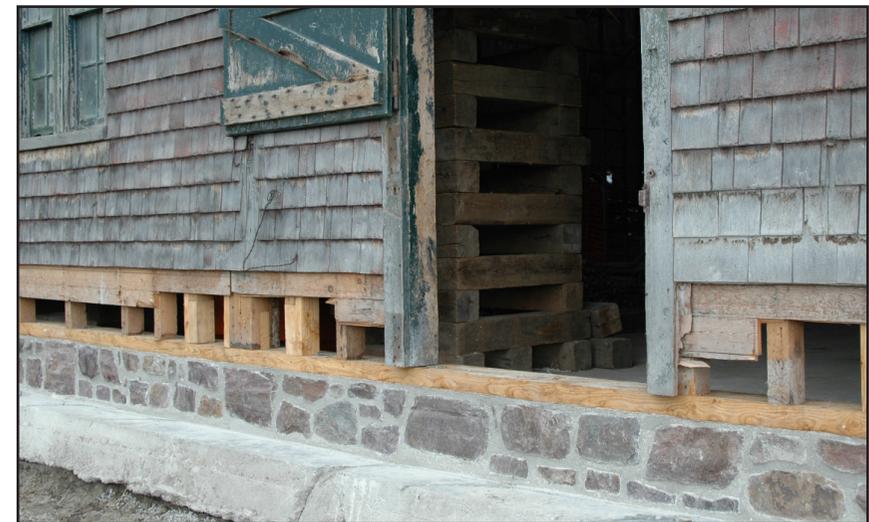
The concrete counterwall on the northwest façade was removed to a depth of approximately six inches below grade, and a new stone stem wall was constructed to support replacement sills.

The top surface of the remaining concrete was detailed to shed water. Following repair of the structural woodwork on this wall, a new stone stem wall was constructed on top of the surviving wall and to sill height. The stone salvaged for this purpose was shaped by hand to replicate the spacing and finish of the original stonework. Stone was laid in a hydraulic lime : sand mortar tooled to match original work. A polyethylene barrier was placed between the new stonework and the existing floor slab, to facilitate the eventual removal of the slab. A foundation drain was installed on the building exterior and tied to an existing drainage system.

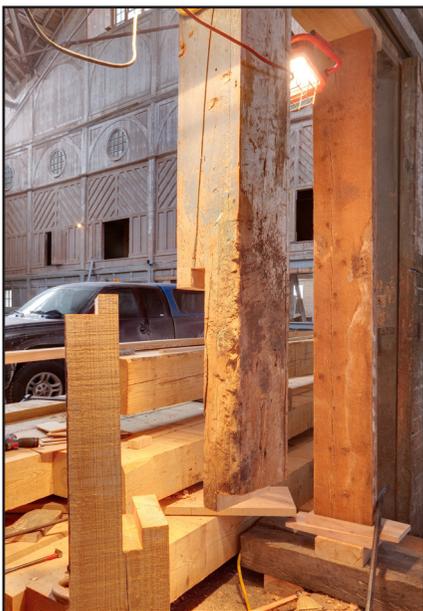
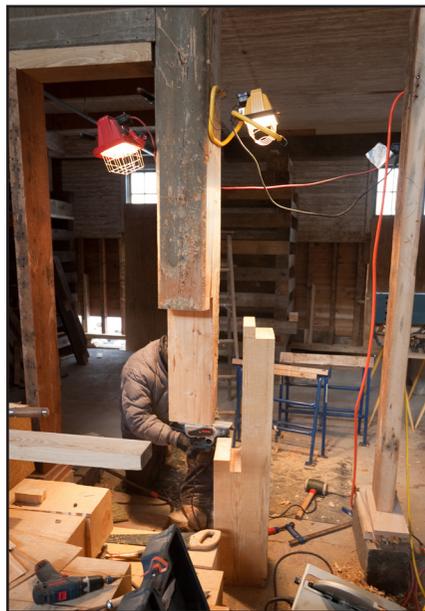
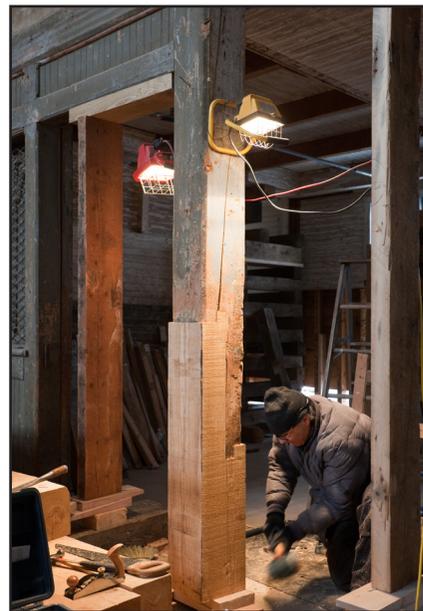
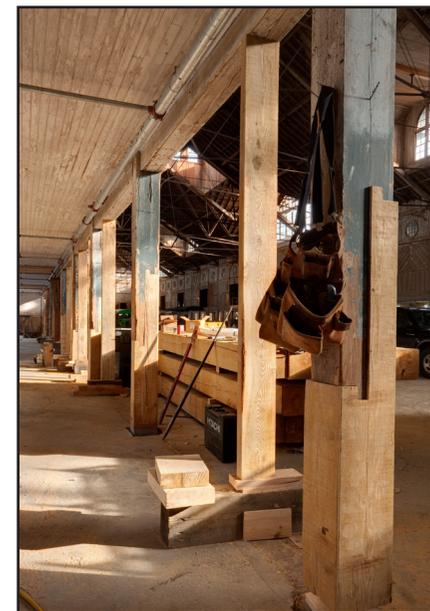
Of the 70 columns surrounding the riding ring, nearly 50 of them were significantly decayed at the bases, partly due to installation of concrete floors in the mid-20th century. In addition, several columns were damaged by animals and agricultural machinery.

Riding ring columns were repaired by scarfing in new timber to replace decayed portions, using a nosed scarf form found elsewhere in the barn. New column bases were placed on limestone plinths and white oak shims, elevating them above a concrete floor installed in the mid-20th century.

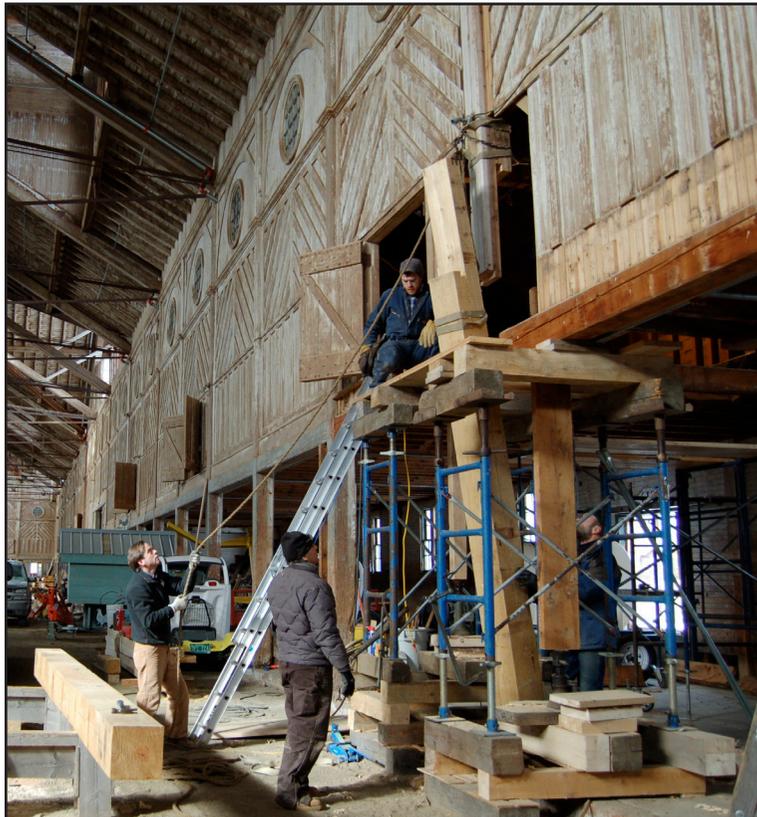
Four of the column repairs (B4.5, B14.5, J4.5, and J12.5), associated with roof leaks at the dormer valleys, extended into the aisle level. In each case, the columns had been repaired at least once before, and misalignment of shoulders in the scarfed splices had resulted in buckling of the columns above the aisle floor. At J4.5, floor girts on either side

Four of the columns located below dormer valleys required repairs extending into the aisle level. Here, a new column base is raised into position (left) and is shown installed with replacement girts (right).

of the repaired column were replaced. New repairs included appropriate dimensioning of scarf joints and installation of free tenons or splines to replace missing joinery that supported aisle floor girts.

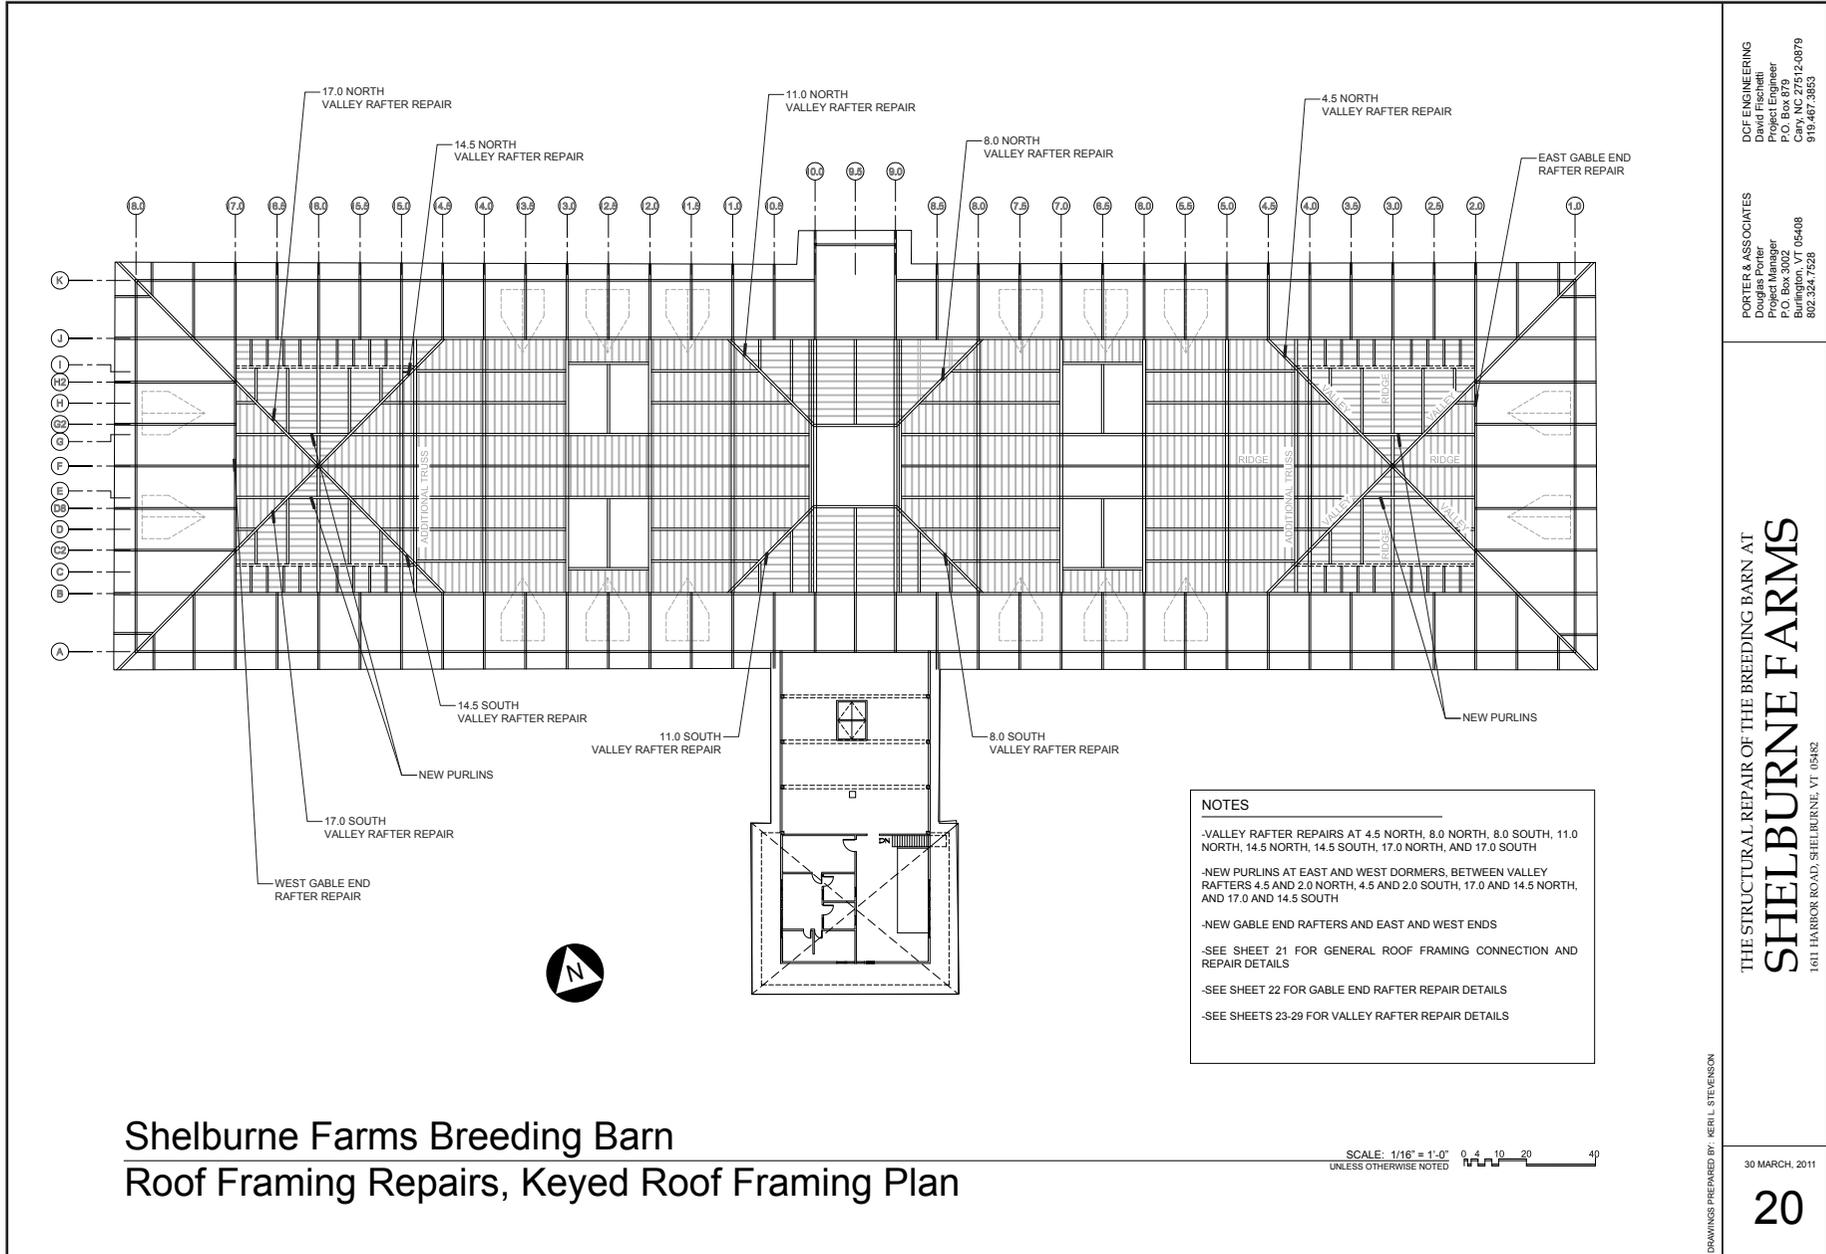
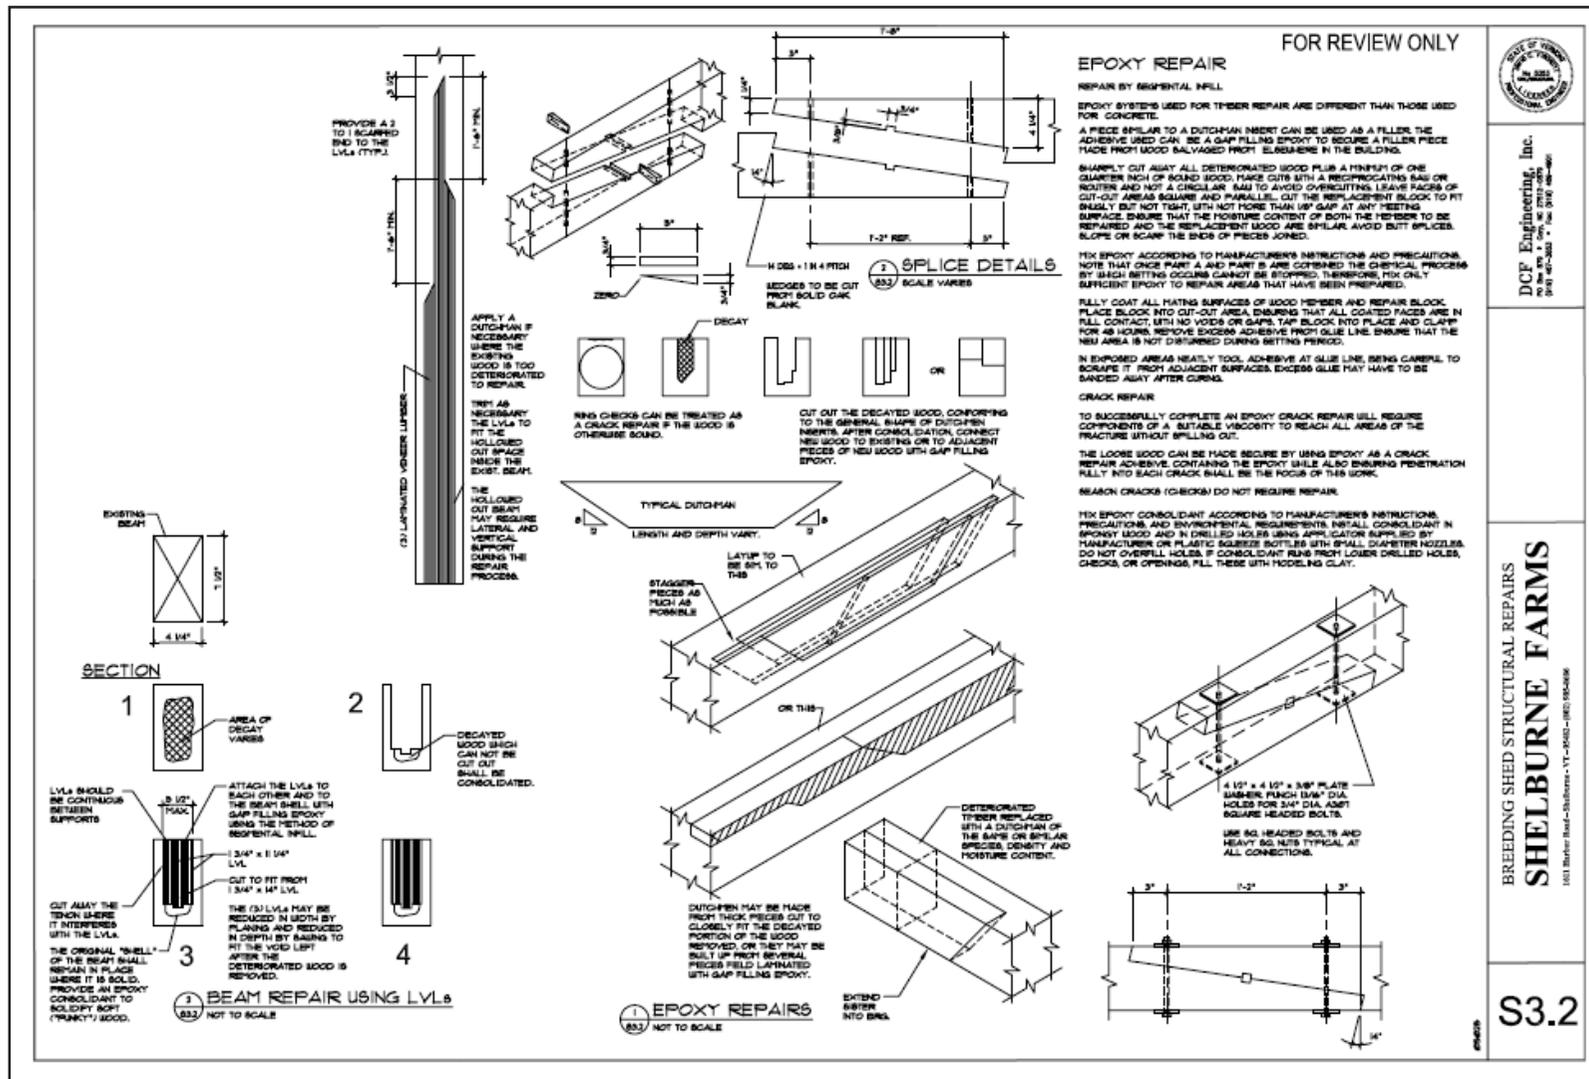
Roof framing plan indicating locations of roof frame repairs

Once roof loads were transferred to the structural staging, steel channels bolted on either side of each valley member were removed. These channels were added to valley members c.1930, apparently in an attempt to address deterioration of the timbers, but connections between the channels and timbers were poorly designed and the channels promoted decay of the wooden elements.

Repair strategies for valley members included: 1) scarfing new timber into historic members in areas where the bending moment is low or where scarf joints receive support from other members of the frame; and 2) installing laminated veneer lumber dutchman repairs in decay voids using a gap-filling epoxy adhesive.

Repairs for valley members included segmental infill of long decay voids using engineered lumber and the scarfing of new timber to replace decayed timber.

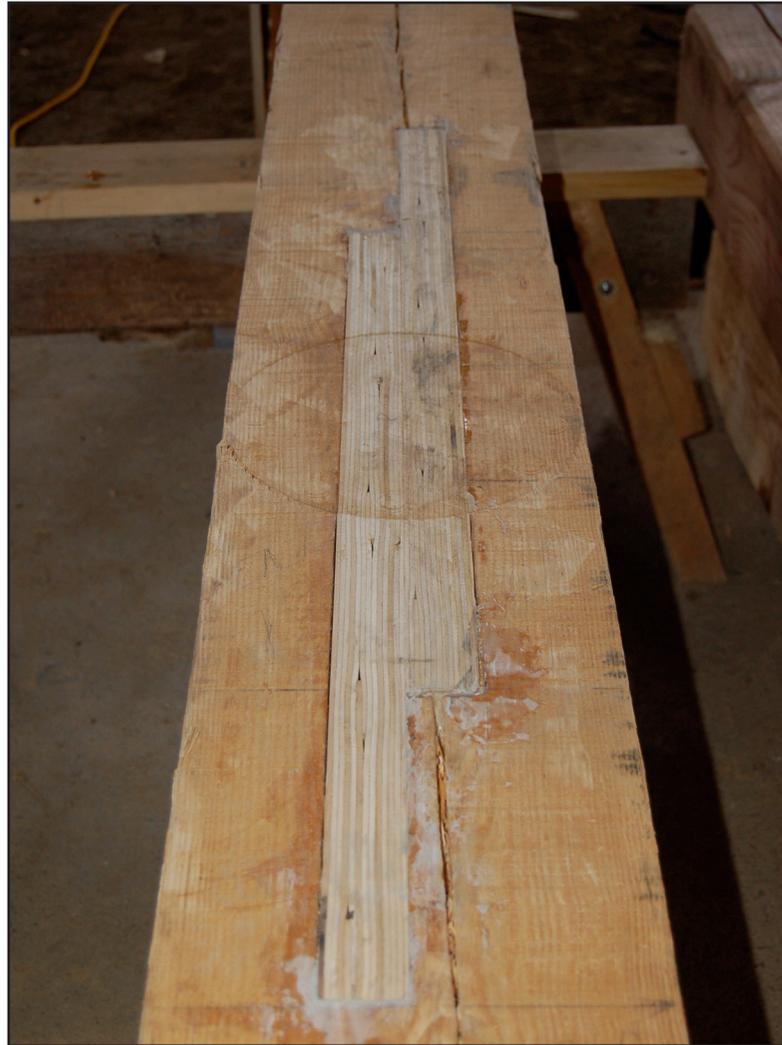
Bending tests were conducted on repair mockups and solid controls to compare repair strategies for valley members.

The tested repairs included nosed, keyed, and bolted scarf joints, and laminated veneer lumber (LVL) dutchman repairs installed in grooves plowed into simulated deteriorated timbers. The ultimate bending strength and mode of failure was recorded for each test. Results were compared to solid timber control specimens. Based on the results (as well as the ability to implement the repair *in situ*), the LVL dutchman repair provided the optimum repair strategy for long unsupported spans. Scarf joints were acceptable where they receive support from other parts of the frame, or where bending moments are low.

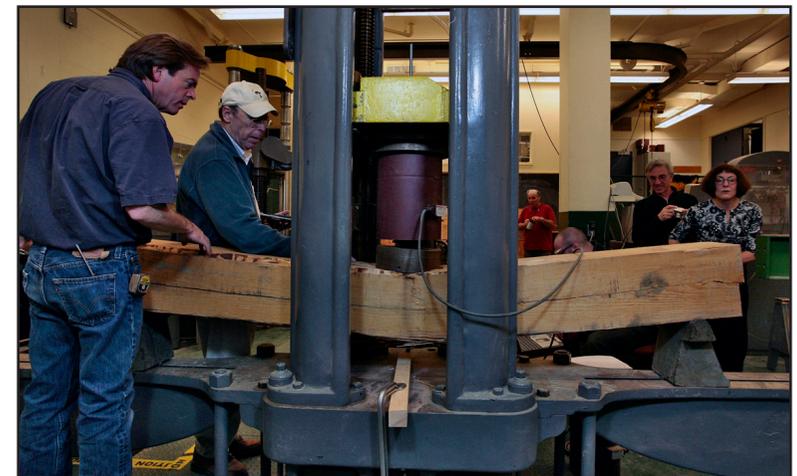
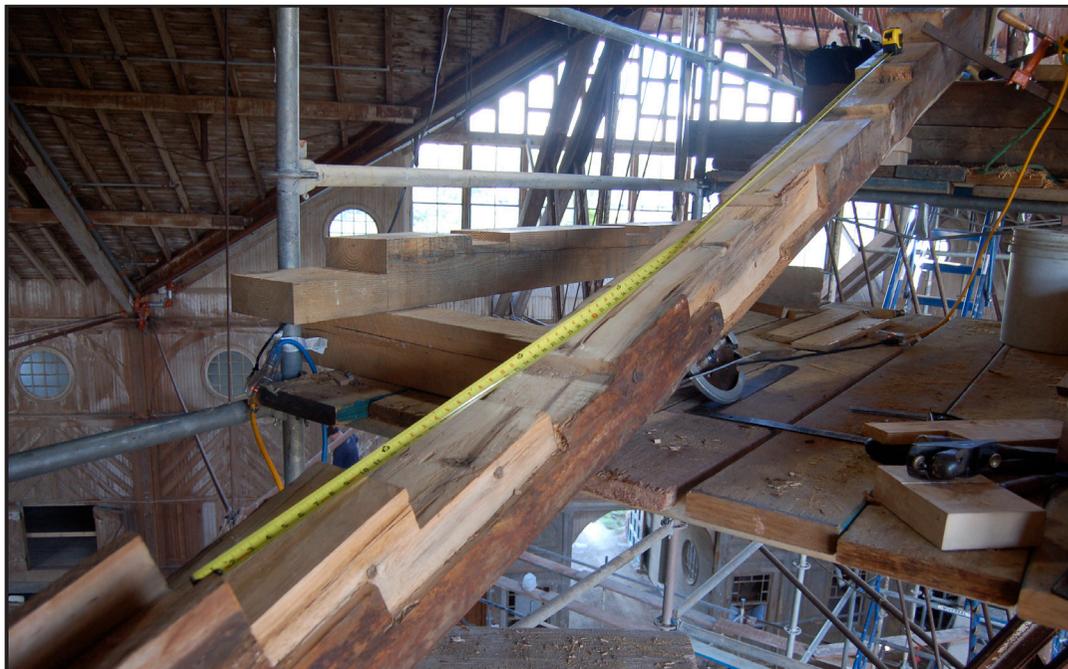
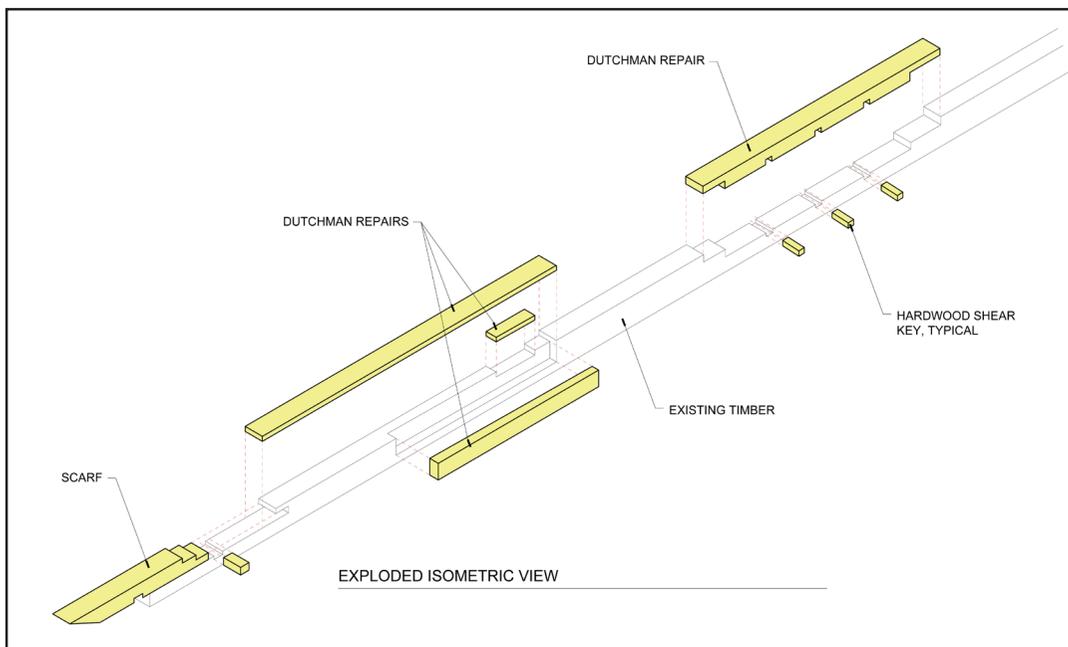
Valley members 17.0 South, 17.0 North, 11.0 South, and 8.0 South were characterized by long decay channels in the upper half of the timber section, apparently the result of water from roof leaks accessing drying checks on the upper surface of each timber. These were repaired by removing decayed material to leave a long dado that was then filled with a segmental engineered lumber dutchman adhered with a gap-filling epoxy. In some instances (as at 11.0 South and 8.0 South) it was possible to drop the timber to the scaffold deck for treatment; in others (as at 17.0 South and 17.0 North), cutting and assembly were done *in situ*.

The valley member at 11.0 South with decayed material removed in the upper half of the span (left). Note the shear block mortises cut in the member and in the timber dutchman on the scaffolding behind the valley timber. The extent and location of the damage necessitated a change in the types of repairs employed (bottom).

For valley members 14.5 South and 14.5 North, decay in the lower third of the length of the members (near their intersections with trusses at gridline 15.0) was repaired by scarfing in new timber; scarf joints were

located near intersections with trusses and were reinforced with bolts and structural washers. For valley members 11.0 South and 8.0 South, scarf repairs were made within 7 feet of the plate timbers, where the bending moments are low. Valley member 11.0 North was replaced in an earlier repair campaign by three butt-joined timbers bolted to the steel channels. This assembly was replaced with a scarfed member (installing a single full-length timber was not feasible without removing a portion of the roof) with the scarf joint located near the lower queen strut, where the bending moment is low.

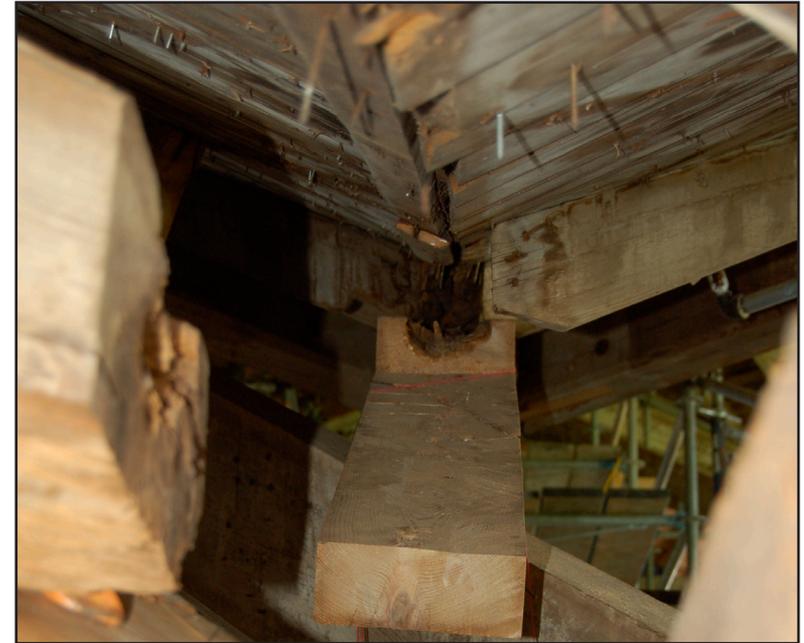
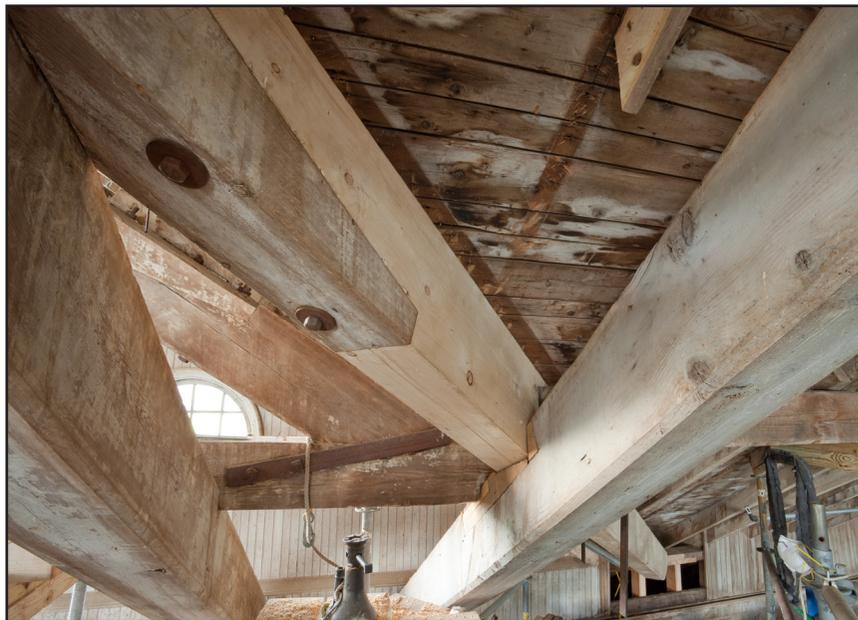
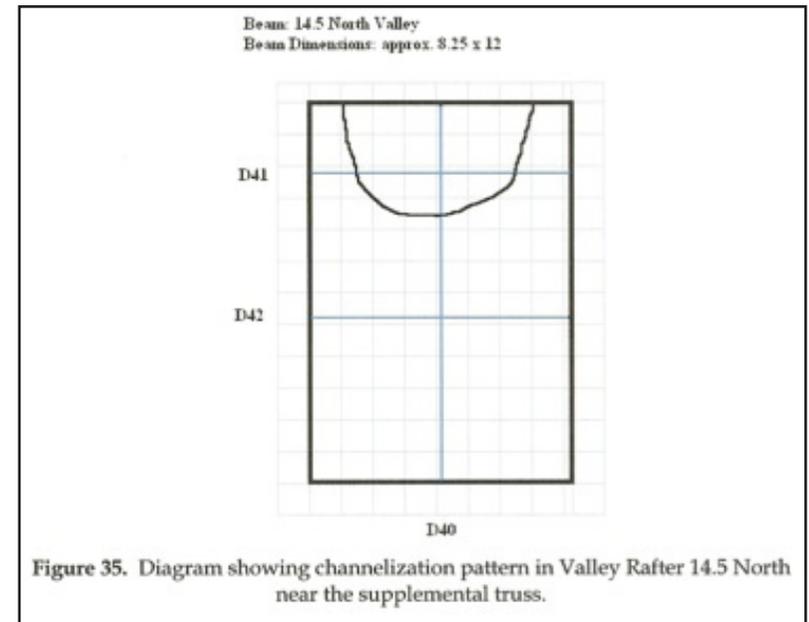
Figure 35. Diagram showing channelization pattern in Valley Rafter 14.5 North near the supplemental truss.

Resistance drilling results typically corresponded well to actual conditions and the drill survey proved to be a powerful tool in anticipating the extent and types of the repairs. For example, the color-coded graphic indicates the portion of the valley member at 14.5 North most severely affected by decay (top left), and the section drawing roughly indicates the size and shape of the decay channel near the intersection of the valley with the rafter at gridline 15.0 (bottom right). The photo taken during construction (top right) demonstrates a close correspondence between the section drawing based on drill results and actual conditions. New timber was scarfed into the valley member at 14.5 North where both timbers receive support from truss rafters. The length of the replacement timber is approximately 21 feet.

vey proved to be a powerful tool in anticipating the extent and types of the repairs. In two cases, however, framers encountered significant damage that did not appear in the assessment documentation. In both instances, there were large areas of decay that appeared to originate at the surfaces where steel channels were attached. These did not appear in the drill survey results in part because the steel channels limited access to those areas. While the presence of decay along the interface between the timbers and steel reinforcements was expected, the extent of decay in these two valleys came as a surprise. For the valley member at 11.0 South, decay along both surfaces was so severe that the repair specification had to be changed. This limitation of resistance drilling should be considered when conducting a condition assessment where access to the full timber is restricted.
