Structural Repair of the Breeding Barn at Shelburne Farms

STRUCTURAL REPAIR OF THE BREEDING BARN AT SHELBURNE FARMS
VOLUME I: REPORT NARRATIVE

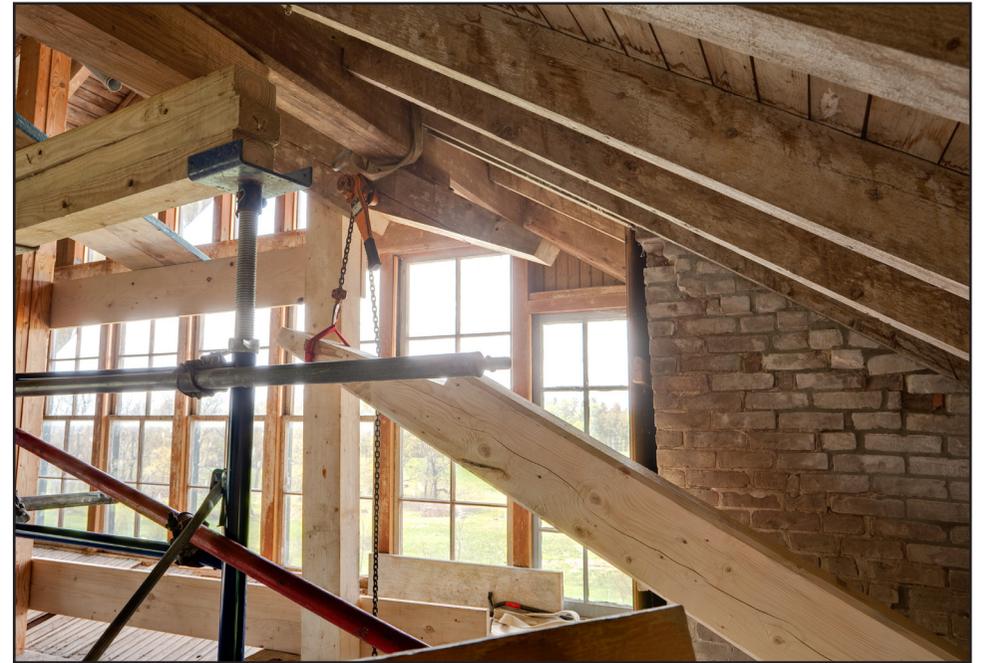
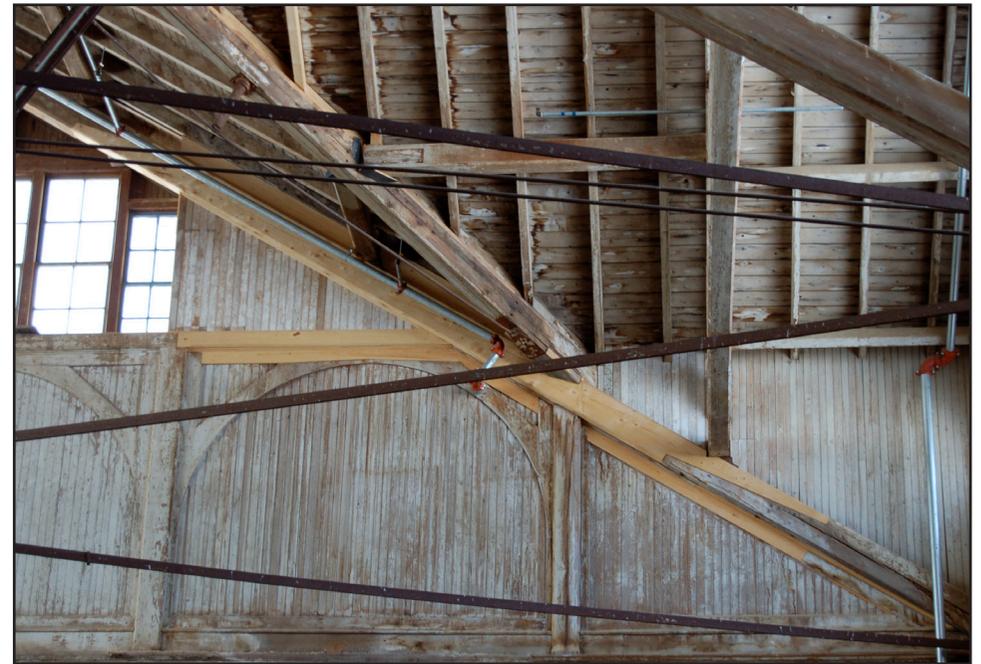
Purlins were extended with loose tenons and jam blocks and supported on custom-made replacement bridles (top). Gable-end rafters were decayed at chimneys and were repaired by scarfing in new timber. Scarfs received support from wall framing (bottom).

At either gable end, principal rafters were repaired by scarfing in new timber to replace decayed sections; scarf joints receive support from gable wall framing. Scarf joints were modeled on joints cut in each top chord element and are typically tapered, at least 4 feet in length, and reinforced with bolts and structural washers. For the repair at the west gable end, the replacement piece was spliced to the existing rafter at an historic scarf joint near gridline J.
