**Fitzgerald Environmental Associates, LLC.**

## **Alder Brook Watershed Phase I and II Stream Geomorphic Assessment Report**

December 29, 2006

Essex Waterways Association  
Essex, Vermont

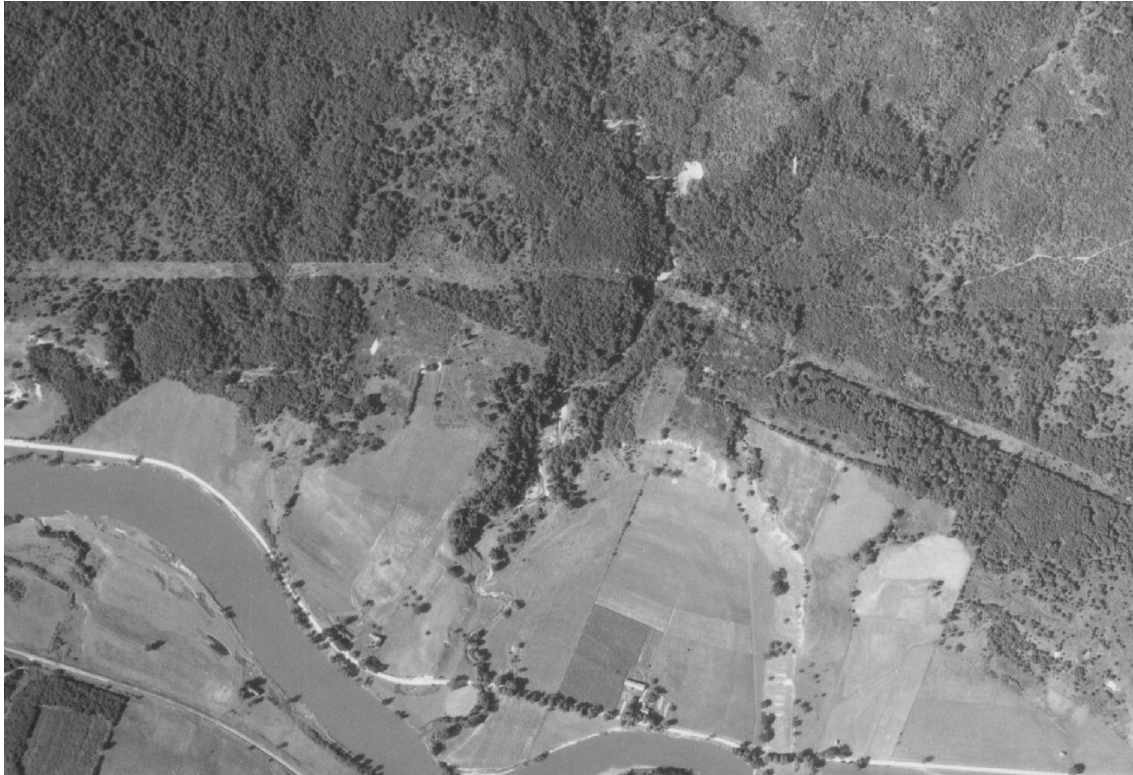
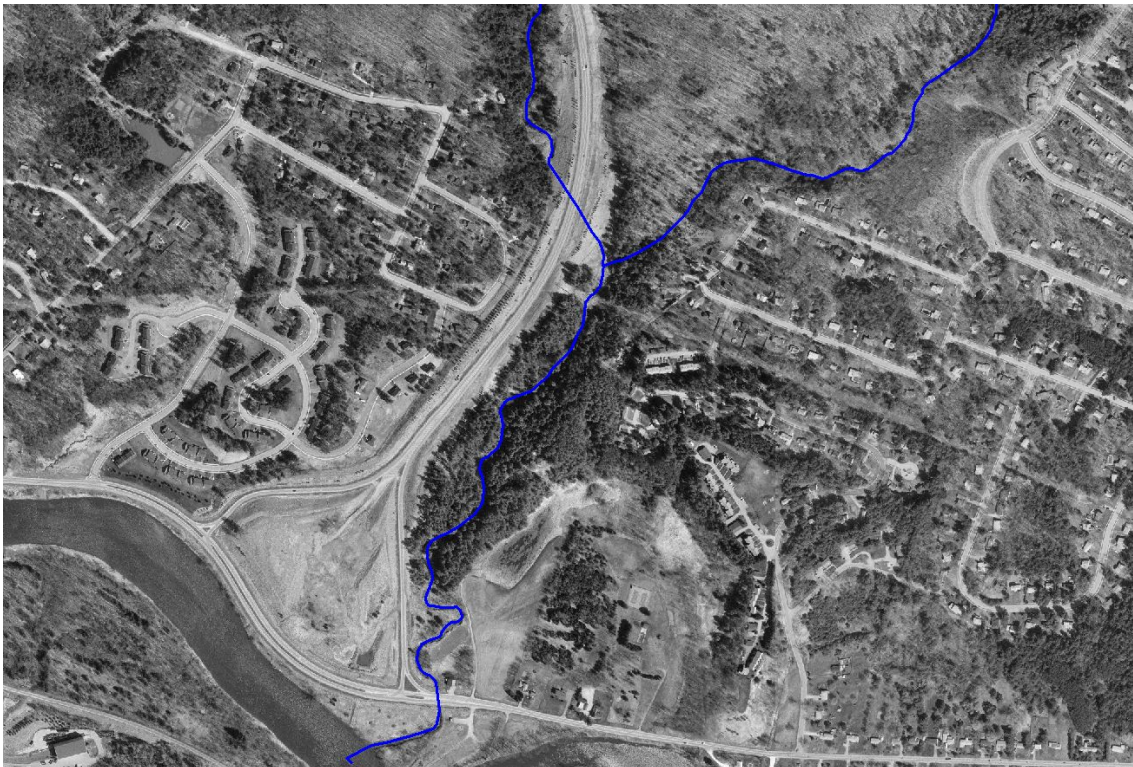
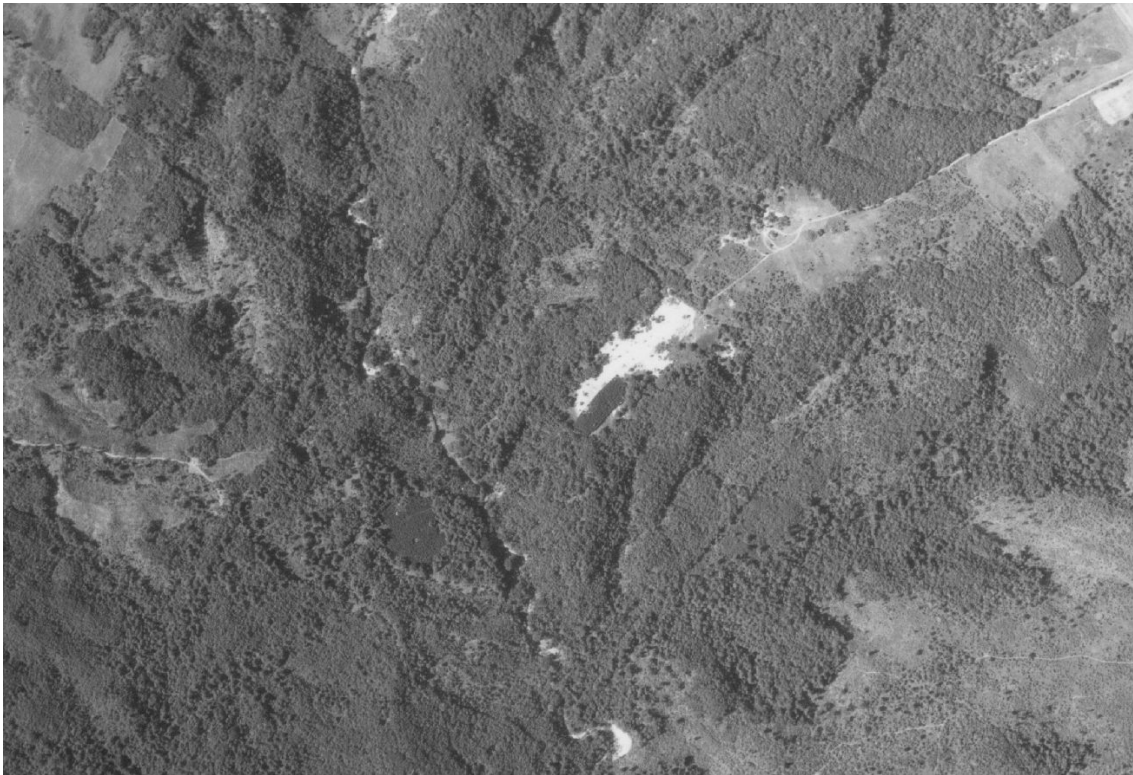
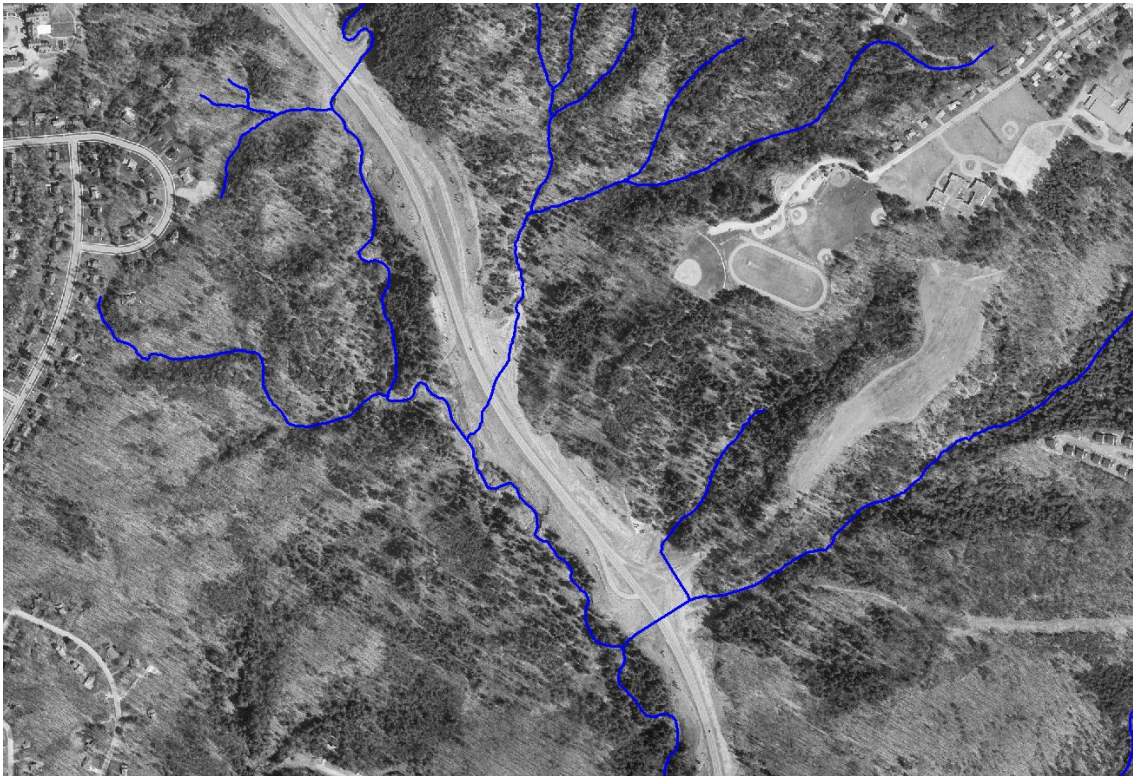
**Figure 1. SCS 1937 Aerial Photograph of Lower Reaches (M01 & M02)**

**Figure 2. 1999 Aerial Photograph of Lower Reaches (M01 & M02)**

**Figure 3. SCS 1937 Aerial Photograph of Lower Reaches (M03 & M04)**

**Figure 4. 1999 Aerial Photograph of Lower Reaches (M03 & M04)**

Figures 1 through 4 depict Reaches M01 through M04 of the lower watershed zone. Note that the change in land cover in these reaches of the watershed is different from that in the area immediately below Essex Center (see Figures 5 and 6). In this lower zone, a large percentage of the recovering forest has been converted to residential areas, and the construction of Route 289 has directly encroached upon the stream channel corridor. Detailed review of the channel location over the 60 year period reveals that it has changed little since the 1930's, suggesting that the watershed scale impacts to the channel from the initial clearing in the 1800's had been ameliorated over time.

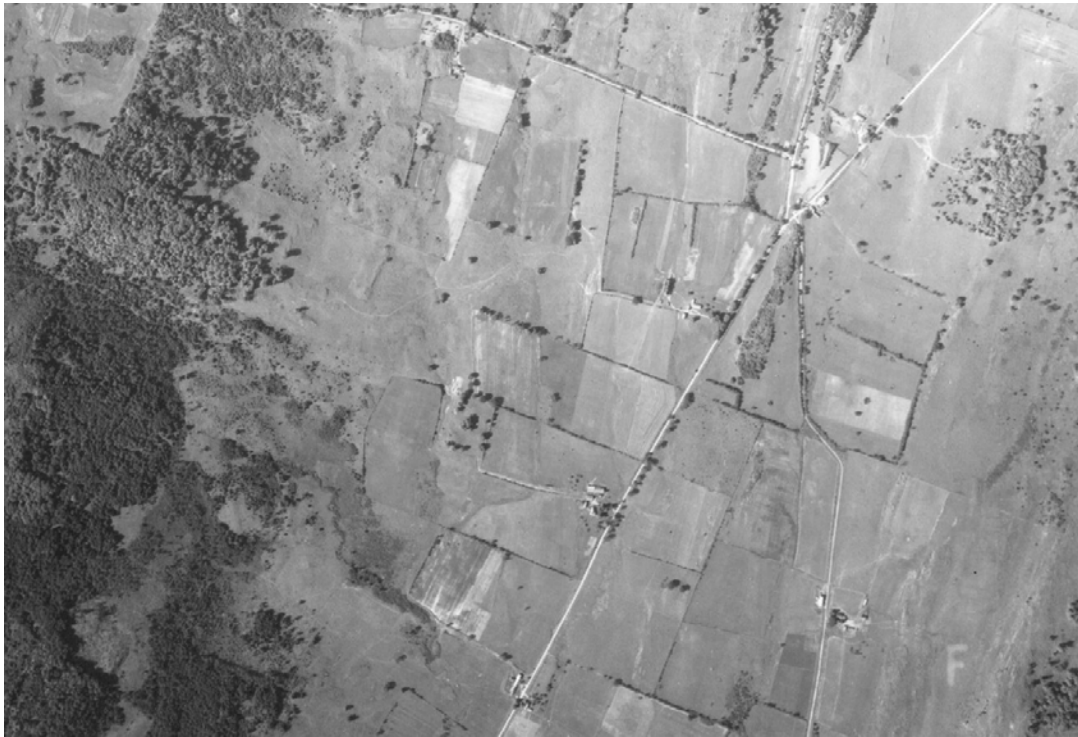
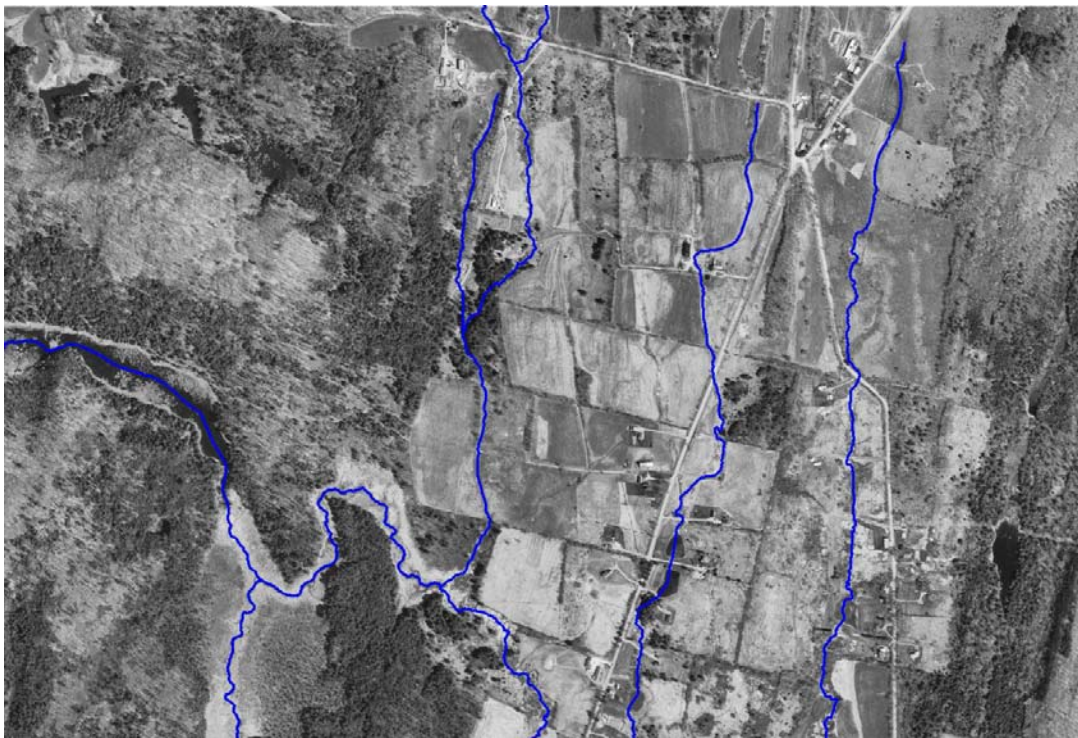
**Figure 9. 1937 SCS Aerial Photograph of Upper Reaches (M13 & M14)**

**Figure 10. 1999 Aerial Photograph of Upper Reaches (M13 & M14)**

Figure 9 and 10 illustrate the large-scale recovery of the forest landscape in the headwaters reaches. This area of the watershed, which has flat and rolling terrain with silty-clay soils suitable for agriculture, was nearly 100% cleared in the 1800s. It has since recovered to approximately 60% forest cover, with the remaining land use being mostly pasture and hayfields for dairy farms.

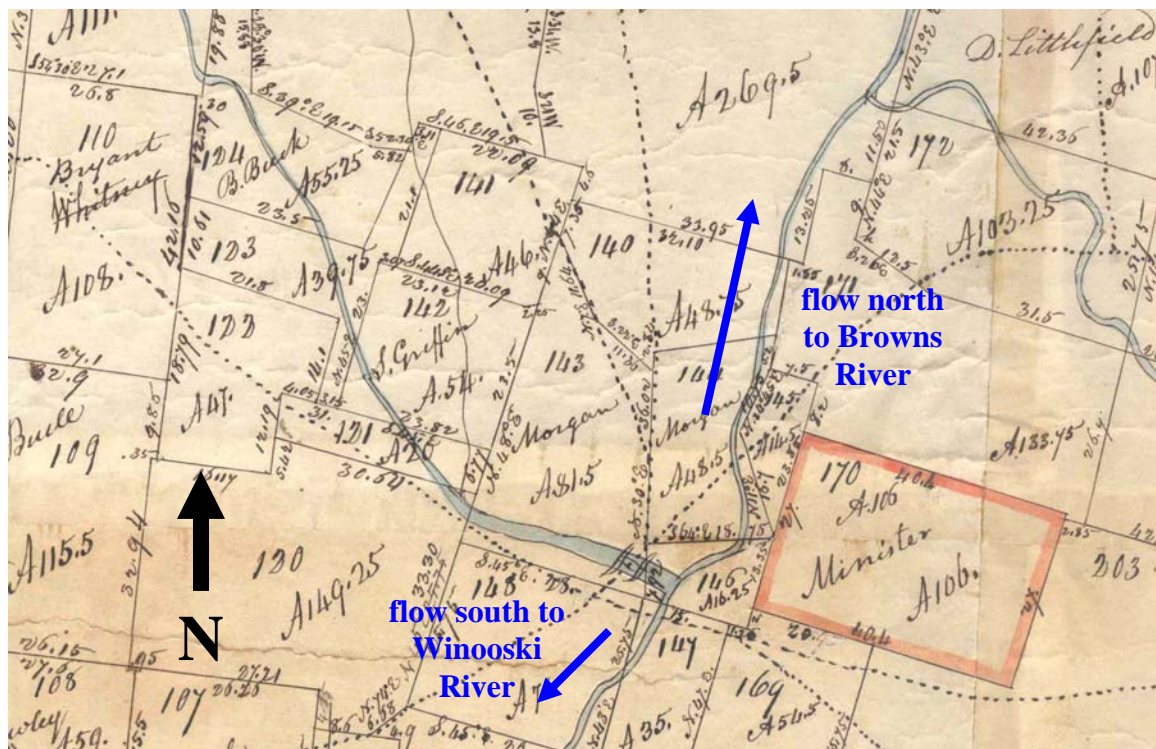
Historical survey maps (see Figure 11) from the time period prior to the freshet of 1830 depict the flow of Alder Brook from Essex Center in two directions: both into the Browns River *and* into the steep ravine towards the Winooski River. It is likely that the diversion flume that carried water to the reservoir and mill below is depicted in blue in this survey, since this survey was conducted prior to the flood that permanently diverted the channel into its present-day location. It seems likely that the manipulation of the channel to divert water away from the Browns River also led to the complete diversion (during the flood) of the channel to the present location. However, it should be noted that the original channel location was separated from the current ravine by only a small elevation gradient, perhaps less than 10

feet. Without topographical surveys of the Essex Center prior to the diversion and flood of the early 1830's, it is impossible to know whether or not the original channel ever accessed this ravine naturally during flood events, or if the ravine had been at least partially formed prior to the 1830 flood.

**Figure 11. Johnson Survey (ca. 1815) of Essex Center**

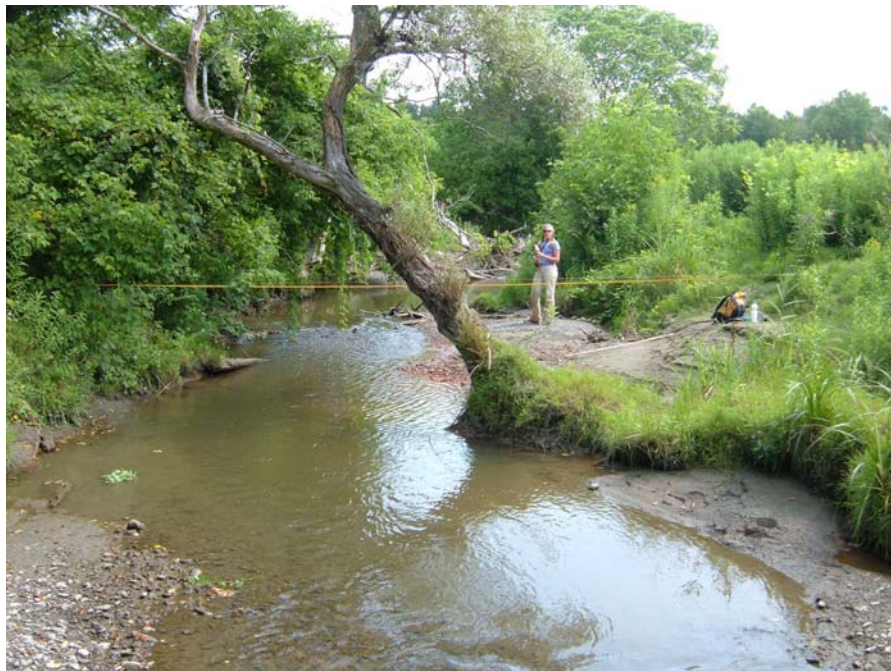
**Figure 14. Channel Cross Section for Reach M01**

This reach is located from the mouth at the Winooski River up to a change in buffer vegetation from open to forested cover. It is found in the historic floodplain of the Winooski River, which has been used heavily for agriculture for centuries. The reach has a length of 1651 feet and an overall channel slope of 0.6%. Observations of natural valley and slope characteristics suggest that the reference channel conditions are C-type with riffle-pool bedform; this channel form was observed during the field assessment. Channel cross sectional geometry suggests that this reach has already gone through a channel evolution process of incision and widening, from which it is currently recovering. Observations of abandoned terraces on the west side of the middle of the reach (where historic straightening had occurred) confirm a classification of stage IV of channel evolution. As the channel continues to adjust laterally to accommodate the excess sediment generated from Stage II and III of channel evolution (see Figure 14), additional erosion, deposition and debris jams will likely persist for years to come; this may adversely affect the habitat conditions and the biotic community it supports. Current geomorphic stability (RGA) and habitat (RHA) scores reflect a reach in fair condition that is still undergoing adjustments due to historic straightening, the historic water diversion, and current impacts from encroachment of the adjacent Circ Highway.

Although this reach has undergone recent encroachment from the Circ Highway, the equilibrium conditions appear to be recovering from the severe adjustments associated with the diversion of 1830. Due to the berming associated with the encroachment along the Circ Highway on-ramp (see map in Appendix 1), and the River Road crossing immediately below, there is little opportunity for restoration of greater floodplain connectivity in the lower section of this reach. There may be, however, opportunity to reestablish natural buffer vegetation along the middle portion of the reach (east bank) where recovery potential (due to Stage IV of channel evolution) is much higher. This would need to involve cooperation from the adjacent landowner whose farm fields abut the stream bank. Given the current stage of channel evolution in this reach, any restoration strategies should seek to avoid active management approaches in favor of cost-effective strategies to restore shading and input of organic materials for improvement of biotic habitat.

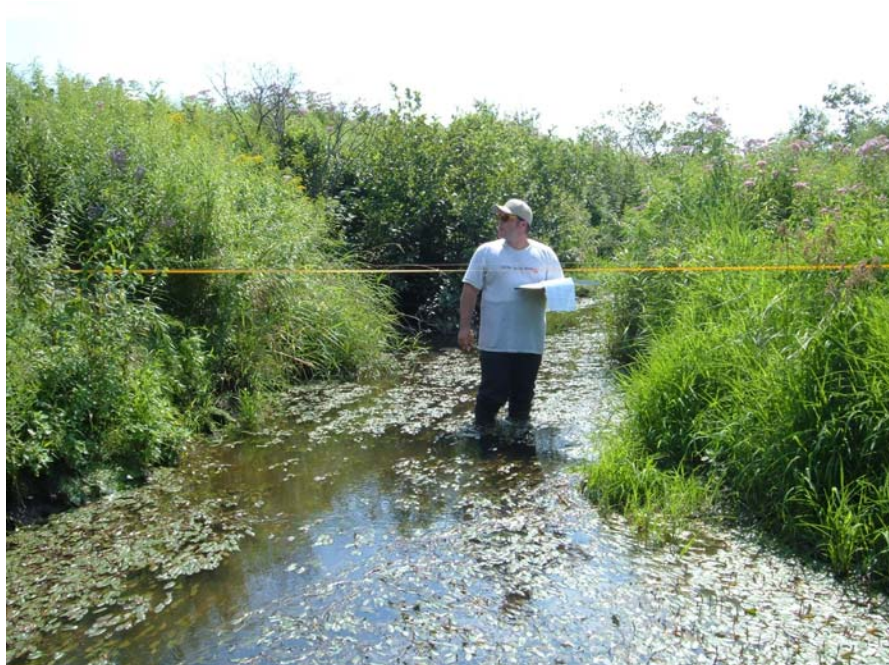
**Figure 24. Cross Section for Reach M08**

Reach M08 begins approximately 500 feet upstream of the Route 128 crossing and extends upstream to the north along Chapin Road to the confluence of two small tributaries entering from the west and east. This reach has a length of 7187 feet with an overall slope of 0.1%, resulting in a very low gradient E-type channel with dune-ripple and plane bedform. A diverse substrate, including some gravel and many macrophytes were present throughout the reach (see Figure 24), however a stream type departure has been noted for Segments A and C where plane bedform dominated over the reference dune-ripple bedform. The reach was segmented in the field because of the abundance of beaver activity found just upstream from Clover Road up to the crossing at Chapin Road. Due to the low gradient nature of the channel, and the overall absence of significant woody vegetation in the buffer, few sedimentation features (bars, debris jams, and mass failures) were noted. Comparison of the 1937 and 1999 aerial photography indicates that the stream planform has changed little over this time period, and straightening was limited (3.4%) along the reach. Fair conditions for geomorphic stability and physical habitat were noted.

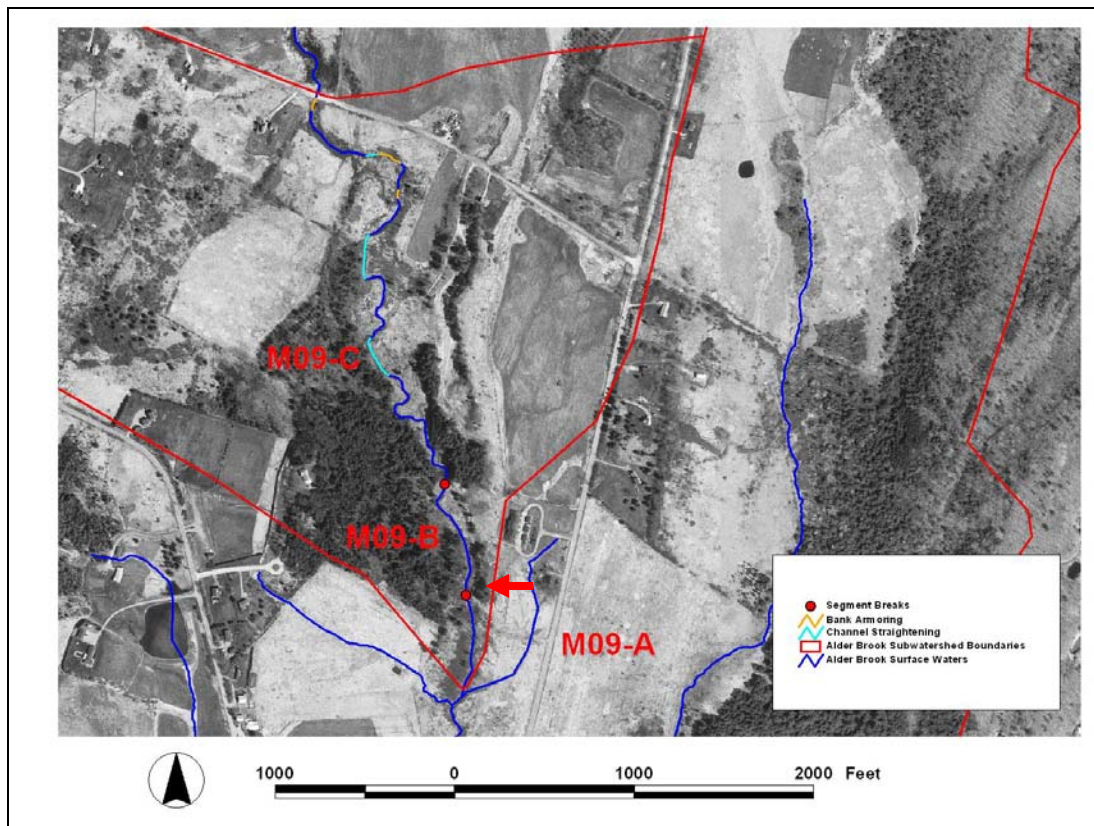
Reach M09 has an overall length of 4435 feet, ending at Col. Page Road to the north. This reach has an overall slope of 0.2%, but the channel gradient is variable and was the basis for creating three segments. Segments A and B are both low gradient E-type streams with planebed features and a mix of gravel and sand substrate. RGA and RHA scores noted for segment A are identical to those calculated for downstream segment M08-C due to the similarity of these segments. Beaver dams were observed in

Segment B and therefore the reach was not assessed for RGA and RHA scores. Segment C has a slightly higher gradient than the overall reach gradient, and C-type geometry with riffle-pool bedform has been noted in the field summary sheets. Significant channel straightening and bank armoring were noted in the upper section of this segment, which is leading to some minor changes in planform. Since there is good floodplain connectivity and buffer integrity in this reach, it is not likely that efforts to restore natural channel sinuosity would improve sediment attenuation or habitat conditions. Therefore, no project areas have been identified.

**Figure 25. Direct Channel Impact Mapping for Reach M09**

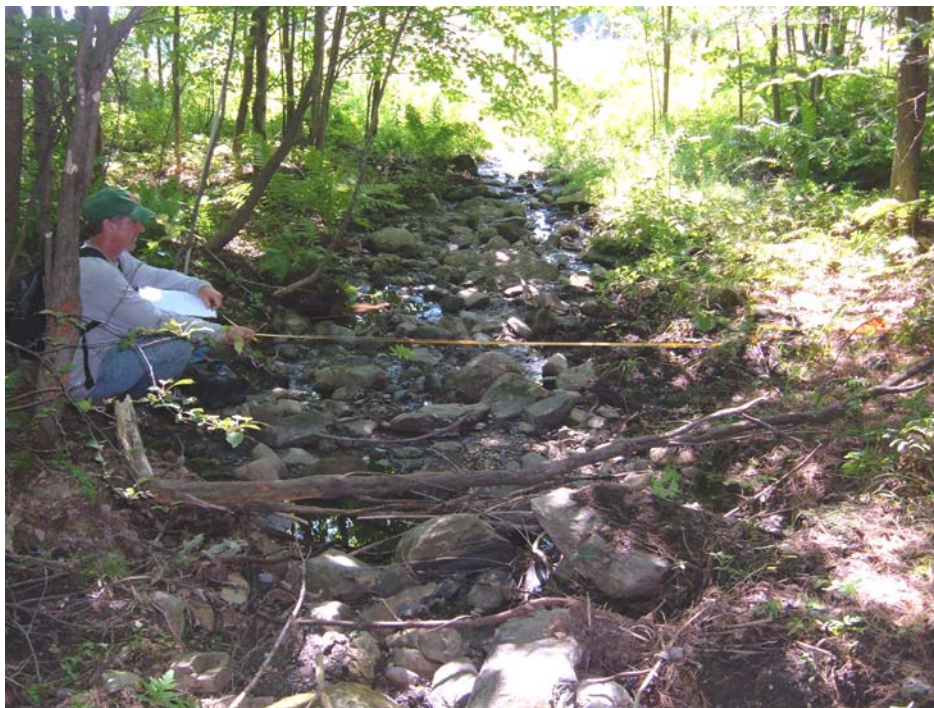
**Figure 28. Channel Cross Section for Reach M15**

Headwaters Reach M15 begins at the Rollin Irish Road crossing and extends approximately 7000 feet through a forested area before reaching the source of Alder Brook: a beaver pond at 900 feet elevation. The overall gradient of this reach is 3.8%, resulting in a cobble-bottomed channel with B-type geometry (see Figure 28). A small amount of historic straightening was observed in the lower part of the reach, but does not appear to have adversely affected the overall stability of the channel. Therefore, geomorphic stability and habitat conditions have been assessed as good with a Channel Evolution Stage of I. No project areas have been identified for this reach.

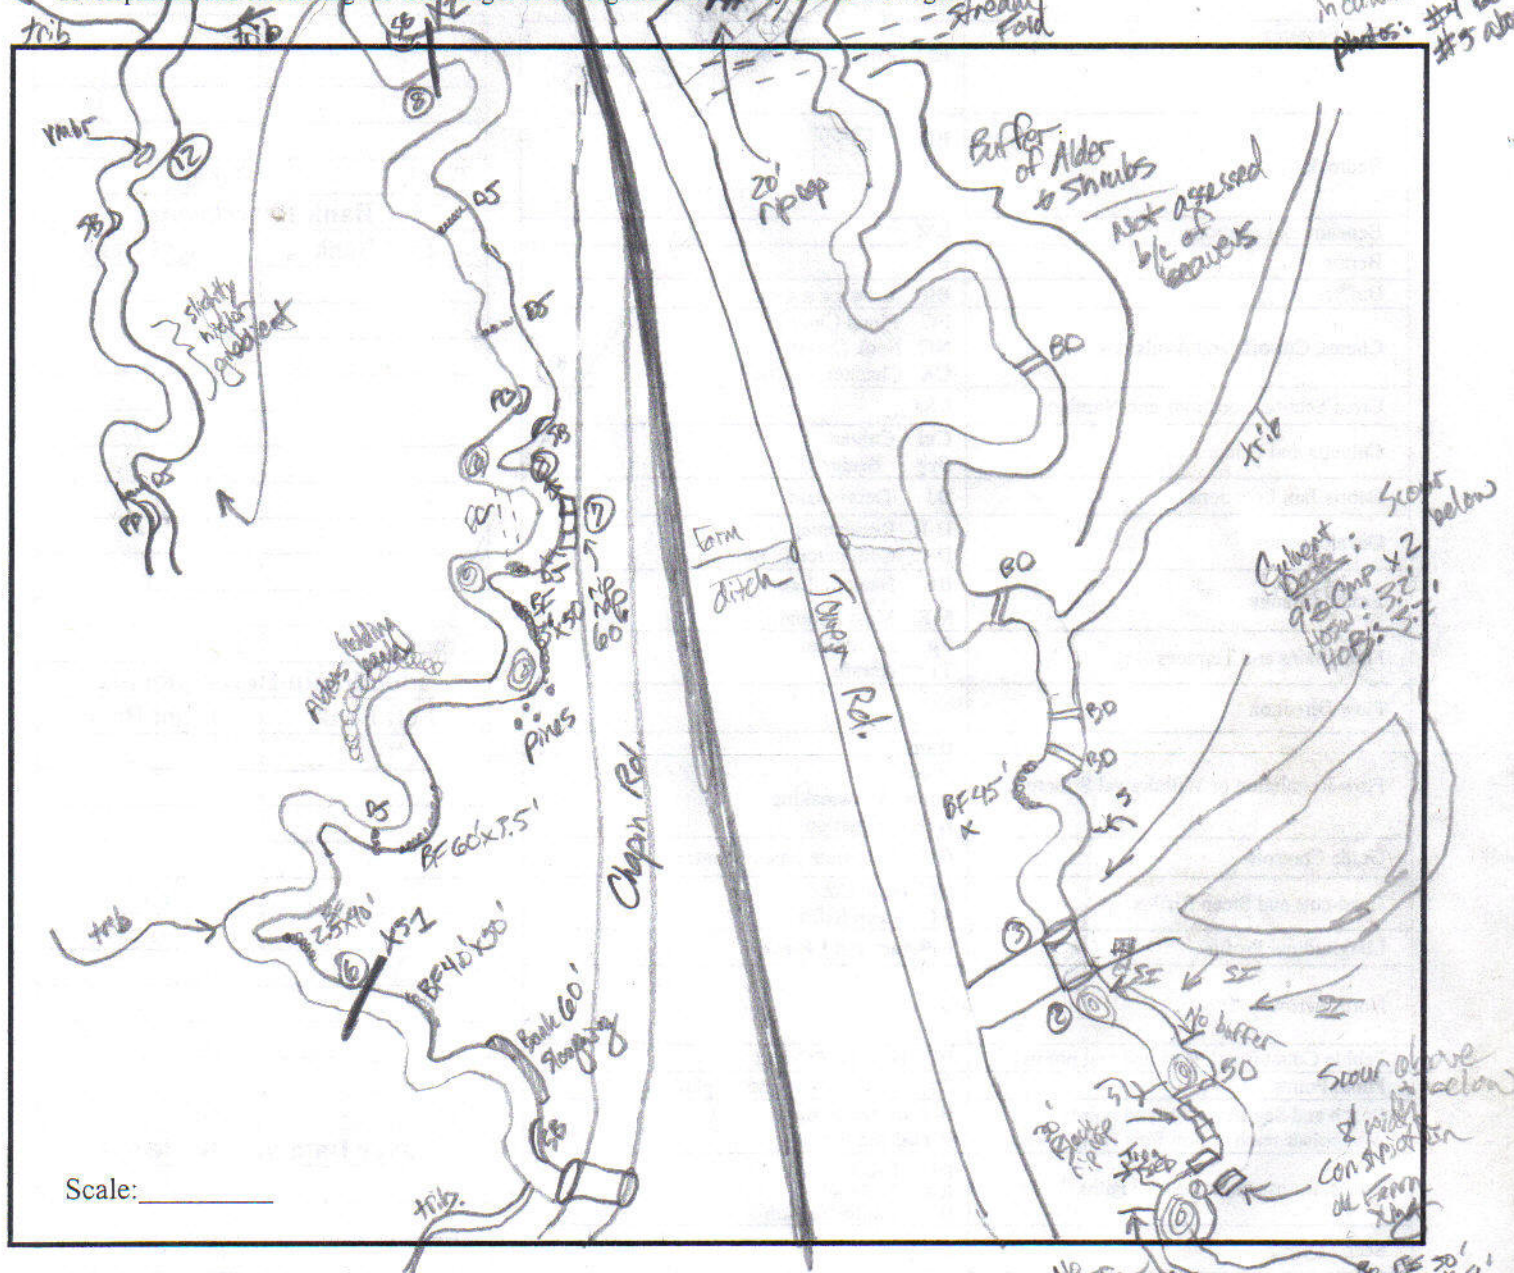
Chopin Rd.  
Culvert Data:  
15' Oomp  
HOB: 2.6'  
Depth  
in culvert: 2.6'  
photos: #4 below  
#5 above
