# **A century of urban landslides: the legacy and consequences of altering riverbank landscapes**

**\*Isabella B. Bennett<sup>1,2</sup> and P. R. Bierman<sup>1,2</sup>**

## **ABSTRACT**

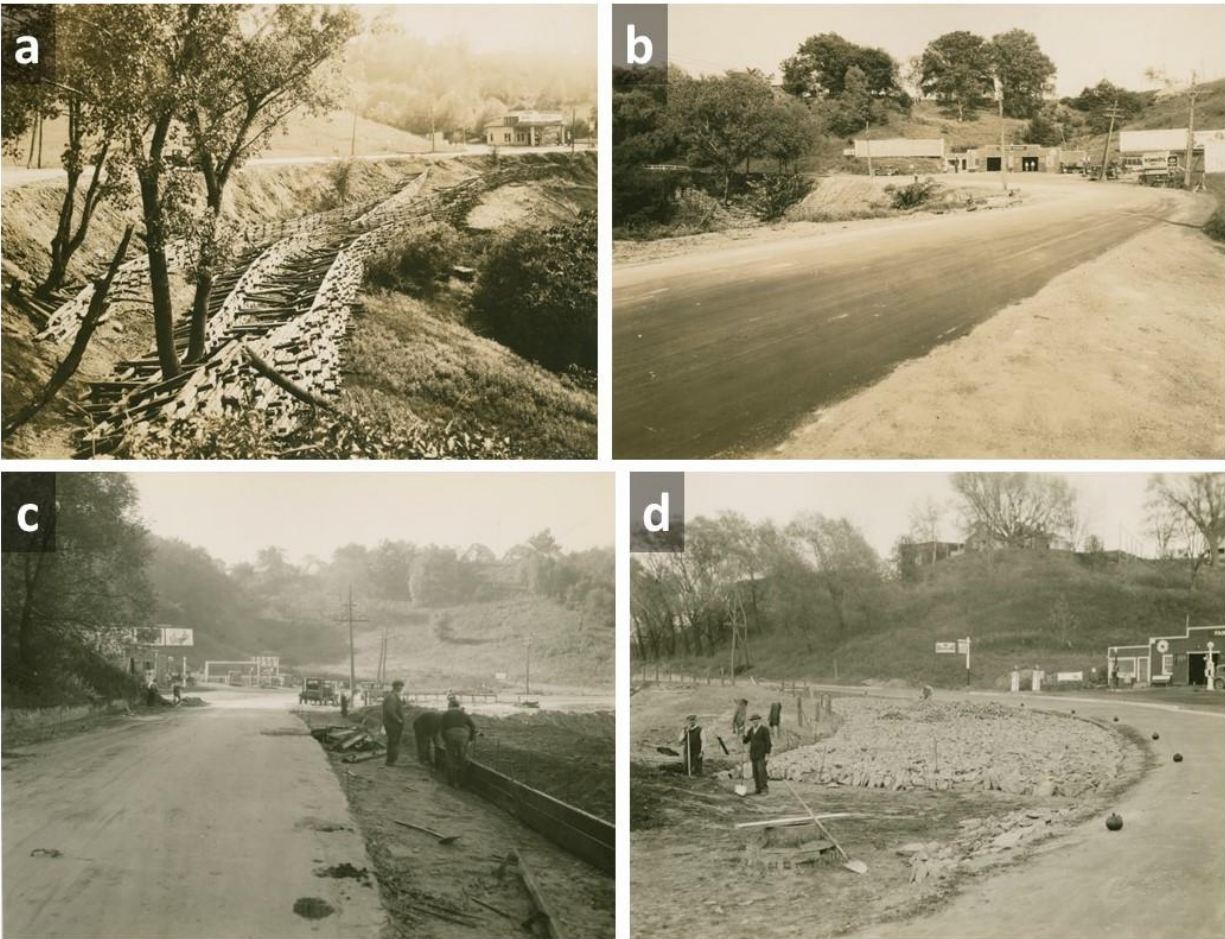
**Fig. 2.**

500 **Figure 2 caption:** *Installation of wooden cribbing material along the northern bank of Riverside*  
501 *Avenue near 114 Riverside Avenue to widen the road (a, b). (c, d) the subsequent addition of fill*  
502 *material on top of that cribbing. (a) and (c) are looking west, (b) and (d) are looking east. Photo*  
503 *source: McAllister Collection, University of Vermont, Special Collections, 1931.*

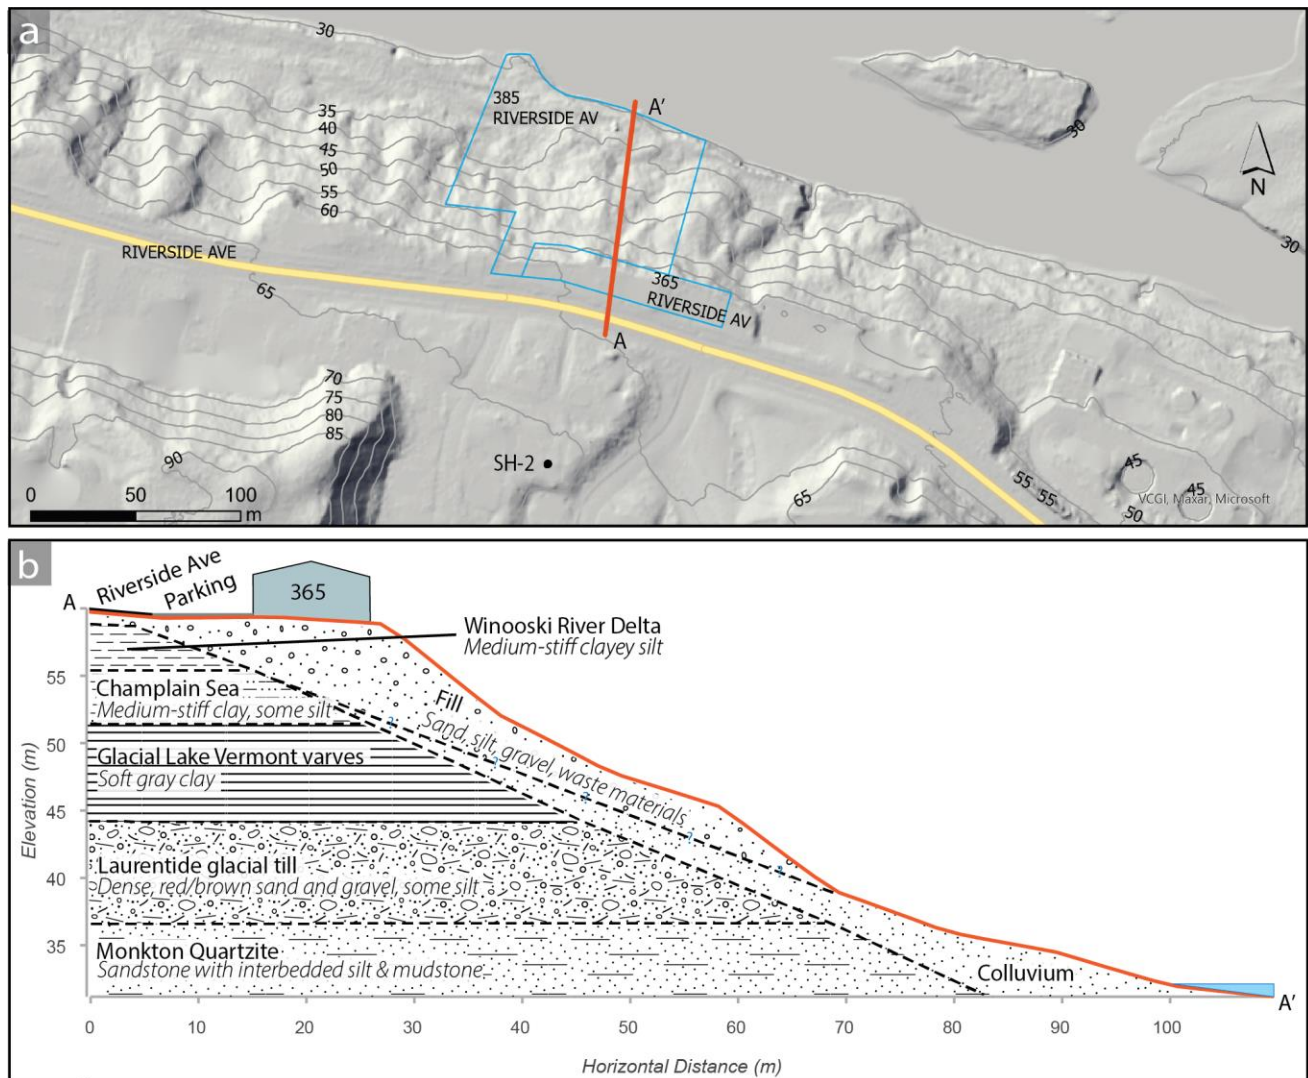
**Fig. 3.**

504 **Figure 3 caption:** *Schematic cross section bisecting the 365 Riverside Avenue parcel.*  
505 *Using data from borehole SH-2 and local stratigraphic descriptions, we developed a schematic*  
506 *cross section of the slope at 365 Riverside Avenue (Sanborn, Head & Associates Inc. 2021;*  
507 *Wright n.d.). We synthesized material descriptions (b) from Sanborn, Head & Associates Inc.*  
508 *(2021).*

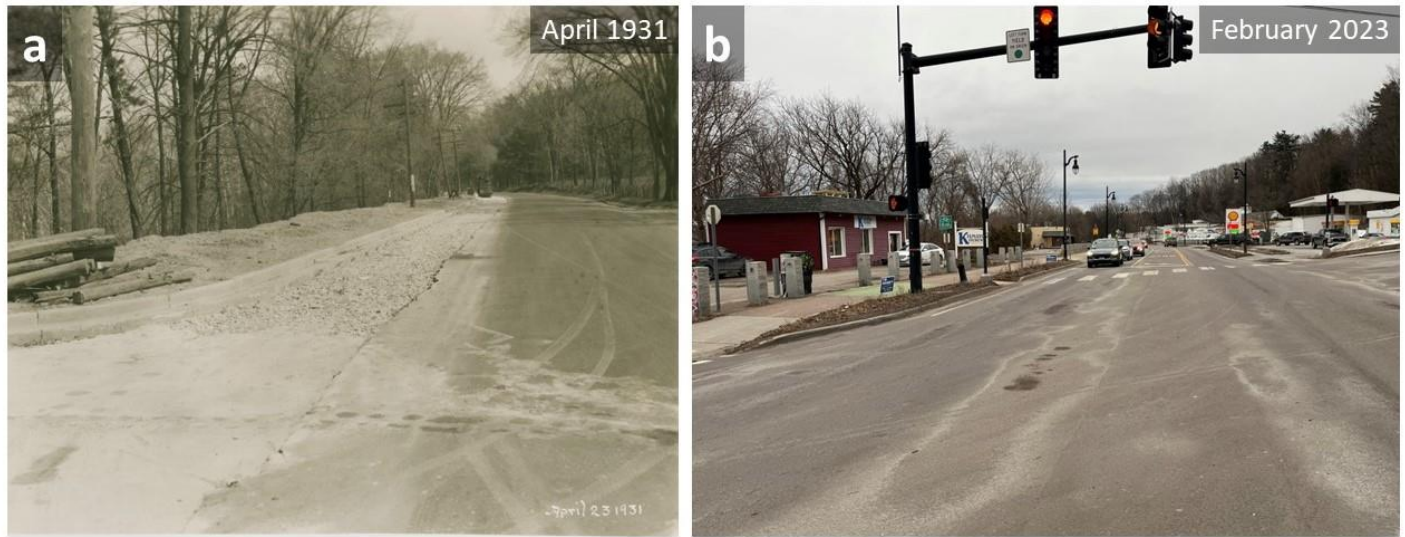
**Fig. 4.**

509 **Figure 4 caption:** *Comparison of a historic photograph and rephotograph (at 505 Riverside*  
510 *Ave) demonstrates development and width of fill emplacement between 1931 and 2023. The*  
511 *image on the left (1931) shows the recently paved road and the fill emplaced on the left side and*  
512 *along the slope. Note the mature trees on the slope. The right image (2023) shows the modern*  
513 *extent of fill and development that has been emplaced on the slope over the preceding 90 years.*  
514 *The red building sits entirely on fill material. Historic photo source: McAllister Collection,*  
515 *University of Vermont, Special Collections, 1931.*

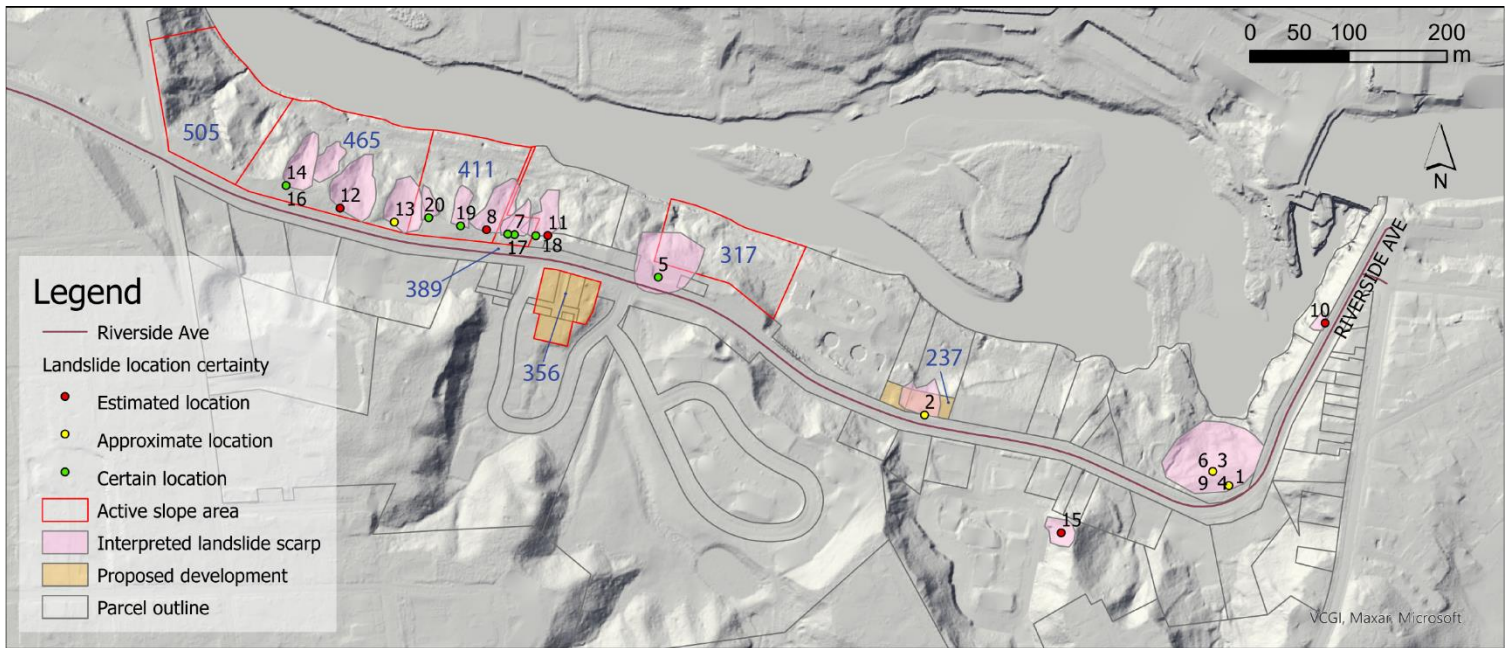
**Fig. 5.**

517 **Figure 5 caption:** *Map of landslide and active slope locations along Riverside Avenue,*  
 518 *Burlington, VT. We compared available location information with the 2014 regional Digital*  
 519 *Elevation Model to estimate the location of each landslide (see location certainty in figure*  
 520 *legend) and outlined the visible scarp most proximal to each location description. The numbers*  
 521 *associated with each location are in chronological order and correspond to the landslides as*  
 522 *listed in Table 1. Due to overlapping landslides and reactivation, these scarp outlines are not*  
 523 *definitive, with the exception of 5, 18, 19, and 20, which were well documented and*  
 524 *georeferenced. Active slope areas from the 2020 Slope Inspection are outlined in red (Hoyle,*  
 525 *Tanner & Associates Inc. 2020; VCGI 2017). Two proposed locations for 64+ apartment*  
 526 *buildings are highlighted in yellow (Gustin, 2021 June, July).*
