Alburg Mobile Home Deconstruction Project

Submitted to:
The Department of Environmental Conservation

Prepared by:
Kendall Kahl and Erin Makowsky
Project Advisor Dan Baker
Department of Community Development and Applied Economics

April 2006

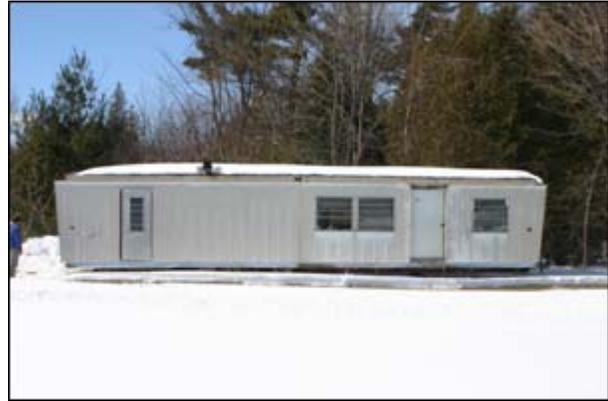
Exterior: The area around the mobile home is clear of obstacles. The property was very well kept. The backside of the trailer faced the woods and was approximately 12 feet in distance. The exterior siding of the mobile home was metal.

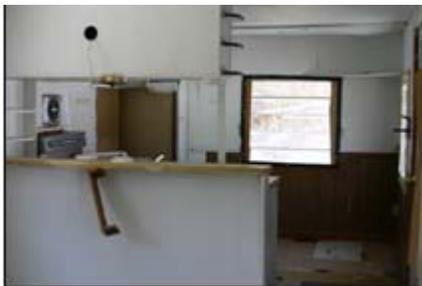
Interior: The mobile home had obviously been cleared of most trash and debris. The interior was carpeted, had a wood bar unit, intact sink, linoleum floors, bathtub, toilet, bathroom sink, generator, and had in tact doors.

Accessibility: The mobile home is easily accessible. The driveway led straight to the mobile home, which was very visible from the public road.

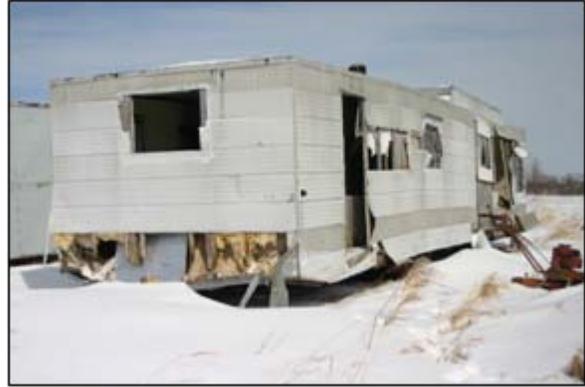
Exterior: The siding is metal. There were no large obstacles immediately surrounding the home besides a second mobile home near by. It did not rest upon a permanent foundation. The exterior of the mobile home was made of metal siding with wood underneath.

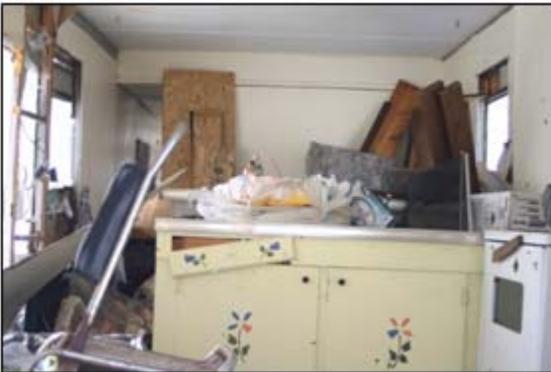
Interior: There was some scrap plywood loose on the inside of the trailer but it was not possible to record a more detailed inventory of interior parts because of the overwhelming amount of trash covering the floors. There was mostly large black trash bags filled with garbage thrown in heaps throughout the interior.

Accessibility: Again, the only foreseen obstacle in removing this mobile home was the distance from of this mobile home to another abandoned mobile home. It would be beneficial to remove the home in front of this one, which is closer to the access road, before attempting to remove this one. The two

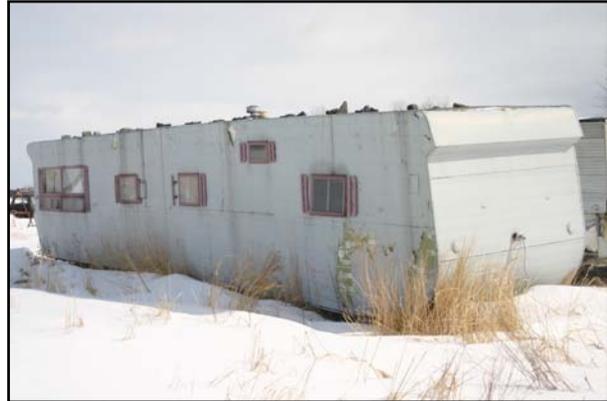
Exterior: The siding of the mobile home is metal. Items such as tires and metal structures were visible from under the snow. This trailer was set behind an intact trailer. However, this would not cause problems with accessibility. There was no permanent foundation.

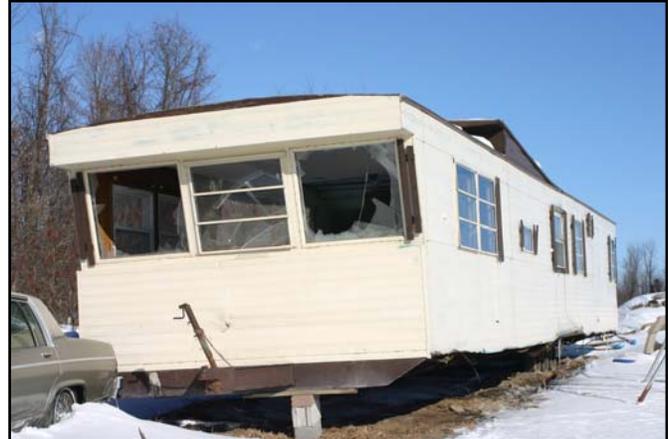
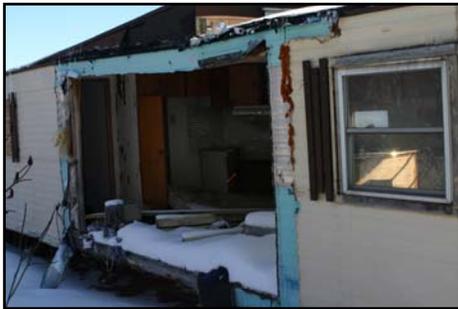
Exterior: The siding is metal, and there is a lot of large junk items and debris around the trailer, including an old car parked close by. It was lifted on cinder blocks at the near end in the above photograph, and supported on axle and wheels at the far end. Many of the

windows were broken, and a large hole extending the full height of the trailer is missing from the long side (right).

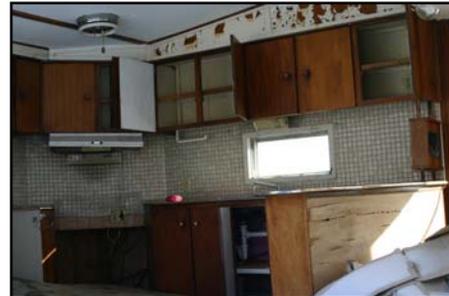
Interior: The interior was full of trash. Most of the walls appeared to be intact. There were a few old mattresses, an old tank, and junk and debris strewn throughout the interior.

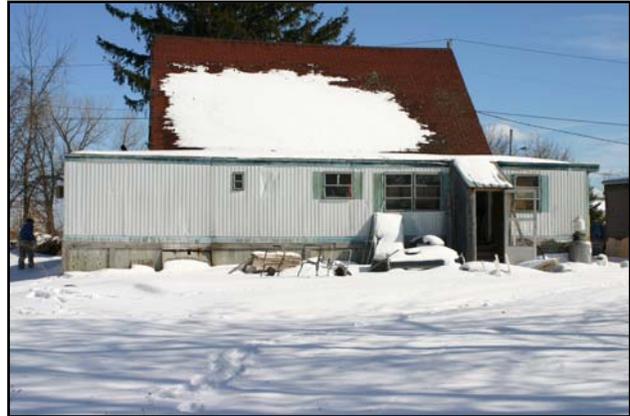
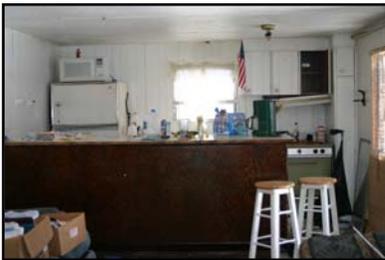
Exterior: The exterior siding is aluminum. There is a wooden foundation about 3 ft high around entire base of the mobile home. There is also a small porch/entrance way with 4 steps leading up to the door. This porch structure and the steps were all made of wood. There is some debris and junk along the front

side of the trailer. It appeared that it was still attached to the propane tanks and would have to be disconnected before removal.

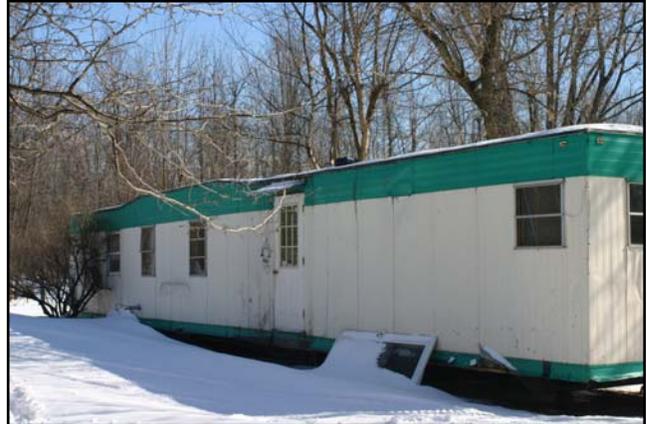
Exterior: Some of the windows were broken. The exterior siding was aluminum. There was no permanent foundation in place or any other exterior additions.

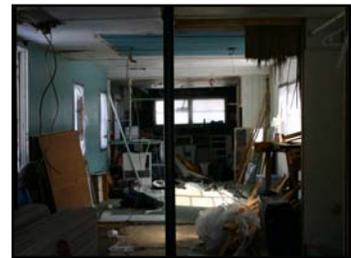
Interior: The inside was fairly open; the only full walls standing were the remnants of a small closet. There was a lot of small junk and old appliances, some intact and some dismantled. It looked as though it had been used as a child's play house at one point, which then became storage for old junk. Part of the perimeter wall had been ripped out, exposing insulation and wood studs. The kitchen had linoleum floors and the rest of the floor space was carpeted.

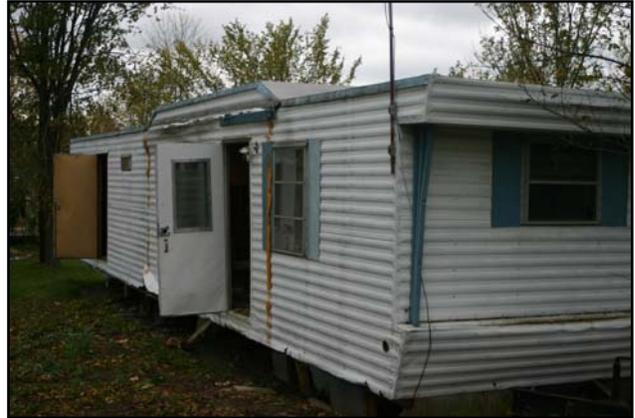
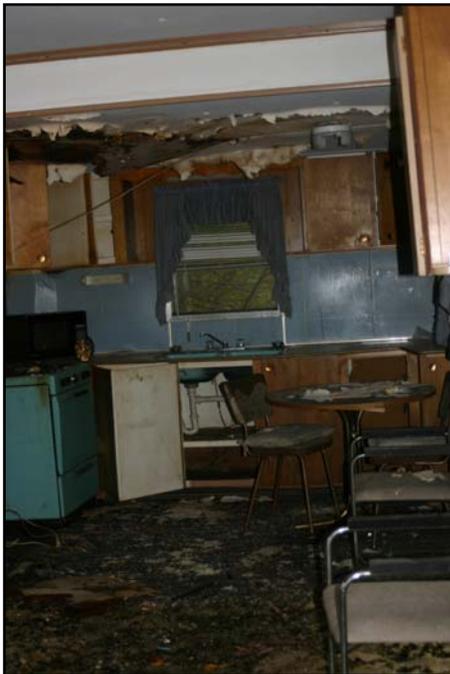
MH-6 has been vacant for several years. The owners wanted to remove the mobile home in order for the lot to be available for rent in Alburg's local campground. The mobile home can be accessed from the road through the campground. The site surrounding the mobile home is void of any obstructions that could pose challenges to removal, and will be relocated to the a central site for deconstruction.

The siding on MH-6 is metal and there is no visible water tank. The interior is free of most non-structural debris. There is an electrical box in the rear bedroom that might hold value. The mobile home does contain a kitchen sink, stove, microwave, wooden kitchen doors, metal bedspring, a bathroom sink and toilet.

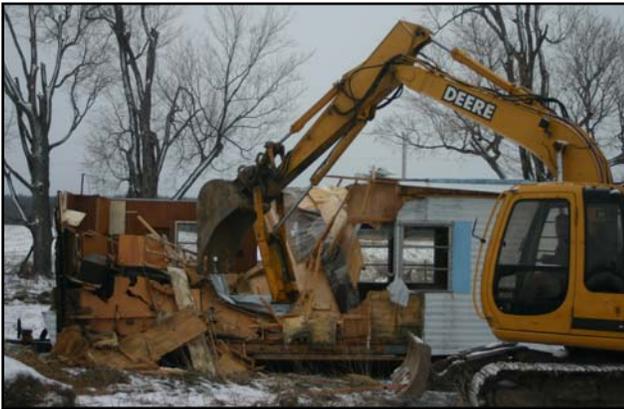
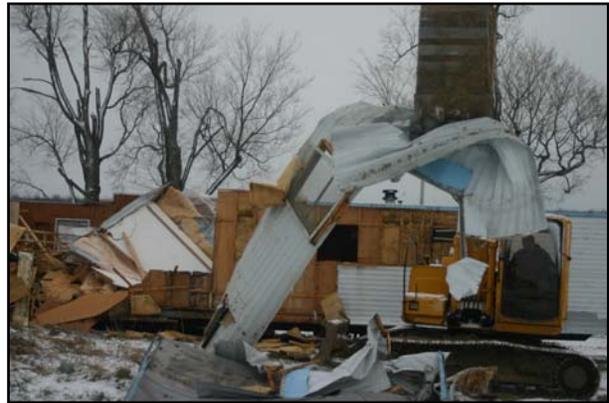
MH-6 was the first of three trailers to be deconstructed on December 7th, 2005 by the Irick construction team. This trailer was relocated from its original site to the deconstruction site. Much of the material in this mobile home was rotting, which made it difficult to peel the metal from the exterior of the structure. The excavator operator, was meticulous about removing all metal components, and was able to do so mainly with the hydraulic thumb. It took approximately 30 minutes to chop up the metal frame into small enough section to fit in the trucks. Additionally, a stove, metal bed frame, and microwave were all separated with the metal for recycling or reuse.

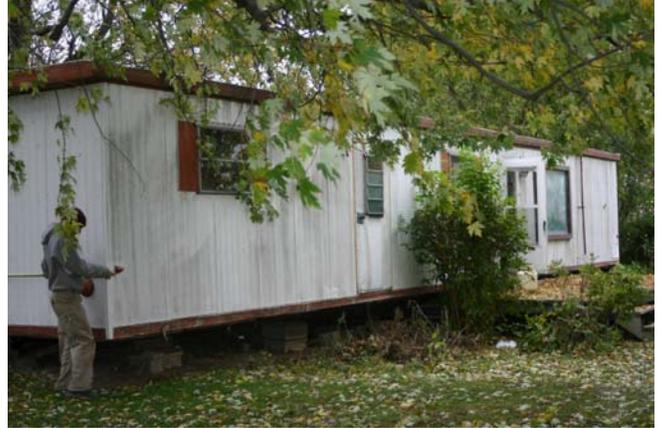
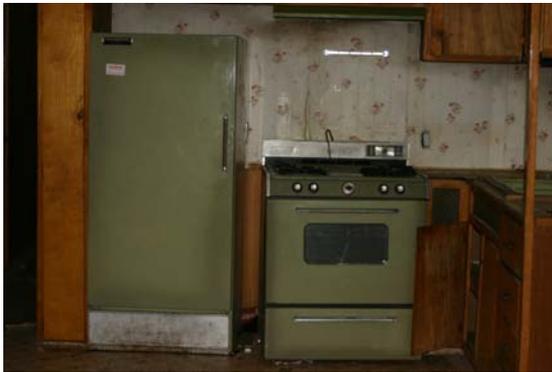
MH-7 is located near the entrance of a campground in Alburg. Although the home does not contain running water or electricity it was used as housing up until last year. This mobile home is closer to the main road and entrance of the campground and there are numerous trees and shrubs that could potentially complicate removal. The home is sitting on cinderblocks but the owner is confident that he can put tires on the axels and move it across town. This property is approximately 5.3 miles from the Farm where the deconstruction will take place.

The siding on MH-7 is not metal. This is the first mobile home to be deconstructed through this project that does not contain metal siding. There is a wooden porch that is in good condition that will be salvaged. The owners have already sold it to another tenant on the campground. There is a stove, sink, and refrigerator in the kitchen along with a bathtub and toilet in the bathroom.

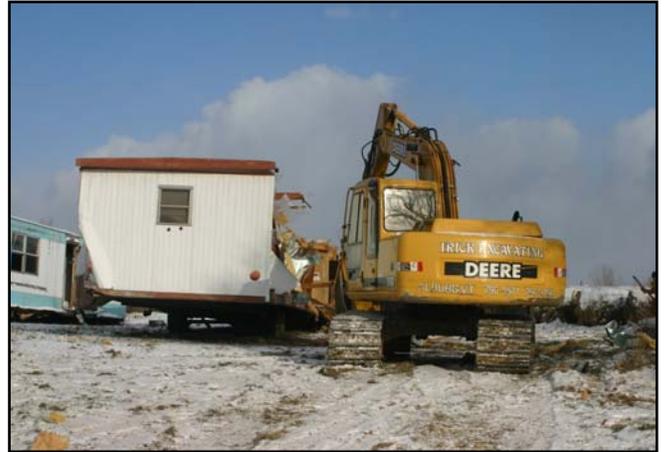
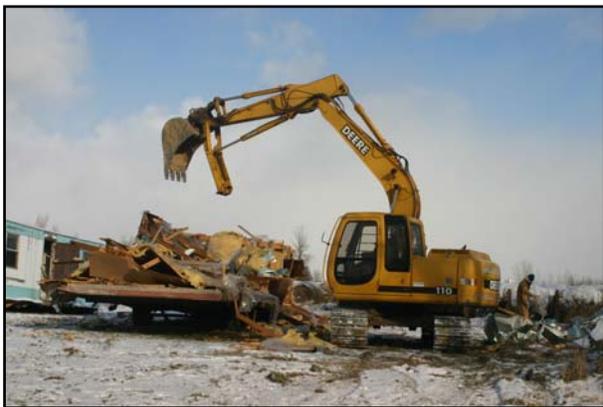
The method of waste removal involved tearing the siding from the exterior walls with the precision of a hydraulic thumb. Following the extraction of the metal siding, the remnants of the walls were crushed into the center of the structure. The metal and waste were then separated into two piles and the remaining frame was chopped into pieces and placed in the metal pile.

The deconstruction lasted 1hr and 45 min, and the construction crew noted that of the three homes removed on February 14th this structure had the least complications. This may be attributed to the less rotted state of the structure, as compared to the other homes. This mobile home's weight was 5.09 tons; 3.4 tons of waste material, and 1.69 tons of salvaged metal. The total amount of salvageable materials accounted for 33% of the total deconstruction weight.

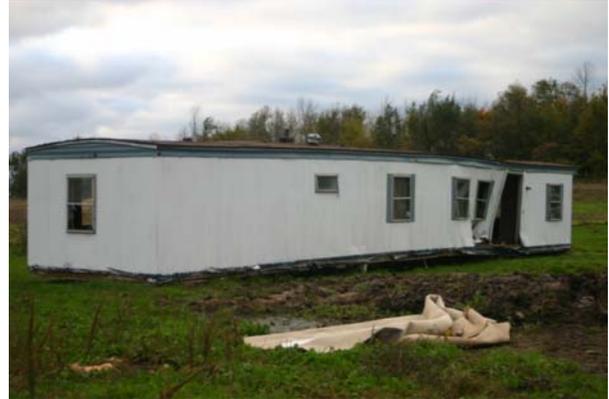
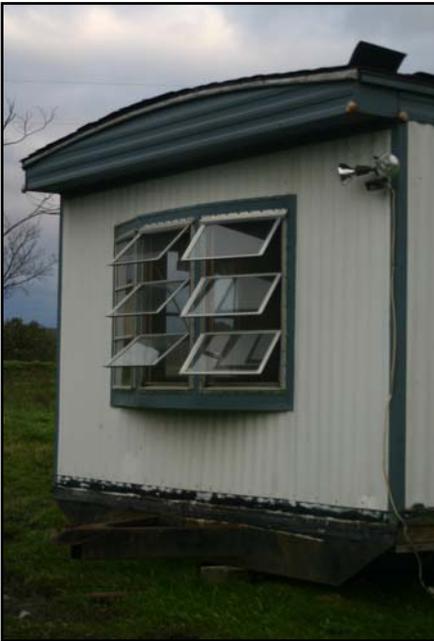
MH-8 previously housed farm laborers. The house is in severe disrepair due to lack of maintenance and irresponsible tenants. The three abandoned mobile homes located on the centralized farm are eyesores, and the owners have been unable to dispose of them because of the excessive costs.

This mobile home sits in a swampy field adjacent from the owner's house. The wet surrounding land is a challenge to deconstruction. The contractors required that the ground be frozen prior to any deconstruction activities. The exterior of this home consisted of metal siding. The home was void of all non-structural waste prior to deconstruction. The interior appliances that remained in the home consisted of a kitchen sink, stove, bathroom sink, bathtub, and toilet.

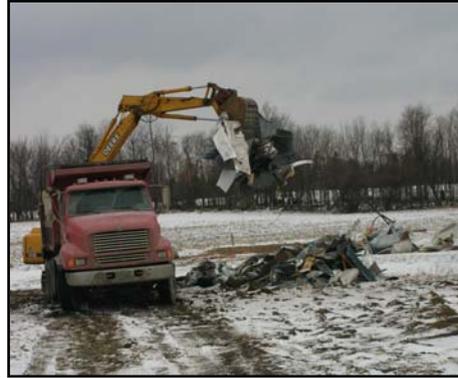
MH-8 Deconstruction Summary

MH-8 was removed on February 14th, 2006 by the Irick construction crew. This home proved to be the most challenging to deconstruct, though the entire demolition process took only 1 hour 45 minutes. The mobile home was different than the others because the roof consisted of plywood covered by tin, followed by another layer of plywood and finally an exterior layer of shingles. Although the contractor was able to remove the tin from the roof it was more time consuming. Additionally, while trying to peel and collect all metal from the exterior the walls kept collapsing in. This scenario had previously occurred in the homes that were rotting out. It was also noted that the tin did not peel off easily in strips but instead broke into small pieces. The contractors suggested that this structure might have been assembled with older, lower quality tin, making it exceedingly difficult to strip from the exterior of the walls. The total weight of MH-8 was 4.59 tons, 3.19 tons of waste material, and 1.4 tons of salvaged metal. The salvageable material amounted to 31% of this mobile home's total deconstruction weight.

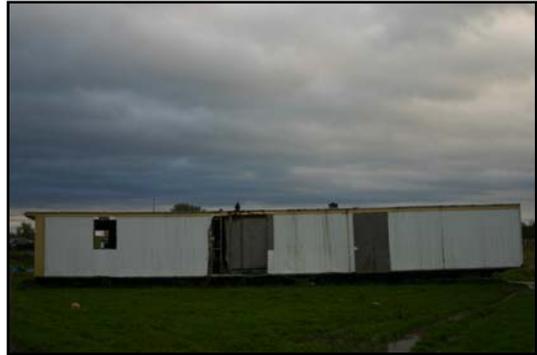
This mobile home sat parallel to MH-9, both of which were subject to sodden ground.

This is the only foreseeable obstacle to removal since there are no physical obstacles that would inhibit vehicular access. The interior does contain additional non-structural waste that will be removed by the owners before deconstruction, as per the agreement between the ARC and homeowners.

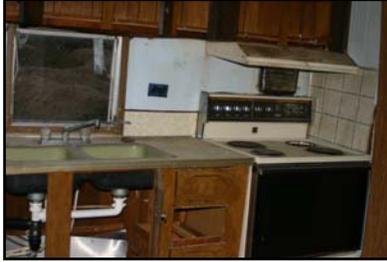
MH-10 resides on a dry section of the farm and is easily accessible. There is sufficient amount of dry and empty surrounding property, and it is likely that any mobile homes transported to the farm will be relocated to this site. The exterior consists of metal siding. The home is clear of interior junk and contains no appliances.

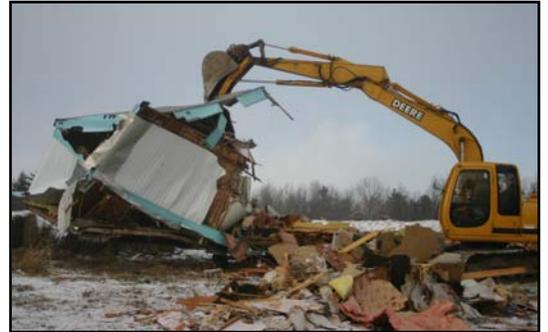
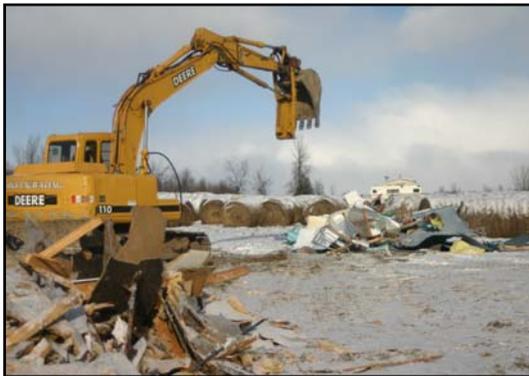
The demolition and waste removal process for MH-10 lasted 1 hour 45 minutes. The process of deconstruction varied slightly as compared to the method used on the previous mobile homes. Unlike the method of peeling large portions of metal from each side of the home, the excavator systematically worked its way from one end of the mobile home to the other, removing metal siding in sections. The contractors noted that this method allowed for the metal to be removed with more ease. After each section of metal was removed the coinciding sections of wall was broken into the middle of the structure. A significant amount of the home contained mold and rotting wood, which slowed down the deconstruction process. In addition to metal components, a stove and water tank were sorted from the waste pile and appropriately recycled. This mobile home's weight was 5.16 tons; 3.54 tons of waste material, and 1.62 tons of salvaged metal. The total amount of salvageable materials accounted for 31% of the total deconstruction weight.

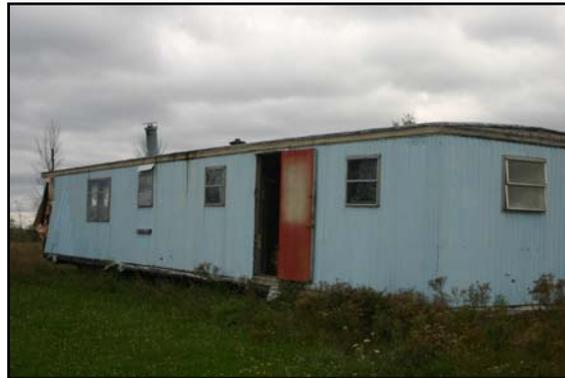
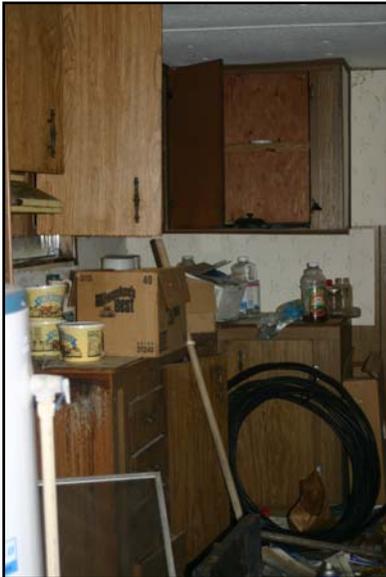
NR-3 has been vacant for approximately one year. The mobile home is close in proximity to the central deconstruction site. The home was rolled or moved a year ago with no notable complications. The owner is confident he will be able to put wheels on it and move it to the alternative property. The siding

is metal and there is a water heater that the owner wishes to keep. There is some excess non-structural debris within the mobile home, which the owner has been asked to remove of before November 11th. The

mobile home does not have a kitchen and the flooring is rotting through which made the interior inventory difficult. If the grounds are not frozen or dry by the removal date there could possible be complications with moving it to the farm.
